**BROUGHDALE DYKE**

## Dyke Inspection Sheet

Report No.: 1 of 2

Date: June 21, 2004  
Inspected By: N.Oliveira, S.Jeater  
Further Investigative Work •

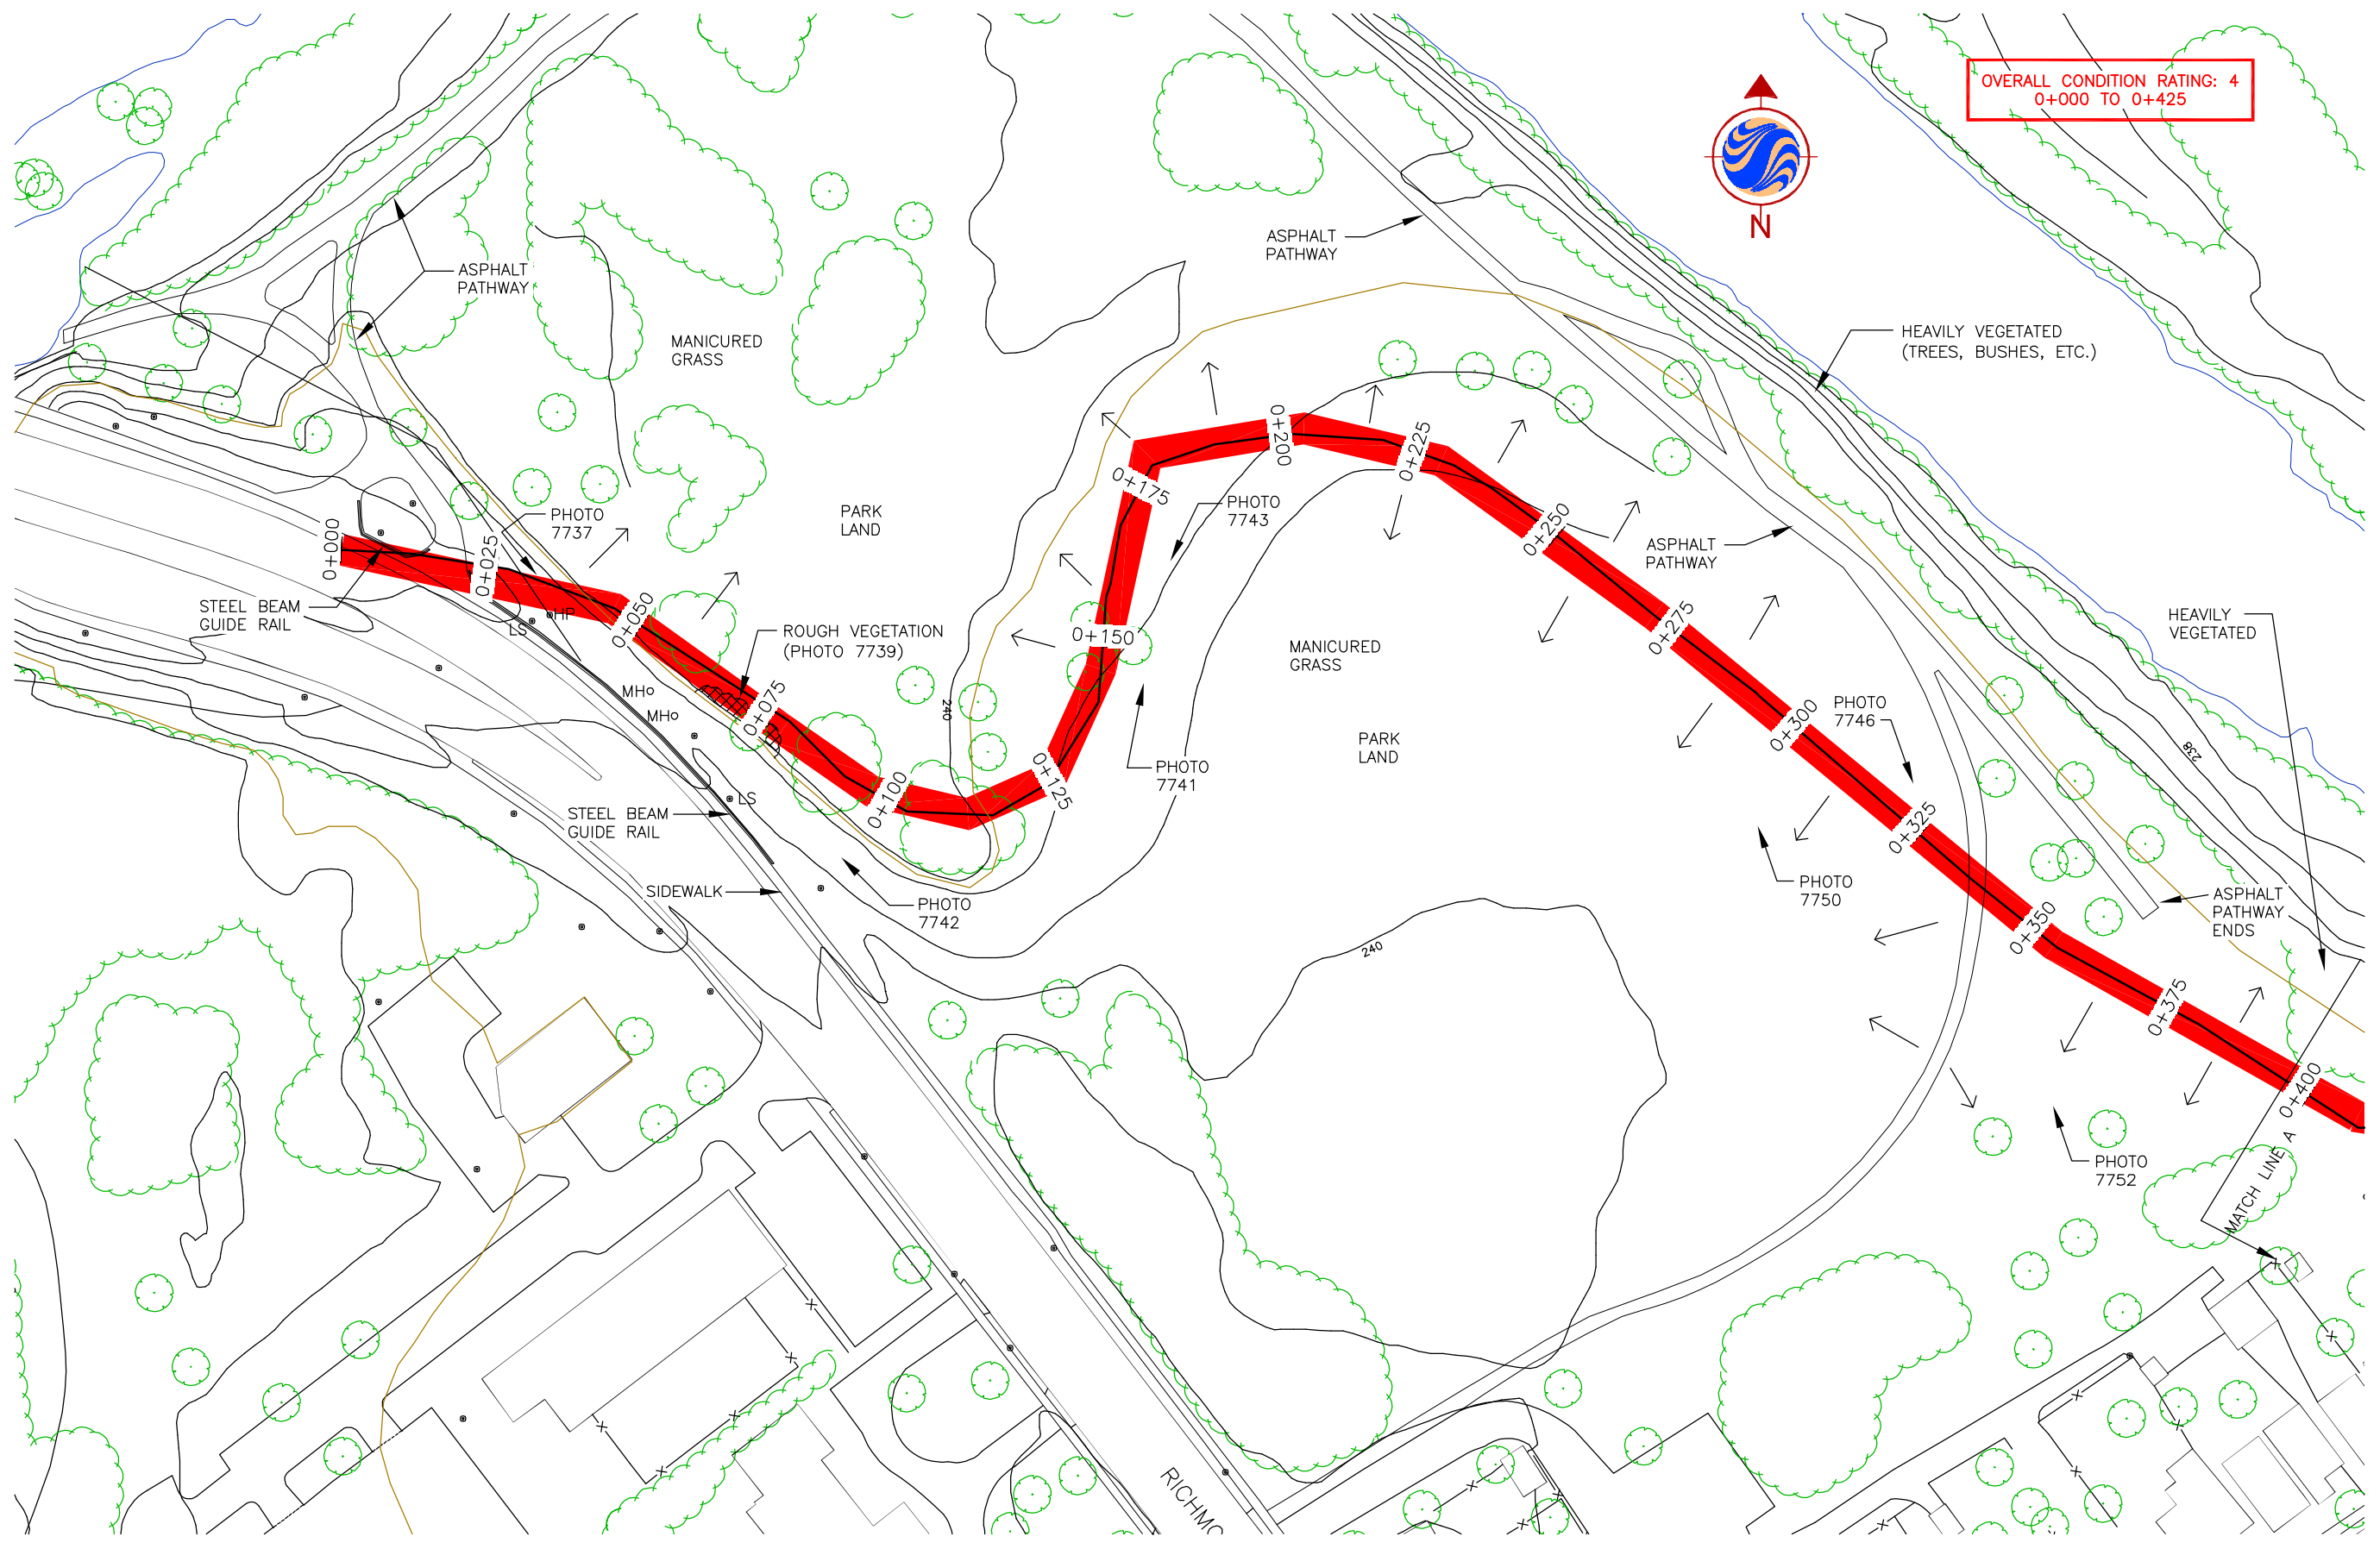
OVERALL CONDITION RATING: 4  
0+000 TO 0+425

General Information	
<u>Section Inspected:</u> Complete • Section ✓ Specify: 0+000 to 0+425 m	Overall Condition Rating: 4 (this section only) <b>Comments:</b>
<u>Adjacent Property Use:</u> Residential ✓ Parkland ✓ Commercial • Industrial •	<b>Comments:</b> Adjacent parkland (Ross Park) from St. 0+000 to 0+425, becoming residential at 0+425.
Dyke Facing	
<u>Dyke Face Material:</u> Concrete • Gabion •  Earthfill ✓ Other ✓ Specify: manicured grass surface/rough vegetation/trees  <b>Condition Rating:</b> 4 <b>Comments:</b> Dyke face consists primarily of an earth berm with manicured grass covering (maintained by the City). Rough vegetation consisting of bushes/shrubs at ~St. 0+070 to 0+080 (photo 7739). Scattered trees located along dyke face/toe from ~St. 0+125 to 0+160.	<u>Structural Condition (Dyke Face):</u> Erosion • Damage (impact, cracks, etc) • Movement (including unevenness, slipping, bulging or slumping) • Specify type: <b>Condition Rating:</b> 4 <b>Comments:</b> No erosion or movement observed.

<b>General Information</b>	
<u>Section Inspected:</u> Complete • Section ✓ Specify: <u>0+425</u> to <u>0+766.8</u> m	Overall Condition Rating: 4 (this section only) <b>Comments:</b> Generally less steep conditions encountered in comparison to the previous section inspected, however several steep areas were noted and should be monitored over time.
<u>Adjacent Property Use:</u> Residential ✓ Parkland ✓ Commercial • Industrial •	<b>Comments:</b> Adjacent residential from 0+425 to 0+525. A daycare facility and commercial businesses border the dyke from 0+525 to 0+600 (termination at Wellington Road).
<b>Dyke Facing</b>	
<u>Dyke Face Material:</u> Concrete • Gabion ✓  Earthfill ✓ Other ✓ Specify: Rough vegetation (photo 7755)/wood retaining wall  <b>Condition Rating:</b> 4 <b>Comments:</b> Dyke face consists primarily of moderate to dense vegetation (trees, bushes, shrubs, wild grass). Some concrete rubble also noted extending down dyke face below drainage outlet pipe at St. 0+710. Gabion basket flood wall from ~St. 0+625 (photo 7773) converting to wood retaining wall on gabion baskets from St. 0+660 to ~0+685 (photo 7778).	<u>Structural Condition (Dyke Face):</u> Erosion • Damage (impact, cracks, etc) ✓ Movement (including unevenness, slipping, bulging or slumping) • Specify type: <b>Condition Rating:</b> 4 <b>Comments:</b> Some rotting and minor damage to wood retaining wall observed. Remainder of dyke facing appears to be in good condition.
