BYRON DYKE

Dyke Inspection Sheet

Report No.: 1 of 1

Date: June 21, 2004
Inspected By: N.Oliveira, S.Jeater
Further Investigative Work •

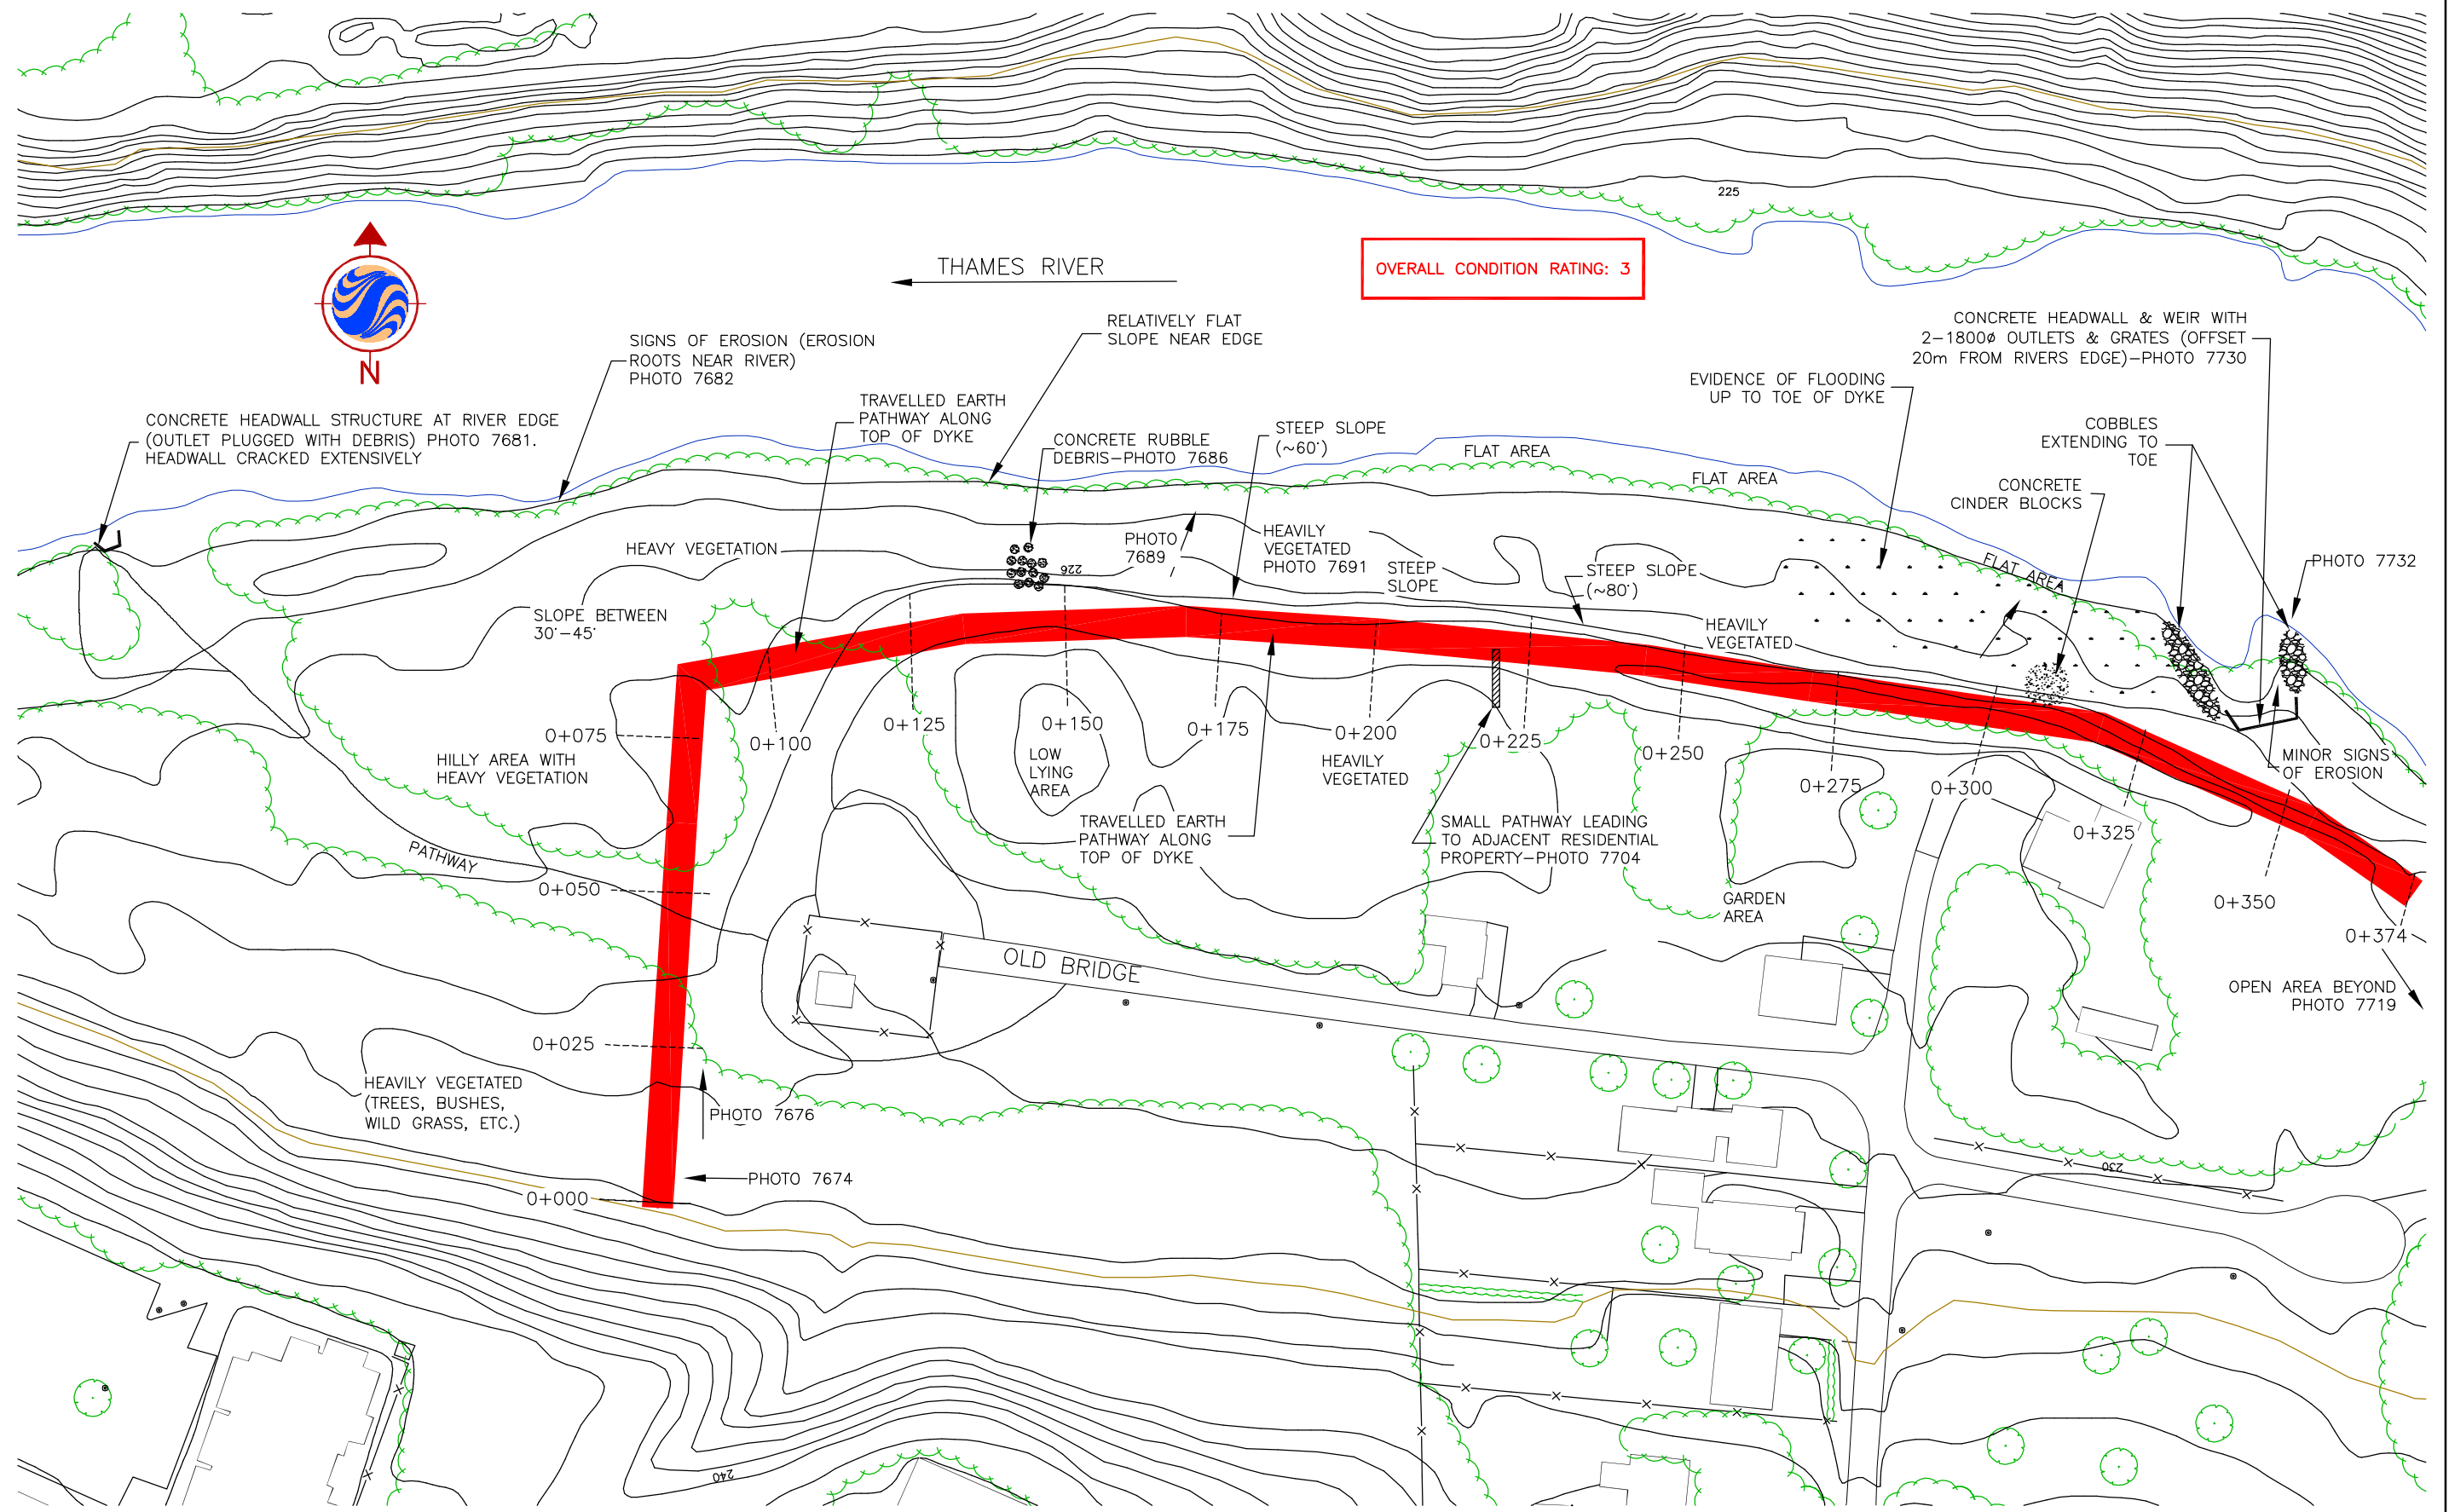
General Information	
<u>Section Inspected:</u> Complete <input checked="" type="checkbox"/> Section <input type="checkbox"/> Specify: _____ to _____ m	Overall Condition Rating: 3 (this section only) Comments: Condition rating relates to difficulty in assessing dyke due to dense vegetation present, noticeable signs of erosion adjacent to the toe and damaged concrete headwall and plugged storm outlet.
<u>Adjacent Property Use:</u> Residential <input checked="" type="checkbox"/> Parkland <input checked="" type="checkbox"/> Commercial <input type="checkbox"/> Industrial <input checked="" type="checkbox"/>	Comments: Adjacent pumping station near St. 0+030. Primarily heavily wooded land from St. 0+050 to 0+200. Residential properties border the dyke from St. 0+200 to the end of the dyke.
Dyke Facing	
<u>Dyke Face Material:</u> Concrete <input type="checkbox"/> Gabion <input type="checkbox"/> Earthfill <input checked="" type="checkbox"/> Other <input checked="" type="checkbox"/> Specify: Trees, bushes, shrubs, wild grass (photo 7674) and cobbles Condition Rating: 3 Comments: Dyke face consists primarily of dense vegetation (trees, bushes, shrubs, wild grass). Cobbles along the dyke face extending to toe at St. 0+330 to 0+360 (adjacent to concrete headwall structure, see photo 7732).	<u>Structural Condition (Dyke Face):</u> Erosion <input type="checkbox"/> Damage (impact, cracks, etc) <input type="checkbox"/> Movement (including unevenness, slipping, bulging or slumping) <input checked="" type="checkbox"/> Specify type: Condition Rating: 3 Comments: Various steep sections noted along the dyke face, primarily from St. 0+180 to 0+260 with toppled vegetation (photo 7688).

<u>Toe:</u> Toe Protection Material (concrete, gabion, earth or other) Specify: Primarily earth (soil) with overlying dense vegetation. Erosion Yes <input checked="" type="checkbox"/> No <input type="checkbox"/> Condition Rating: 3 Comments: Signs of erosion noted at and near the toe in several areas (photo 7682), causing exposure of roots.	<u>Joints:</u> (not applicable to earthfill dykes) Sealant Present Yes <input type="checkbox"/> No <input type="checkbox"/> If yes, condition rating: Vegetation (in joints) Yes <input type="checkbox"/> No <input type="checkbox"/> Comments: Not applicable.
<u>Vegetation:</u> None <input type="checkbox"/> Full <input checked="" type="checkbox"/> Partial <input type="checkbox"/> Type: Primarily trees with shrubs, bushes, wild grass, etc. Comments: Vegetation generally well established along side slopes of dyke (photo 7691), however some loss has occurred likely due to the steep slope conditions encountered in several areas. Vegetation along toe of dyke showed evidence of recent flooding in the area.	<u>Water Infiltration:</u> (look for where water can leak behind structure) Yes <input type="checkbox"/> No <input checked="" type="checkbox"/> If yes, due to: Joints <input type="checkbox"/> Cracks <input type="checkbox"/> Liner <input type="checkbox"/> Other (specify) <input type="checkbox"/> Comments:

<p>Yes ✓ No • (if no, proceed to next section) If yes, type of structure (i.e. outlet, headwall, drainage pipe, channel or flush): Specify: Concrete headwall structure with unknown discharge pipe (possible sanitary line) at ~St. 0+050 (photo 7681). Concrete headwall structure with two 1800mm (approx.) storm sewer outlets (photos 7724 and 7726) at St. 0+340. Condition Rating: 2 Comments: Poor rating relates to headwall structure located at St. 0+050. Structure badly cracked and pipe ~80 percent plugged at discharge.</p>	<p><u>Outlet:</u> (check for presence of gates or grates at the outlet) Flap Gate Yes • No • Safety Grate Yes • No ✓ Condition Rating: 4 Comments: No apparent damage to safety grate on storm discharge pipes located at St. 0+340. No safety grates or flap gates located on storm outlet at St. 0+050.</p>
<p><u>Outlet Flow:</u> (check for condition of channel downstream from pipe, obstructions within pipe, etc.) Obstructions Yes ✓ No ✓ Downstream Erosion Yes • No ✓ Comments: Obstruction noted relates to concrete headwall structure located at St. 0+050. No obstructions or erosion noted for the headwall structure at 0+340.</p>	<p>General Comments:</p>

OVERALL CONDITION RATING: 3

CONCRETE HEADWALL STRUCTURE AT RIVER EDGE (OUTLET PLUGGED WITH DEBRIS) PHOTO 7681. HEADWALL CRACKED EXTENSIVELY

SIGNS OF EROSION (EROSION ROOTS NEAR RIVER) PHOTO 7682

CONCRETE RUBBLE DEBRIS—PHOTO 7686

EVIDENCE OF FLOODING UP TO TOE OF DYKE

CONCRETE HEADWALL & WEIR WITH 2-1800Ø OUTLETS & GRATES (OFFSET 20m FROM RIVERS EDGE)—PHOTO 7730
