**NELSON/CLARENCE DYKE**

**Dyke Inspection Sheet**

**Report No.: 1 of 2**

**Report No.: 2 of 2**

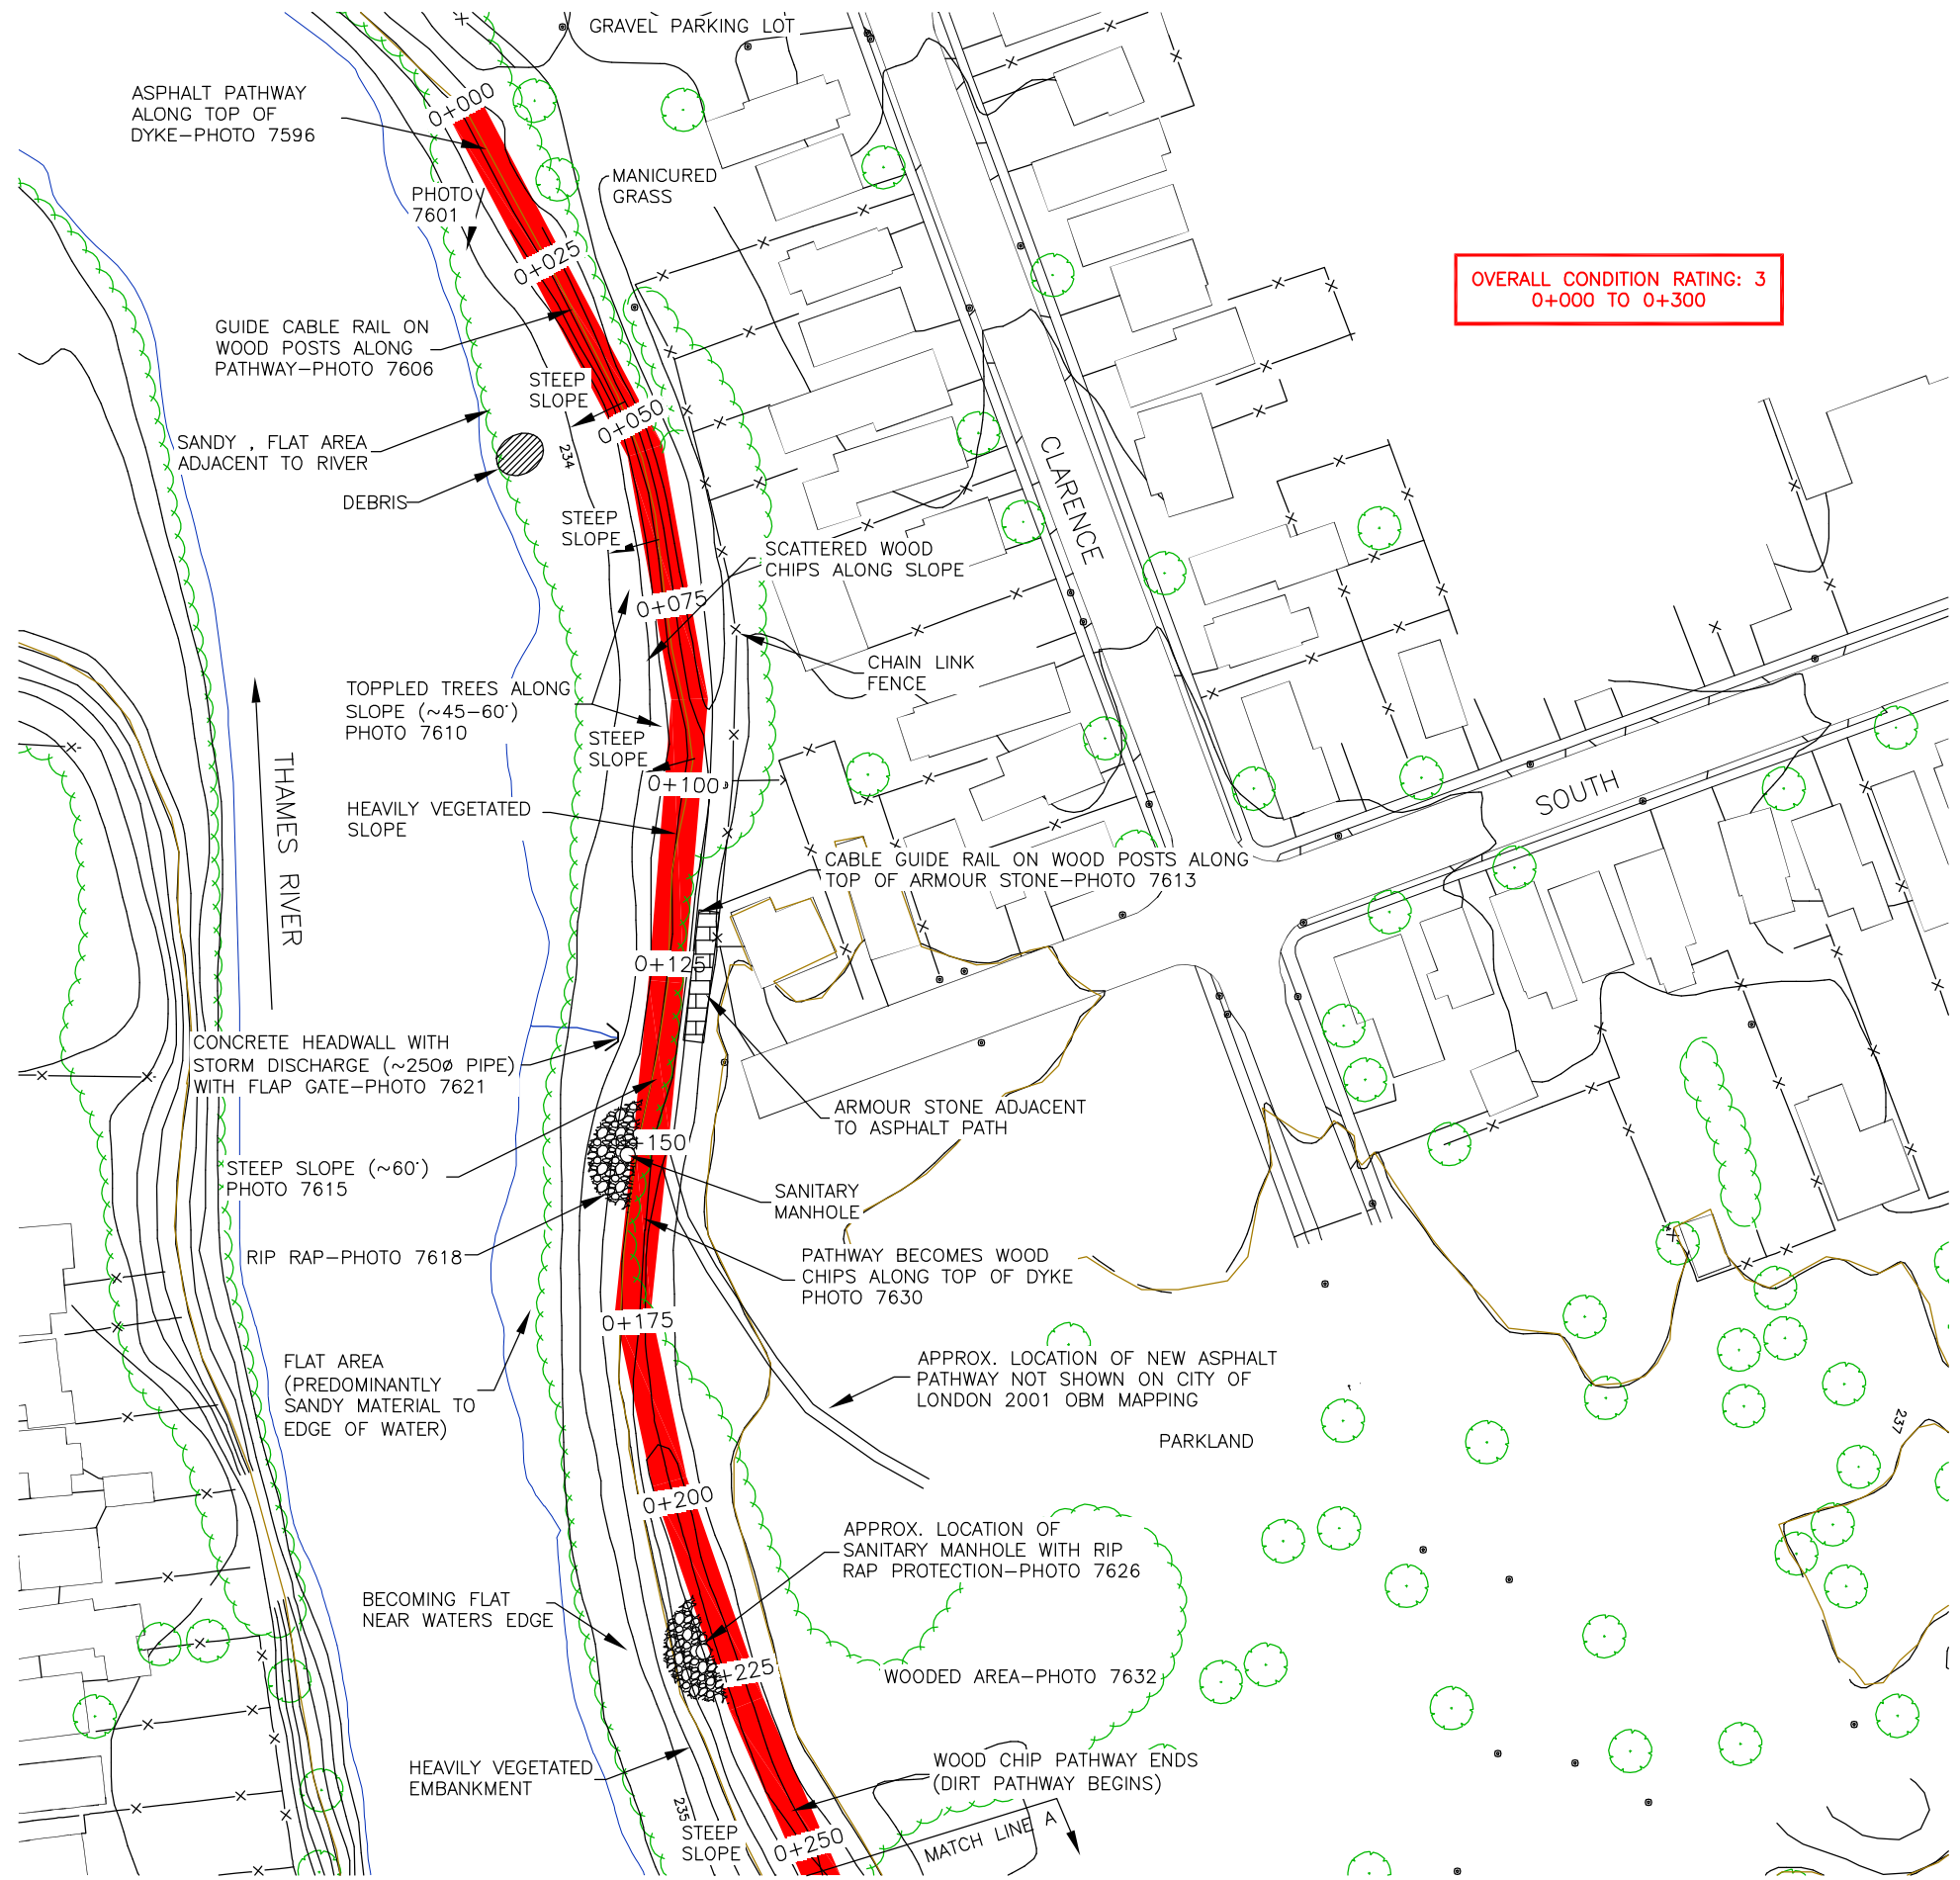
OVERALL CONDITION RATING: 3  
0+000 TO 0+300

General Information	
<p><u>Section Inspected:</u> Complete • Section ✓ Specify: <u>0+000</u> to <u>0+300</u> m</p>	<p><u>Overall Condition Rating:</u> 3 (this section only) <b>Comments:</b> Condition rating relates to general inability to assess dyke condition based on dense vegetation present. In addition, areas noted with loss of vegetation along steep slopes should be monitored to assess potential for future movement/slipping.</p>
<p><u>Adjacent Property Use:</u> Residential ✓ Parkland ✓ Commercial • Industrial •</p>	<p><b>Comments:</b> Adjacent residential from 0+000 to 0+125. The Richard B. Harrison Park borders the dyke from 0+125 to 0+300.</p>
Dyke Facing	
<p><u>Dyke Face Material:</u> Concrete • Gabion •  Earthfill ✓ Other ✓ Specify: Rip-rap, wood chip <b>Condition Rating:</b> 3 <b>Comments:</b> Dyke face consists primarily of dense vegetation (trees, bushes, shrubs, wild grass). Areas of toppled trees, etc. correlated to steep slopes along the dyke face. Scattered wood chips were observed overlying the upper face of the dyke near St. 0+080 and ~0+185. Rip-rap noted near St. 0+150 and ~0+220 surrounded sanitary manhole structures and extended to the toe of the dyke.</p>	<p><u>Structural Condition (Dyke Face):</u> Erosion • Damage (impact, cracks, etc) • Movement (including unevenness, slipping, bulging or slumping) ✓ Specify type: <b>Condition Rating:</b> 3 <b>Comments:</b> Due to the access restrictions caused by the dense nature of the vegetation and the steep slopes encountered, sections of the dyke could not be inspected. Areas visually inspected from the top of the dyke showed loss of vegetation along the side slopes likely due to the steep slope conditions encountered.</p>

<p><u>Toe:</u> Toe Protection Material (concrete, gabion, earth or other) Specify: Primarily earth (soil) with overlying dense vegetation. Rip-rap at locations 0+150 and 0+220 corresponding to the sanitary manhole structures. Erosion Yes • No ✓ <b>Condition Rating:</b> 4 <b>Comments:</b> No signs of erosion noted, however sections of the toe could not be visually inspected due to access restrictions.</p>	<p><u>Joints:</u> (not applicable to earthfill dykes) Sealant Present Yes • No •  <b>If yes, condition rating:</b> Vegetation (in joints) Yes • No • <b>Comments:</b> Not applicable.</p>
<p><u>Vegetation:</u> None • Full ✓ Partial • Type: Primarily trees with shrubs, bushes, wild grass, etc. <b>Comments:</b> Vegetation generally well established along side slopes of dyke, however some loss has occurred likely due to the steep slope conditions.</p>	<p><u>Water Infiltration:</u> (look for where water can leak behind structure) Yes • No ✓ If yes, due to: Joints • Cracks • Liner • Other (specify) • <b>Comments:</b></p>

<p><u>Additional Information:</u>  <b>Comments:</b> Sanitary manhole structures located along the top of dyke at St. 0+150 and 0+220. Steep slopes along the dyke face separated from the edge of the asphalt pathway by approximately 0.6m in some areas (photo 7615).</p>	
Area behind the Dyke (immediately adjacent)	
<p><u>Predominant Material:</u>            Concrete   •                                      Asphalt   •            Earth      ✓                                      Grass      ✓            Other      ✓                                      Specify:    Rough vegetation  <b>Condition Rating:</b> 4  <b>Comments:</b> Predominantly grass from St. 0+000 to 0+150, becoming earth with rough vegetation (mostly trees) to 0+300 (general area within Richard B. Harrison Park).</p>	<p><u>Drainage Conditions:</u> (ponding or low areas present)            Good                                      ✓                                      Poor   •  <b>Comments:</b> Although ponded water was not observed during the site visit (dry conditions), low lying areas were noted behind the dyke, in several areas.            Are catchbasins present?      Yes   •                                      No   ✓  <b>If yes, condition rating:</b>  <b>Comments:</b></p>

Storm Sewers/Sanitary Sewers/Outlet Structures	
<p>Yes      ✓                                      No   •      (if no, proceed to next section)            If yes, type of structure (i.e. outlet, headwall, drainage pipe, channel or flush): Specify: Concrete headwall with 250mm storm outlet and flap gate at ~St. 0+125 (photo 7621). Sanitary manhole structures at St. 0+150 and 0+220 (no visible outlets observed).  <b>Condition Rating:</b> 4  <b>Comments:</b> No signs of concrete deterioration.</p>	<p><u>Outlet:</u> (check for presence of gates or grates at the outlet)            Flap Gate      Yes      ✓                                      No   •            Safety Gate      Yes   •                                      No   •  <b>Condition Rating:</b> 4  <b>Comments:</b> Signs of recent flow through the outlet structure (photo 7622) verifies operation of flap gate.</p>
<p><u>Outlet Flow:</u> (check for condition of channel downstream from pipe, obstructions within pipe, etc.)            Obstructions                                      Yes   •                                      No   ✓            Downstream Erosion                                      Yes   •                                      No   ✓  <b>Comments:</b> No signs of erosion immediately downstream of the outlet structure. No outlets observed for the sanitary sewers.</p>	<p><b>General Comments:</b></p>

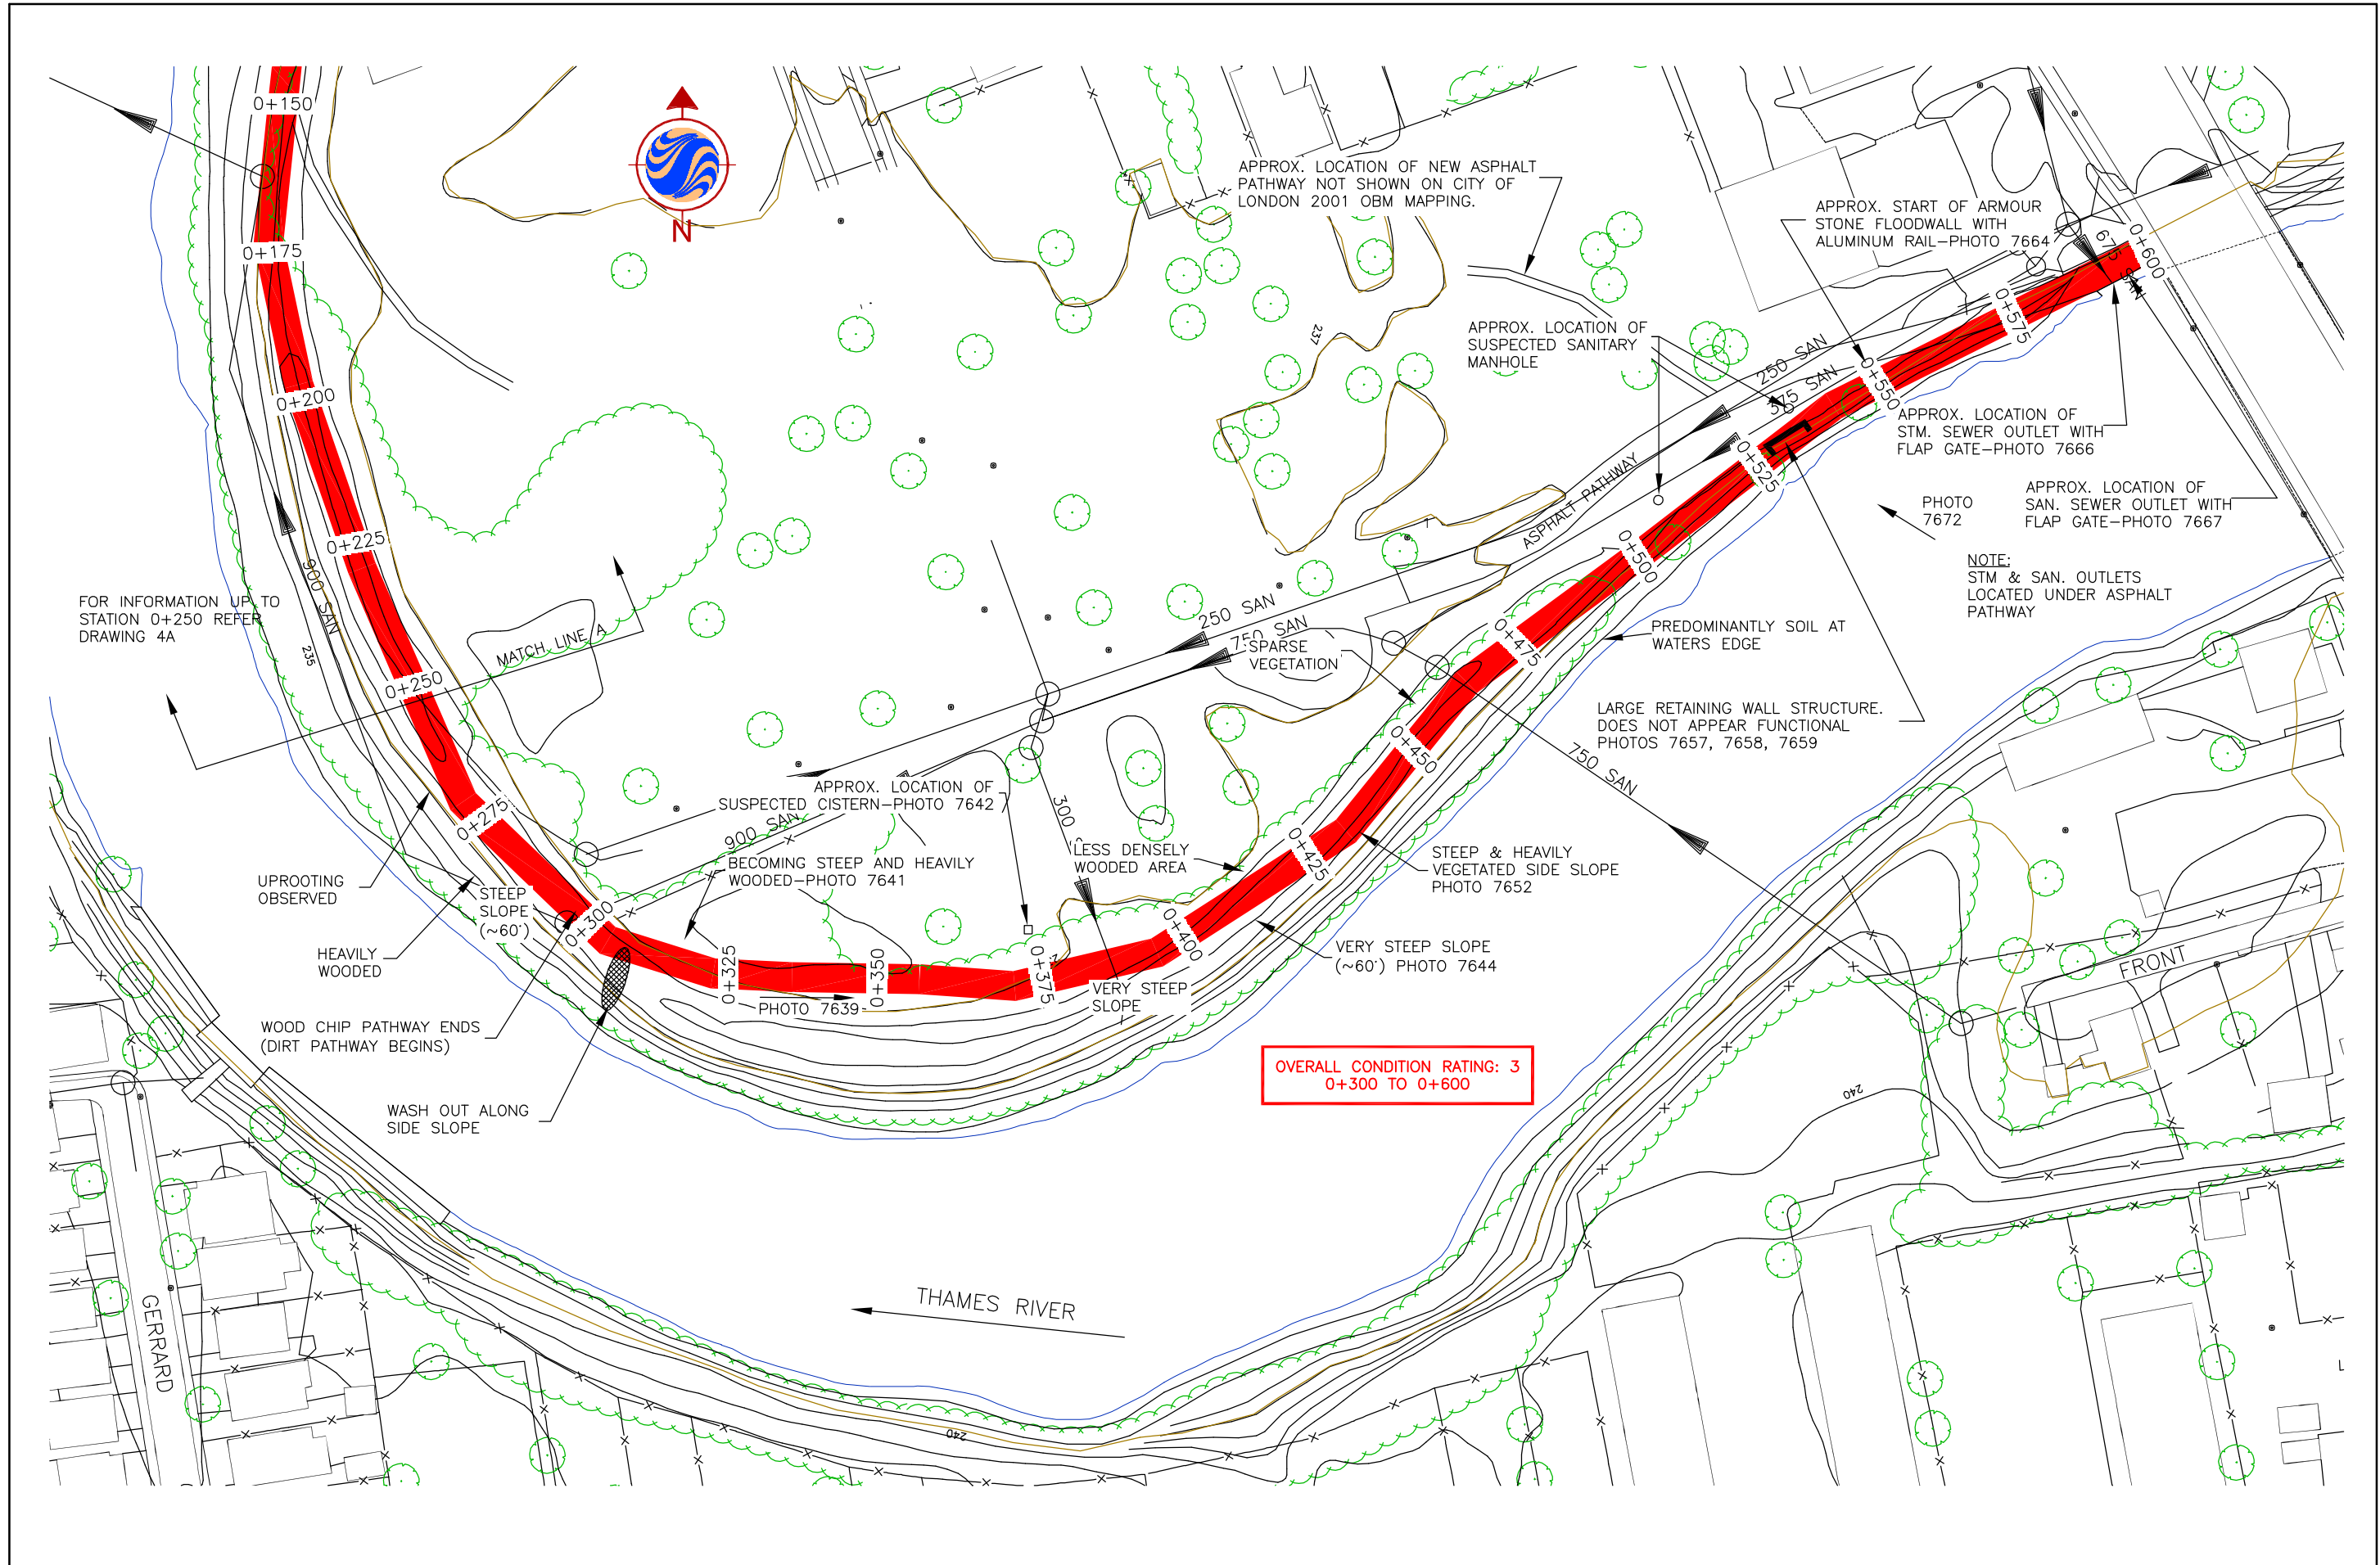
General Information	
<p><u>Section Inspected:</u> Complete • Section ✓ Specify: <u>0+300</u> to <u>0+600</u> m</p>	<p><u>Overall Condition Rating:</u> 3 (this section only) <b>Comments:</b> Generally less steep conditions encountered in comparison to the previous section inspected, however several steep areas were noted and should be monitored.</p>
<p><u>Adjacent Property Use:</u> Residential • Parkland ✓ Commercial ✓ Industrial •</p>	<p><b>Comments:</b> Adjacent parkland from 0+300 to 0+525. A daycare facility and commercial businesses border the dyke from 0+525 to 0+600 (termination at Wellington Road).</p>
Dyke Facing	
<p><u>Dyke Face Material:</u> Concrete • Gabion •  Earthfill ✓ Other ✓ Specify: Armor stone <b>Condition Rating:</b> 3 <b>Comments:</b> Dyke face consists primarily of dense vegetation (trees, bushes, shrubs, wild grass). Areas of toppled trees, etc. correlated to steep slopes along the dyke face (photo 7644). A washout area was observed along the dyke face at St. 0+305, causing erosion along the earth face. Armor stone floodwall noted along the dyke face, starting at ~St. 0+550 (photo 7664).</p>	<p><u>Structural Condition (Dyke Face):</u> Erosion ✓ Damage (impact, cracks, etc) • Movement (including unevenness, slipping, bulging or slumping) ✓ Specify type: <b>Condition Rating:</b> 3 <b>Comments:</b> Average rating relates primarily to the access restrictions caused by the dense nature of the vegetation and the steep slopes encountered throughout most of the dyke section inspected. Areas visually inspected from the top of the dyke showed loss of vegetation along the side slopes likely due to the steep slope conditions encountered along several areas. Armor stone was observed to be in good condition.</p>

<p><u>Pedestrian Access:</u> Sidewalk • Pathway ✓ None • Other • Specify: If present, width of access way: <b>Condition Rating (if present):</b> 4 <b>Comments:</b> Dirt (earth pathway) pathway from St. 0+300 to ~0+560 (photo 7648) with several areas of restricted access due to dense vegetation present adjacent to top of dyke. Asphalt pathway from 0+560 onwards.</p>	<p><u>Protective Barrier:</u> Fence • Guard Rail ✓ None ✓ Other • Specify: <b>Condition Rating (if present):</b> 4 <b>Comments:</b> No protective barrier from St. 0+300 to ~0+560. Aluminum railing along asphalt pathway near start of armor stone at St. 0+560 (photo 7664).</p>

<p><u>Protective Barrier:</u>            Fence •      Guard •                      None      ✓                                Rail            Other •      Specify:            If fence, list type and ownership (i.e. private or city): No railing present over section reviewed.  <b>Condition Rating (if present):</b>  <b>Comments:</b></p>	<p><u>Illumination:</u> (check for lighting present behind the dyke)            Yes •                      No      ✓  <b>Condition Rating:</b>  <b>Comments:</b></p>
Storm Sewers/Sanitary Sewers/Outlet Structures	
<p>Yes      ✓                      No •      (if no, proceed to next section)            If yes, type of structure (i.e. outlet, headwall, drainage pipe, channel or flush): Specify: Storm and sanitary sewer outlets located at ~St. 0+580 (photos 7668 and 7670) under asphalt pathway. Sanitary manholes located near St. 0+520 and 0+530 behind dyke. Suspected cistern located at St. 0+375 (photo 7642). Reported sanitary outlet structure at St. 0+385 (as per City of London drawings provided) not observed at the time of the site visit.  <b>Condition Rating:</b> 4  <b>Comments:</b> No signs of concrete deterioration.</p>	<p><u>Outlet:</u> (check for presence of gates or grates at the outlet)            Flap Gate      Yes      ✓                      No •            Safety Grate      Yes •                      No •  <b>Condition Rating:</b> 3  <b>Comments:</b> Flap gates provided for storm and sanitary outlets (photos 7666 and 7667). Average rating reflects inability to access flap gates to confirm operation.</p>
