**EMBRO DAM
CLASS ENVIRONMENTAL ASSESSMENT
FLUVIAL GEOMORPHOLOGY REPORT**

Prepared for:
UPPER THAMES RIVER CONSERVATION AUTHORITY

Prepared by:
MATRIX SOLUTIONS INC.

Version 0.1
November 2022
Kitchener, Ontario

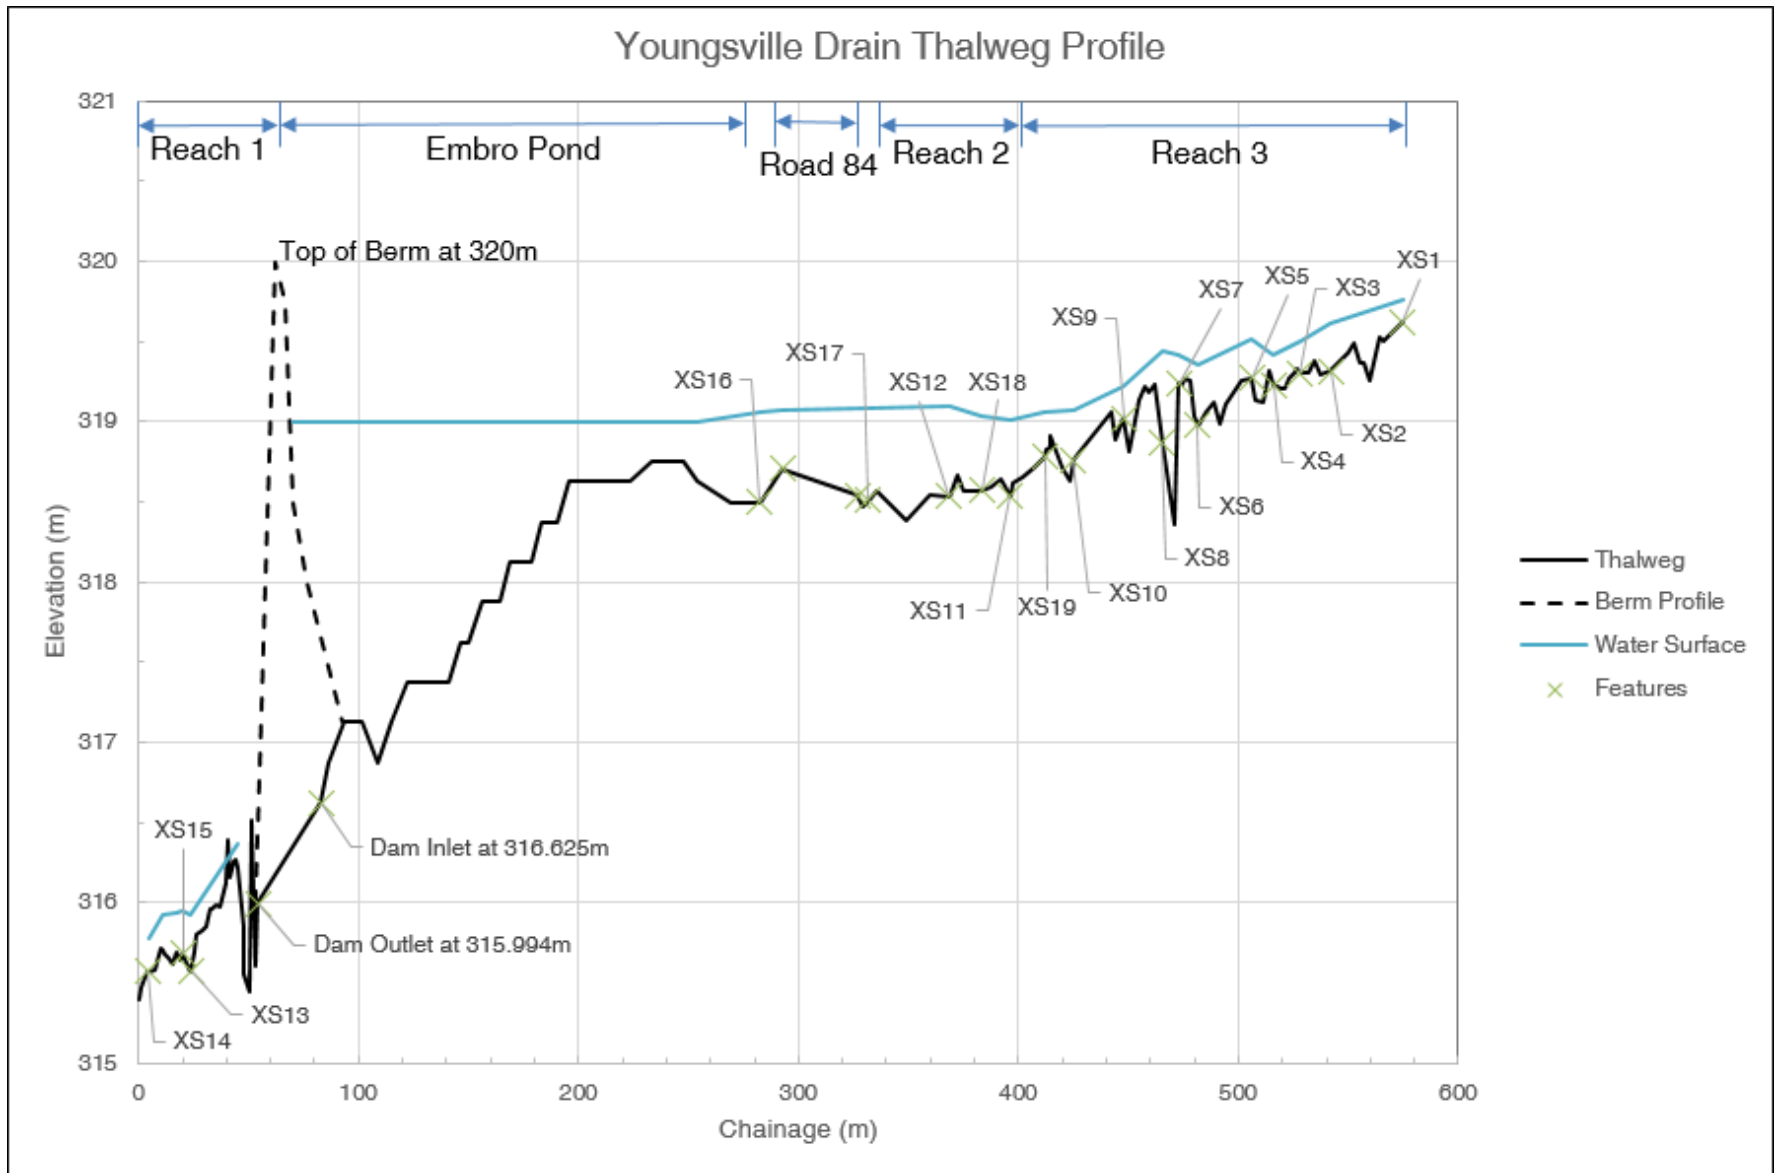
FIGURE 3 Surveyed Channel Bed Profile along Youngsville Drain

Analysis of the topographic channel bed profile, provided by UTRCA, was undertaken. This revealed that the average water surface grade during the field survey (June 11, 2015) was 0.32 % and the average bankfull grade was 0.43 %. Quantification of riffle and pool parameters, for Reach 3 is provided in Table 4.

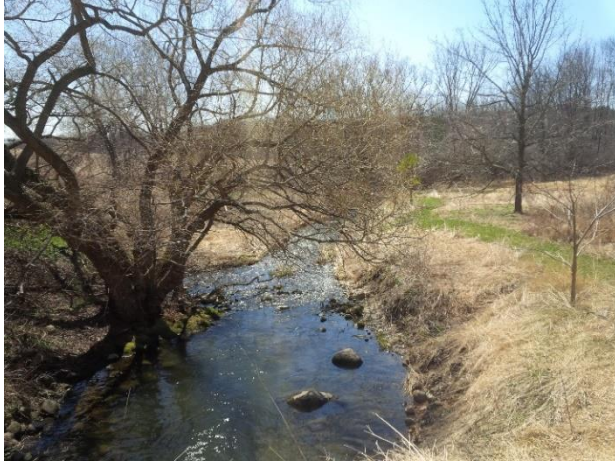
A deep pool (0.93 m) occurred within 5 m downstream of the Embro Dam outlet. The dominant bed morphology along the entire reach was riffle/run with shallow pools. A deeper pool where vegetation was overhanging into the watercourse. The channel bed consisted primarily of cobbles and gravel. Glacial till was exposed along the toe of the bank along a pool.

View downstream from dam outlet (2015).

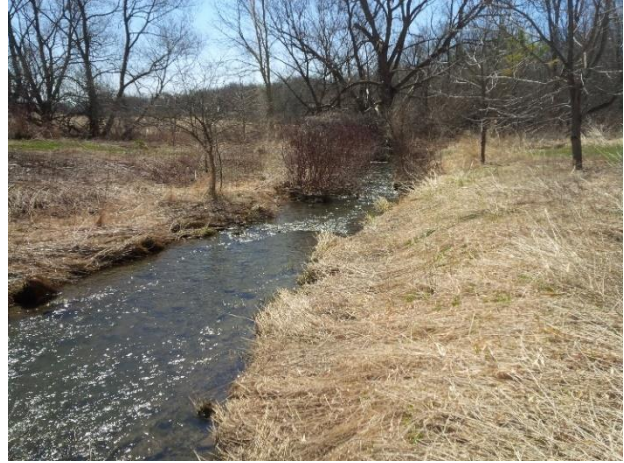
The channel cross-sections were generally symmetrical in shape and trapezoidal. The cross-sections were set within a larger channel. The active channel was ~ 3.70m wide with an average water depth of 0.29m. Riparian vegetation consisted of dense grasses and herbaceous plants; roots extended to the bottom of the banks. Towards the downstream end of the reach, shrubs and trees were overhanging into the creek.

Downstream view along creek, towards property line at trees (2015).

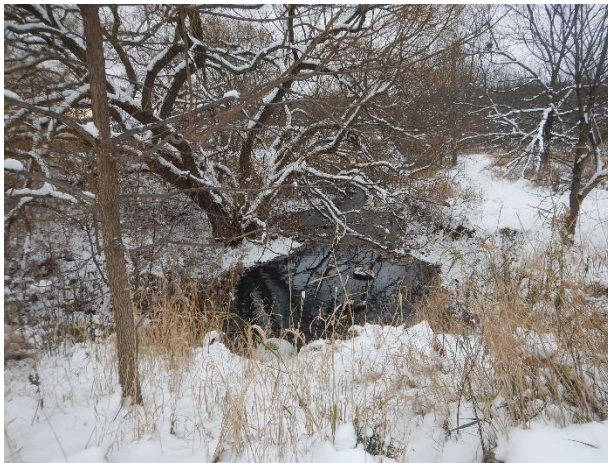
From the outlet of Embro pond, Reach 1 maintained a relatively straight planform, but maintained some bends towards the downstream extent. The banks were well vegetated with grasses, shrubs, and trees. Cut faces were noted on some banks, particularly the western bank downstream of the dam outlet pool. The channel bed remained primarily riffles and runs with shallow pools, measuring up to 0.35 m deep. The bed material consisted of gravels and cobbles, with some sand deposits. The scour pool downstream of the dam outlet was measured to be 0.89 m deep.

The RGA completed for Reach 1 indicated the creek is considered to be 'in transition' through the dominant processes of degradation/incision.

View downstream from dam outlet (2022).

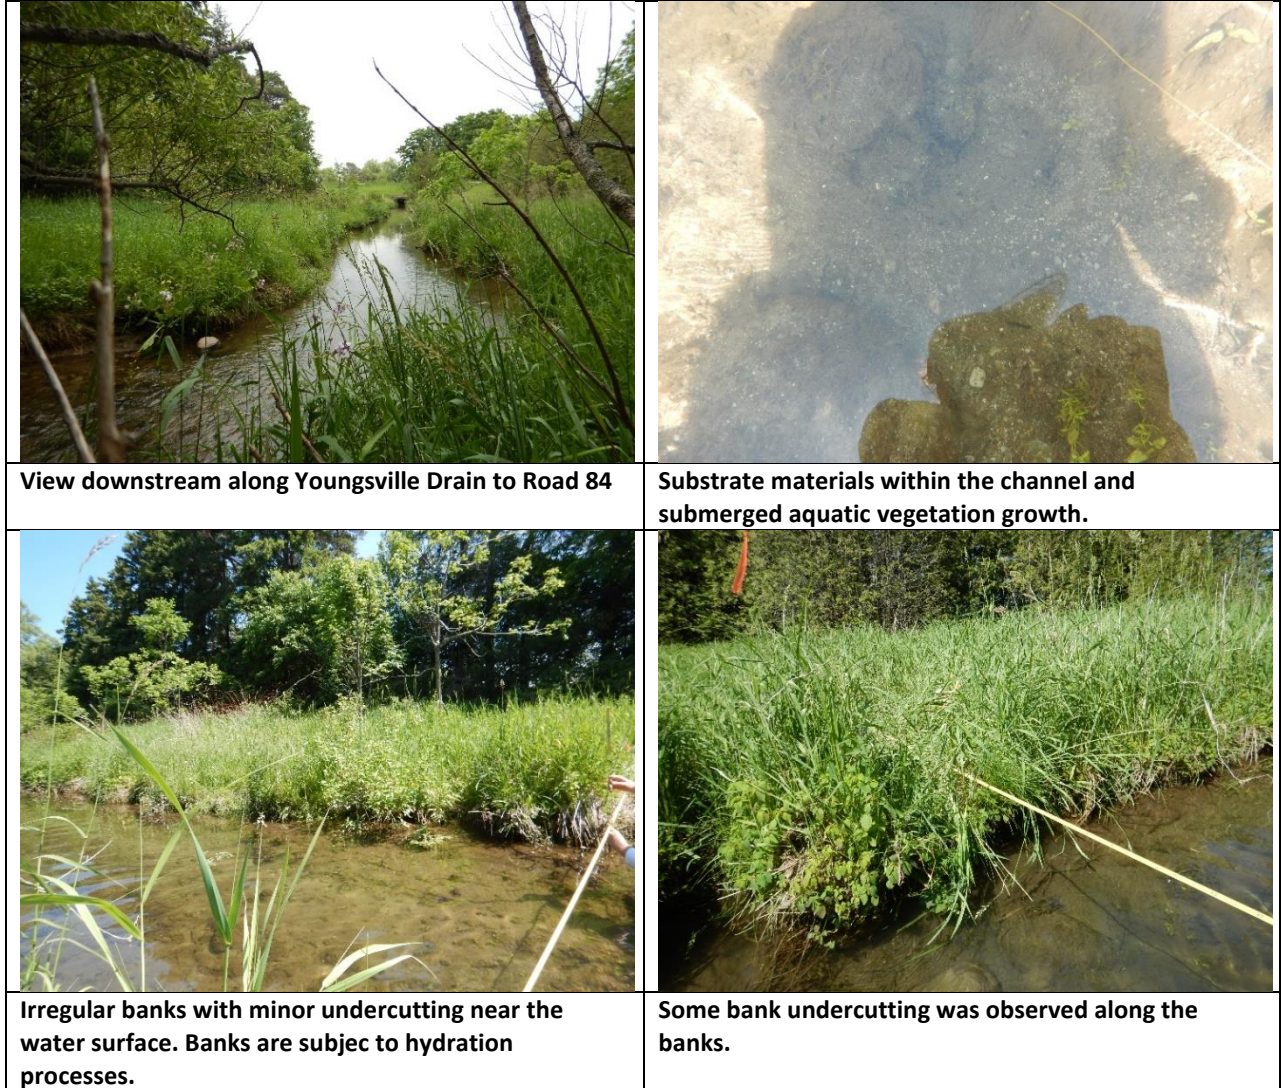
FIGURE 5 Reach 2 Photos Illustrating Site Conditions

In this portion of the watercourse, Youngsville Drain appeared to be under backwater conditions and influenced by water levels from Embro Pond (Figure 5). In 2015, the backwater conditions extended 85 m upstream of Road 84; the channel was straight. Measurements of channel cross-section parameters and substrate materials were made at two locations within this reach in 2015 (Table 2).

The channel bed morphology was poorly developed and was relatively uniform in configuration. Channel bed materials consisted primarily of silt and sand sized particles with few gravels. The bed materials were 'soft' due to their hydrated condition. Submerged aquatic plants were observed on the channel bed.

In 2022, overall channel conditions remained similar to those observed in 2015. Water levels in the pond appeared lower than they had in 2015; communication with UTRCA indicated that the seasonal lowering had already occurred. Application of the Rapid Geomorphic Assessment (RGA) for this reach indicated that the channel was considered to be 'in regime'. The dominant process within the reach was deposition; this is reflective of the backwater condition created by the dam.

An RGA completed for this reach resulted in a Stability Index rating of 0.313 (transitioning) with the primary characteristic of this reach being aggradation.

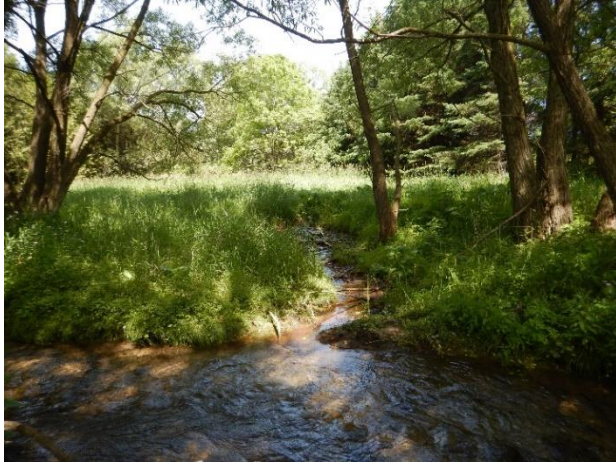
Along the east side of the channel, two locations were identified at which surface drainage was actively being conveyed over the bank into the creek. The source of water was not investigated.

Active drainage channels discharge into the creek.

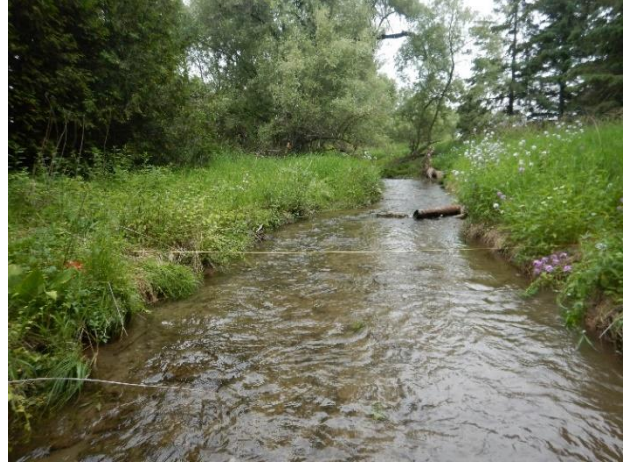
Channel is well connected to its floodplain

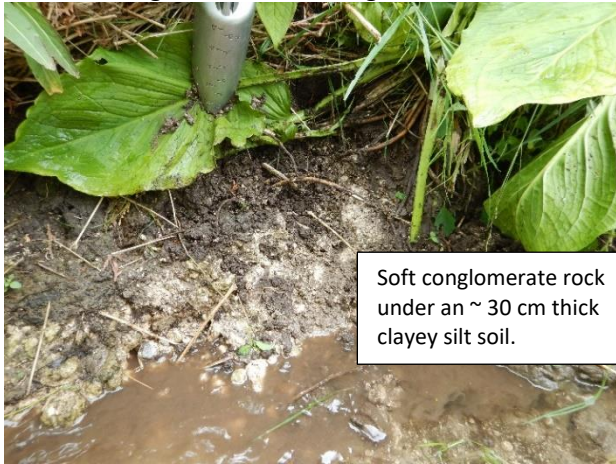
Banks were generally steep. No active erosion was noted. Undercutting of the banks was generally minimal (up to 8 cm), but measured up to 24 cm underneath a root wad 17 cm and occurred at the bottom of the rooting zone and/or the interface with underlying stratigraphic materials. Along the lower bank, a soft rock was observed which resembled a conglomerate rock type (i.e., round gravels situated within a fine matrix of silt and sand sized particles). The cobble and gravel sized sediment observed on the channel bed consisted of this conglomerate material; pressure exerted onto the particles would cause it to break into smaller pieces.

The channel bed morphology has developed into the soft conglomerate sedimentary rock. Field measurements revealed that from distance from the top of this unit to the channel bed was 30 cm, suggesting that the channel has incised this depth into the materials. The dominance of riffle/run features along the channel bed is a result of this resistant bed material. Shallow pools have formed and occur along the outside bends of meanders. The underlying bedrock controls profile development and reflects the relatively small difference in depth between pool and riffle sections (Table 3). The deepest pool evident on Figure 3 was 0.87 m deep; in general, all other pool depths were considered to be shallow (i.e., residual depths ranged from 0.15-0.28 m).

Soft conglomerate rock under an ~ 30 cm thick clayey silt soil.

Bank stratigraphy includes a lower unit that provides bedrock control on profile development.

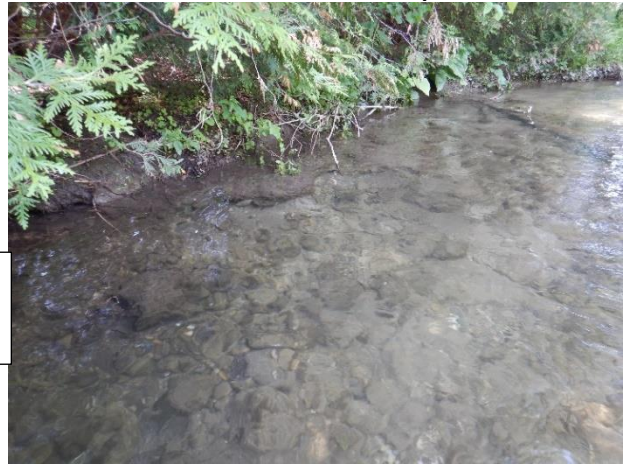
Substrate consisted of cobbles on a gravel-sandy bed

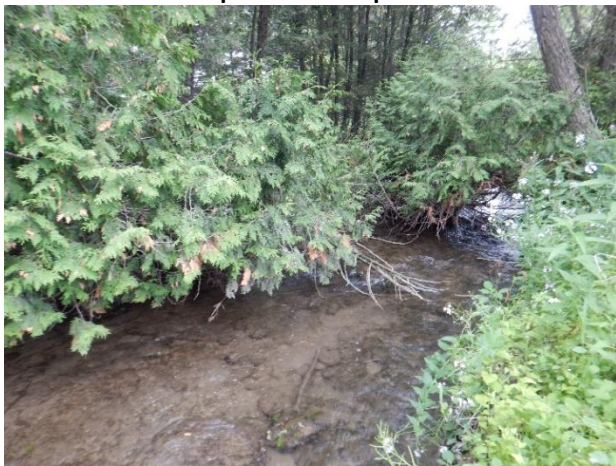
Riparian vegetation includes both grasses/herbaceous plants and trees (cedar/willow)
