Emburo Dam and Conservation Area

Existing Geomorphic Conditions

December 2015, Draft

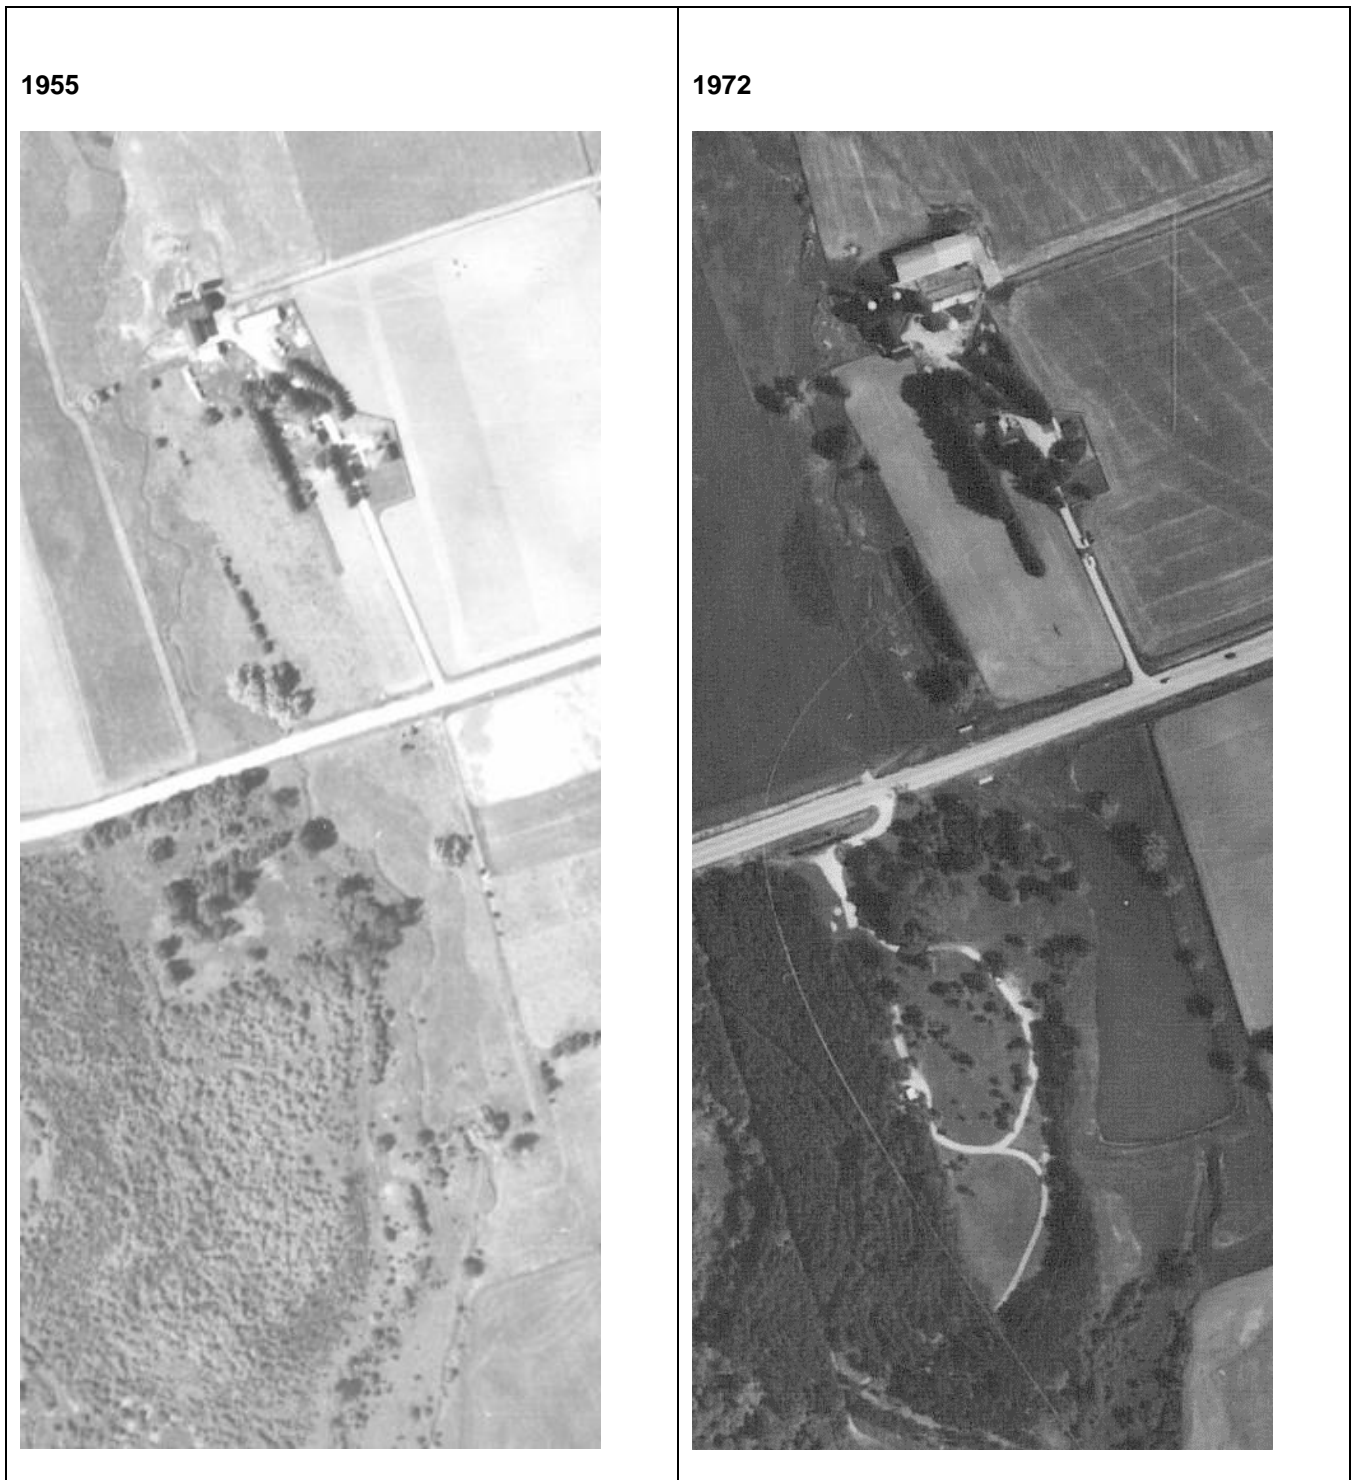
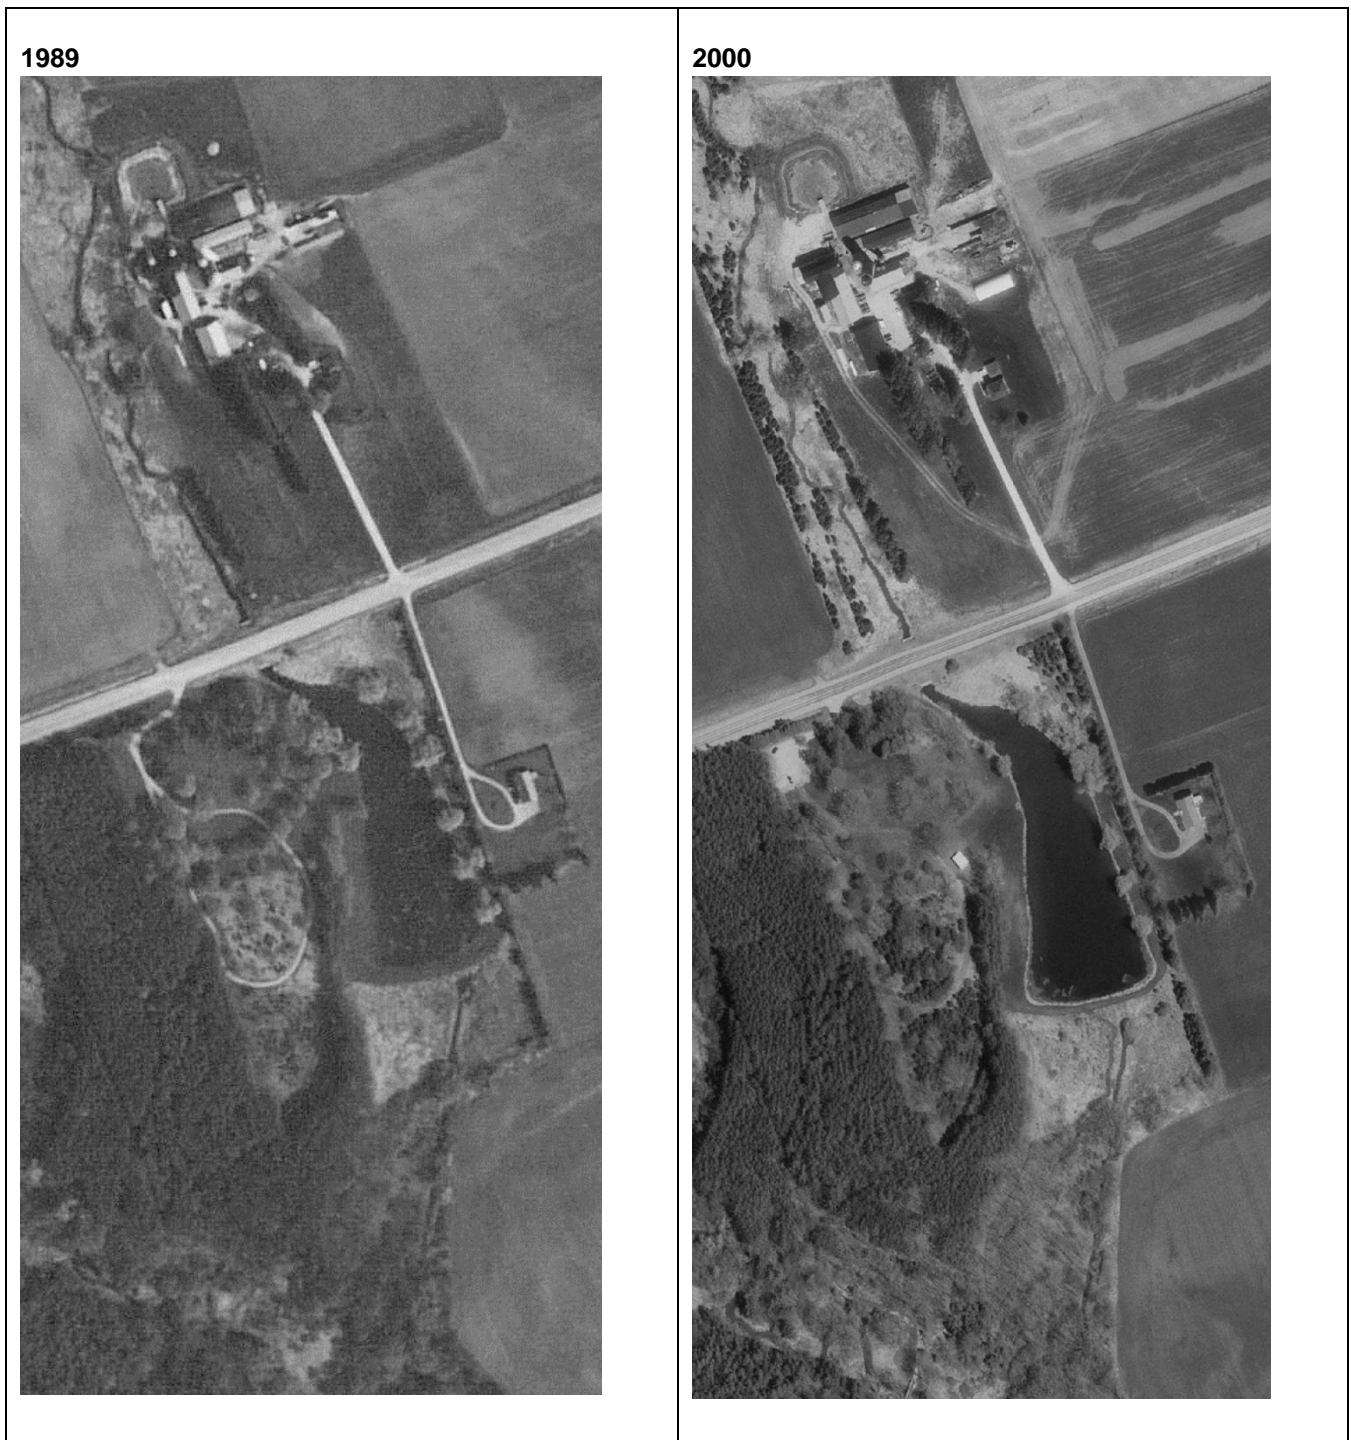
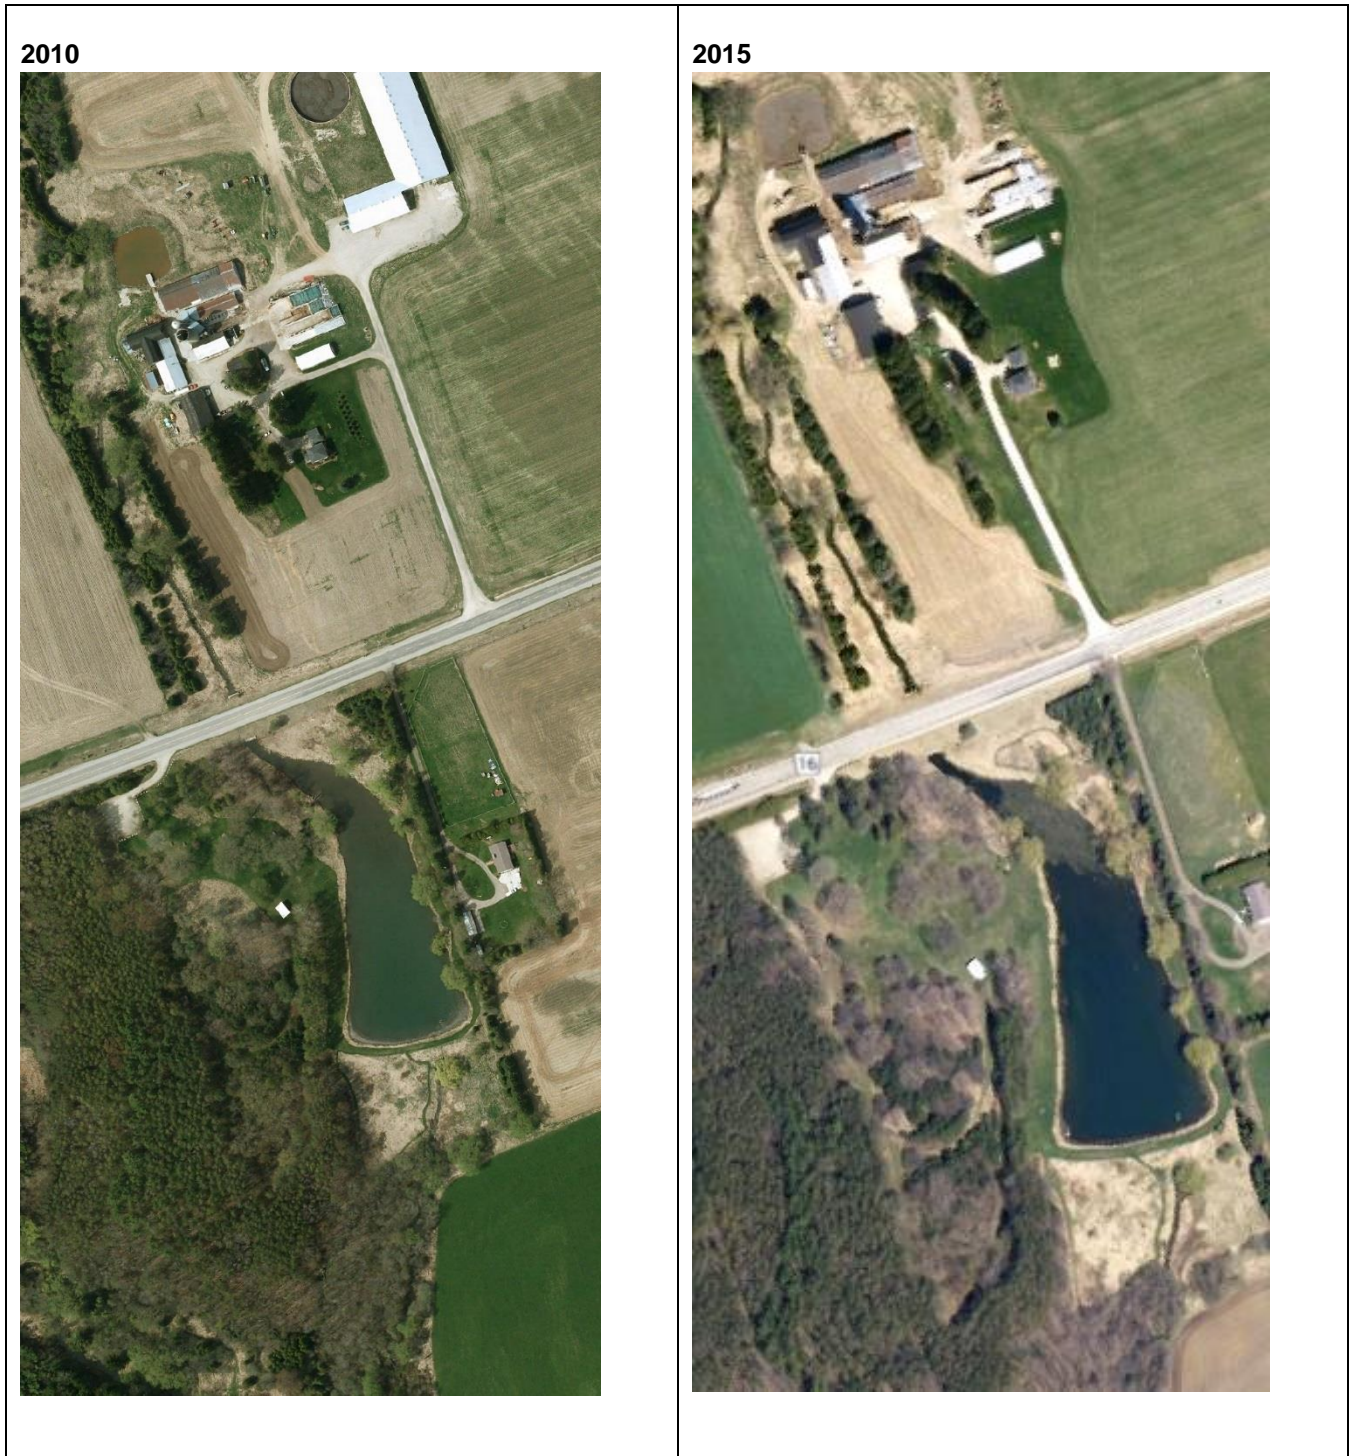
Figure 1-1a. Overview of historical channel change along Youngsville Drain in proximity to Embro Pond.

A review of historical channel conditions was completed to gain insight into changes that have occurred within the study area. UTRCA provided airphotos dated from 1955, 1972, 1989, 2000, 2010; additional aerial imagery was available from Google Earth (2015). Key observations are summarized in **Table 1-1**; a collection of historical airphotos of the study area is provided in **Figure 1-1**.

| Year | Observation |
|---|--|
| 1972 | <ul style="list-style-type: none"> Construction of Embro pond was complete Channel realignment/straightening occurred, beginning at ~ 95 m north of Road 84. Channel modifications appear to have occurred at the outlet of the dam (widening, deepening, straightening). |
| 1989 | <ul style="list-style-type: none"> Floodplain vegetation west of Youngsville Drain, and north of Road 84, appears to be naturalizing and increasing in diversity Some channel planform development appears to be occurring at the upstream limit of the channel straightening |

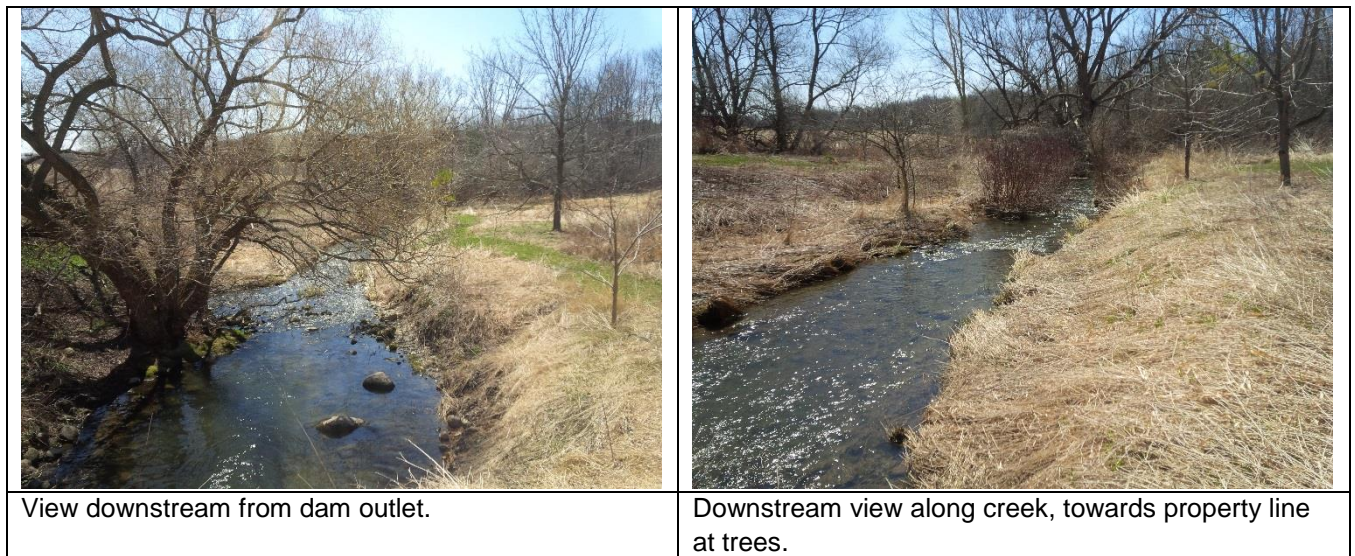
Figure 1-4. Reach 1 photos illustrating site conditions

From the outlet of Embro pond to the end of the UTRCA property, the watercourse was relatively straight; a slight meander was beginning to form near the downstream limit of the reach. The creek was likely straightened in conjunction with construction of the dam.

The channel cross-sections were generally symmetrical in shape and trapezoidal. The cross-sections were set within a larger channel. The active channel was ~ 3.70 m wide with an average water depth of 0.29 m. Riparian vegetation consisted of dense grasses and herbaceous plants; roots extended to the bottom of the banks. Towards the downstream end of the reach, shrubs and trees were overhanging into the creek.

A deep pool (0.93 m) occurred within 5 m downstream of the Embro Dam outlet. The dominant bed morphology along the entire reach was riffle/run with shallow pools. A deeper pool where vegetation was overhanging into the watercourse. The channel bed consisted primarily of cobbles and gravel. Glacial till was exposed along the toe of the bank along a pool.

Overall, the Youngsville Drain appeared to be stable throughout the reach.

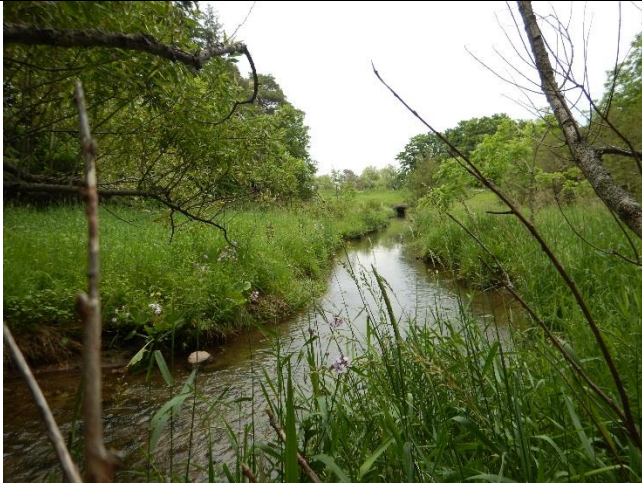
| <p>View downstream along Youngsville Drain to Road 84</p> | <p>Substrate materials within the channel and submerged aquatic vegetation growth.</p> |

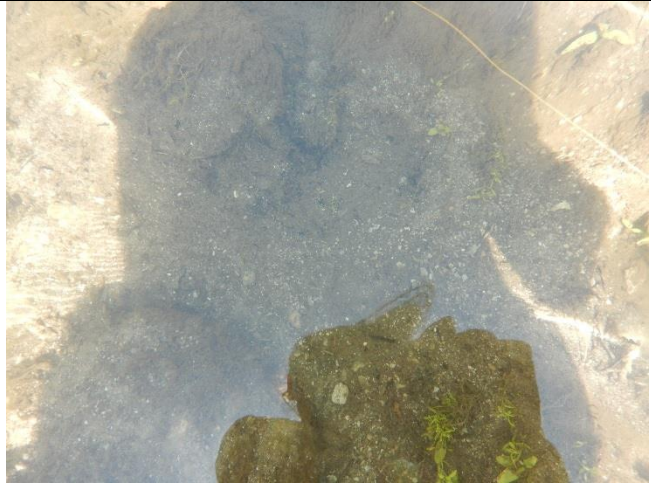
The channel bed morphology was poorly developed and was relatively uniform in configuration. Channel bed materials consisted primarily of silt and sand sized particles with few gravels. The bed materials were ‘soft’ due to their hydrated condition. Submerged aquatic plants were observed on the channel bed.

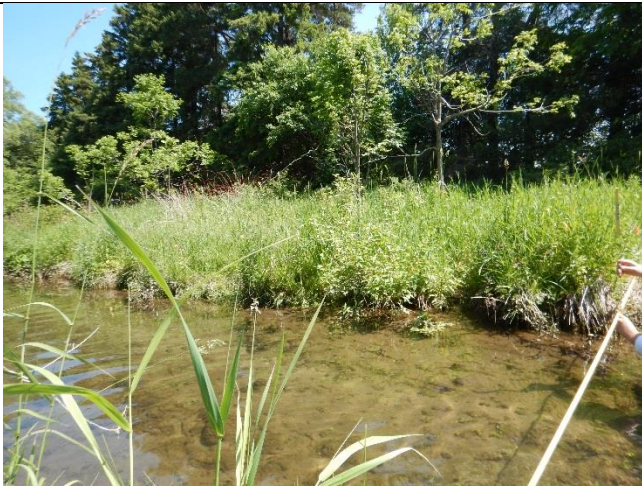
Channel banks were well vegetated with grasses and herbaceous plants; the fine and dense rooting network extended to the water surface. The bank configuration was generally irregular which is characteristic of banks influenced by backwater conditions in which hydration of bank materials leads to erosion; the rooting network of bankside vegetation holds the banks together in ‘clumps’. Undercutting of the banks occurred near the water surface and was consistently measured as 7 – 8 cm deep. The relatively low banks indicate good floodplain accessibility during high flows.

Application of the Rapid Geomorphic Assessment (RGA) for this reach indicated that the channel is ‘in regime’. The dominant process within the reach is deposition. Gradual widening of the cross-section is expected due to the hydration effect typically associated with backwater conditions.

| <p>Irregular banks with minor undercutting near the water surface. Banks are subject to hydration processes.</p> | <p>Some bank undercutting was observed along the banks.</p> |

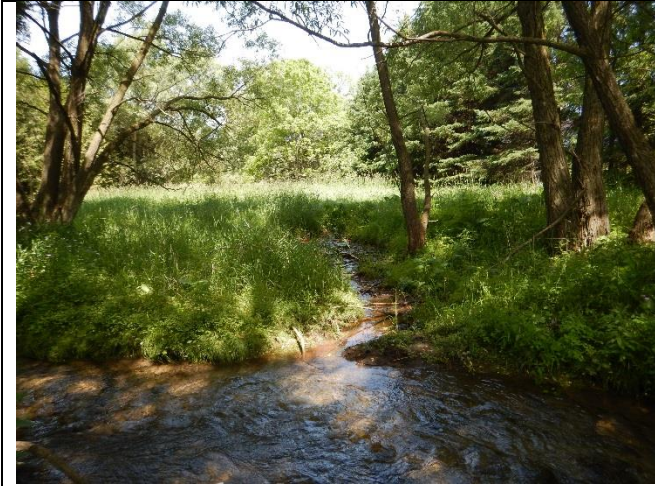
Along the east side of the channel, two locations were identified at which surface drainage was actively being conveyed over the bank into the creek. The source of water was not investigated.

Active drainage channels discharge into the creek.

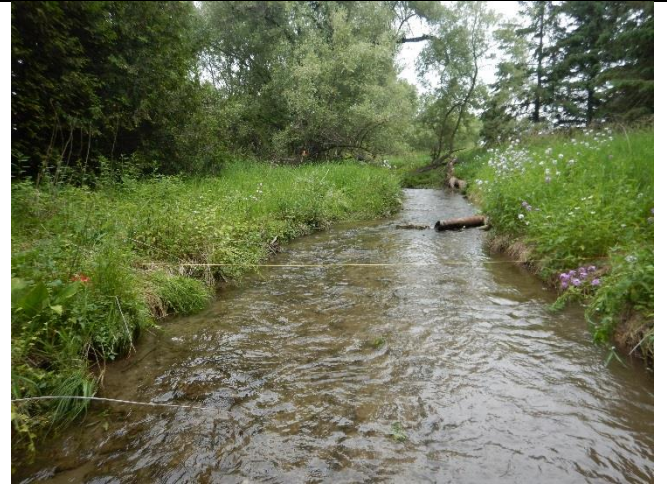
Channel is well connected to its floodplain

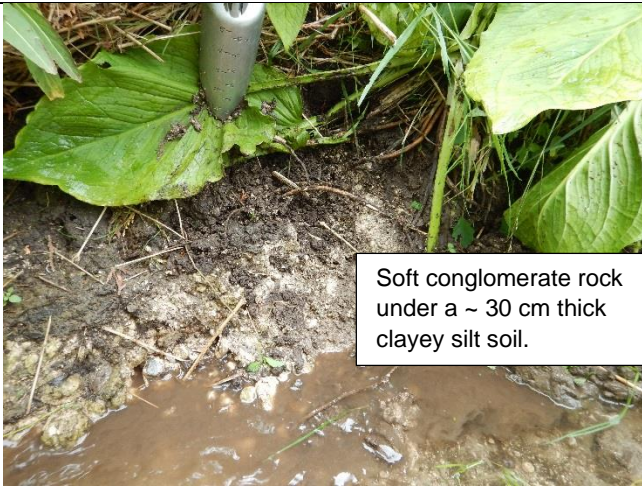
The channel bed morphology has developed into the soft conglomerate sedimentary rock. Field measurements revealed that from distance from the top of this unit to the channel bed was 30 cm, suggesting that the channel has incised this depth into the materials. The dominance of riffle/run features along the channel bed is a result of this resistant bed material. Shallow pools have formed and occur along the outside bends of meanders. The underlying bedrock controls profile development and reflects the relatively small difference in depth between pool and riffle sections (**Table 1-3**). The deepest pool evident on **Figure 1-3** was 0.87 m deep; in general, all other pool depths were considered to be shallow (i.e., residual depths ranged from 0.15-0.28 m). The overall channel bed grade was 0.66%.

Soft conglomerate rock under a ~ 30 cm thick clayey silt soil.

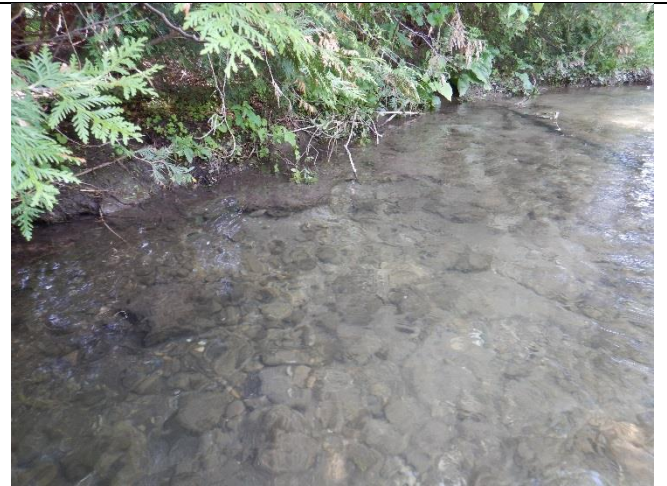
Substrate consisted of cobbles on a gravel-sandy bed

Bank stratigraphy includes a lower unit that provides bedrock control on profile development.

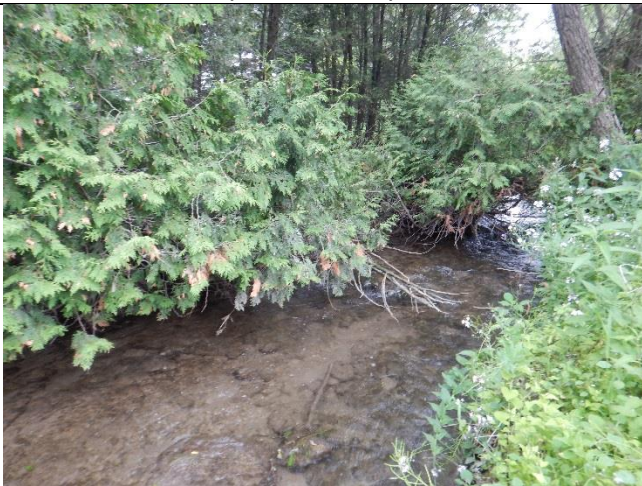
Riparian vegetation includes both grasses/herbaceous plants and trees (cedar/willow)
