**Acres International Limited
Dam Inspection Report**

Dam Inspection Report

Structure: Embro Dam

**Dam Safety Program
Revisions - Embro Spillway Rehabilitation**

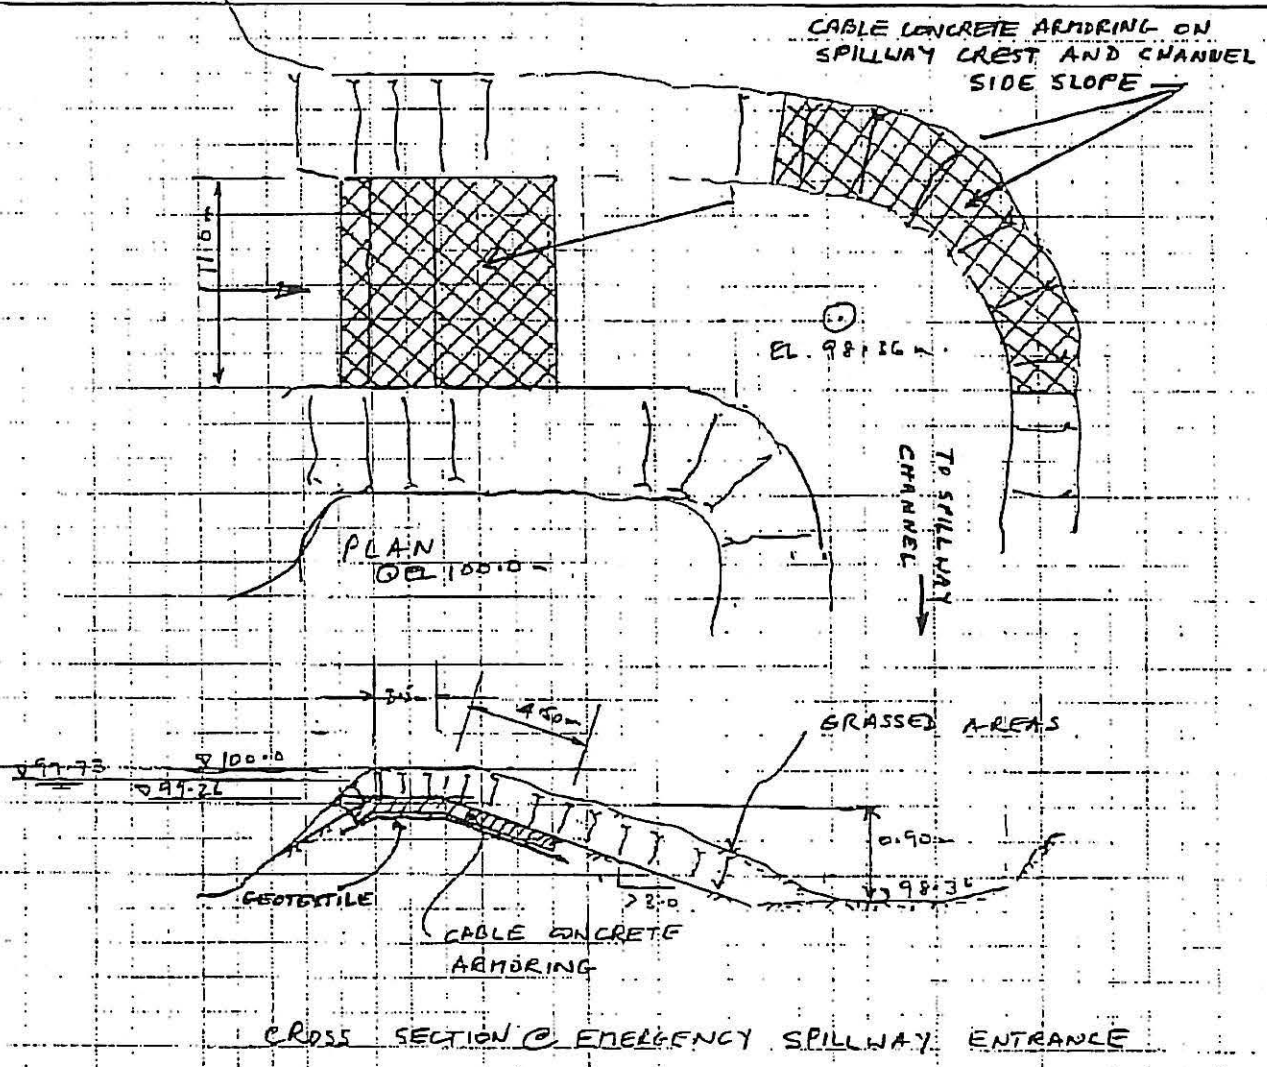
CREST DETAILS - REVISION # 1

The emergency spillway entrance should be excavated to a width of 11 m at an elevation of 99.26 m (based on local datum from the hazard identification drawing). The entrance invert and curve should be lined with cable-connected concrete blocks underlaid with a suitable geotextile to prevent the native material from becoming eroded as recommended previously. The emergency spillway channel should be excavated with a bed width of 6.50 m, 1.5H:1V side slopes and a bed slope of 0.0080 to prevent erosion. With respect to the connection between the spillway channel and creek, your proposal to flare out this channel horizontally and vertically over a sufficient distance as it enters the creek is feasible and should keep the exit down-slope velocity within the permissible limit.

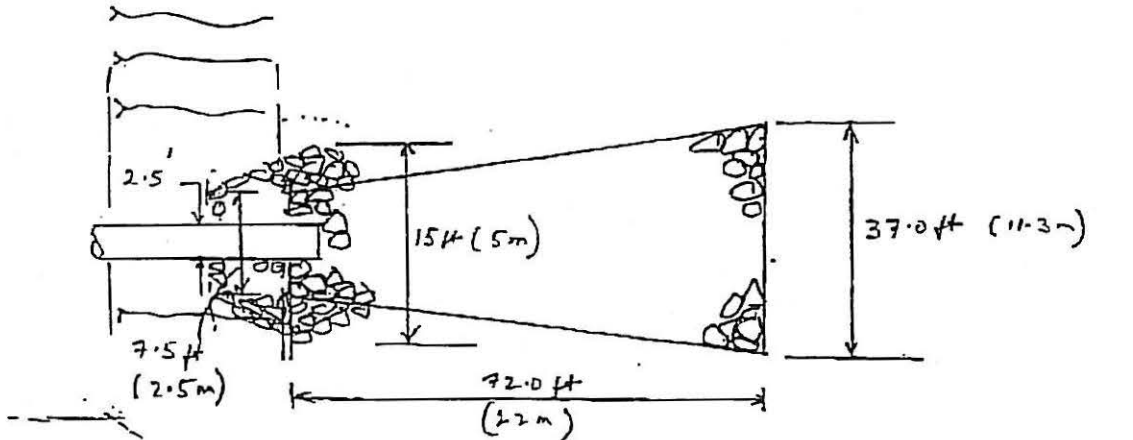
Subject DIMENSIONS OF RIP RAP APRON Page _____ of _____

FILTER BLANKET
 MEDIAN STONE SIZE (d_{50}) = 1.15 ft (0.35 m)
 MAX. STONE DIAMETER = 1.73 ft (0.53 m)
 IN WELL GRADED RIP RAP APRON

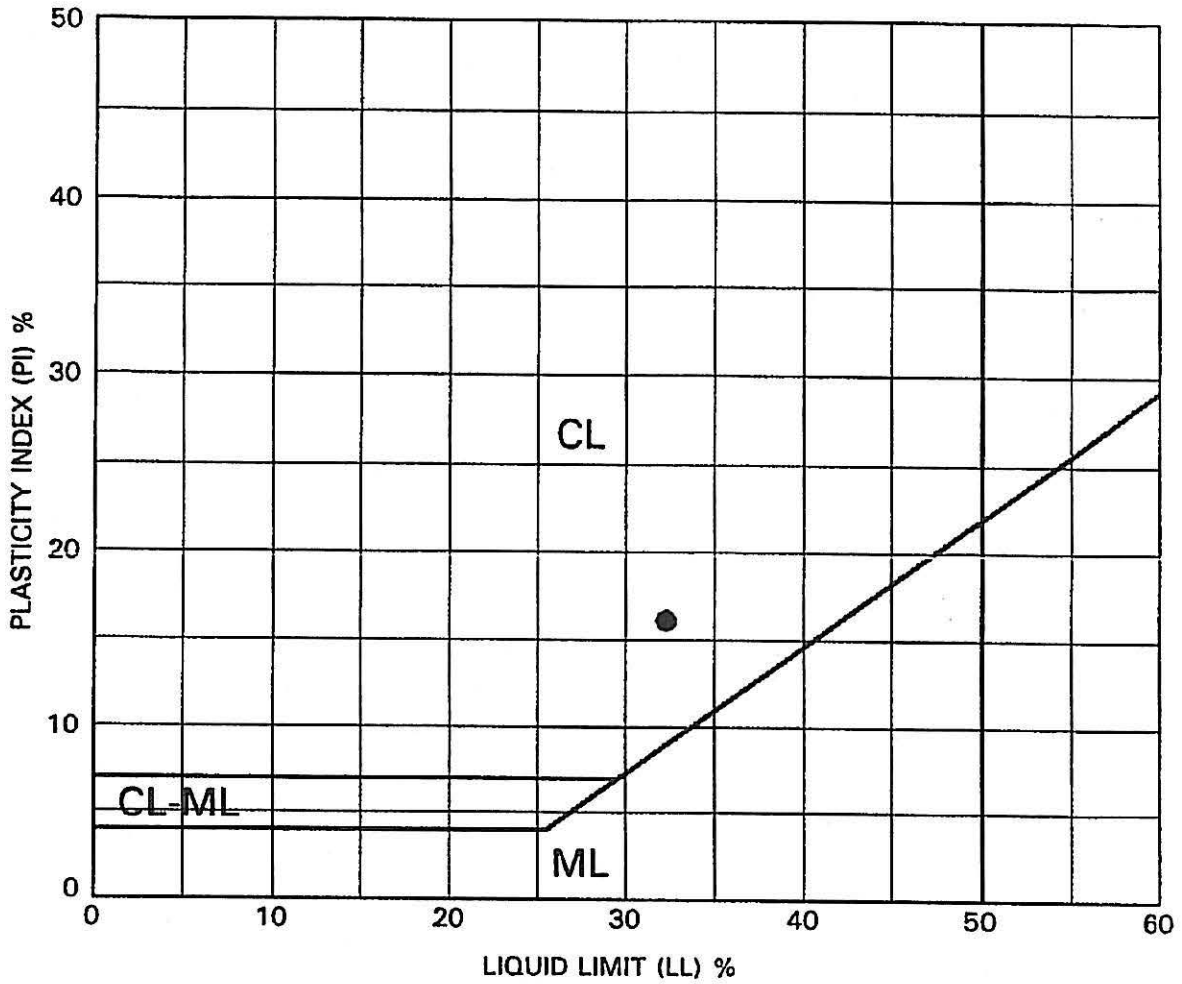
Geotechnical Investigations Upper Thames Conservation Authority	
PLASTICITY CHART Embro Dam	PROJECT NO. P1450404 FIGURE NO.

LEGEND	BH	DEPTH (m)	LL%	PL%	PI%
●	EMBH1	3.81	32	16	16
