**Appendix F**  
**Site Photographs**

<b>Embros Dam Embankment Stability Study</b> County Road 16 Township of Zorra, Ontario

Naylor Engineering Associates Ltd. CONSULTING ENGINEERS	<b>CURRENT DOWNSTREAM RESULTS FOR STEADY STATE SEEPAGE WITH MAXIMUM STORAGE POOL</b>			
		Date	Scale	Job No.	Figure No.
		Sept. 2008	NTS	7607G1	1A

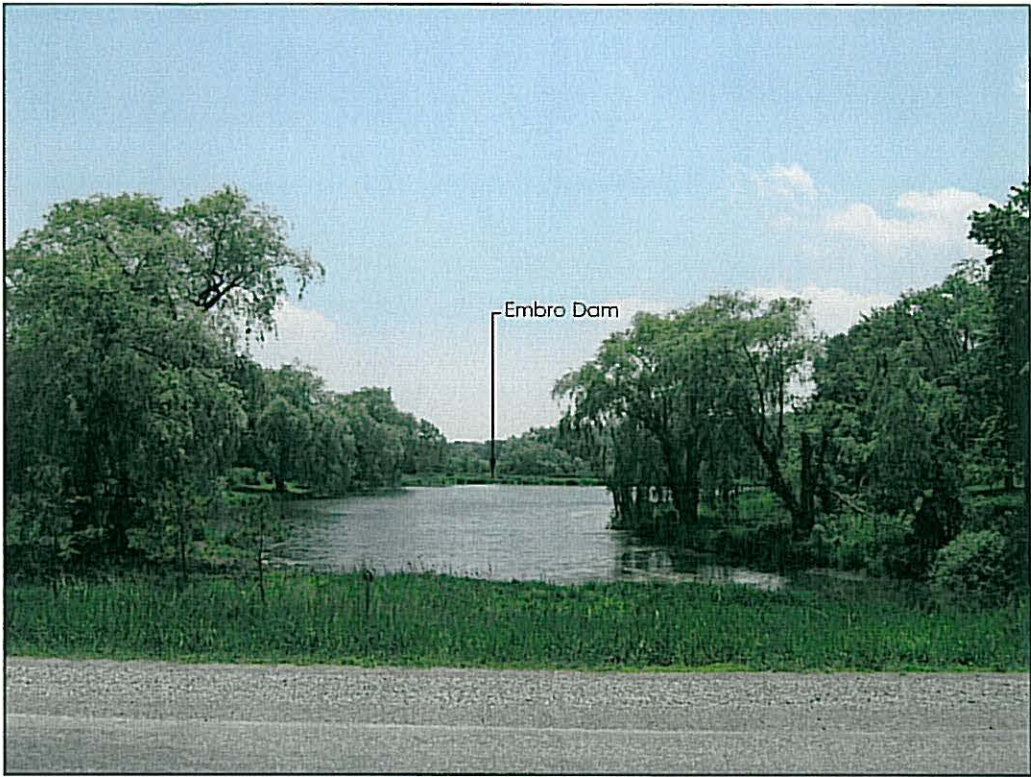
**Photo 1:** Looking south at Embro Dam and pond from Oxford County Road 16.

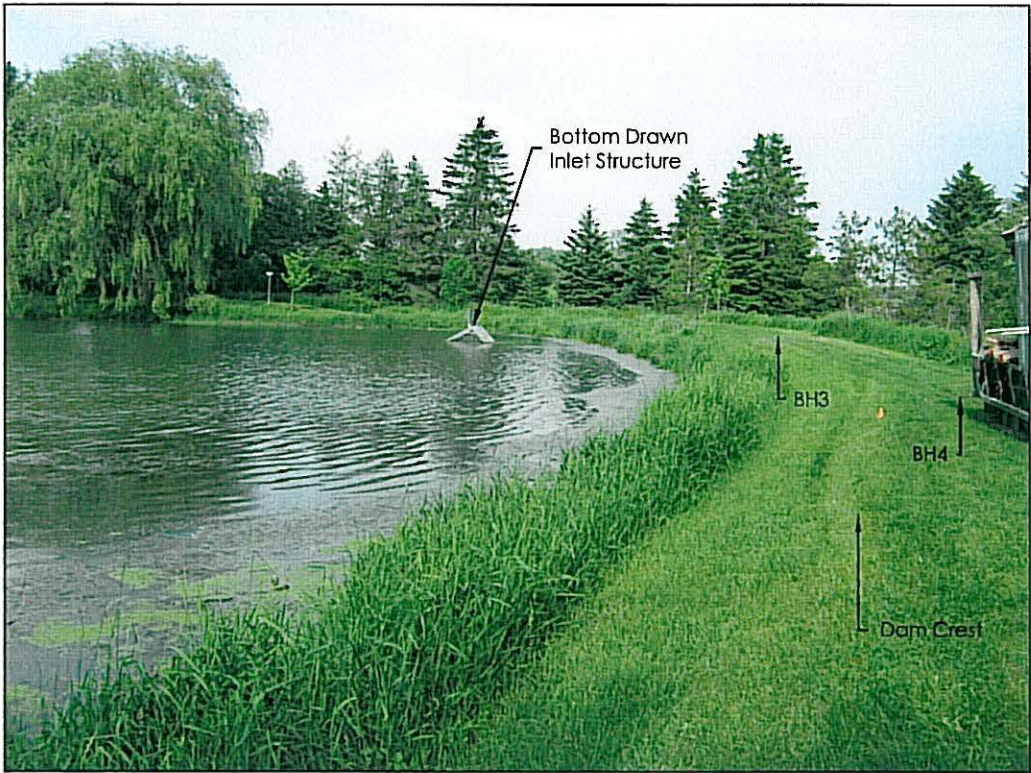
**Photo 2:** Looking east from west end of dam berm.

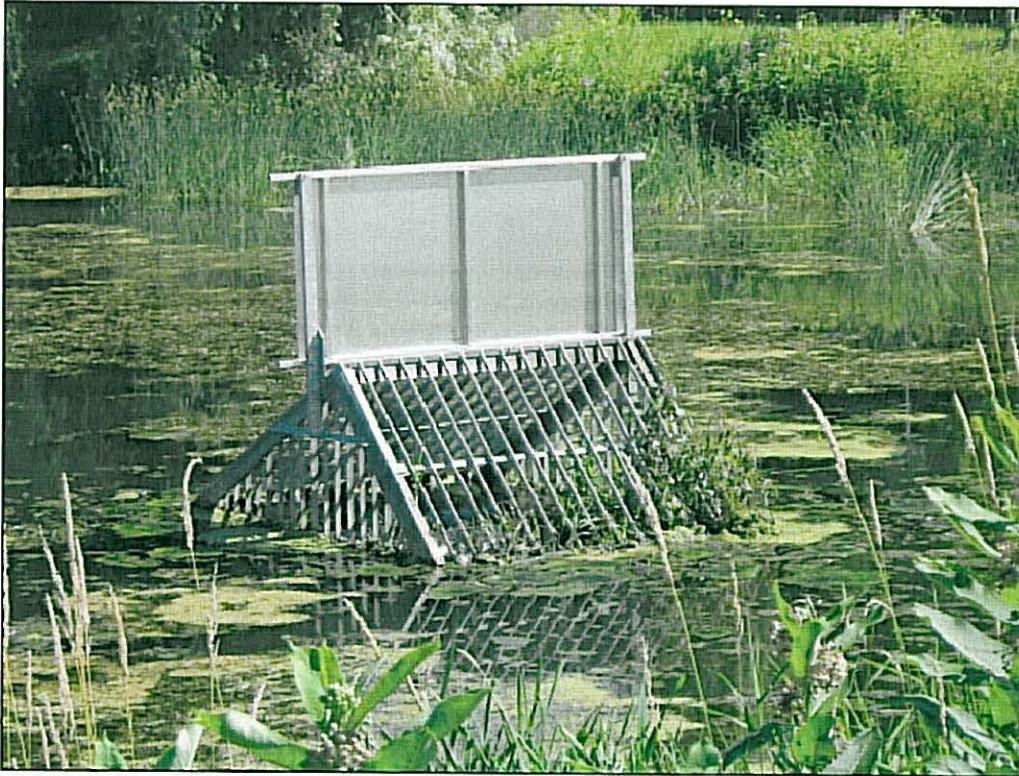
**Photo 7:** Bottom drawn inlet structure.

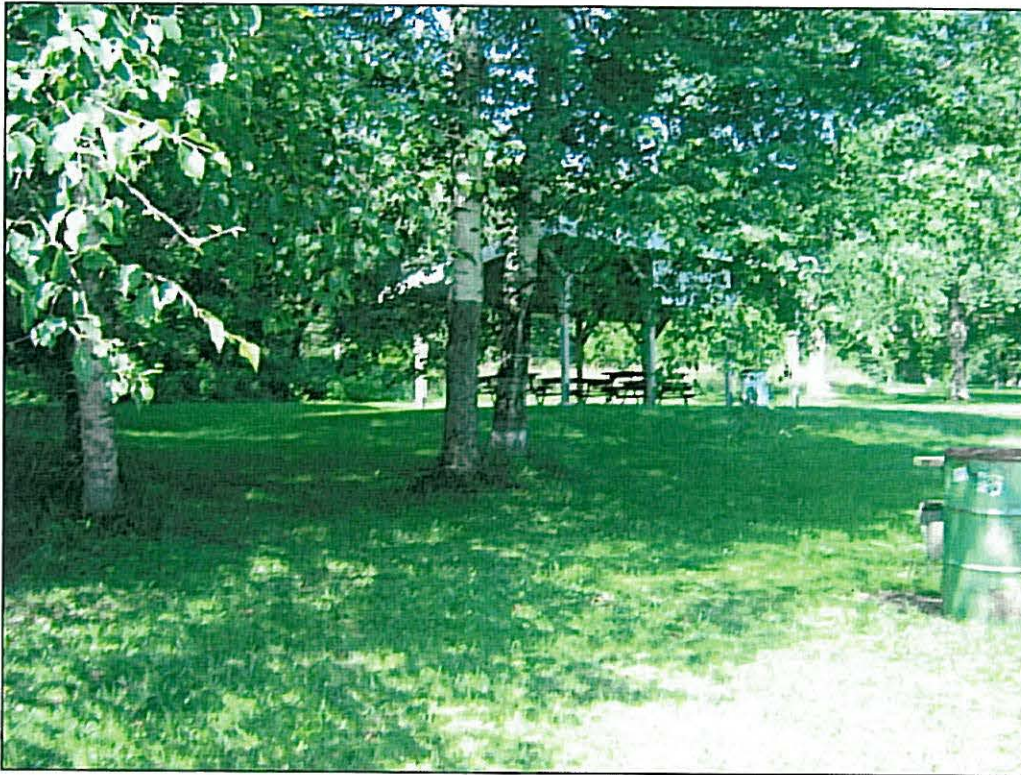
**Photo 8:** Looking east towards the Pavillion at location of temporary benchmark.

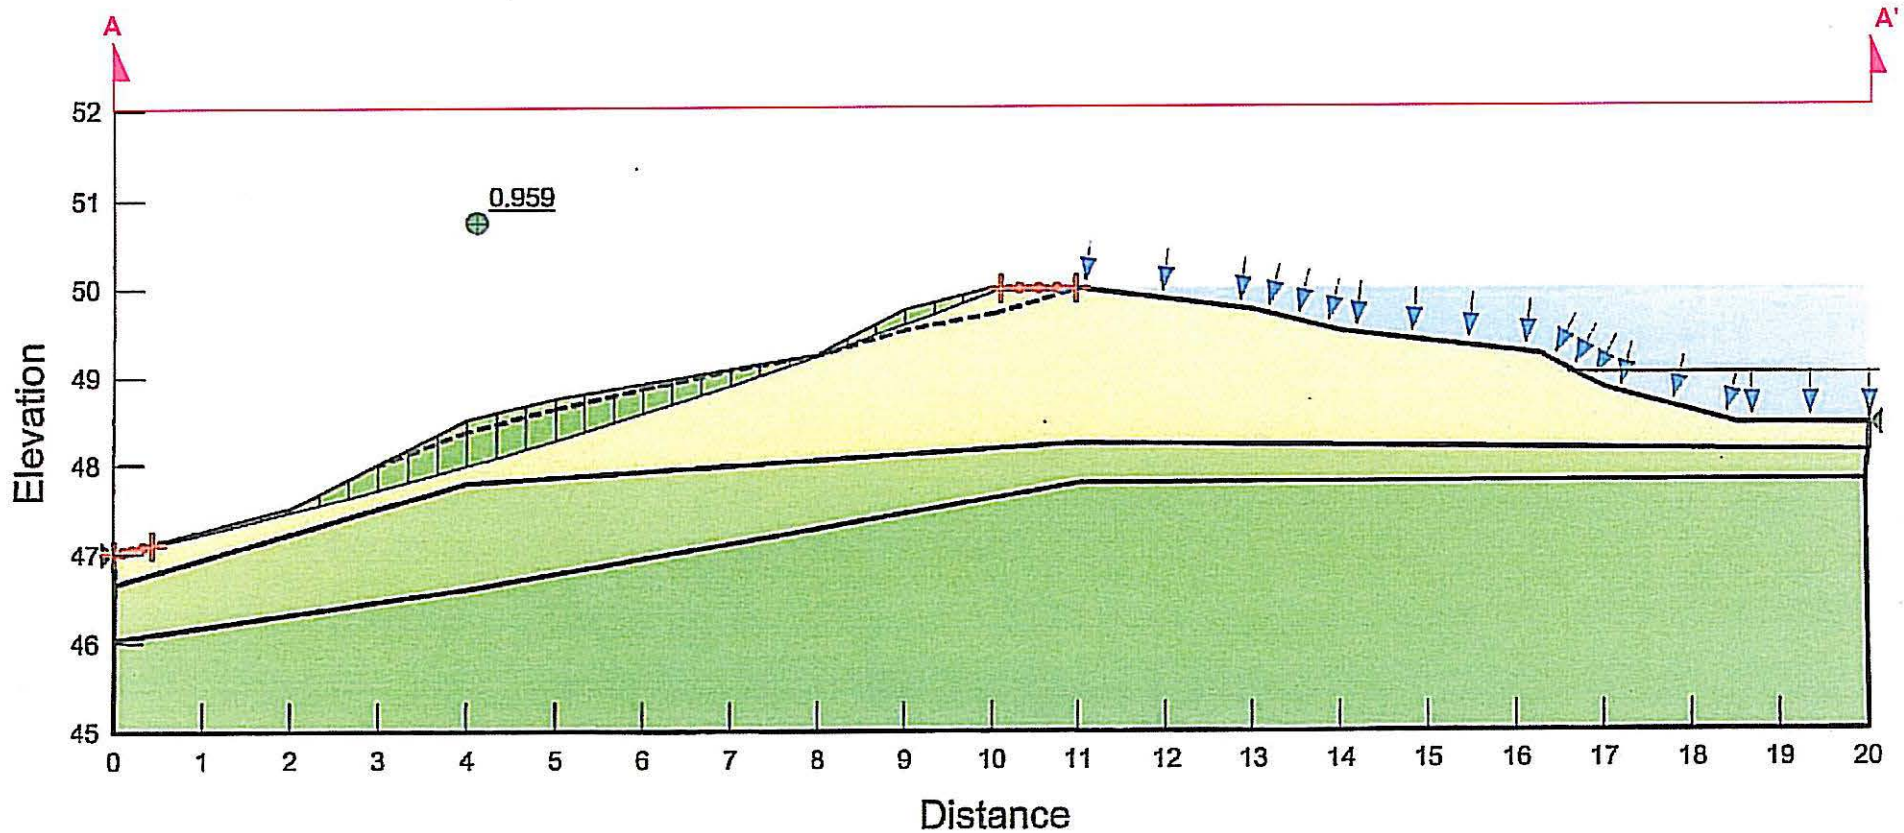
Figure 1A to 1C: Current downstream results for steady state seepage with maximum storage pool

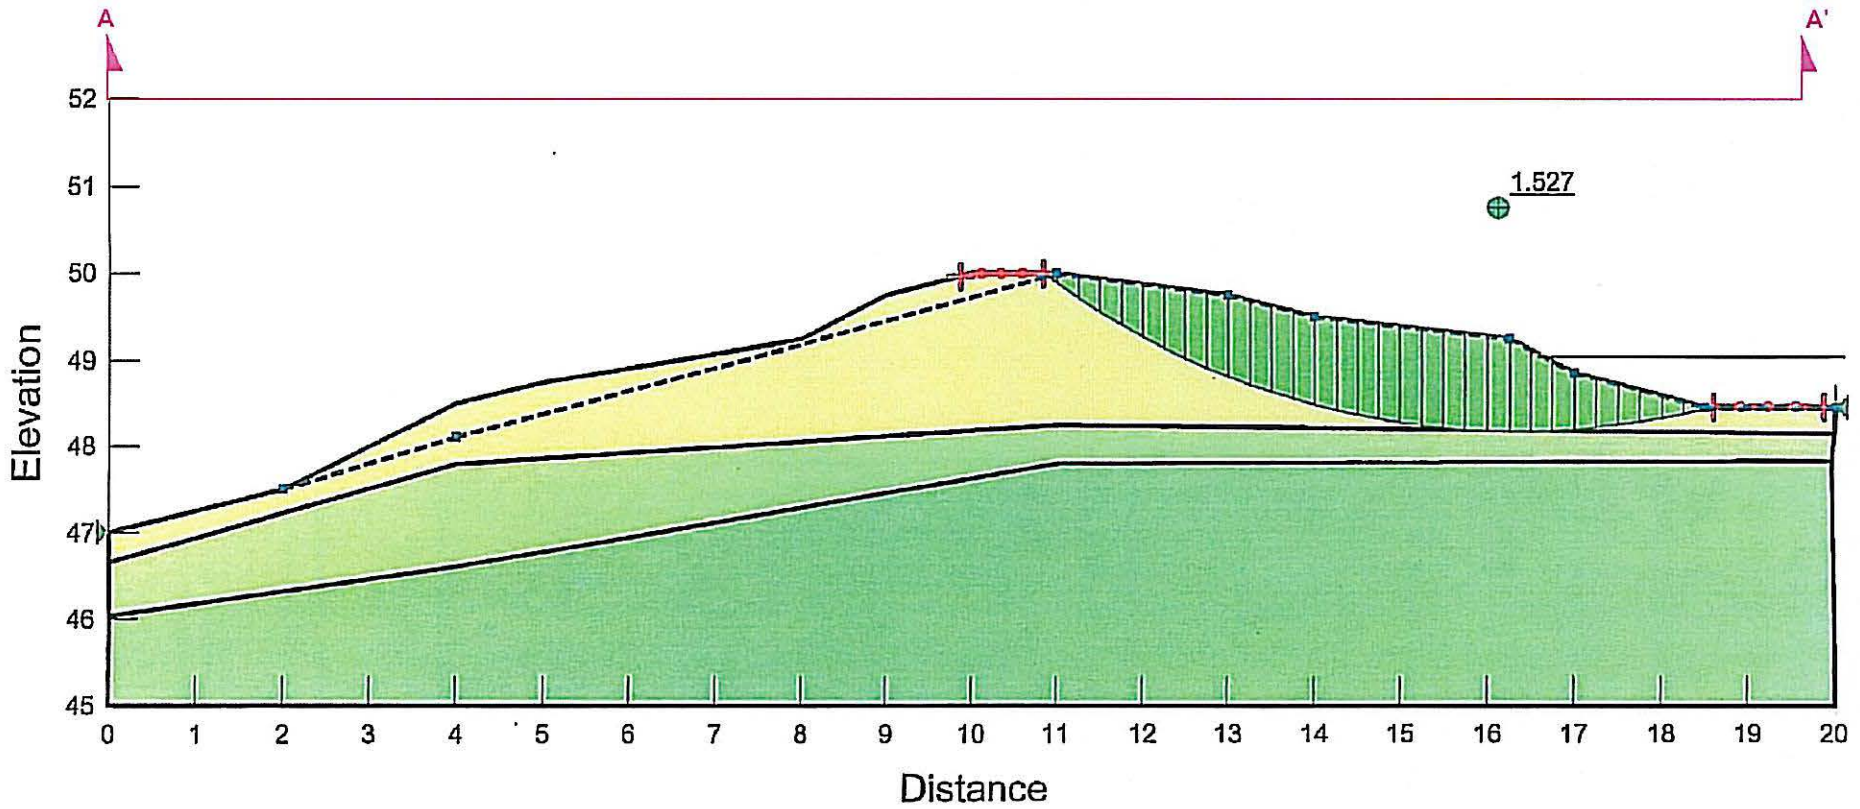
CURRENT UPSTREAM RESULTS FOR FULL RAPID DRAWDOWN			
Date	Scale	Job No.	Figure No.
Sept. 2008	NTS	7607G1	2A

Figure 2A to 2C: Current upstream results for full rapid drawdown

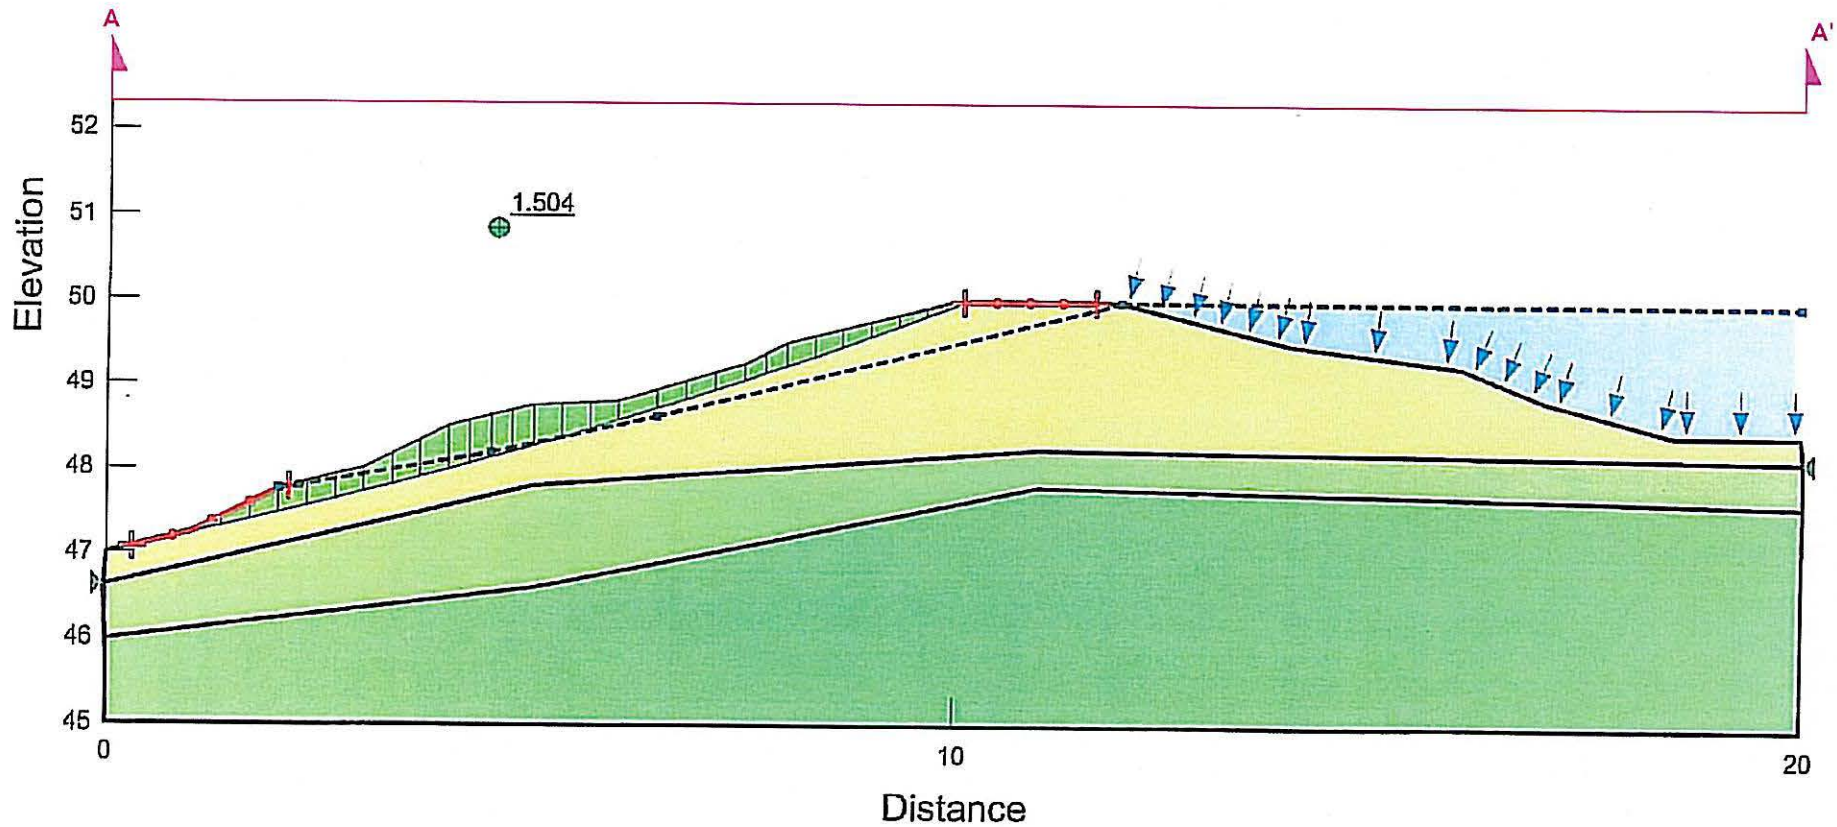
CURRENT RESULTS FOR DOWNSTREAM HORIZONTAL SEISMIC LOAD			
Date	Scale	Job No.	Figure No.
Sept. 2008	NTS	7607G1	3A

Figure 3A to 3C: Current results for downstream horizontal seismic load

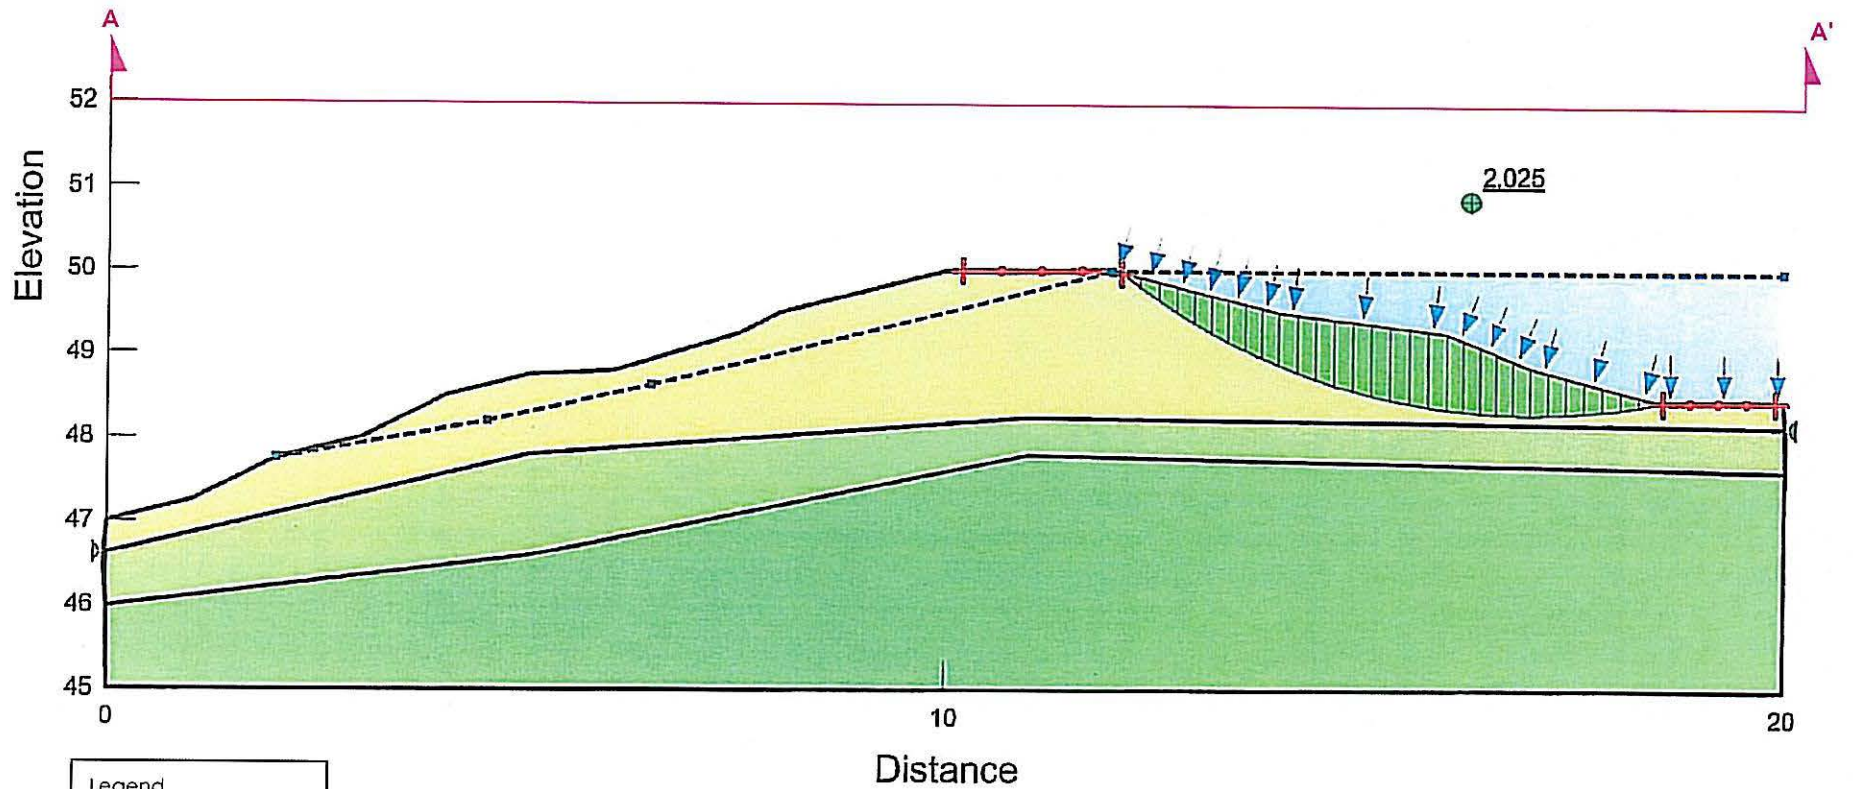
CURRENT RESULTS FOR UPSTREAM HORIZONTAL SEISMIC LOAD			
Date	Scale	Job No.	Figure No.
Sept. 2008	NTS	7607G1	4A

Figure 4A to 4C: Current results for upstream horizontal seismic load
