**GEOTECHNICAL INVESTIGATION  
EMBRO DAM EMBANKMENT STABILITY ASSESSMENT  
843970 ROAD 84  
MUNICIPALITY OF ZORRA, ONTARIO  
for  
UPPER THAMES RIVER CONSERVATION AUTHORITY**

7607G1.R02  
September 2008

**Re: Geotechnical Investigation  
Embryo Dam Embankment Stability Assessment  
843970 Road 84  
Municipality of Zorra, Ontario**

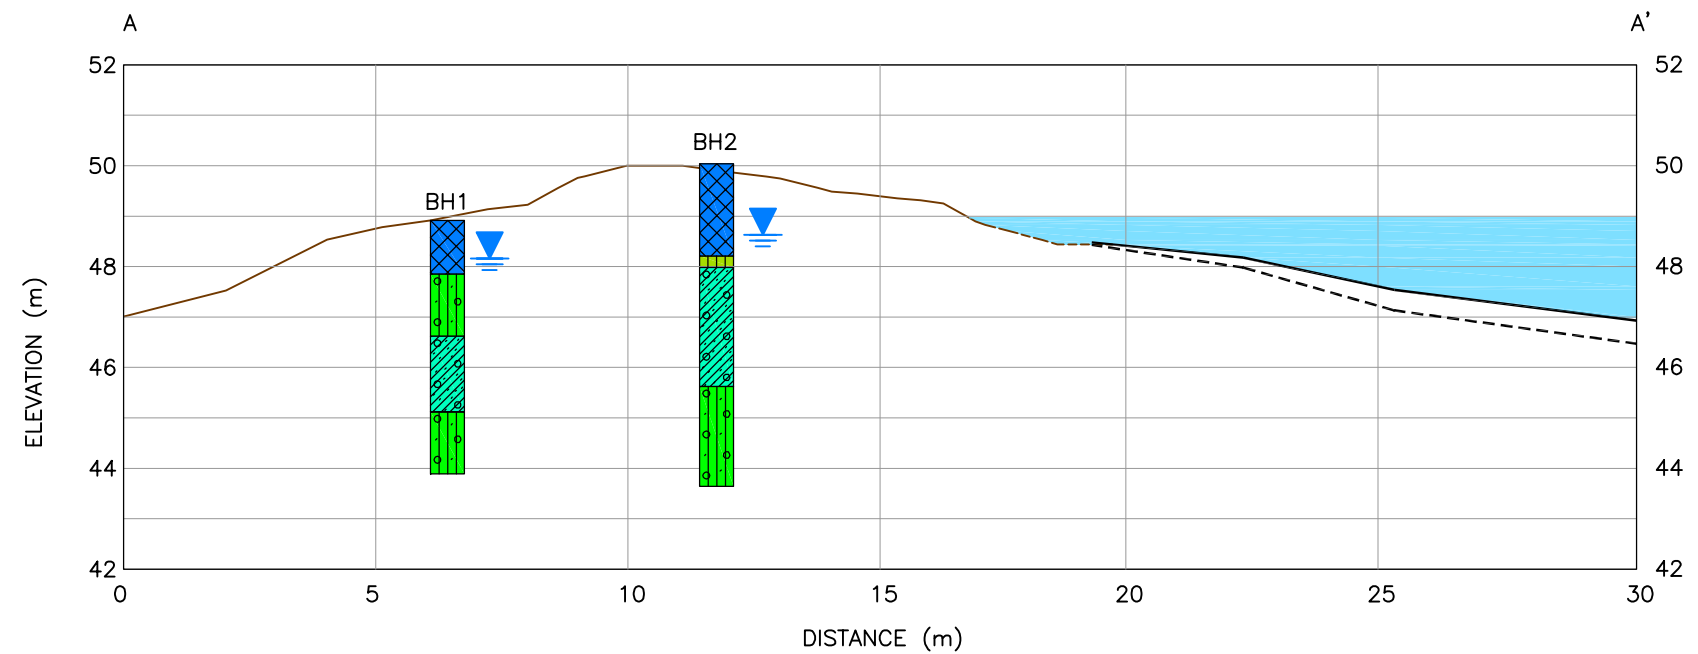
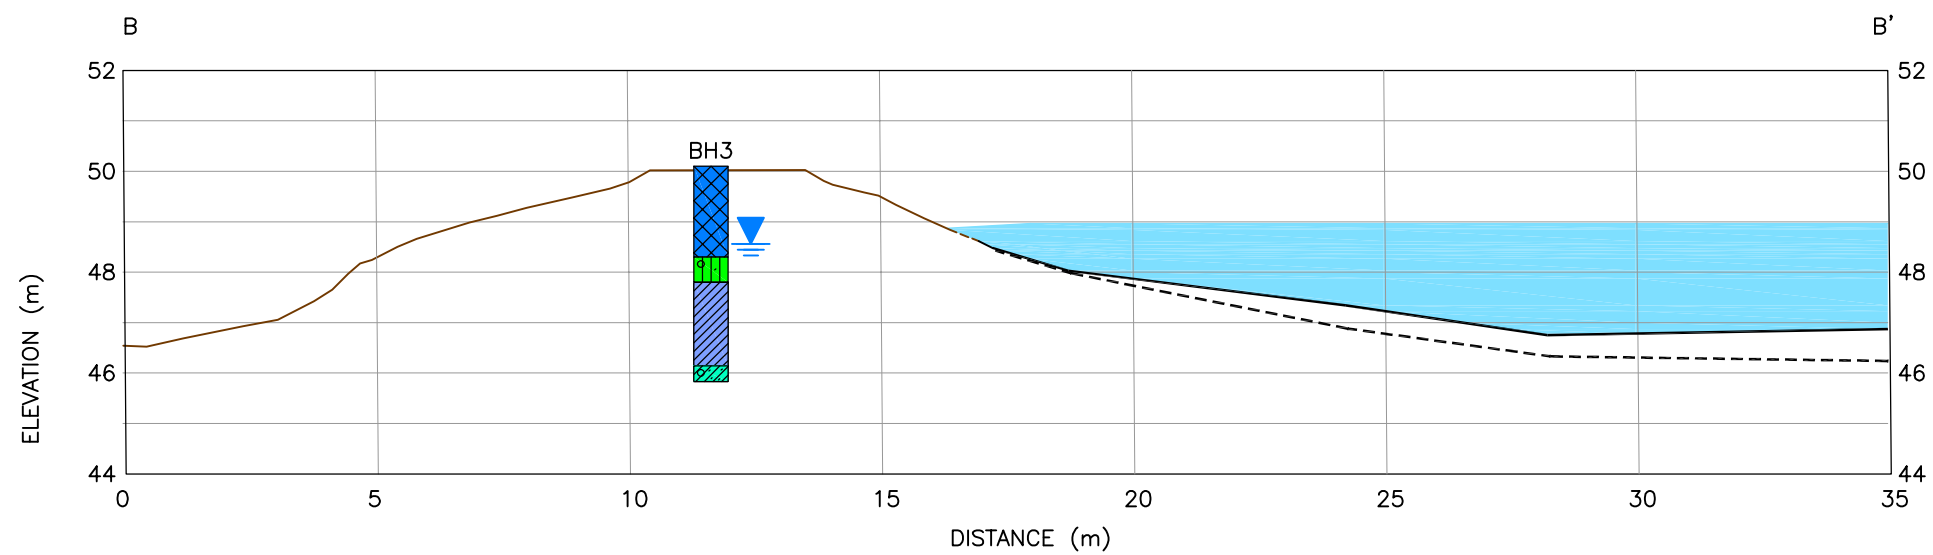
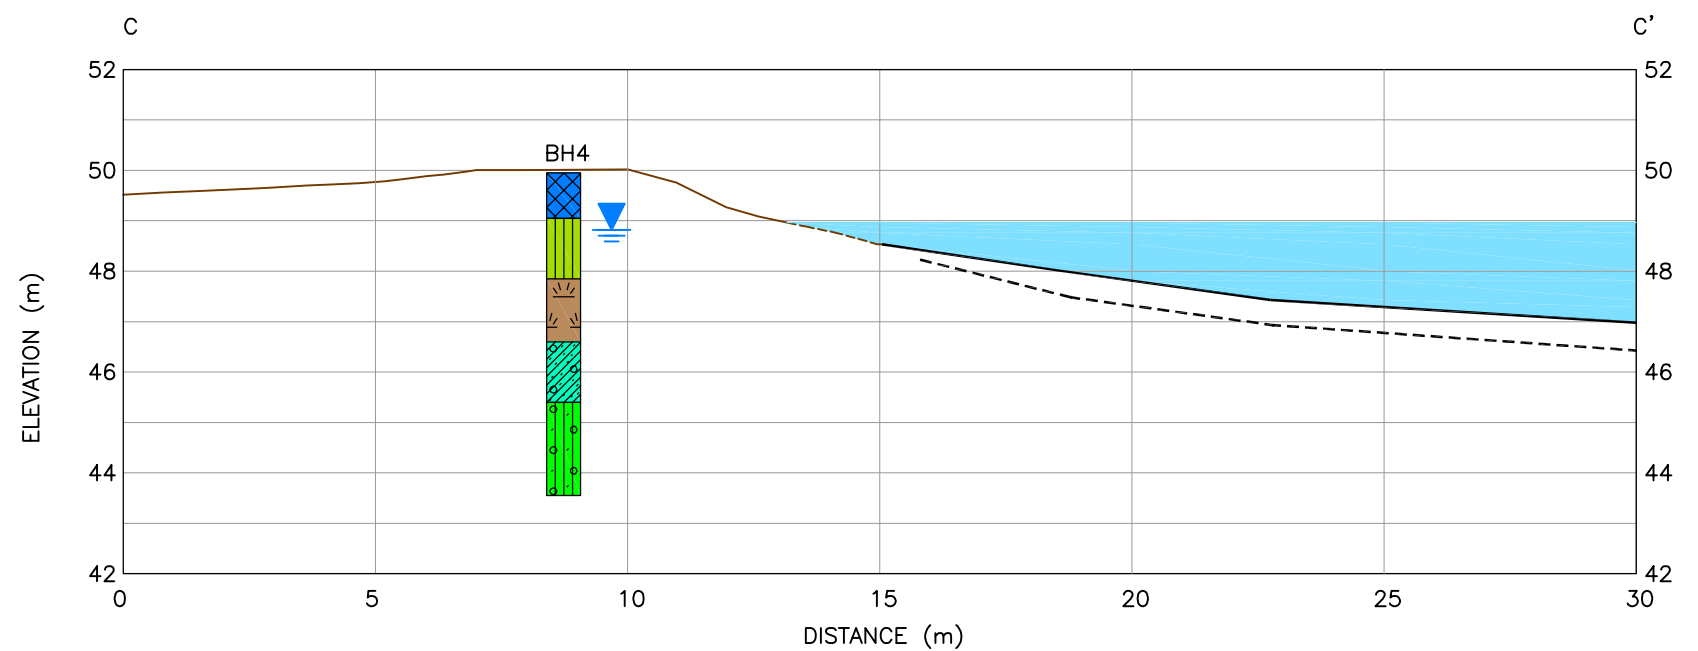
**CROSS-SECTIONS A - A', B - B' and C - C'**

The inferred stratigraphy shown on this cross-section is based on the subsurface stratigraphy contacted at the boreholes. The subsurface conditions between the boreholes will vary.
