DAM SAFETY ASSESSMENT REPORT FOR
Emburo Dam
Final
July, 2007

DAM SAFETY ASSESSMENT REPORT FOR
Emburo Dam

Final
July, 2007

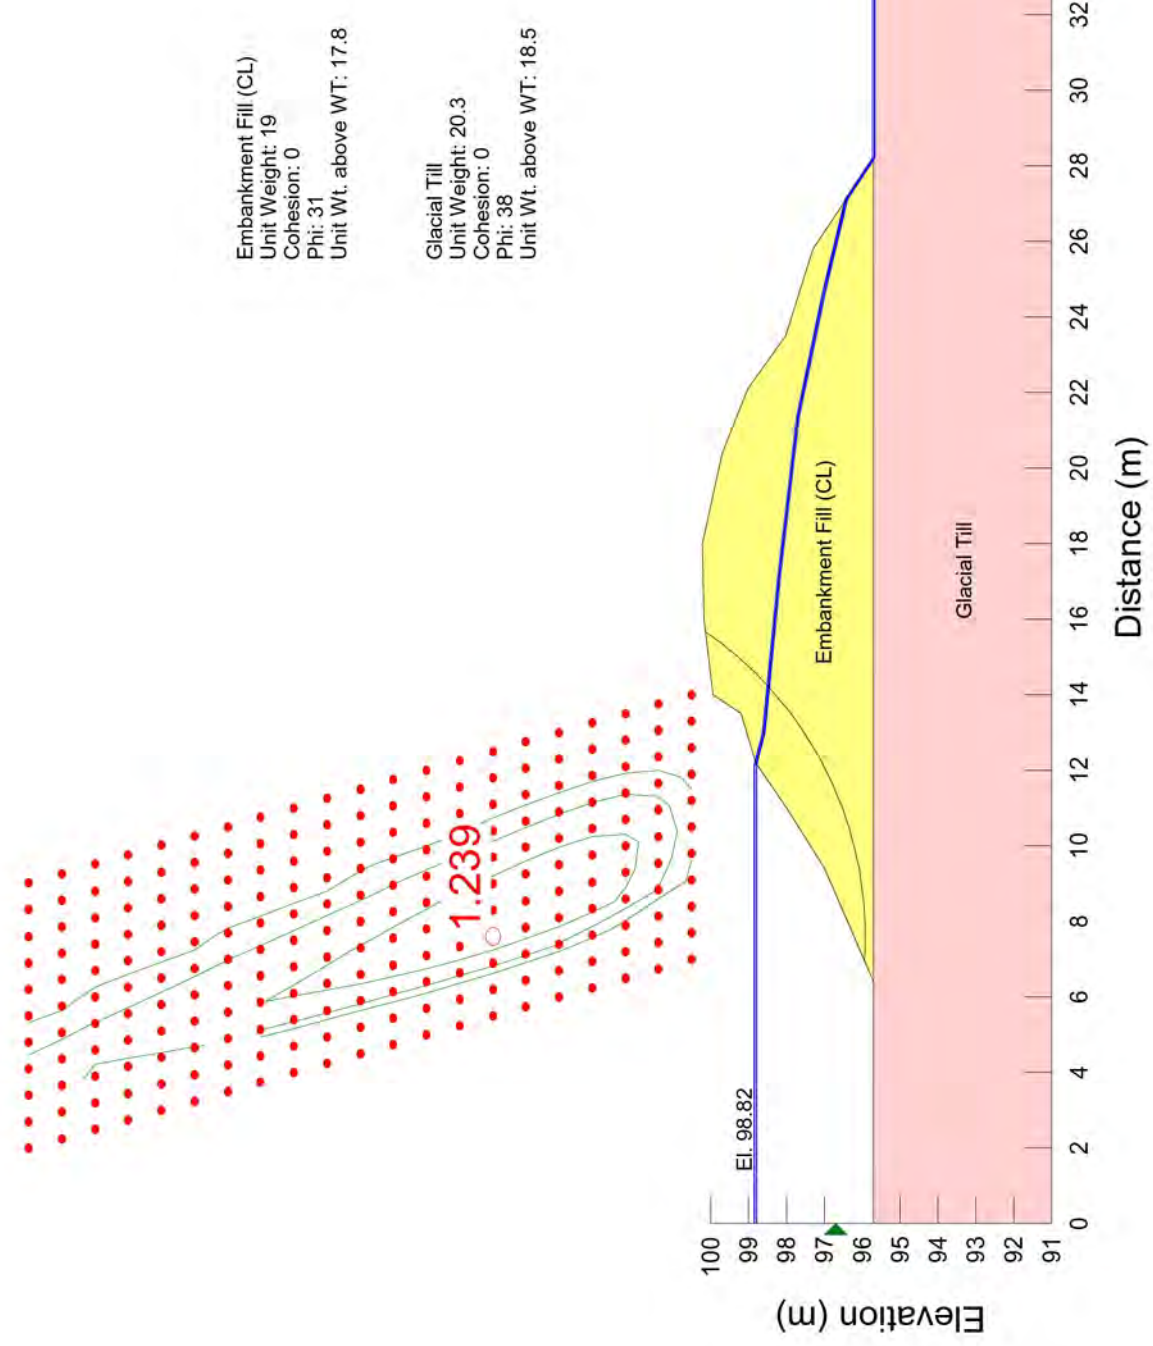
Figure 8.3
 Upper Thames River Conservation Authority
 Dam Safety Assessment Report - Embro Dam
Upstream Stability, Normal Load Condition

The dam does not meet all the required stability criteria. Stability of the upstream slope should be reviewed based on a surveyed profile.

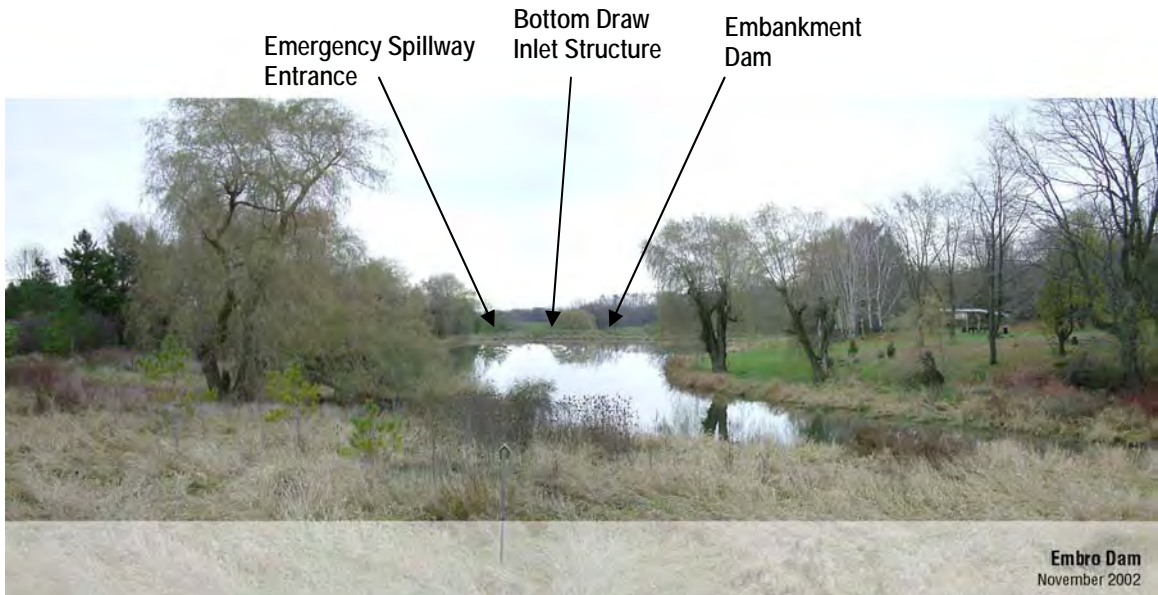
Photo 1 – View of Dam from Far End of Pond

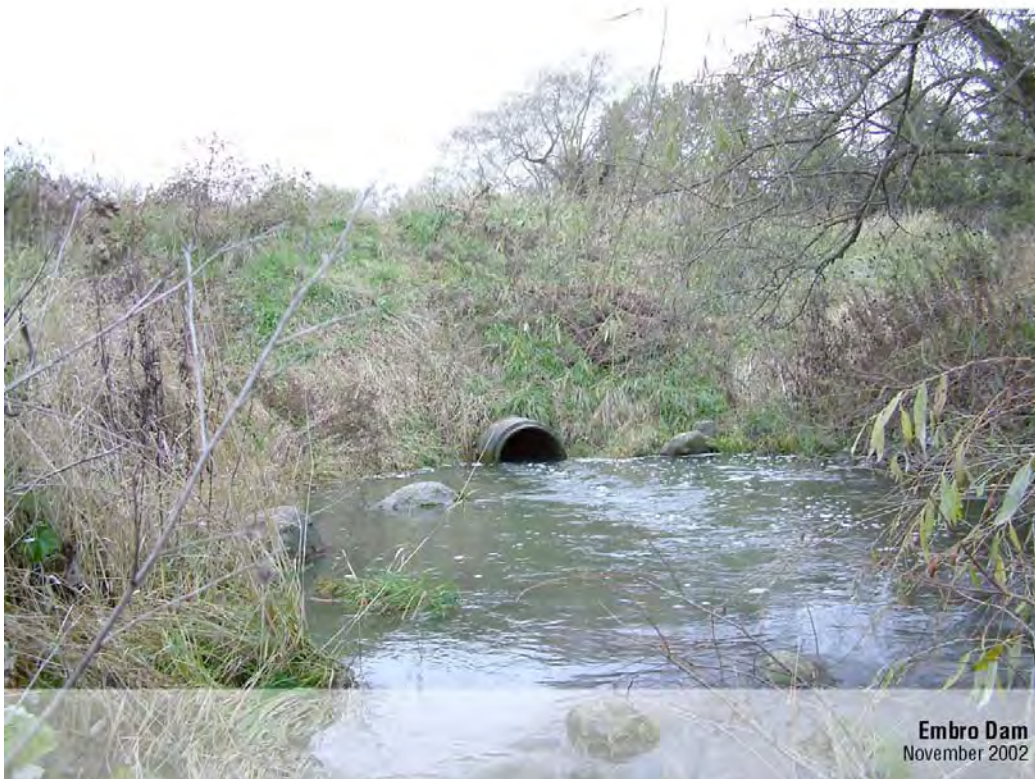
The outlet conduit consists of precast concrete pipe with an inside diameter of 762 mm (30 in.) (Photo 2). No joints were exposed at the outlet, and the concrete appeared to be in good condition.

Photo 2 – Downstream View of Embankment at Pipe Outlet

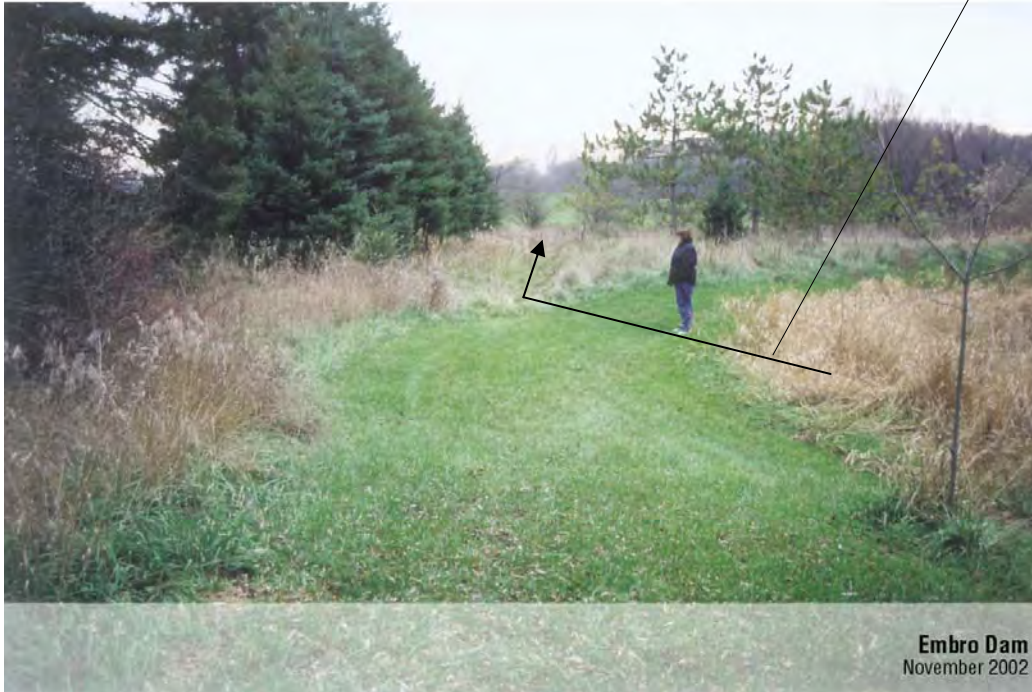
Photo 3 – Emergency Spillway Entrance

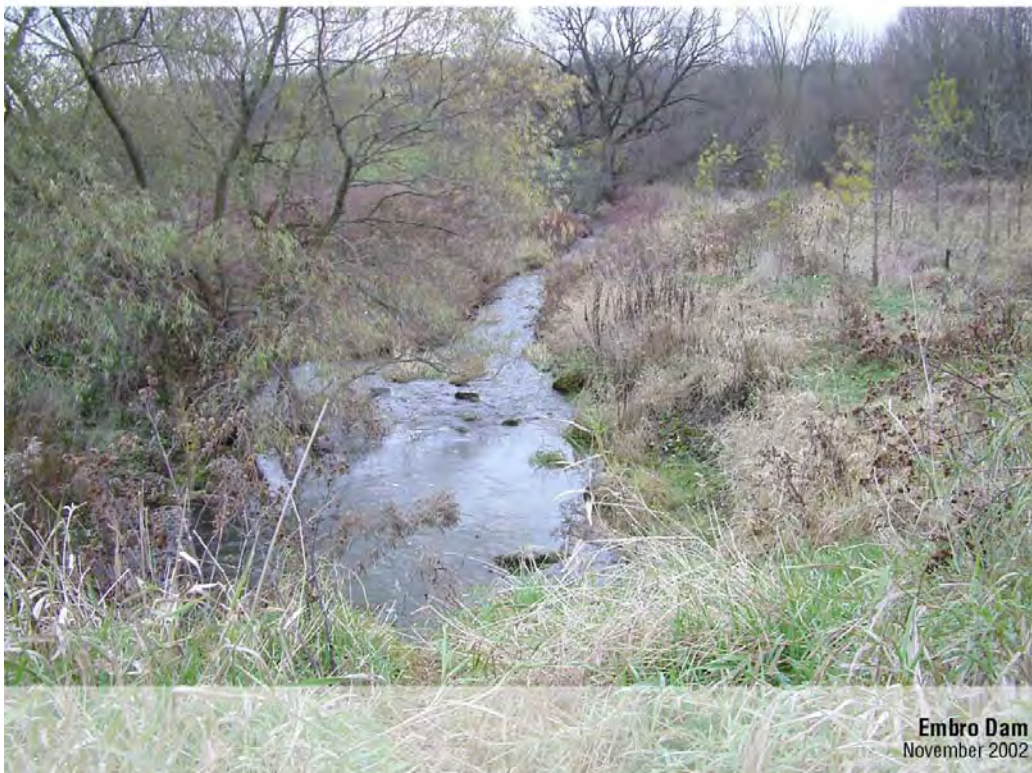
Photo 4 – Downstream Channel

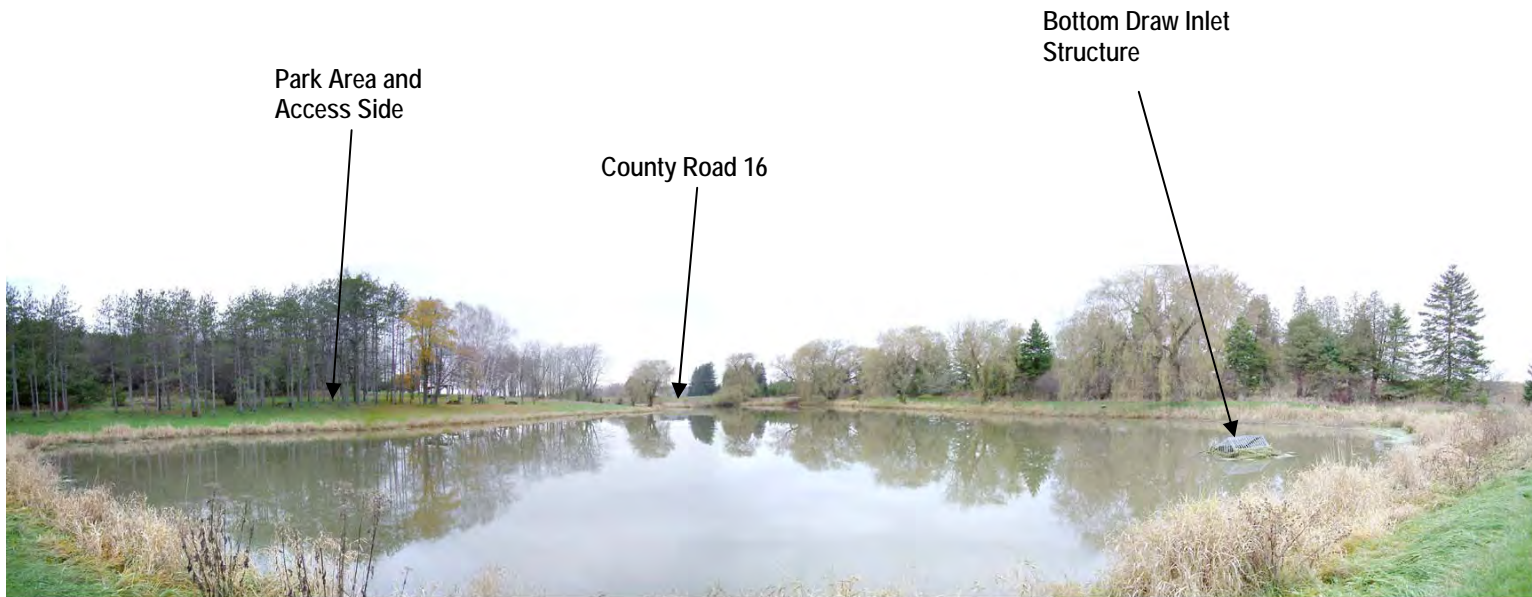
Photo 5 – Upstream View of Pond

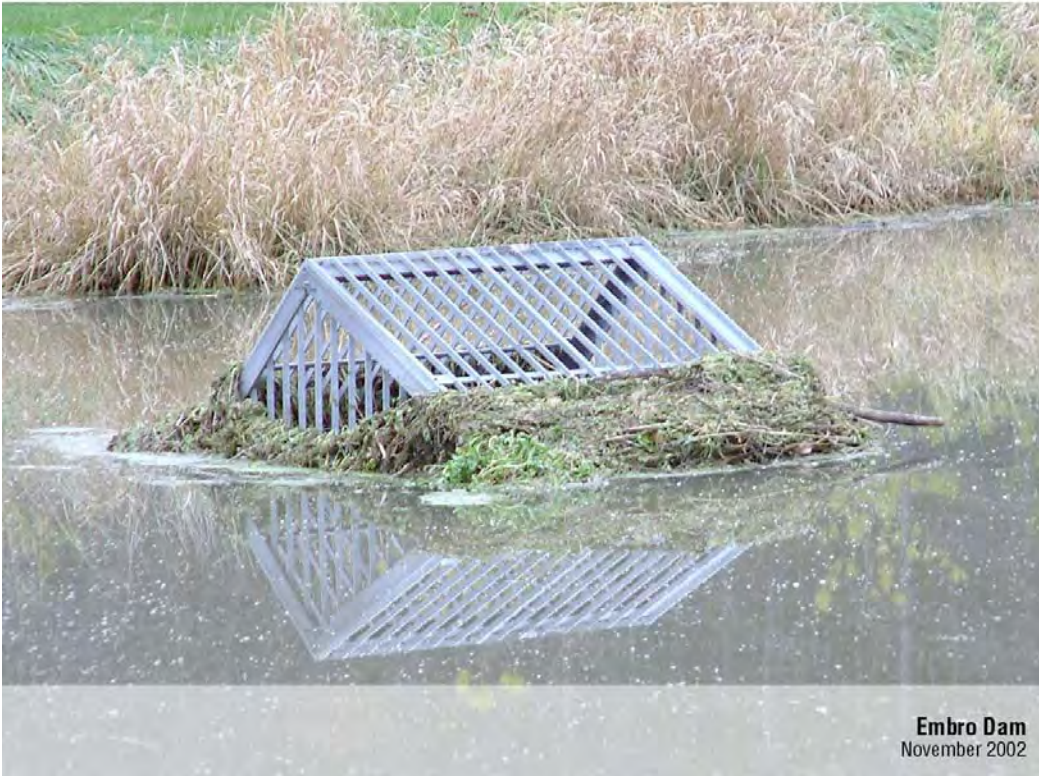
At the time of inspection, the concrete intake was overflowing and clogged with weeds and other debris (Photo 6). The trashrack is constructed of galvanized steel and appears to be in good condition and well-anchored to the concrete intake.

Photo 6 – Bottom Draw Inlet Structure

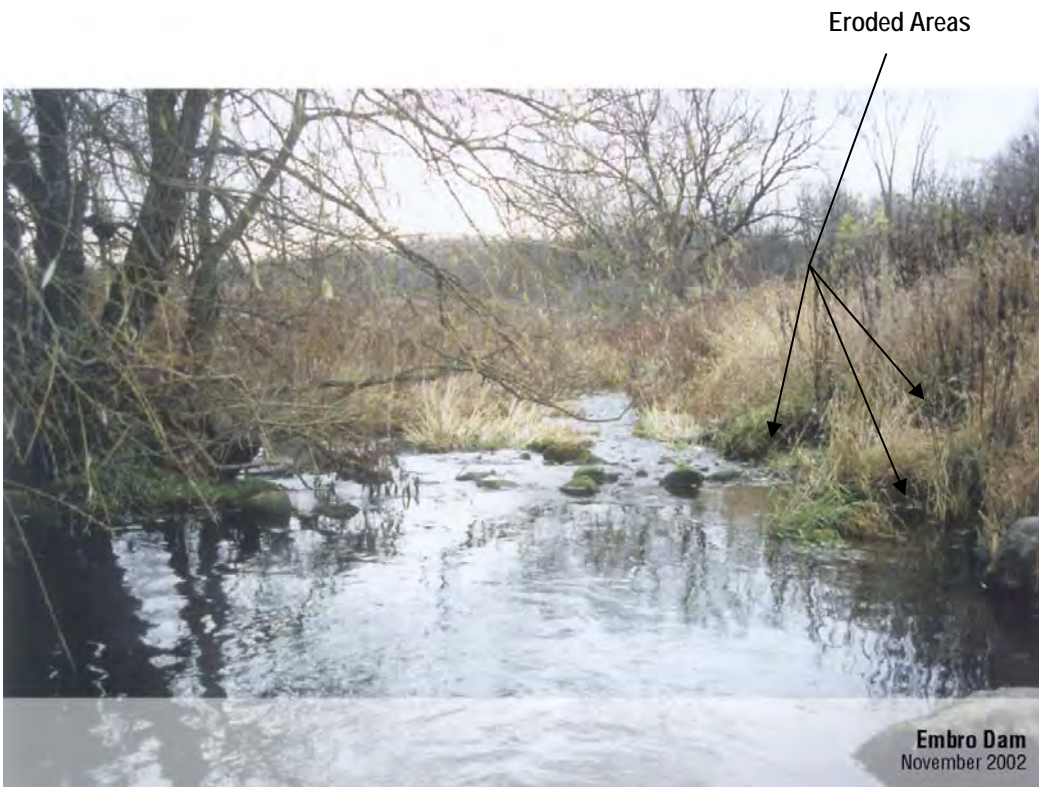
The entire damsite is founded on overburden, and the discharge from the bottom draw inlet and circular pipe has formed a small pool at the pipe outlet (Photo 7). The channel downstream slopes gradually away from the outlet pipe and the banks are overgrown with grasses, brushes and trees (Photo 4). The creek channel downstream of the reservoir has a reasonable bed slope that winds through wooded land until it reaches open area (farms). There are no permanent dwellings or development in the downstream reach of the discharge channel for a distance of nearly 1 km. The dam was previously overtopped in the summer of 2000 with minor damage.

Photo 7 – Pool Area at Pipe Outlet

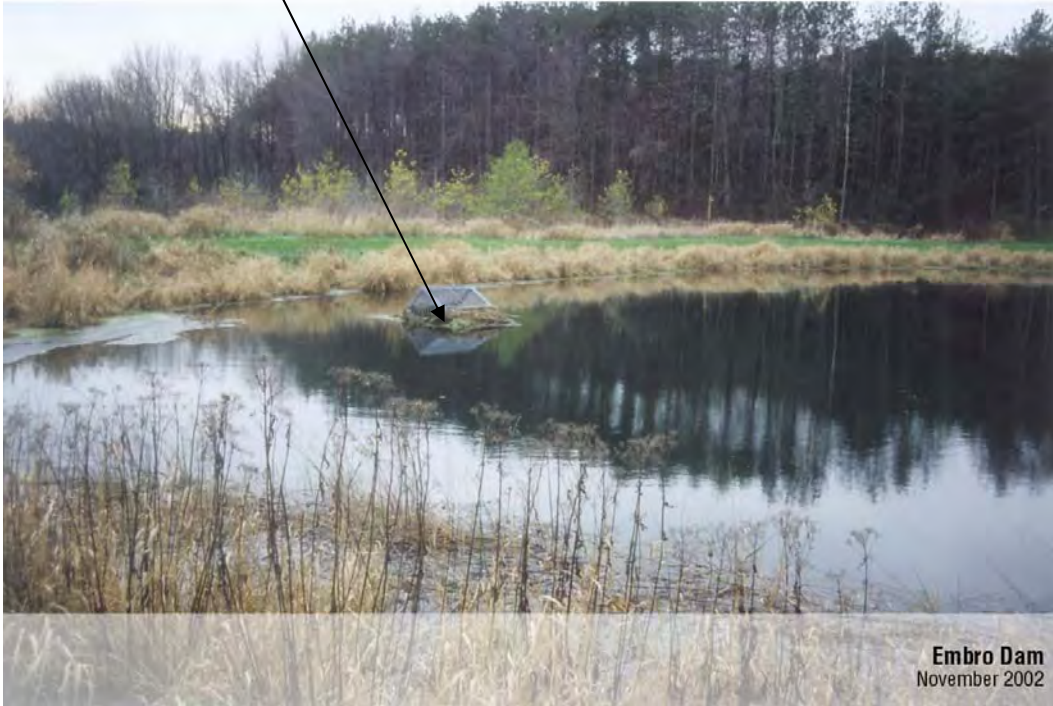
No unusual conditions such as sloughing, sinkholes, cracking, settlement or displacement were observed on the upstream slope (Photo 8). The slope was overgrown with reeds and grass. No slope protection was apparent. No erosion or benching was apparent.

Photo 8 – Upstream Face of Dam

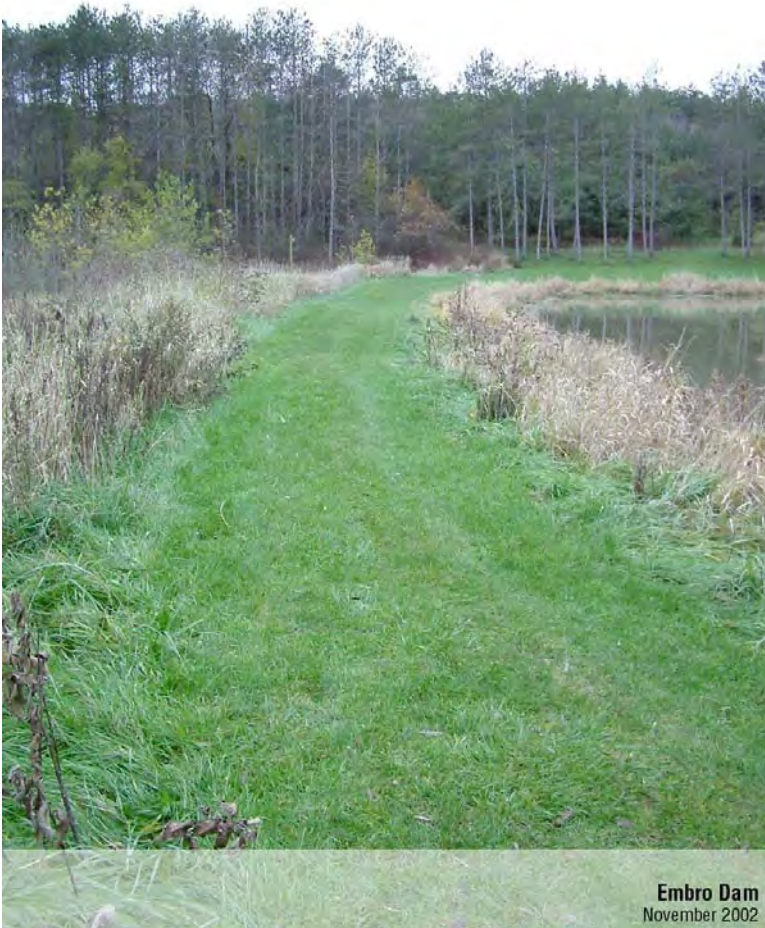
No unusual conditions such as cracking, displacement, settlement, or sinkholes were observed (Photo 9).

Photo 9 – View along Dam Crest

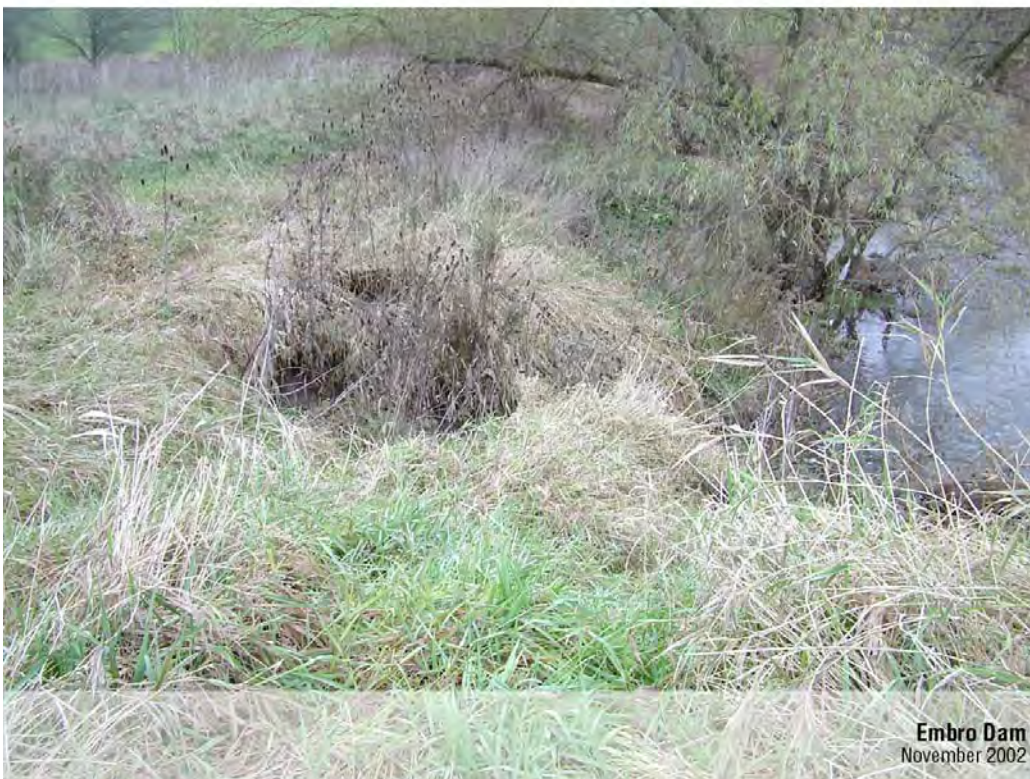
There is no evidence of settlement, cracking, displacement or sinkholes in the dam or in the abutments. Embro Dam is, however, poorly maintained; for example, there is no riprap protection on the upstream slope and wave-induced erosion has occurred (this conflicts with the site inspection report as explained in Section 8.1). A gully/sinkhole has been eroded on the left bank at the downstream toe. This appears to have been caused by emergency spillway overflow redirected towards the downstream toe of the dam instead of taking the planned route which was overgrown with grass. Some minor washing/erosion of the right bank downstream of the pipe outlet has also occurred as a result of this redirected overflow.

Photo 10 – Eroded Area at Downstream Toe, Left Bank

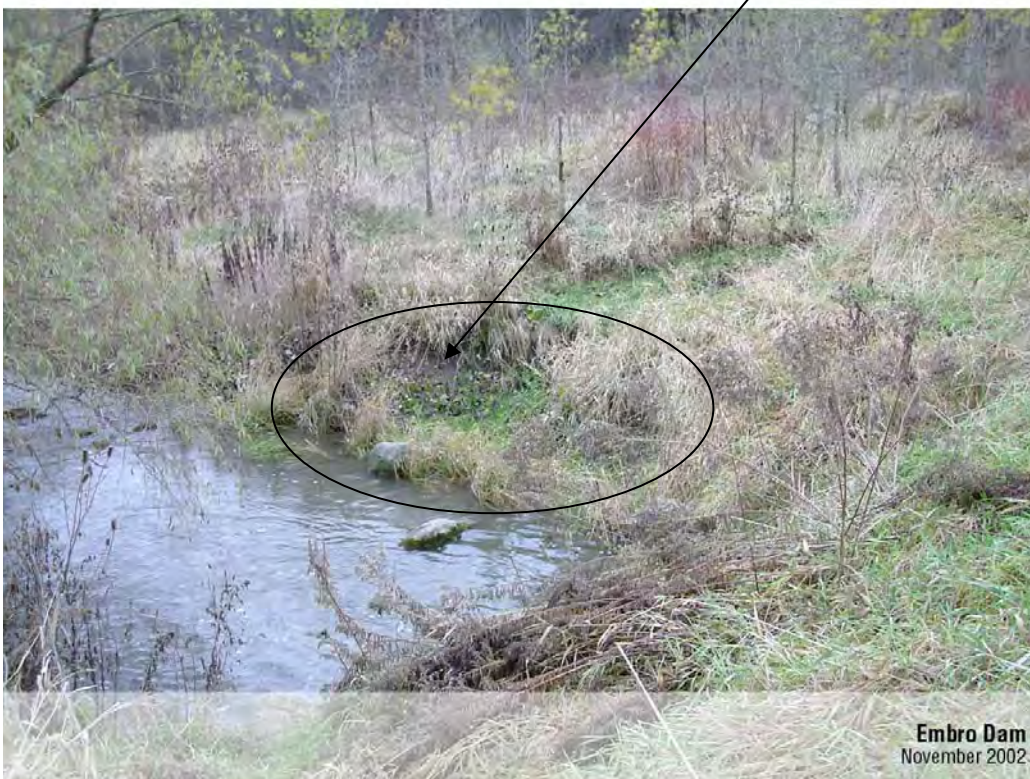
Photo 11 – Erosion along Right Downstream Channel
