DAM SAFETY ASSESSMENT REPORT FOR
Fullarton Dam
Final
August, 2007

DAM SAFETY ASSESSMENT REPORT FOR
Fullarton Dam

Final
August, 2007

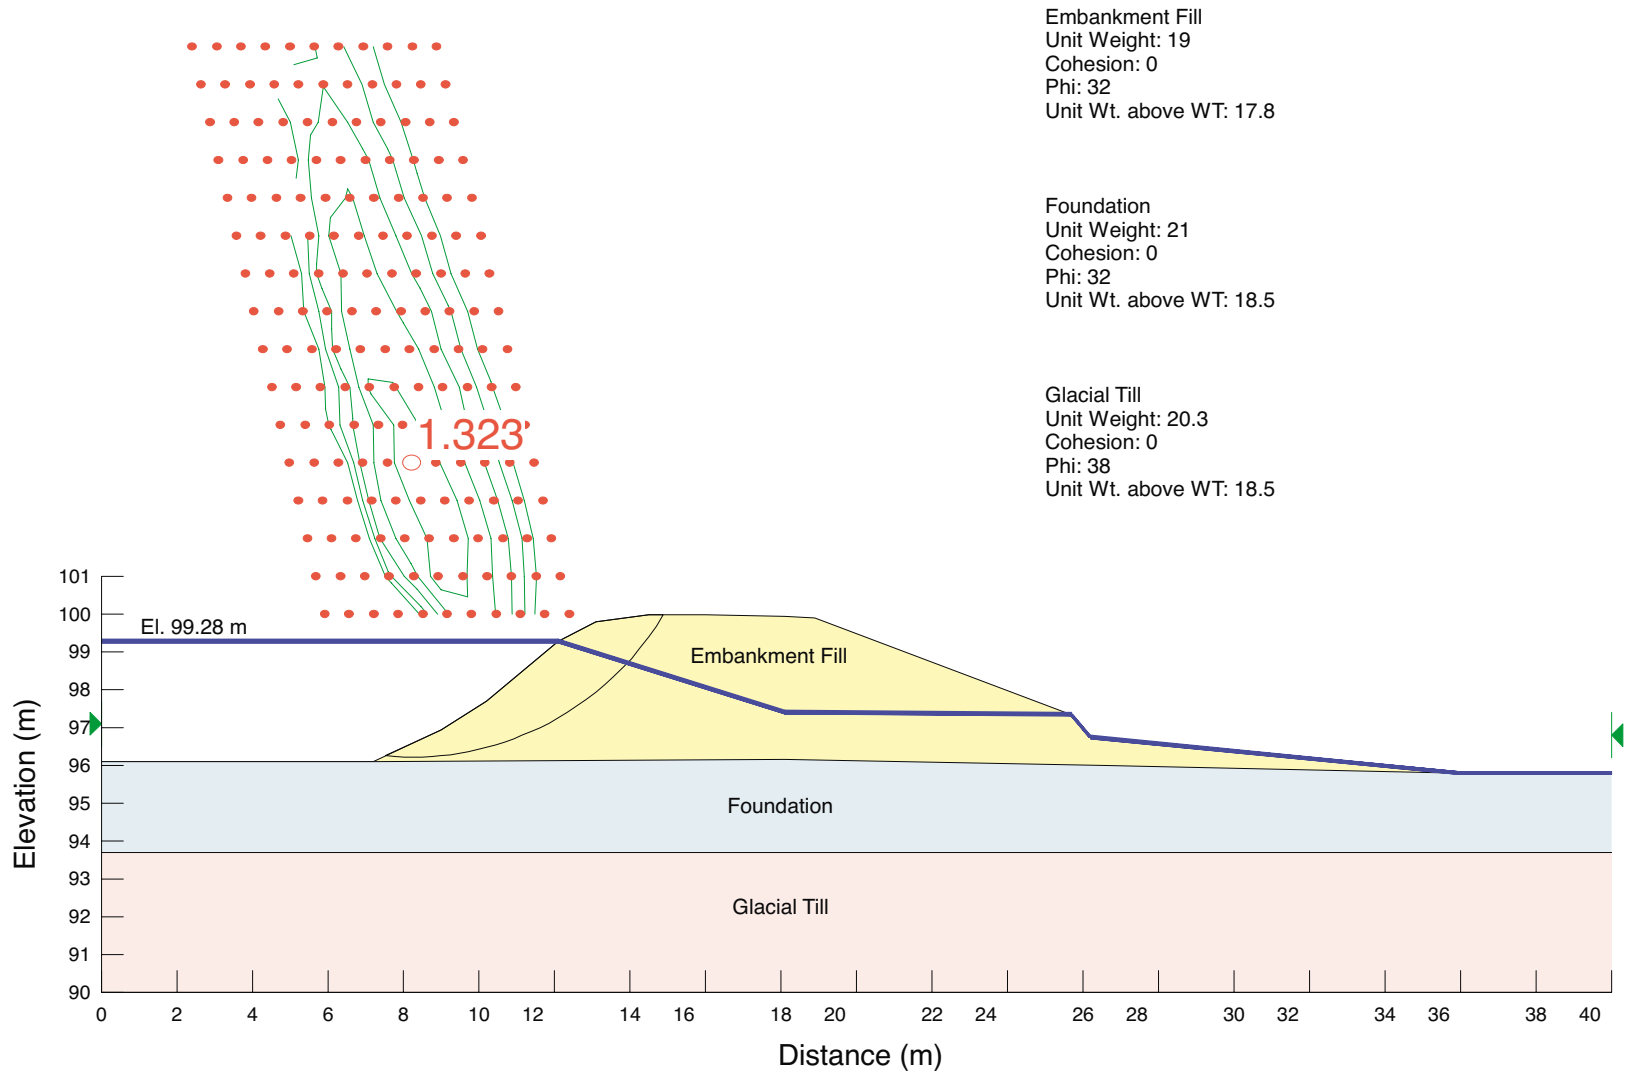
The upstream slope and the downstream slope fail to meet acceptance criteria for the normal water level condition.

A parametric study indicates that a small increase in the angle of friction for the embankment fill would bring the dam stability into compliance. It may be that the actual angle of friction of the fill is greater than that assumed, and perhaps sufficiently greater to meet compliance requirements. It is recommended that further shear strength testing be done followed by reanalysis. It is noted that sufficient sample material is available from the recently completed boreholes.

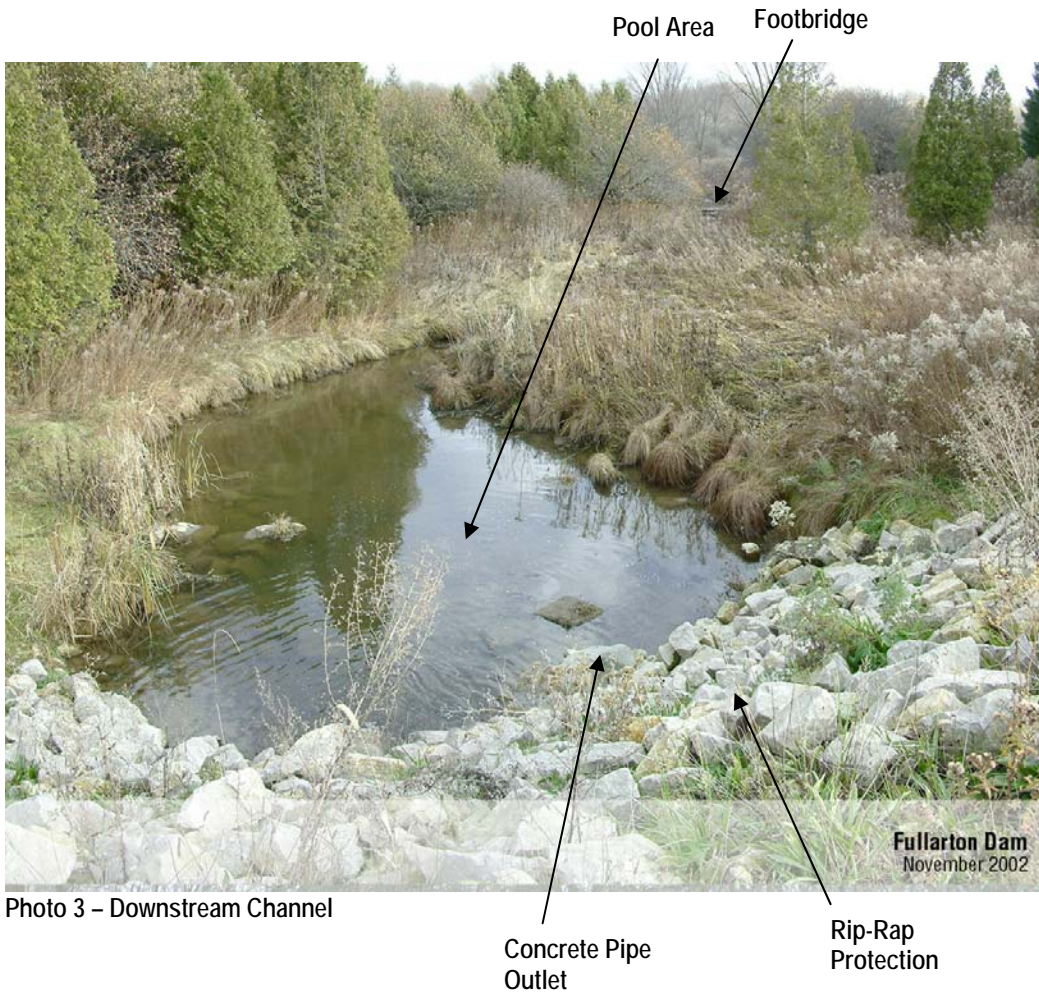
Photo 3 – Downstream Channel

The entire damsite is founded on overburden, and the discharge from the drop inlet and circular pipe has formed a deep pool at its outlet point (Photo 3). The channel is armored with large cobbles and boulders around the outlet, and both banks are lined with grasses, brushes and mature trees. The channel downstream appears to slope relatively gently, and there is a small wooden footbridge (Photo 8) (planks) that crosses it some distance downstream. There is no evidence that high tailwater levels are present or that a problem exists at this dam. The dam was overtopped in the summer of 2000, and the high outflows eroded the embankment in the area of the outflow pipe. There are no permanent dwellings or development in the immediate vicinity of the downstream reach of the discharge channel.

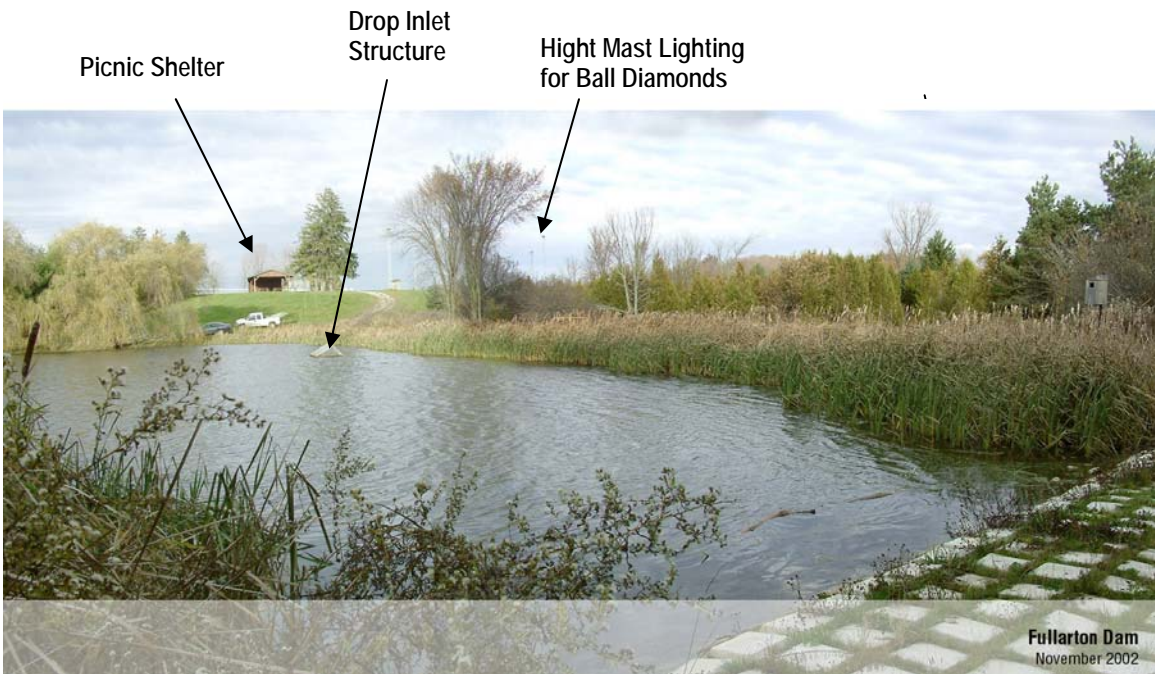
Photo 9 – Upstream Face of Dam

The upstream slope (Photo 9) was not protected with riprap and was overgrown with cottontail growth. Benching due to erosion by wave action had occurred locally up to 0.5 m. No sloughing, displacement, settlement, cracking or sinkholes were evident. No floating debris had accumulated.

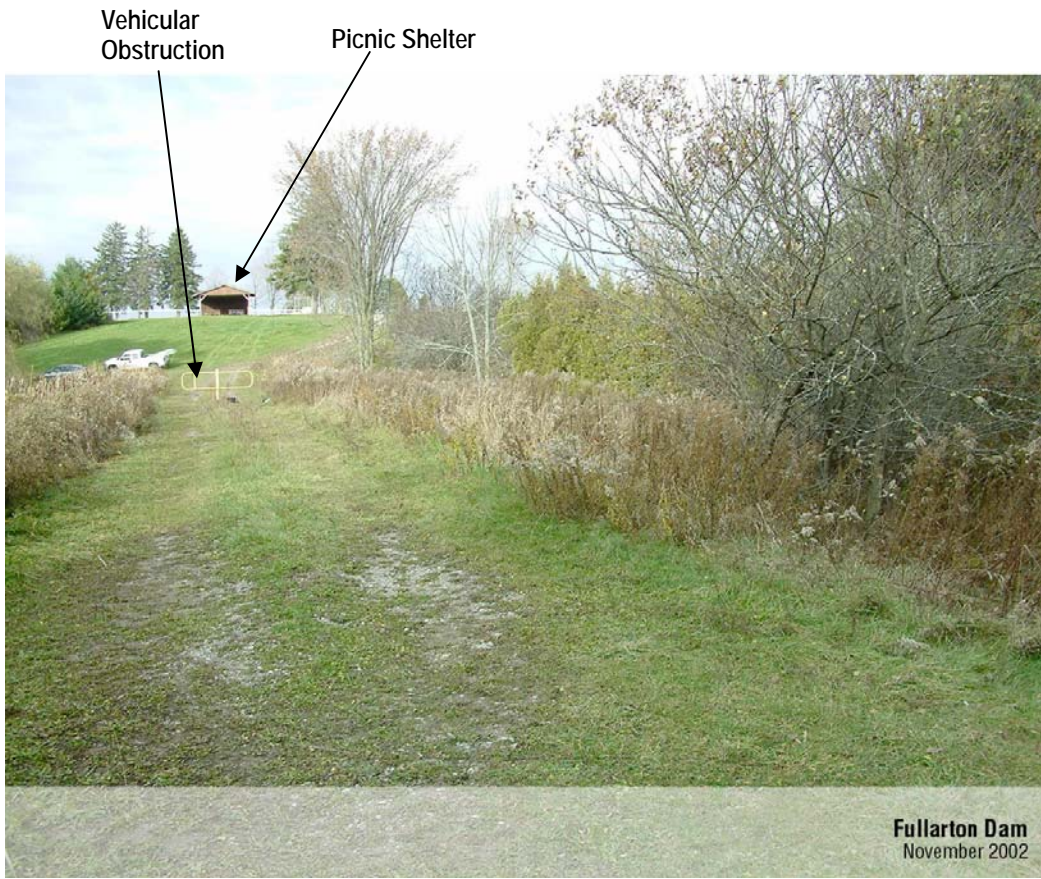
Photo 10 – View of Crest from Right Bank

The crest (Photo 10) showed no cracking, displacement, sinkholes or settlement. Camber was not apparent.

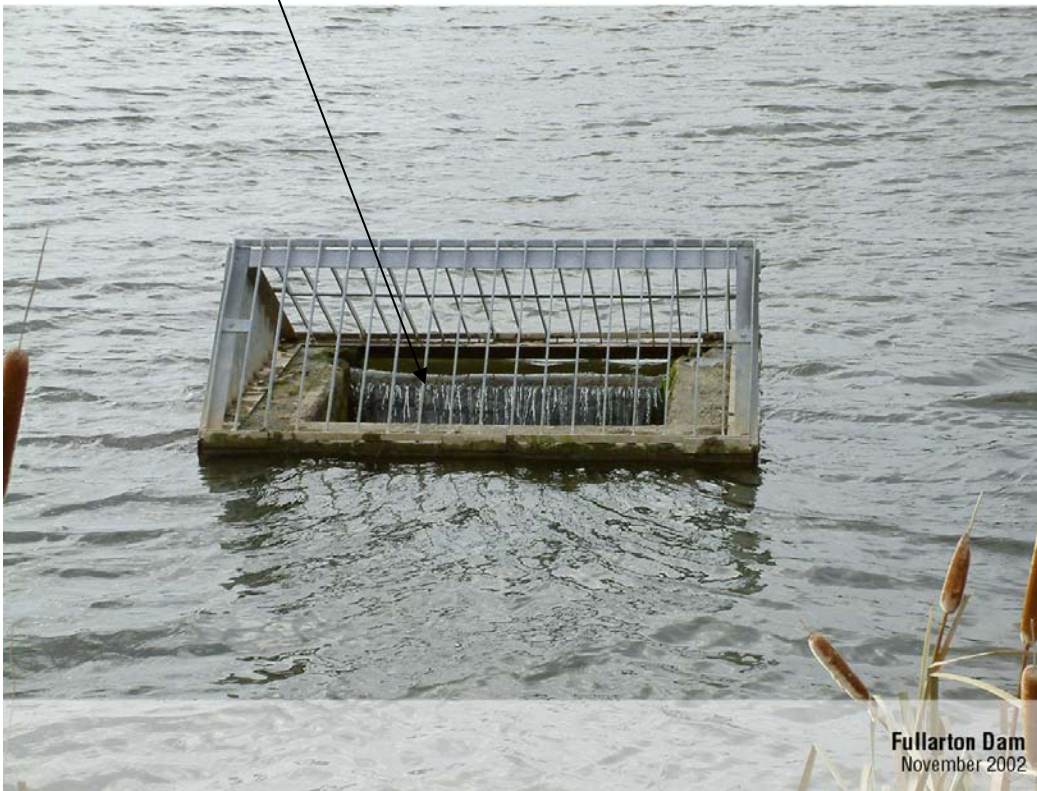
Photo 12 – Drop Inlet Structure

Erosion Pocket

Erosion of Concrete Face
