**GEOTECHNICAL INVESTIGATION
FULLARTON DAM EMBANKMENT STABILITY ASSESSEMENT
MUNICIPALITY OF WEST PERTH, ONTARIO
for
UPPER THAMES RIVER CONSERVATION AUTHORITY**

6031G1.R01
February 2006

**Re: Geotechnical Investigation
Fullarton Dam Embankment Stability Assessment
Municipality of West Perth, Ontario**

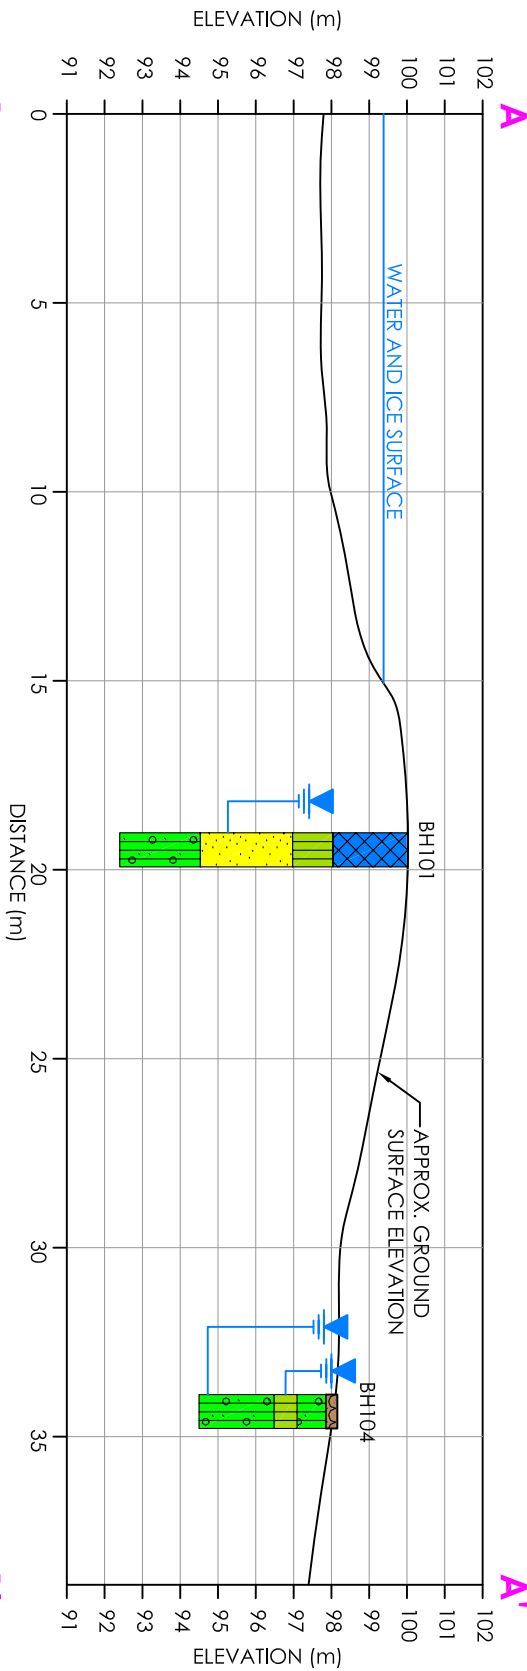
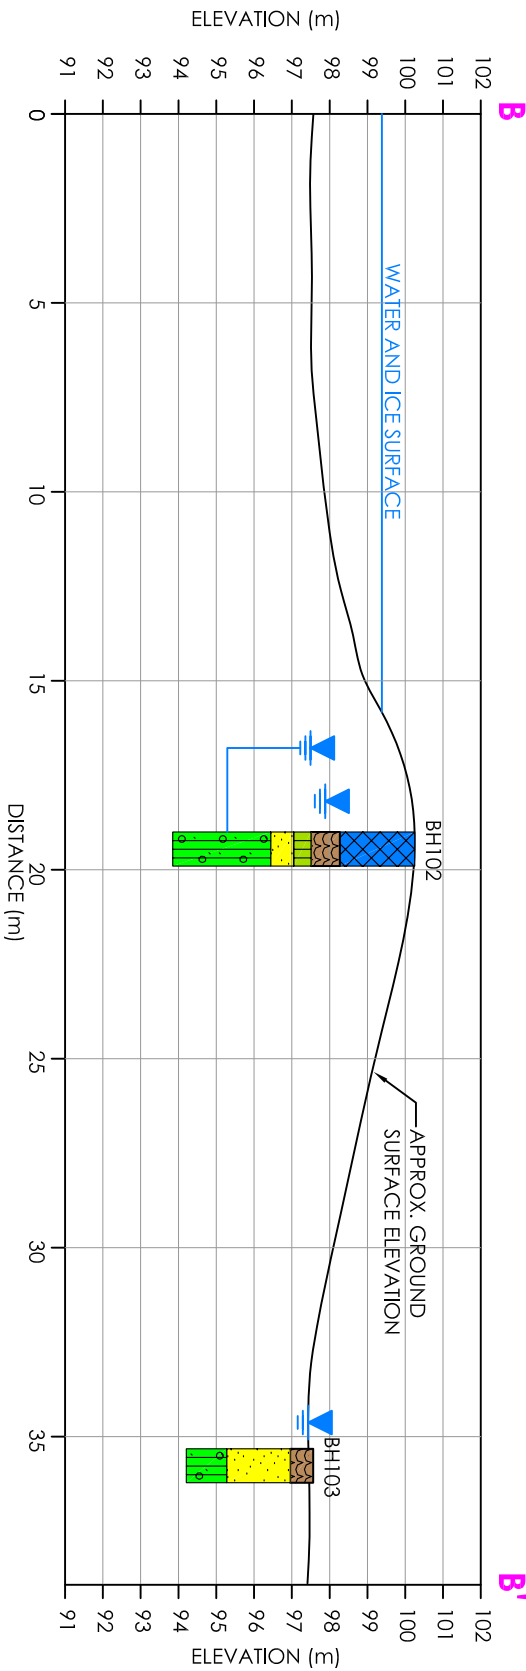
Naylor Engineering Associates Ltd. CONSULTING ENGINEERS			CROSS SECTIONS A-A' & B-B'		
	0		Feb. 2006										
	1												
	2												
3				Date		Scale		Job No.		Drawing No.			
Report Issued		Feb. 2006		Feb. 2006		1:200		6031G1		3

Notes:
Groundwater measurements taken on November 28, 2005. Seasonal fluctuations in groundwater levels would be expected. The inferred stratigraphy shown on this cross-section is based on the subsurface stratigraphy contacted at the boreholes. The subsurface conditions between the boreholes will vary.

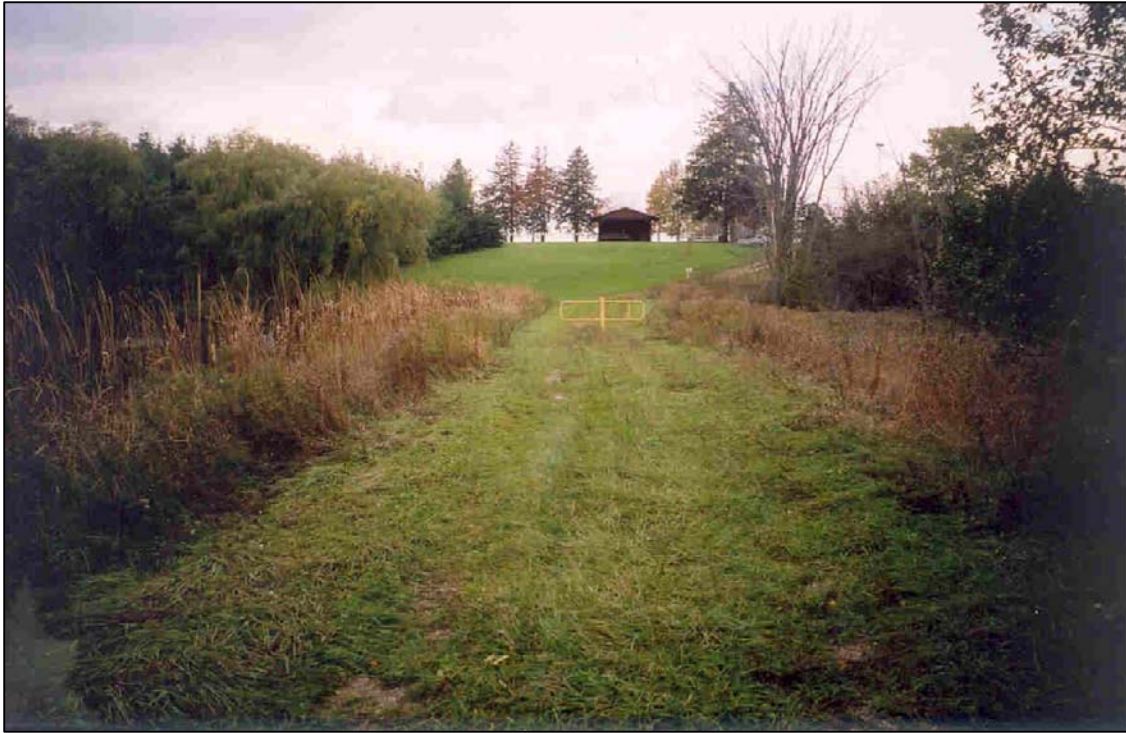
The crest of the dam is about 6 m wide and is vegetated with grass. The crest showed no cracking, sink holes or settlement at the time of the fieldwork.

Photo 1: Looking west along the top of the dam.

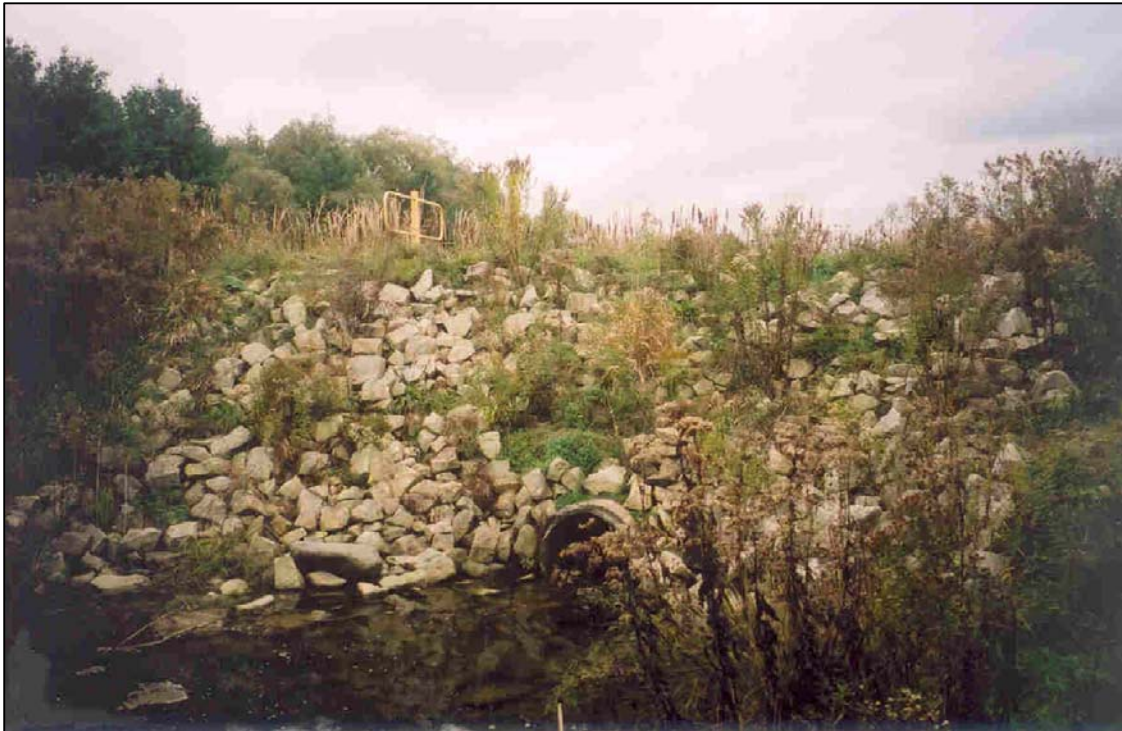
The outlet pipe consists of a pre-cast concrete pipe with an inside diameter of 762 mm. The downstream edge of the pipe was chipped and damaged and rip-rap has been placed at the end of the outlet pipe.

Photo 4: Outlet pipe on the north side of the dam.

It was anticipated that the existing outlet pipe through the Fullarton Dam will be maintained. The existing outlet appears satisfactory, although there is a risk of deterioration and piping erosion beneath or on the sides of pipe over time. We suggest that if the pipe is replaced then a clay or concrete cutoff collar be installed as required.

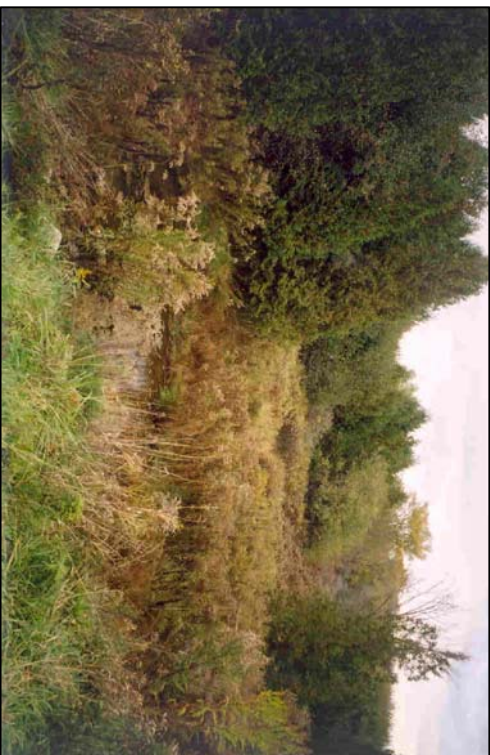
The stream channel north of the dam is about 3 m wide and 300 mm deep and situated within a low lying marsh area. Minor erosion was evident along the sides of the stream channel at the time of the investigation.

Photo 6: Creek north of the dam.
