# Harrington Dam and Conservation Area

## Existing Geomorphic Conditions

December 2015, Draft

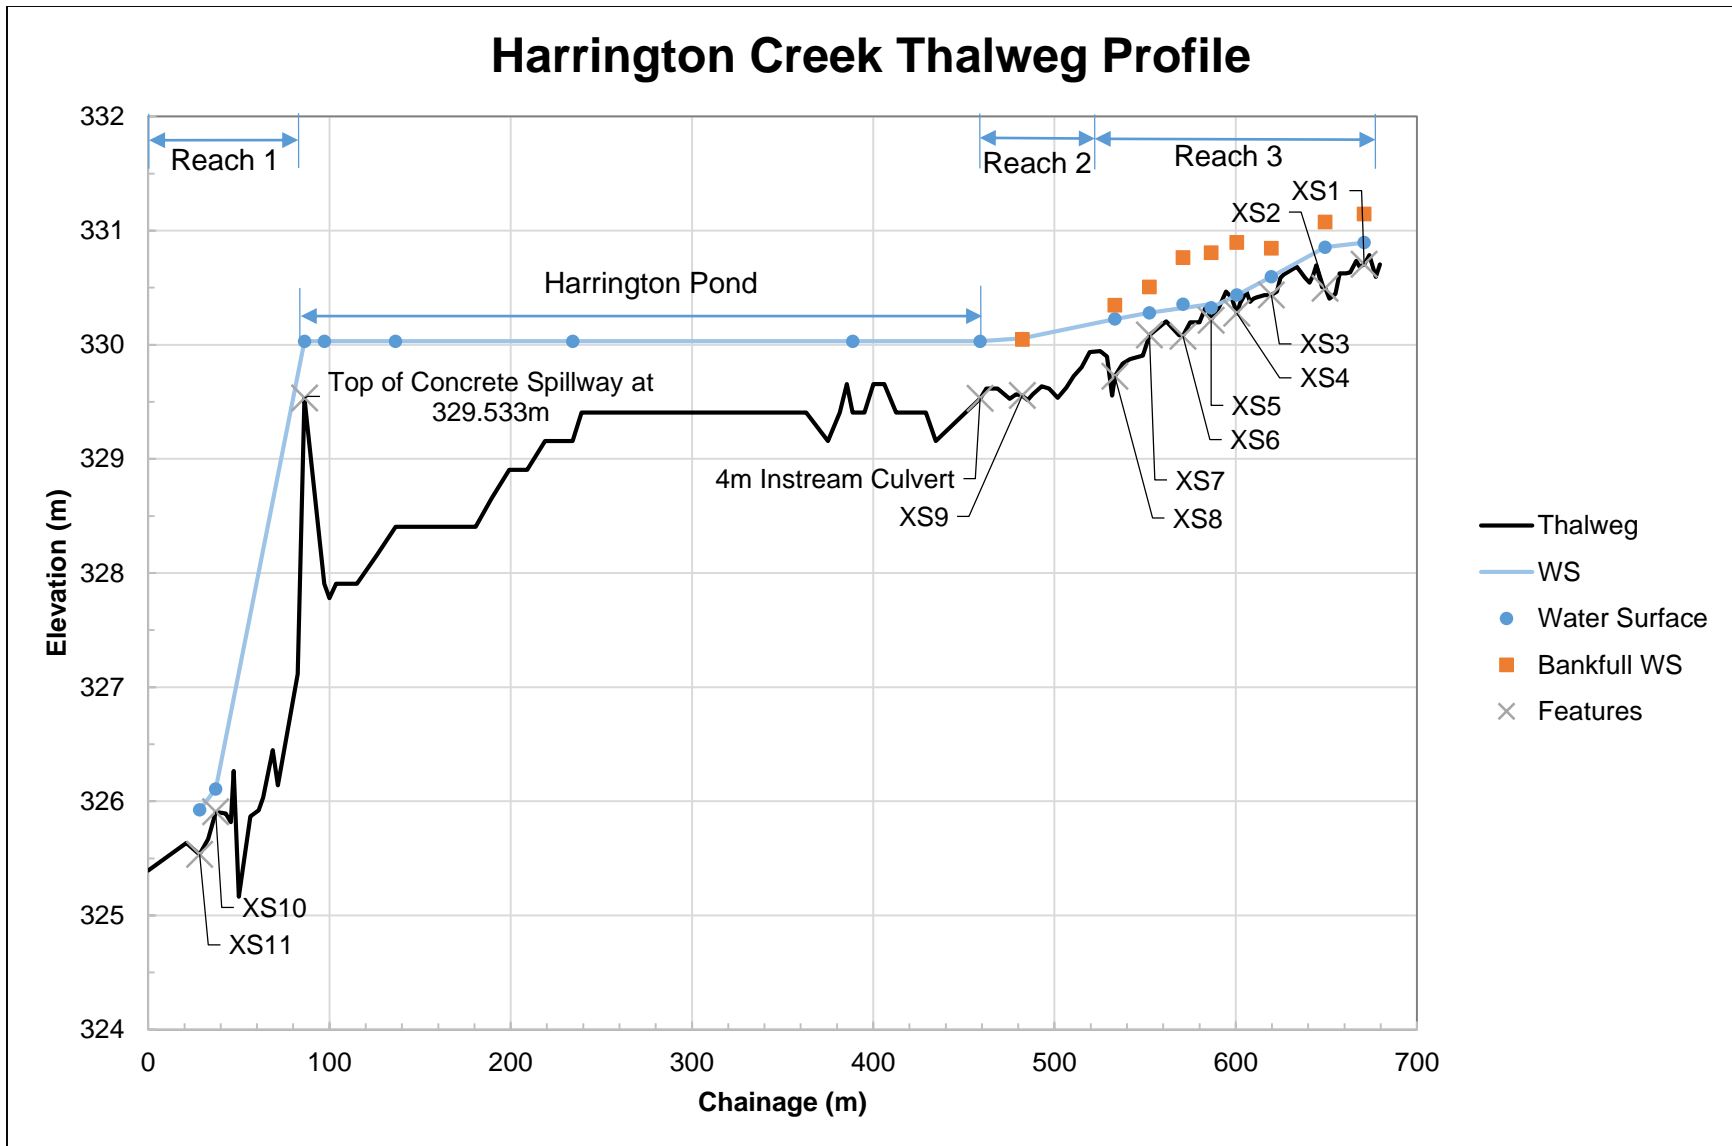
Figure 1-3. Channel bed profile along Harrington Creek.

Overall, the reach was considered to be stable. Given the low energy grade (see **Figure 1-3**), both aggradation and channel widening processes are gradually affecting channel form and processes.

The channel bed configuration consisted of riffles and shallow pools (depth ranged from 0.12 to 0.34 m) (Figure 1-3). The water surface grade, from the upstream to downstream cross-section was 0.65 %. Overall, the bed morphology appeared to be poorly developed. This is likely due to the influence of large woody debris and the high channel width-depth ratio which reduces scour potential of pools.

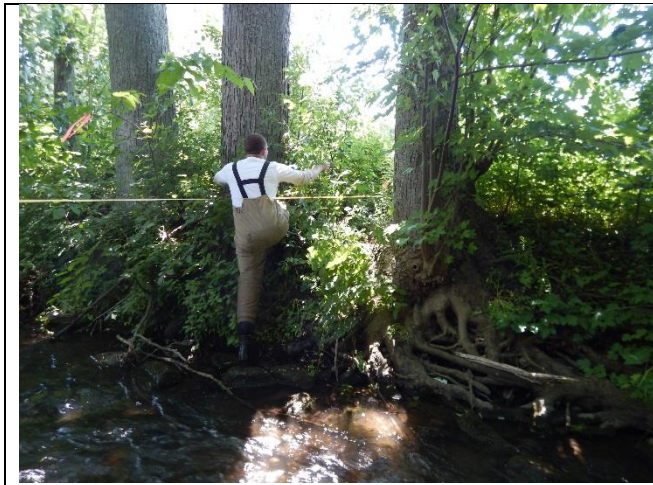
The cross-sections were trapezoidal and banks were steeper and higher along the west side of the channel. The bankfull channel was set within a deeper channel cross-section. Banks were well vegetated with trees and shrubs. Tree roots were exposed and minor undercutting (0.14 m) was measured.

West bank along cross-section 10.

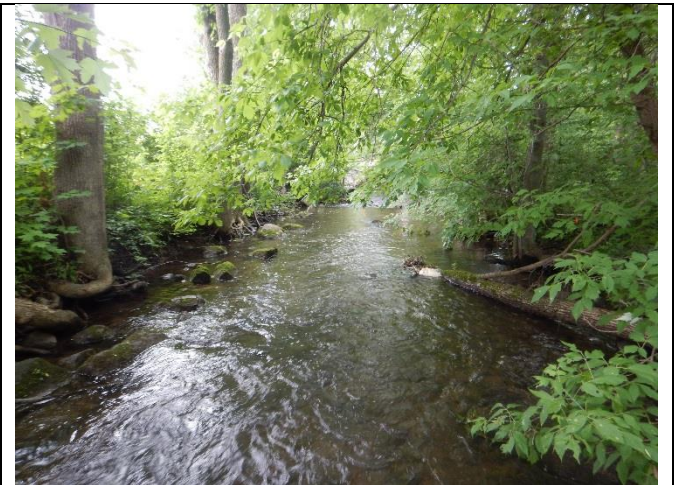
Overall, the creek was considered stable, downstream of Harrington Pond.

View downstream at Cross-section 11.

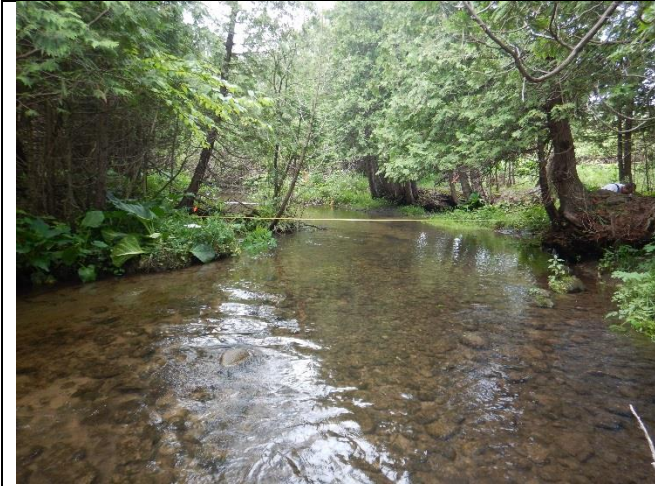
View upstream near downstream limit of Reach 3. Banks were low; the creek was well connected to its floodplain.

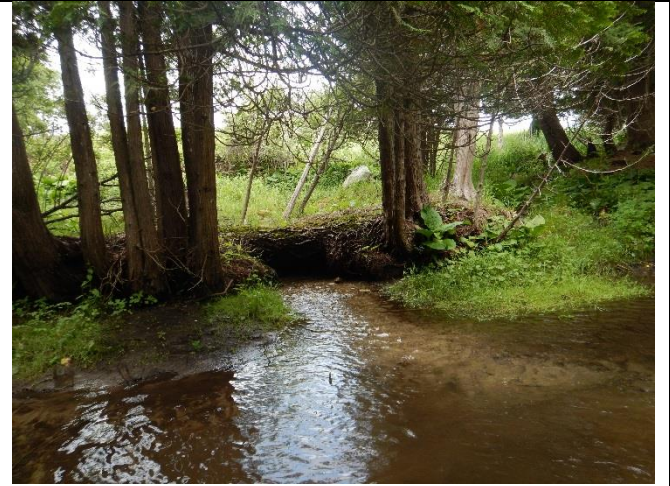
Floodplain materials, especially those along the west side of the channel were often moist and surface water channels originating from within the west floodplain were observed. Fallen and leaning trees were common within the reach and occupied the entire cross-section in several locations.

Seepage from the west flood plain entered the creek in several locations

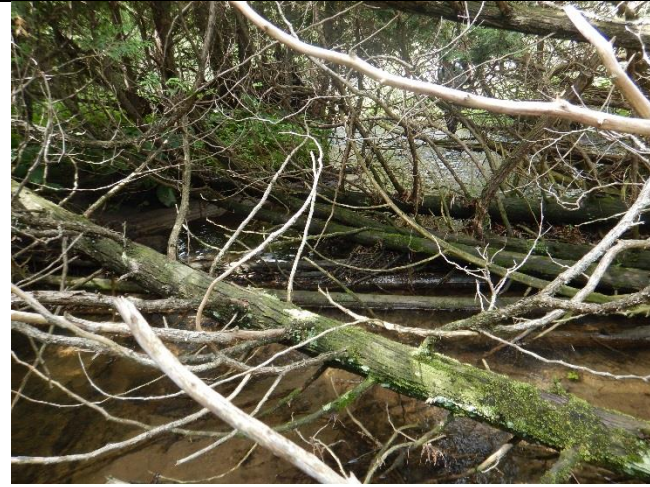
Overall, Harrington Creek had a somewhat sinuous planform configuration; no well-developed meander bends were observed. In several locations, large woody debris appears to have caused the channel to bifurcate or split. Accumulations of fine sediment (silt/sand) were observed in the 'lee' side of logs or fallen trees in the channel.

Large woody debris were frequently in the channel.

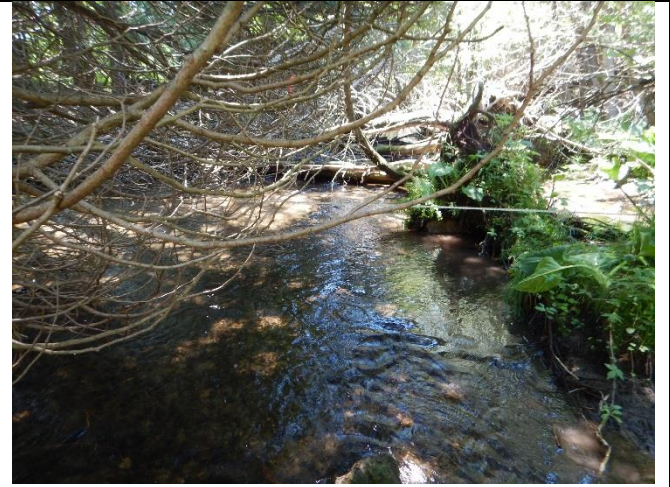
Leaning trees were common along the reach.

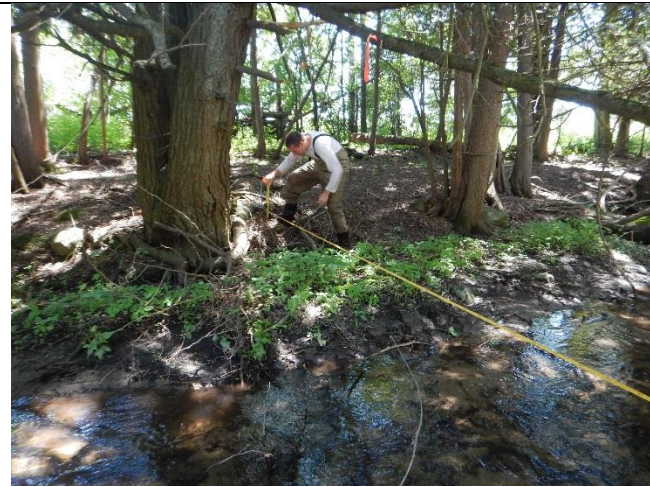
The upstream limit of the backwater conditions appeared to extend to a shallow and low gradient riffle feature. Harrington Creek, within this reach, was situated within a predominantly wooded (cedar) forest. Subtle terracing was observed in the floodplain in a few locations, suggesting that, in the long term, Harrington Creek has likely gradually migrated over its floodplain and downcut.

The floodplain was typically accessible and included subtle terracing.
