DAM SAFETY ASSESSMENT REPORT FOR  
**Harrington Dam**  
Final  
July, 2007

DAM SAFETY ASSESSMENT REPORT FOR  
**Harrington Dam**

Final  
July, 2007

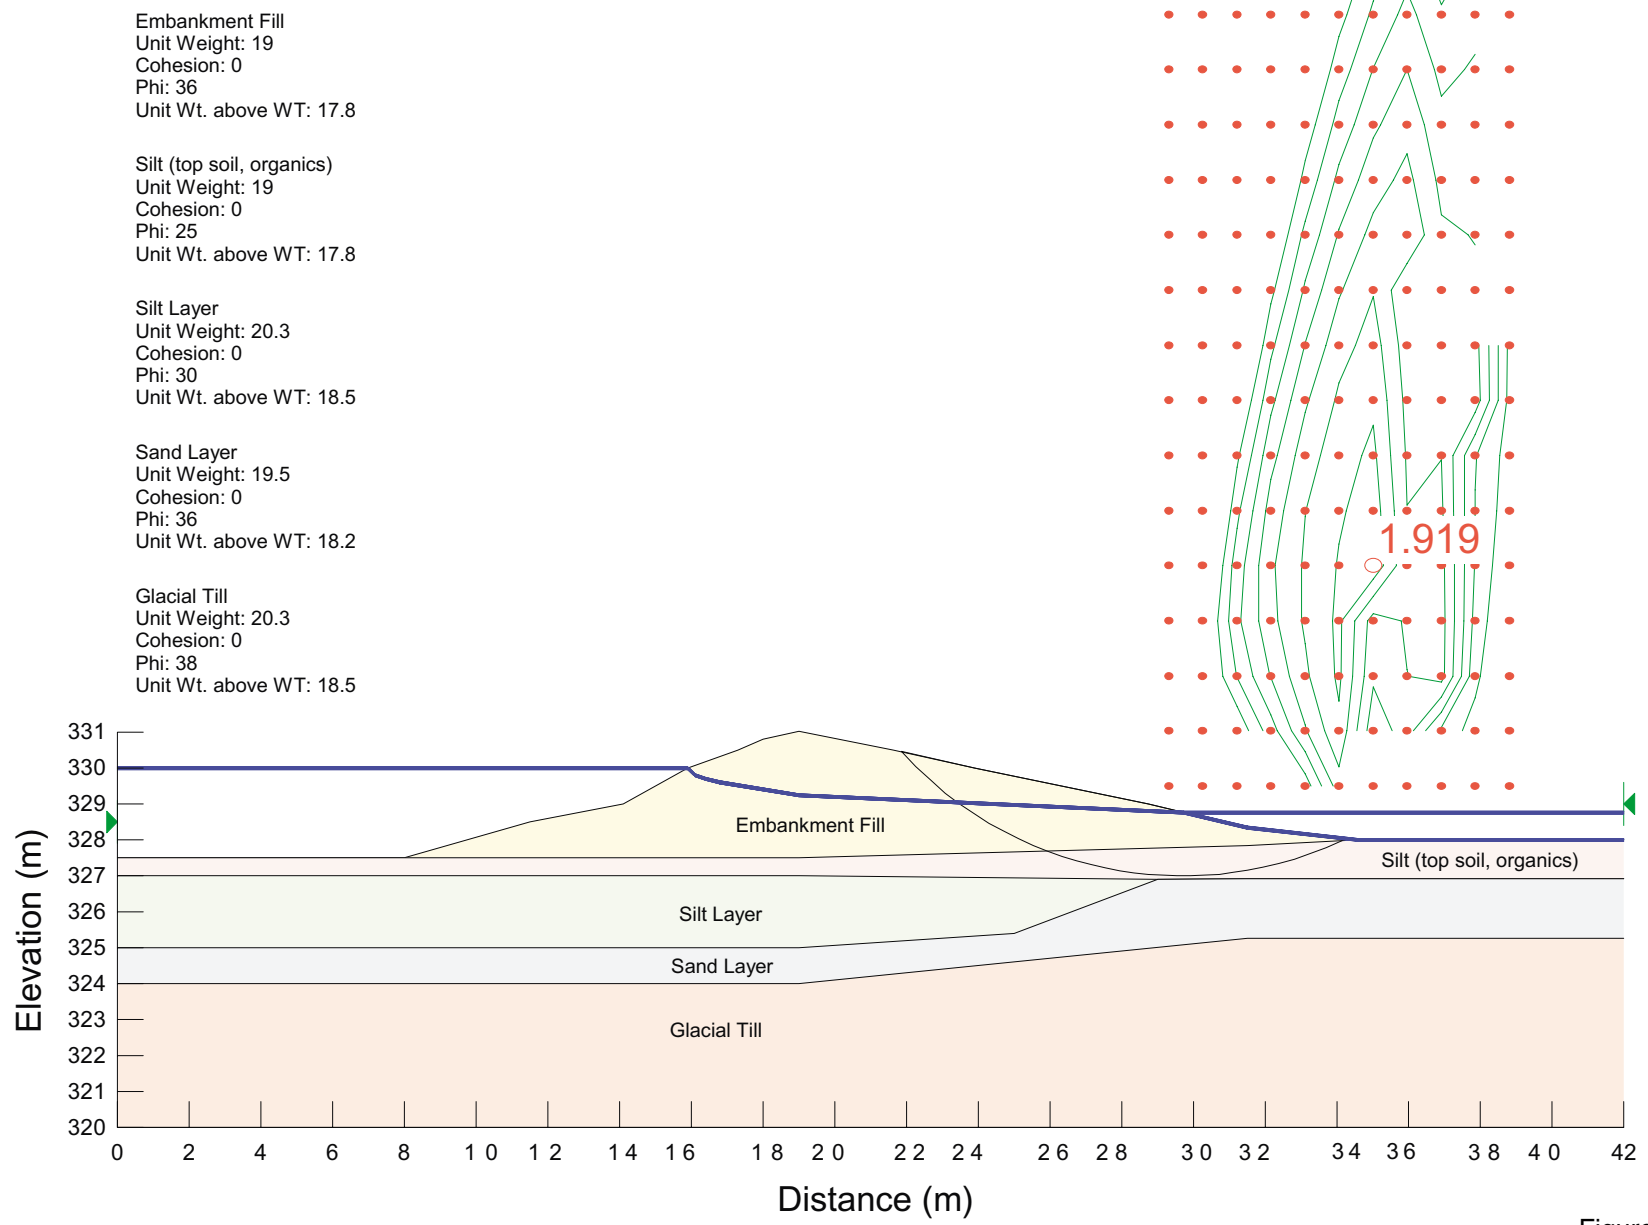
Figure 8.2  
 Upper Thames River Conservation Authority  
 Dam Safety Assessment Report - Harrington Dam  
**Downstream Slope Stability, Normal Load Condition**

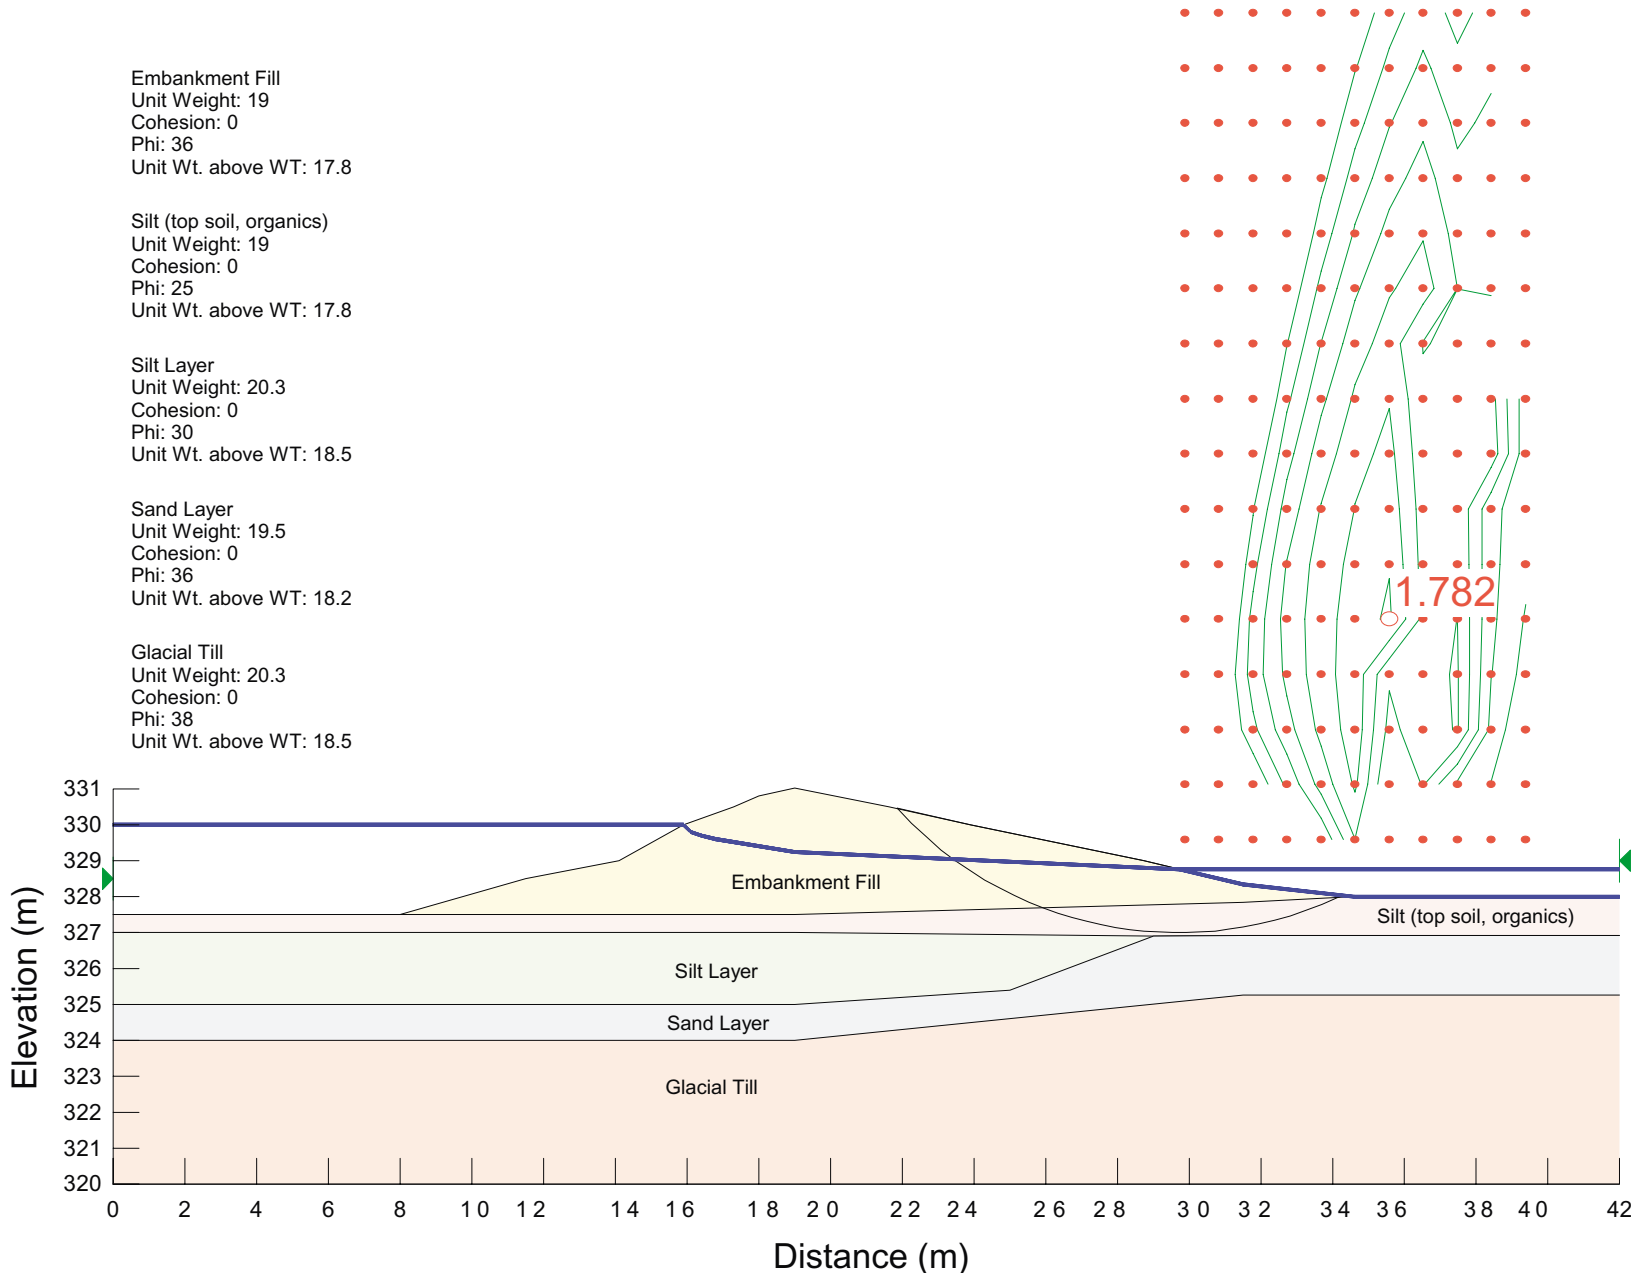
Figure 8.3  
 Upper Thames River Conservation Authority  
 Dam Safety Assessment Report - Harrington Dam  
**Downstream Slope Stability, Extreme Load Condition (NWL, S<sub>h</sub>)**

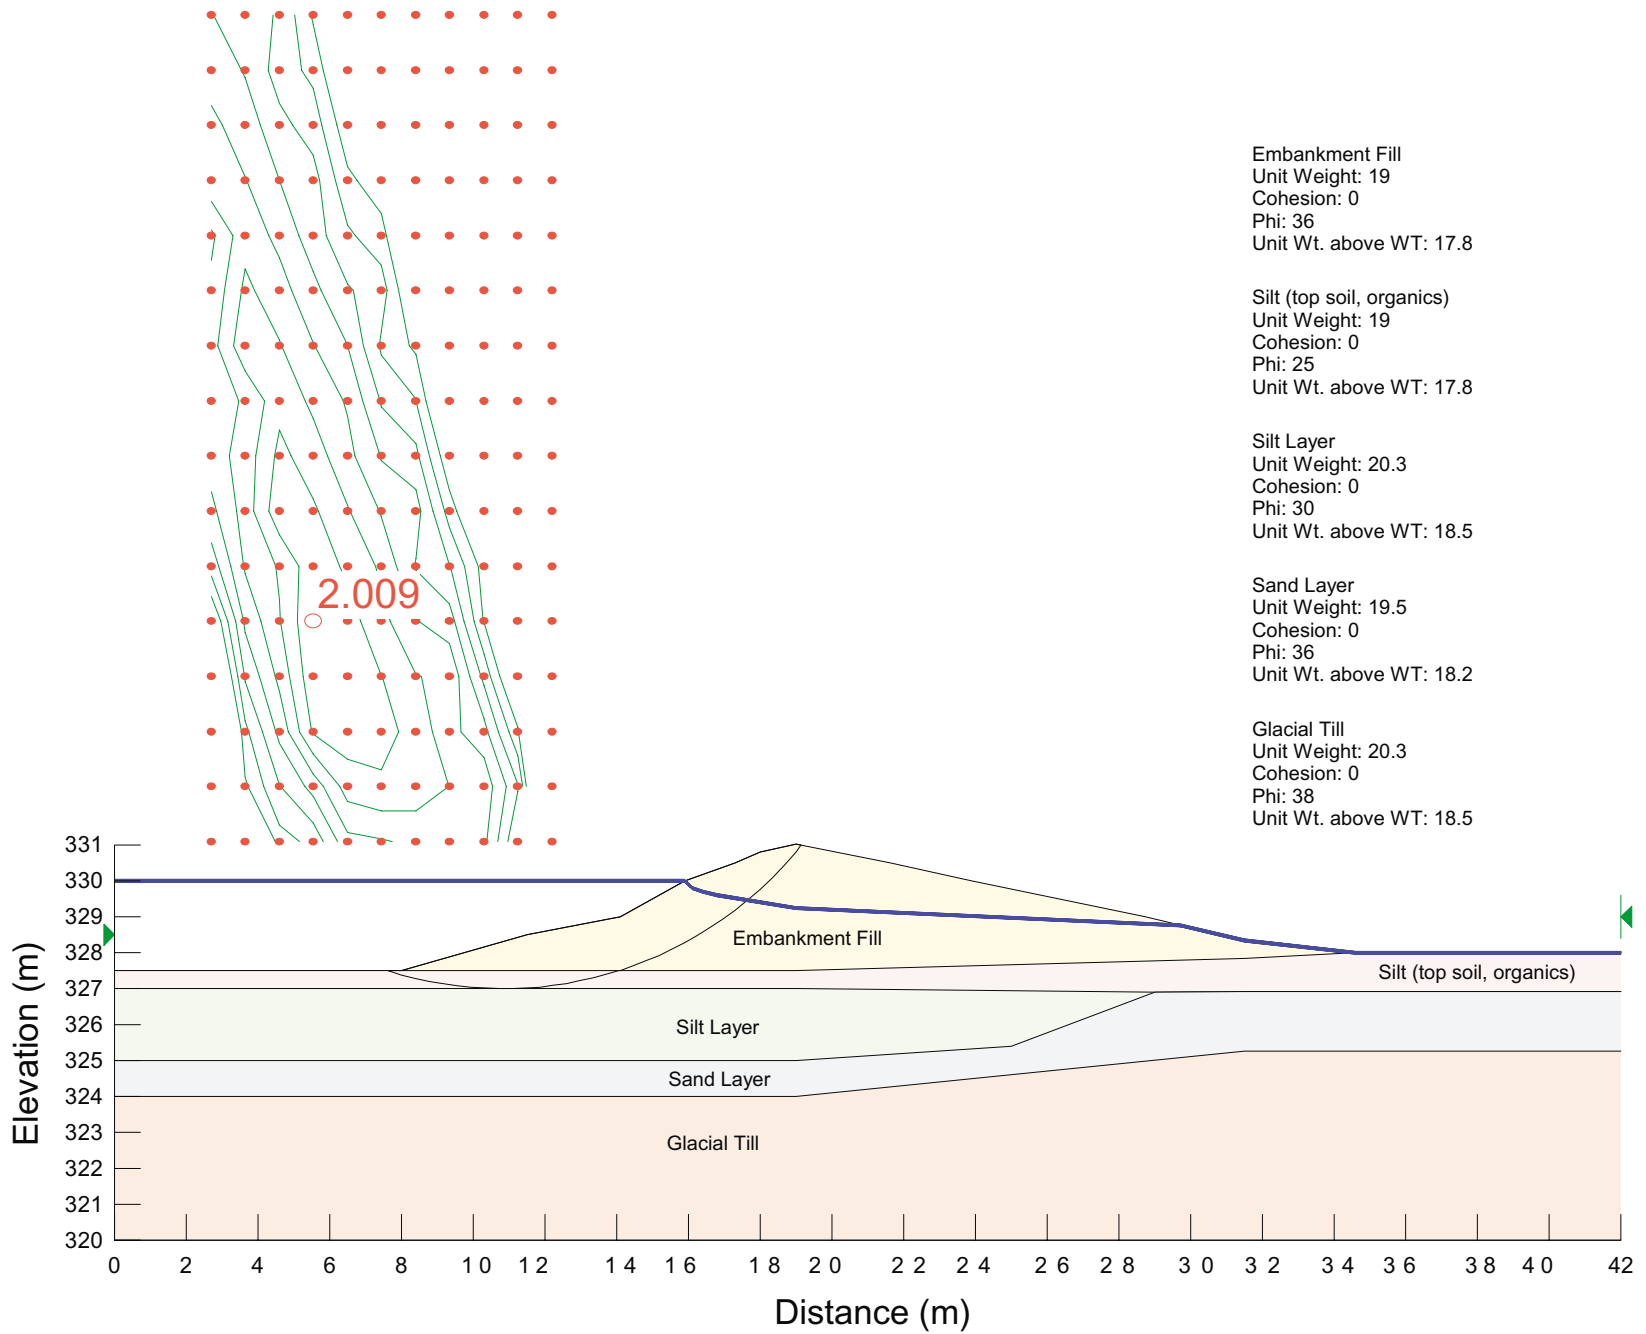
Figure 8.4  
 Upper Thames River Conservation Authority  
 Dam Safety Assessment Report - Harrington Dam  
**Upstream Slope Stability, Normal Load Condition**

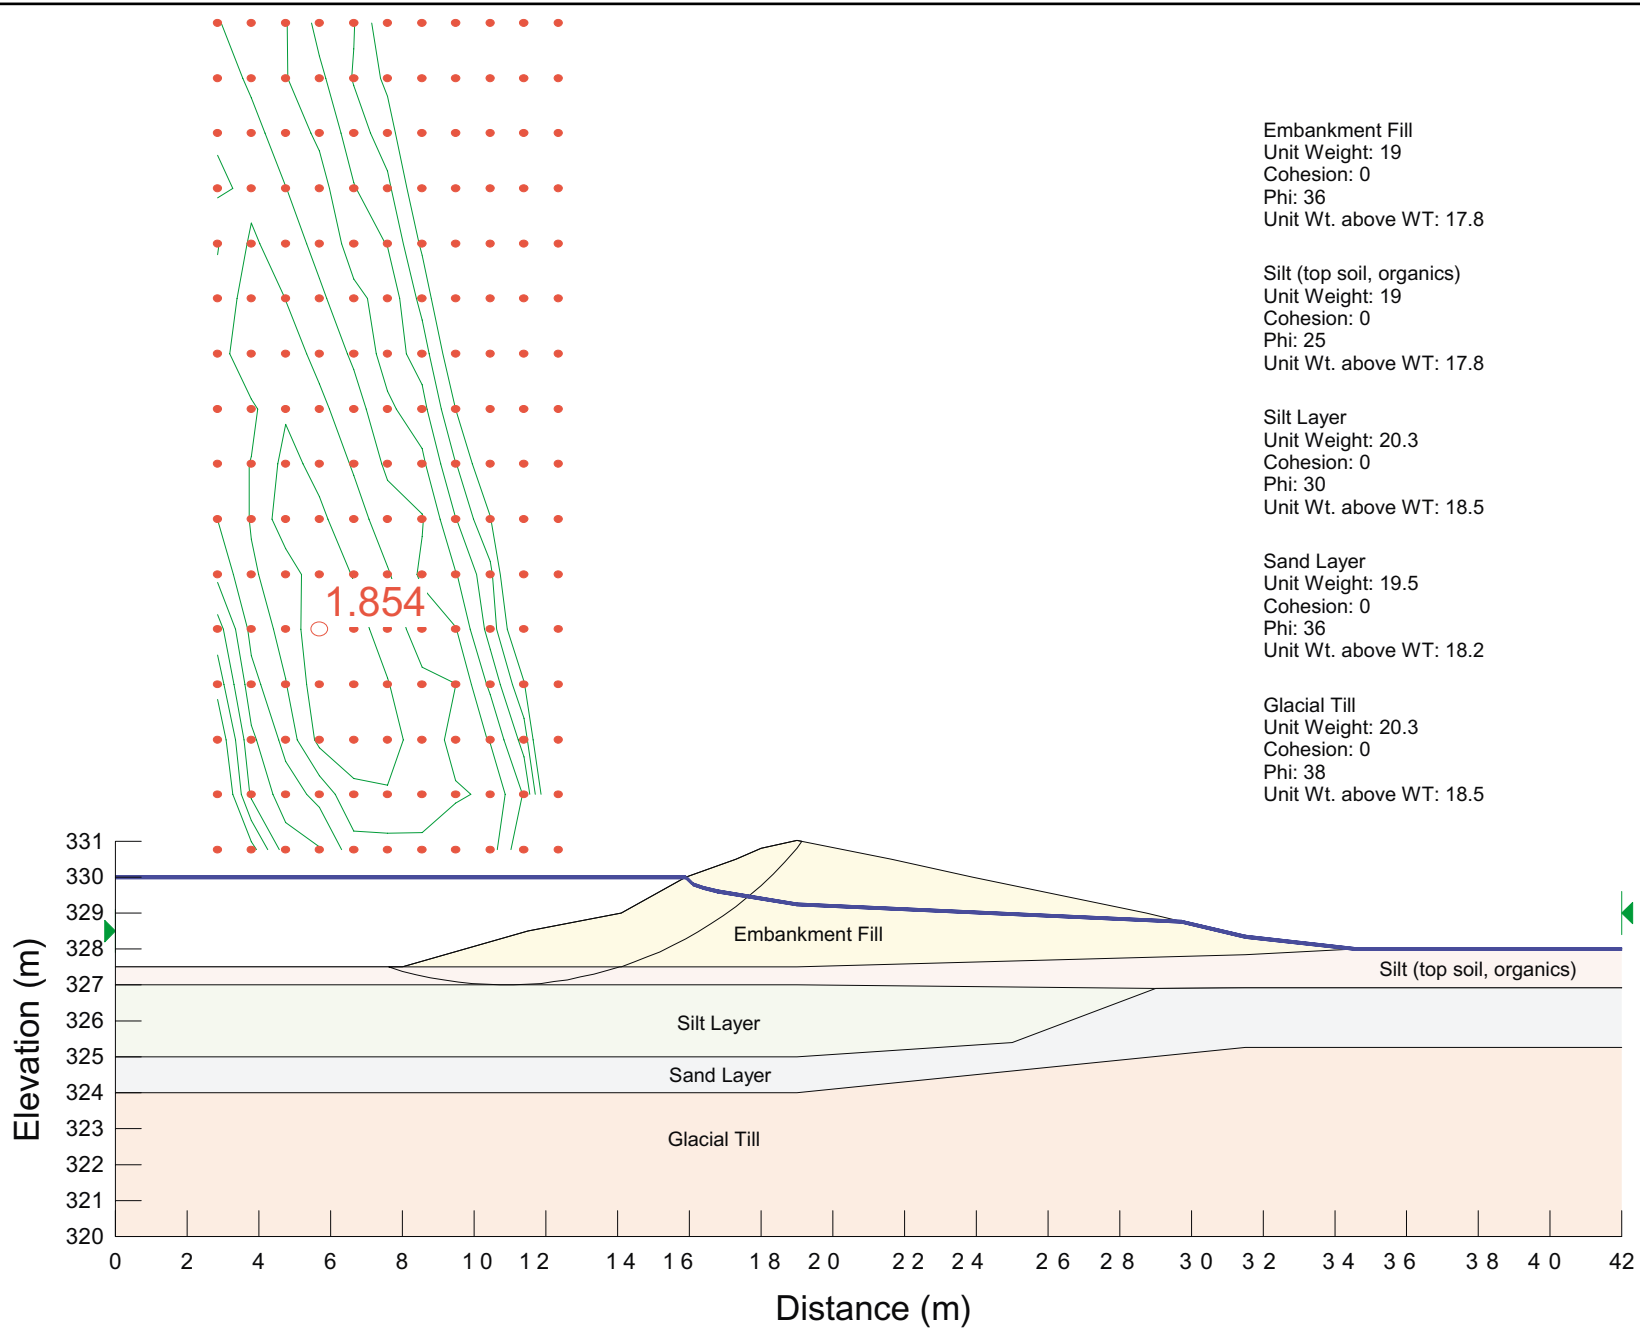
Figure 8.5  
 Upper Thames River Conservation Authority  
 Dam Safety Assessment Report - Harrington Dam  
**Upstream Slope Stability, Extreme Load Condition (NWL,  $S_n$ )**

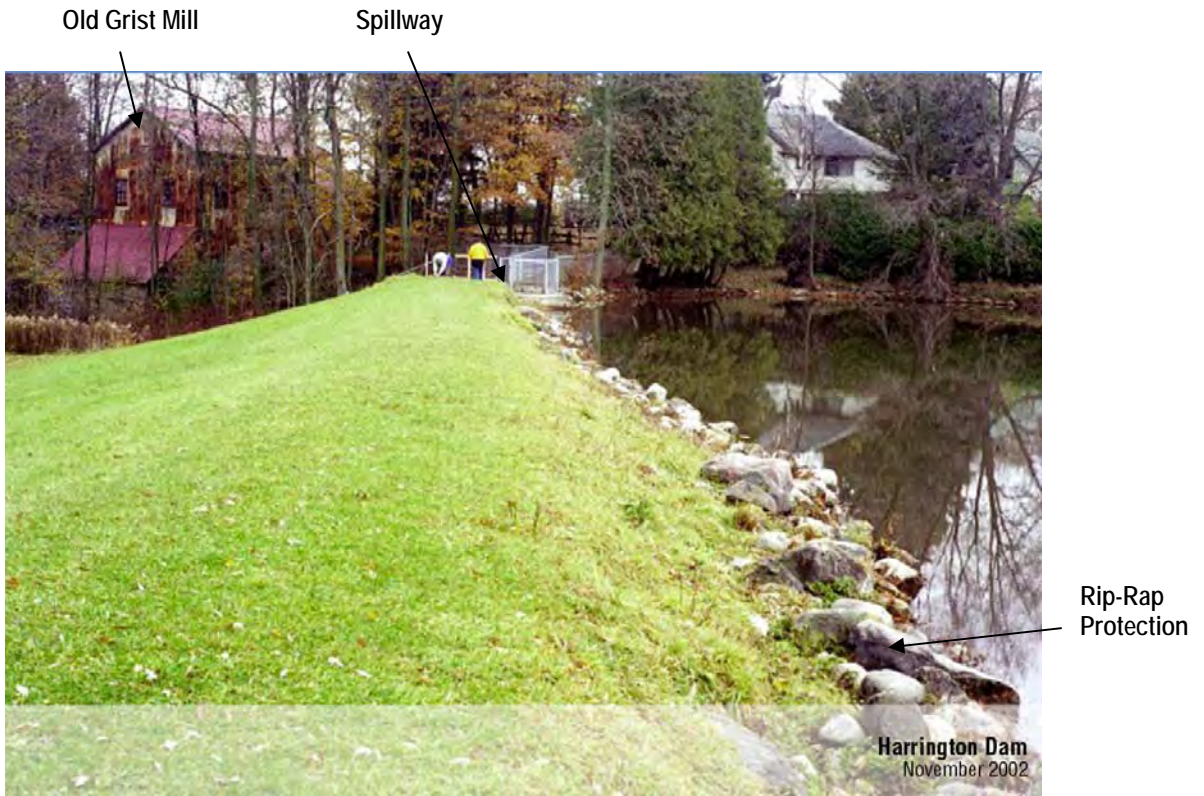
Photo 11 – Upstream Slope and Crest of Left Embankment

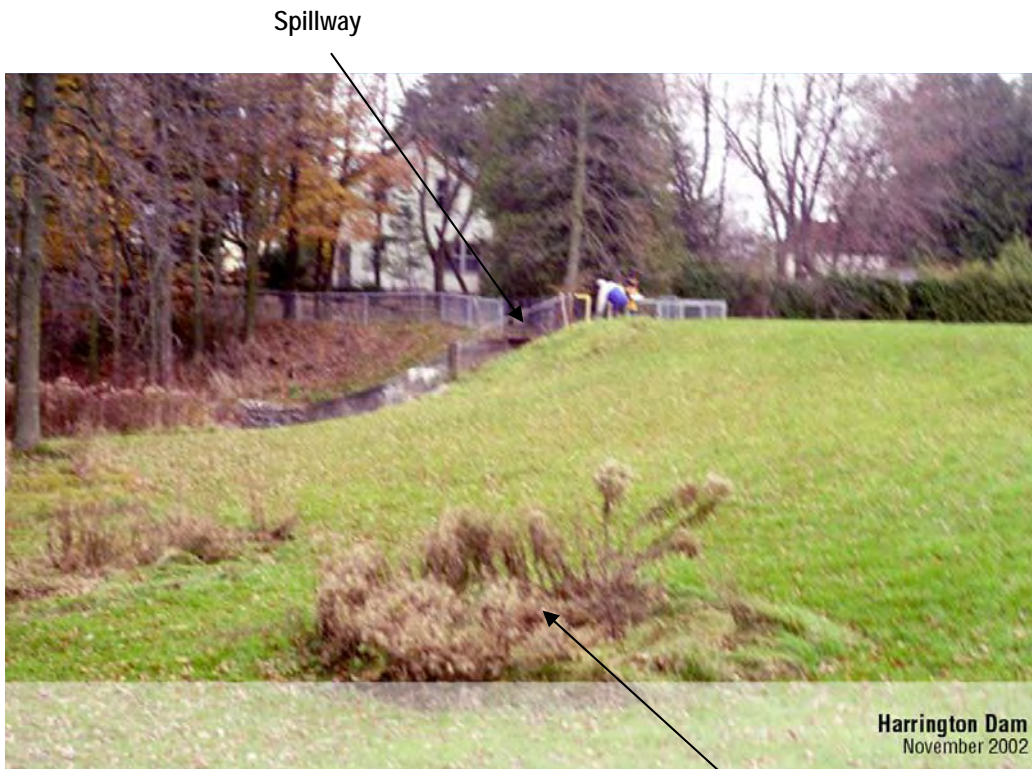
Photo 12 – Leakage Area, Left Downstream Slope

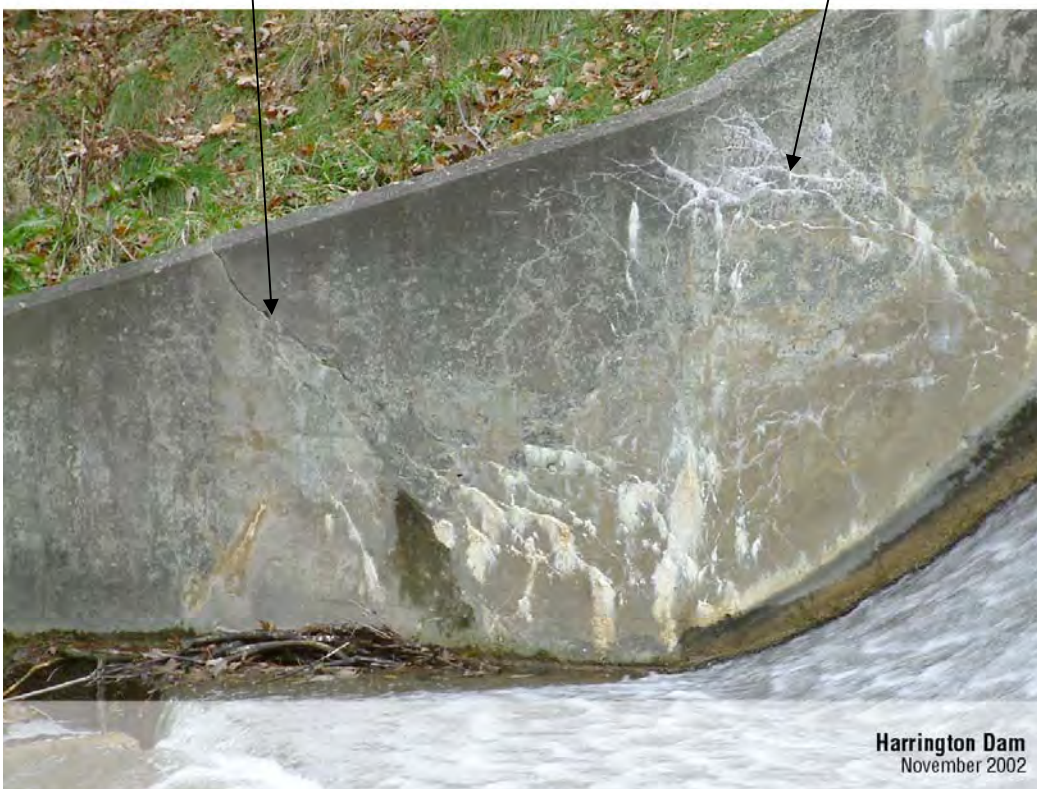
Wide Diagonal Crack

Pattern Cracking and Efflorescence

Photo 15 – Close-up of Cracking in Right Downstream Wingwall

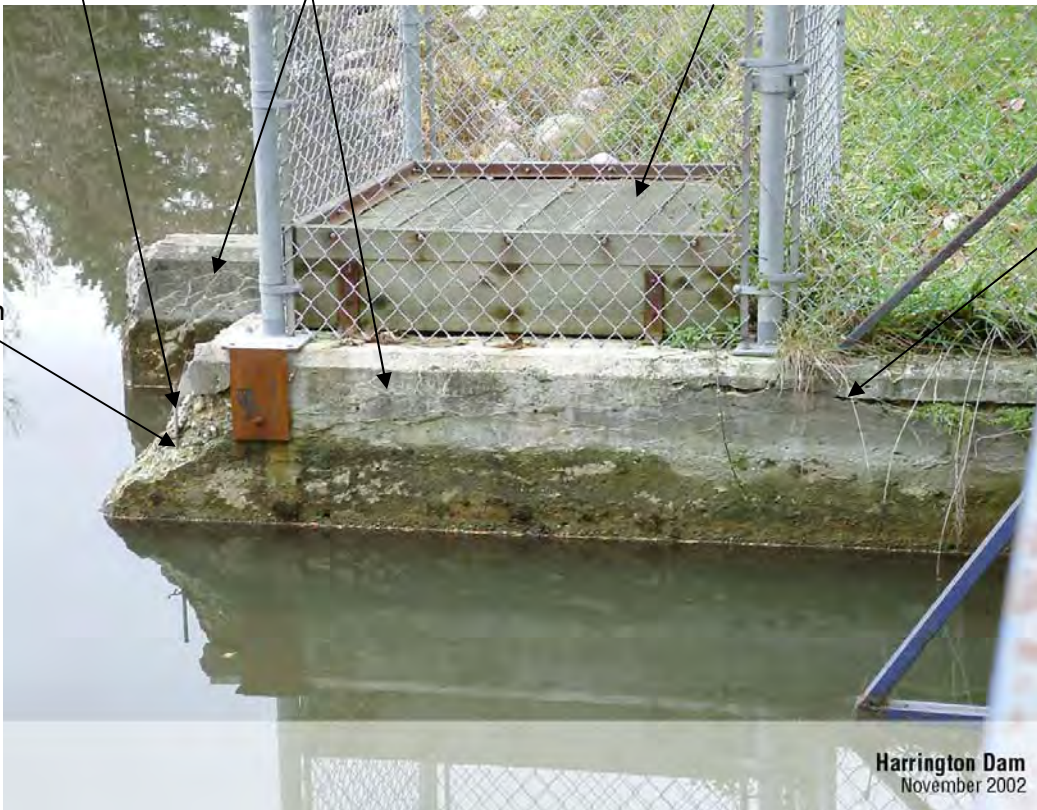
Exposed Rebar

Severe Deterioration

Photo 16 – Concrete Deterioration, Left Abutment

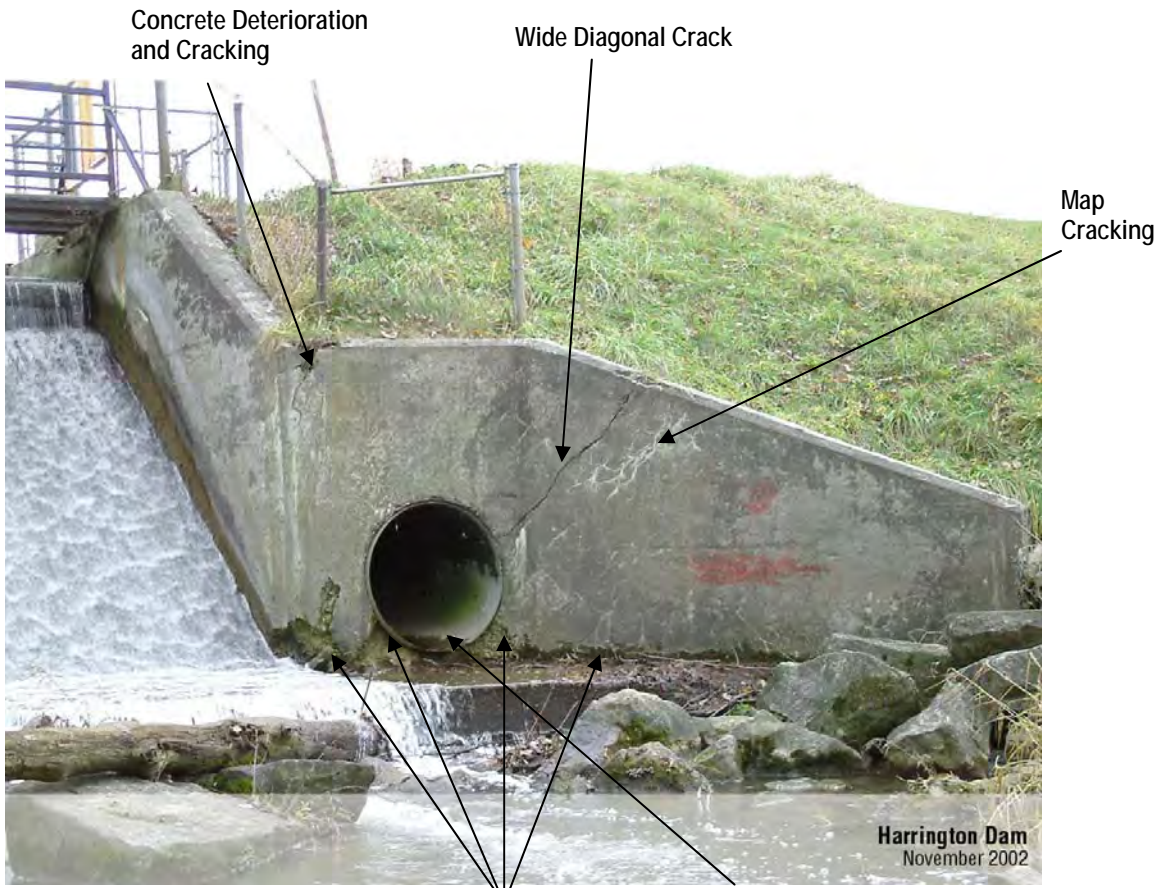
Photo 17 – Left Downstream Wingwall

Severe Spalling
