Appendix A
Acres International Limited
Dam Inspection Report

Dam Inspection Report

Date: November 12 and 19, 2002

Structure: Harrington Dam

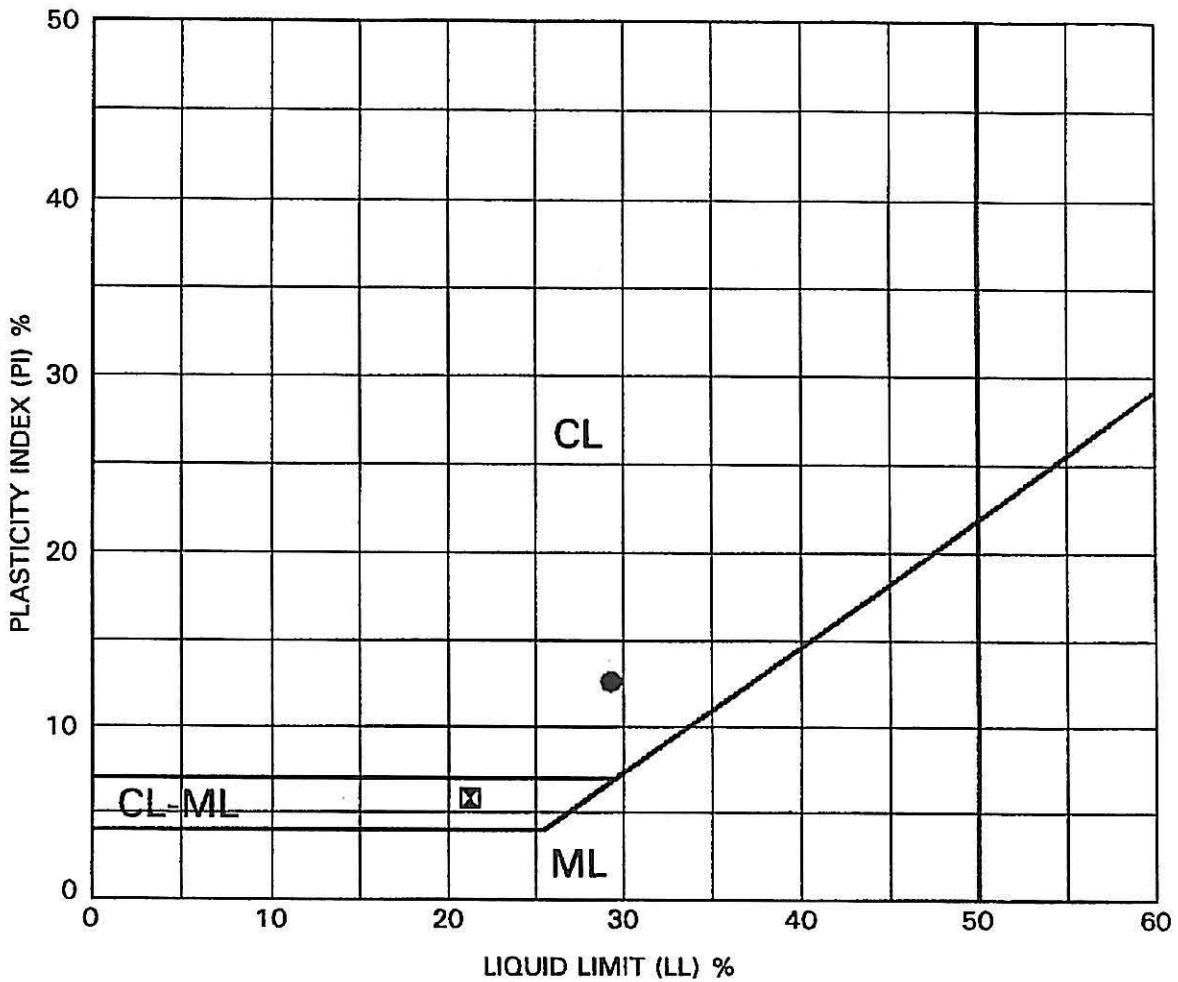
LEGEND	BH	DEPTH (m)	LL%	PL%	PI%
●	HTBH1	3.05	29	17	13
☒	HTBH2	0.00	21	16	6

Note: Sample from HTBH2 is a remolded composite sample taken from AQ2 and AQ3 and used for triaxial testing.

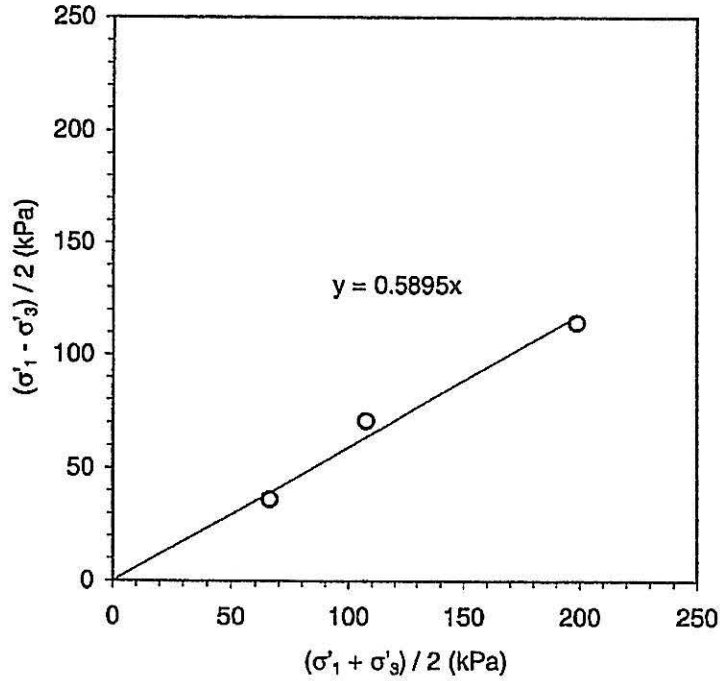
Harrington Dam
Consolidated Undrained Triaxial Compression Tests

Effective friction angle, $\phi' = 36^\circ$

Cohesion, $c = 0$
