**Appendix E**  
**Site Photographs**

# **Excerpts from Ontario Dam Safety Guidelines**

# **Geo-Slope Modelling Results**

Harrington Dam Embankment  
 Stability Assessment  
 County Road 28  
 Harrington, Ontario

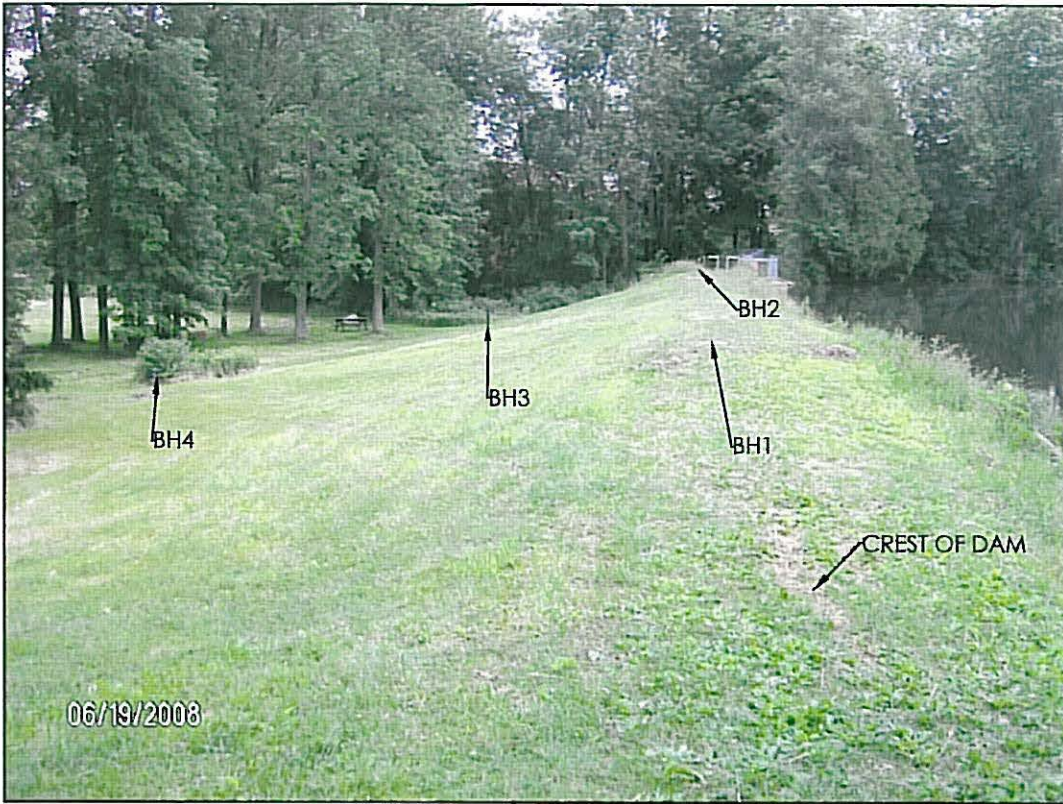
**Photo 1:** Looking east along the west embankment.

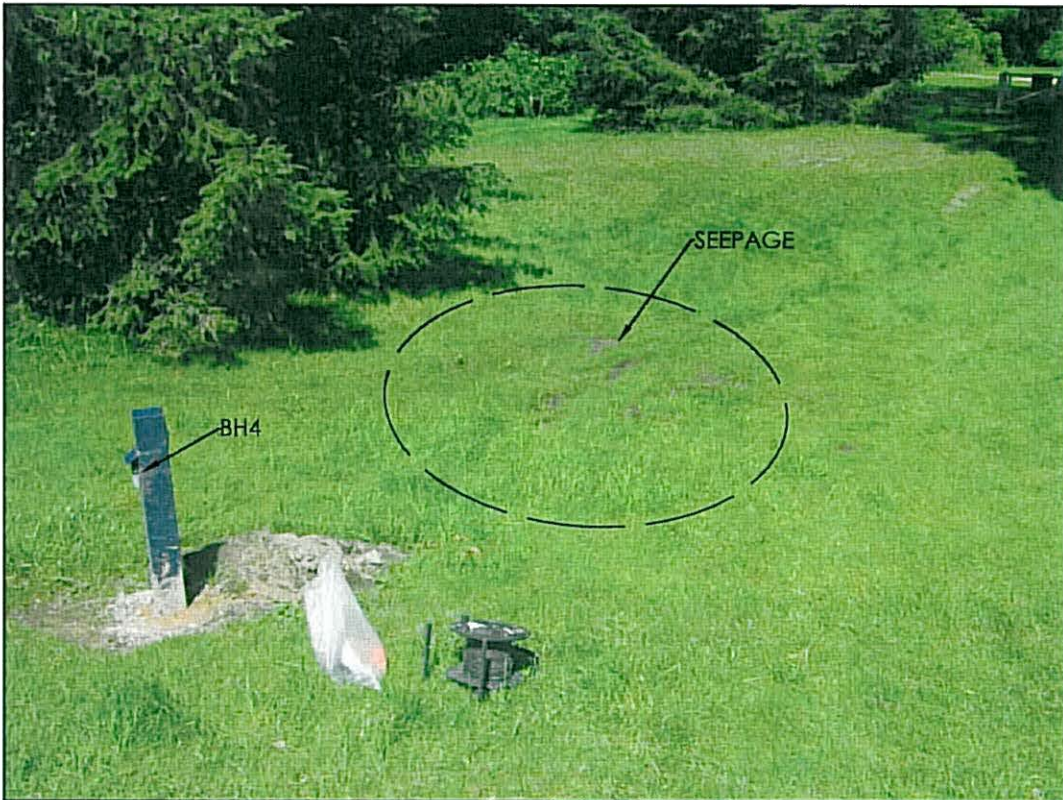
**Photo 2:** Looking northwest at Borehole 4.

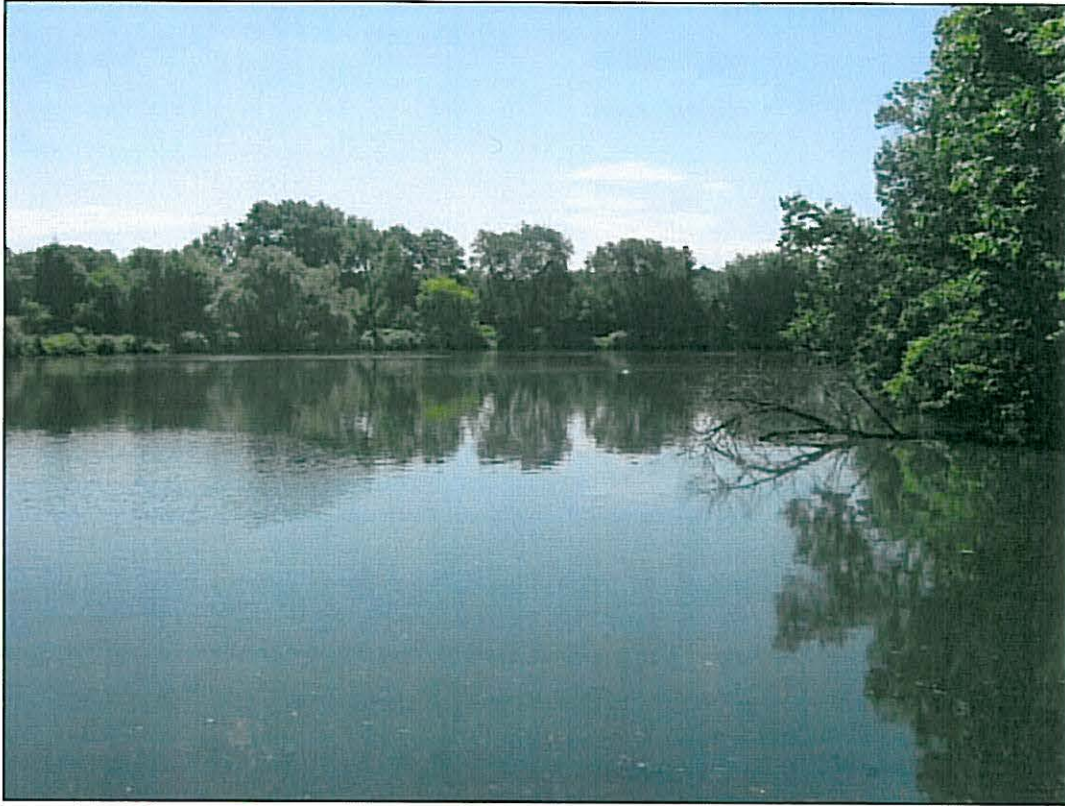
**Photo 3:** Looking south over the dam reservoir.

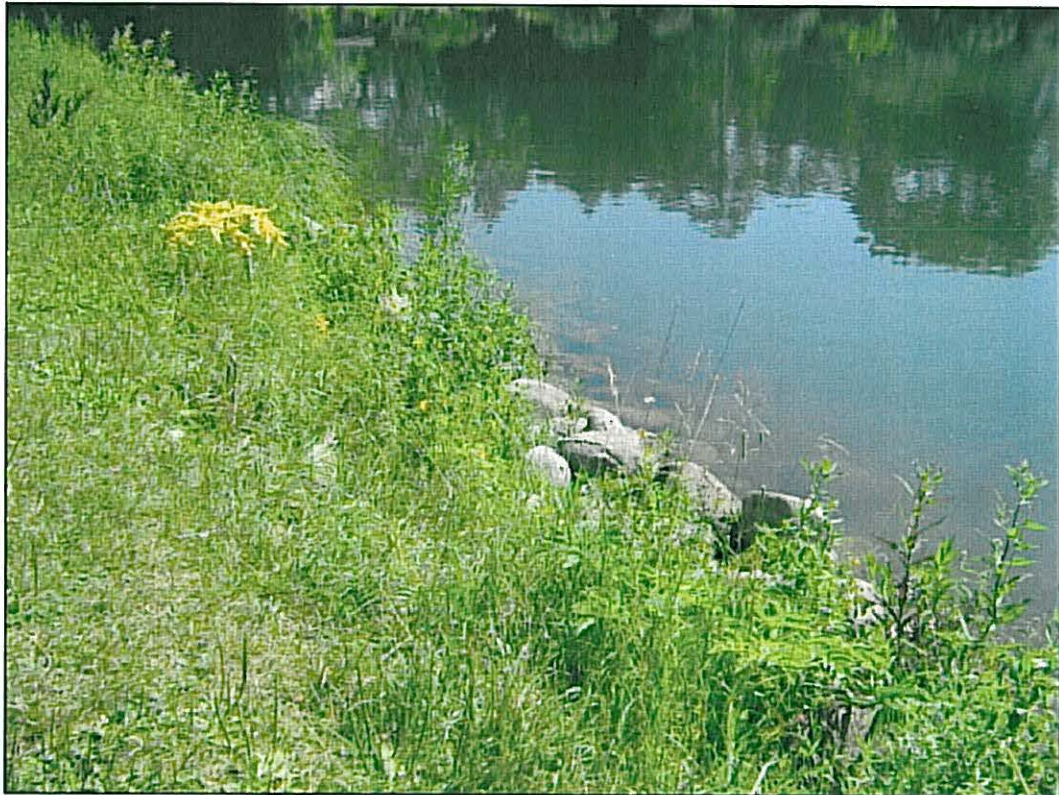
**Photo 4:** Showing the rip rap located on the south (pond) side of the embankment.

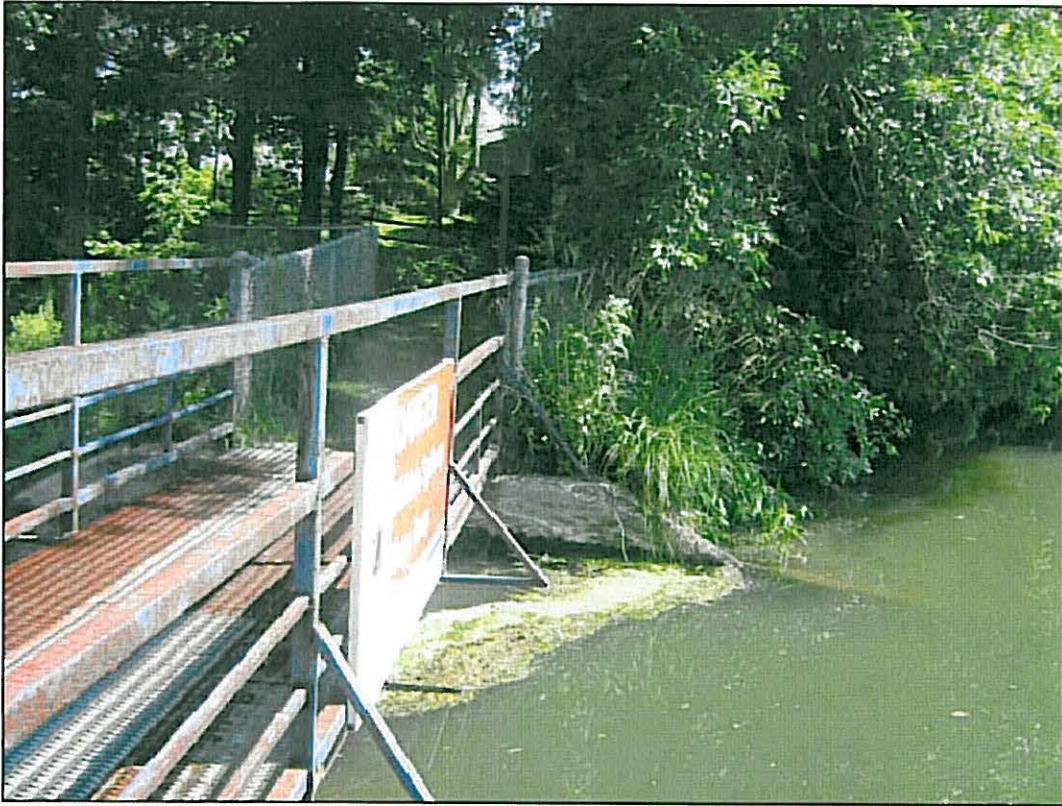
**Photo 5:** Looking east toward the south face of the dam spillway.

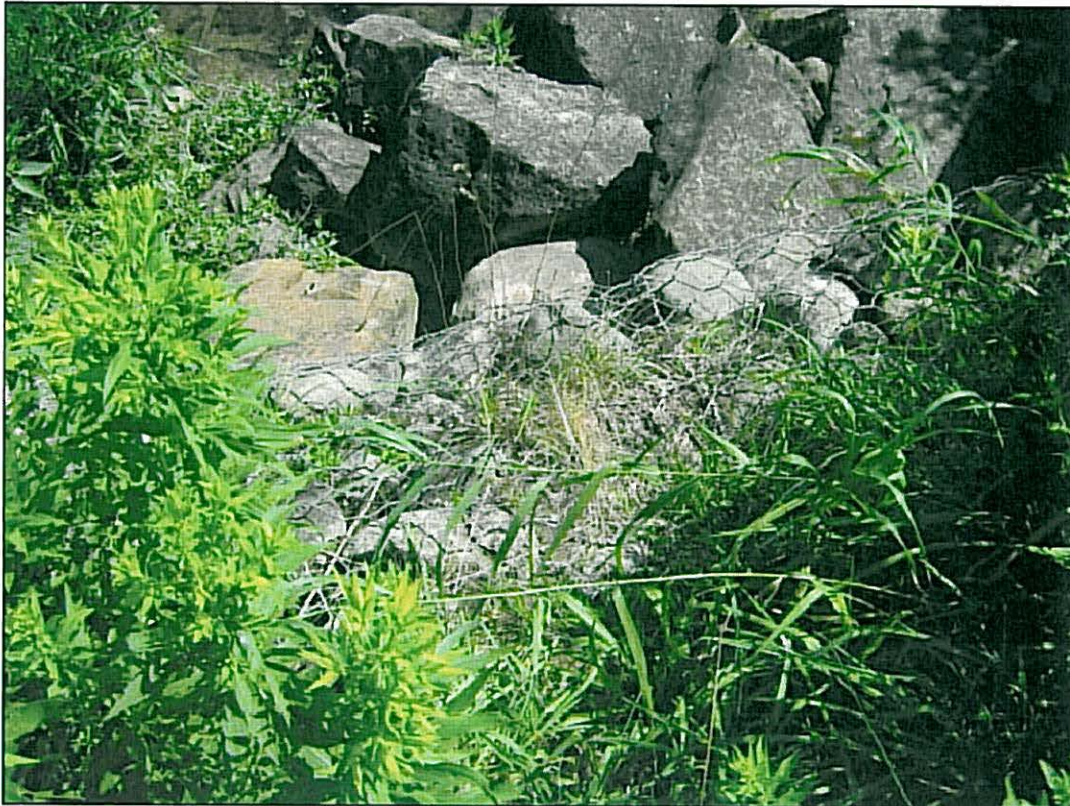
**Photo 6:** Rip rap lining the creek channel immediately downstream of the dam.

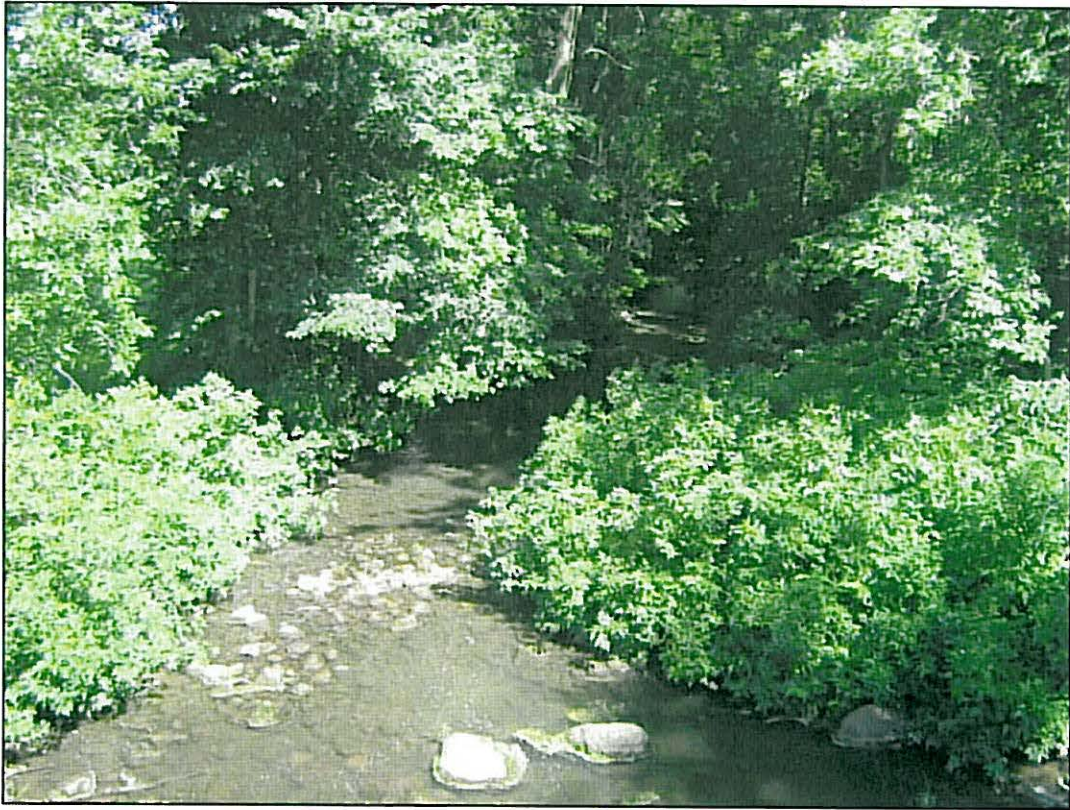
**Photo 7:** Looking north towards the stream downstream of the dam.

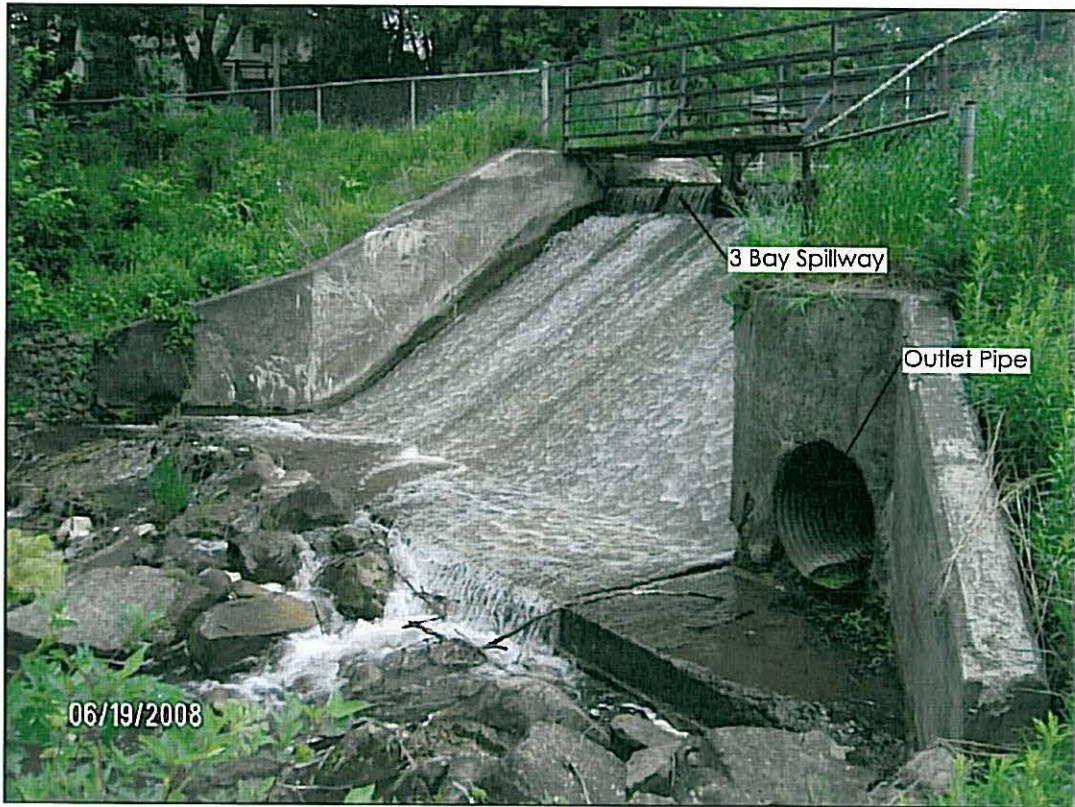
**Photo 8:** Looking southeast at the dam structure.

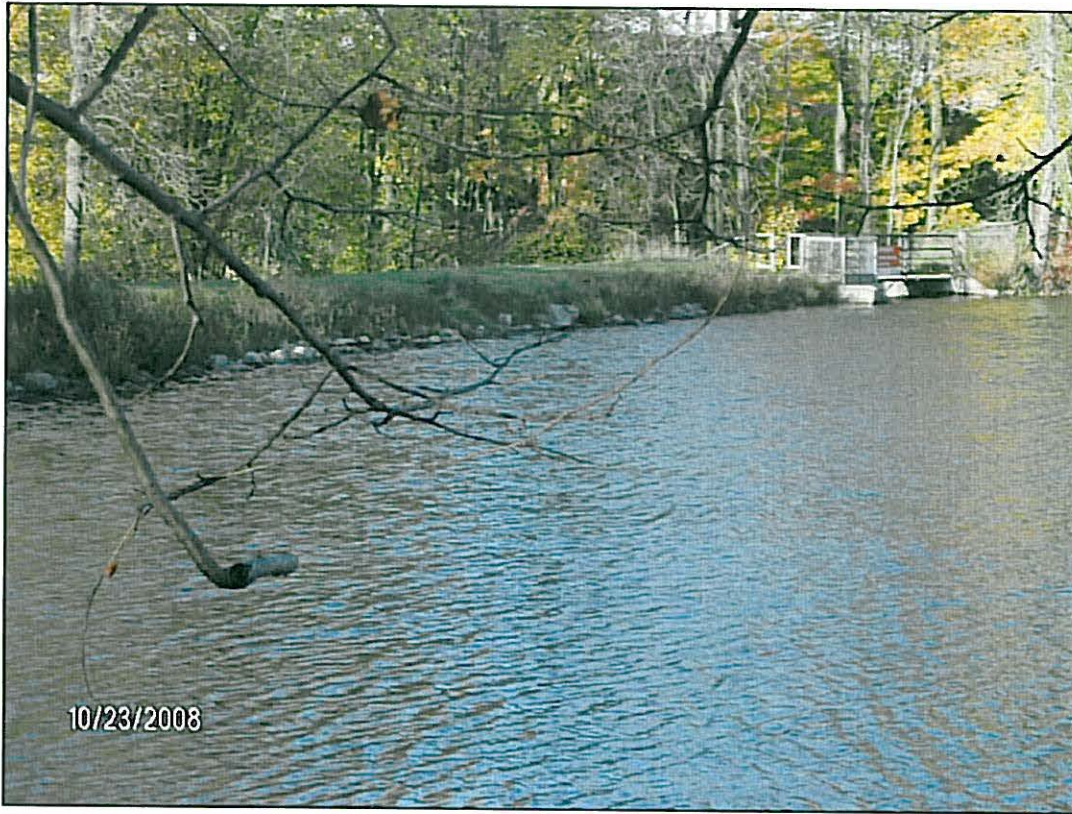
**Photo 9:** Looking northeast towards the dam.

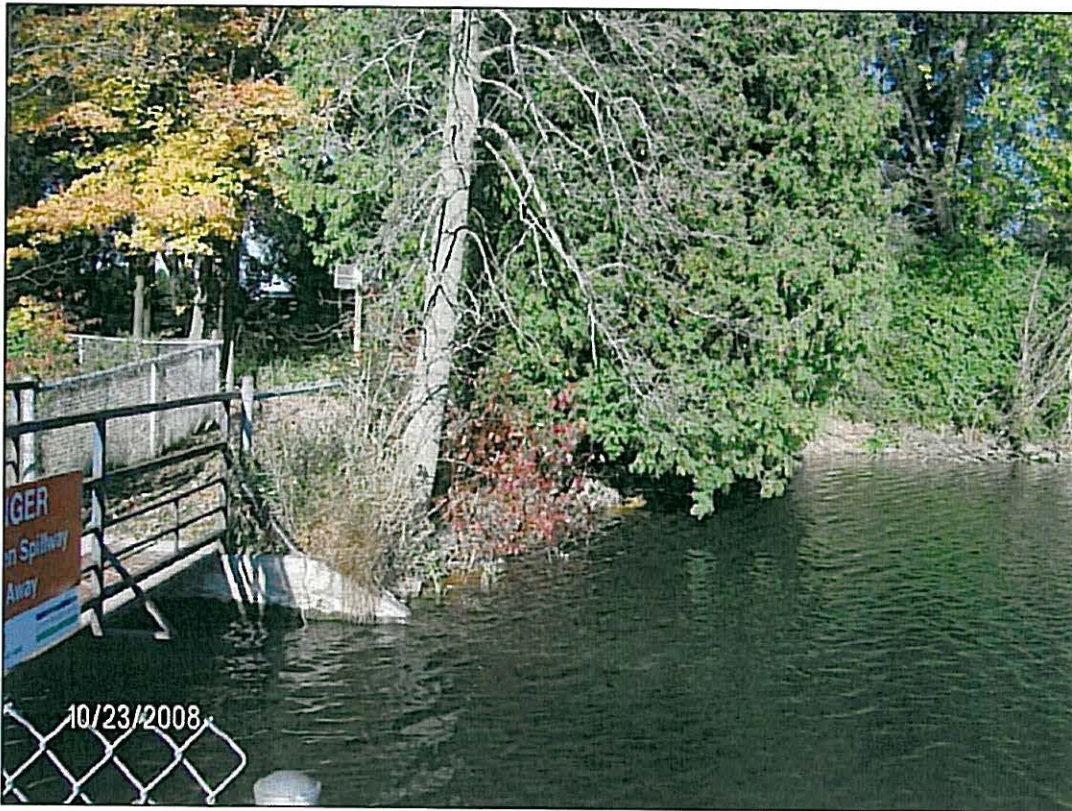
**Photo 10:** Trees at east embankment.

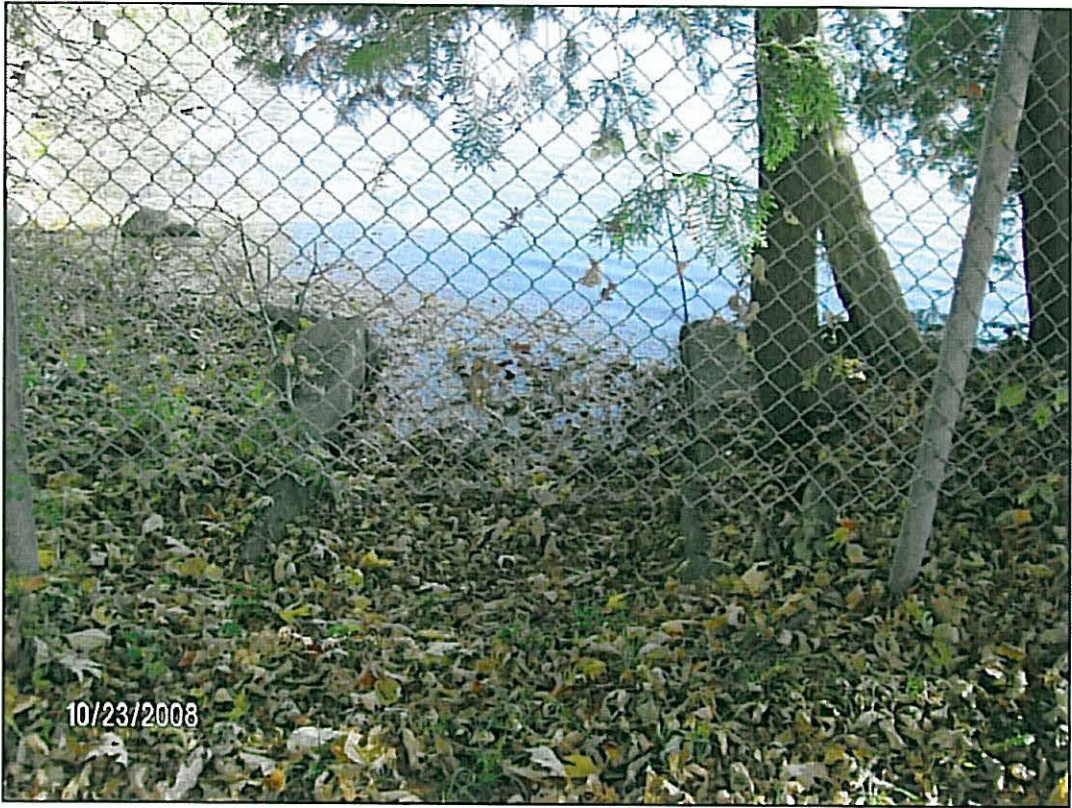
**Photo 11:** Inlet of old mill race.

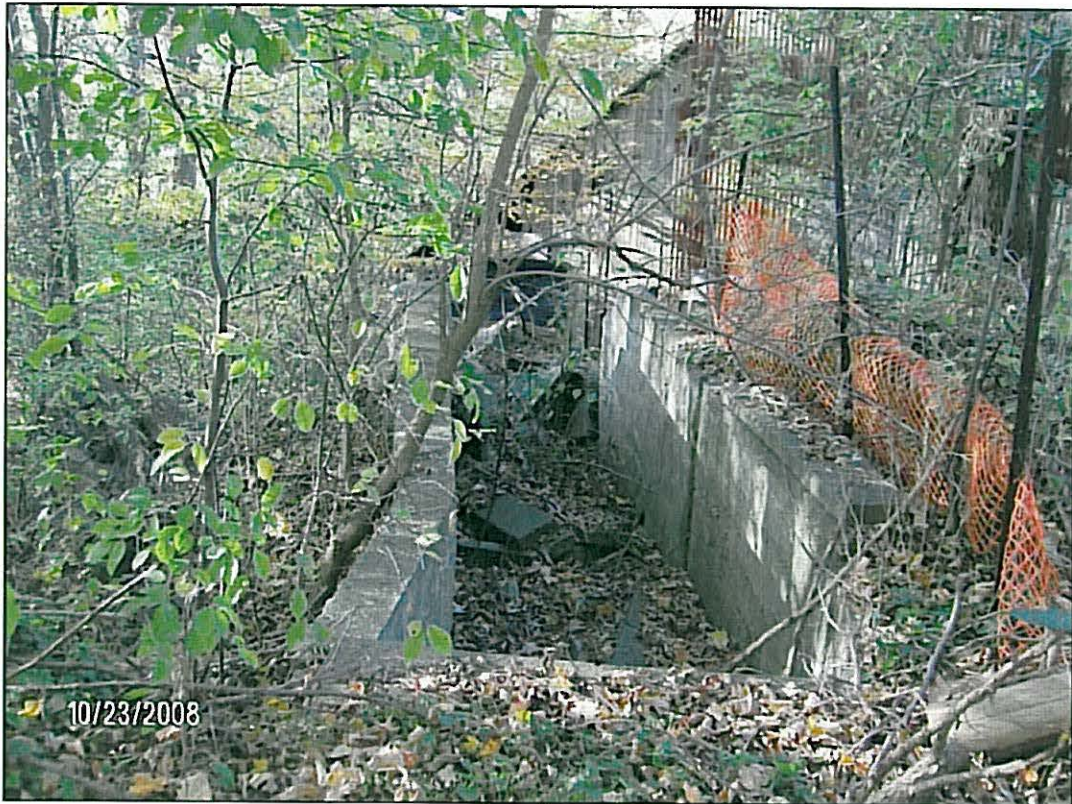
**Photo 12:** Looking north along mill race from dam.

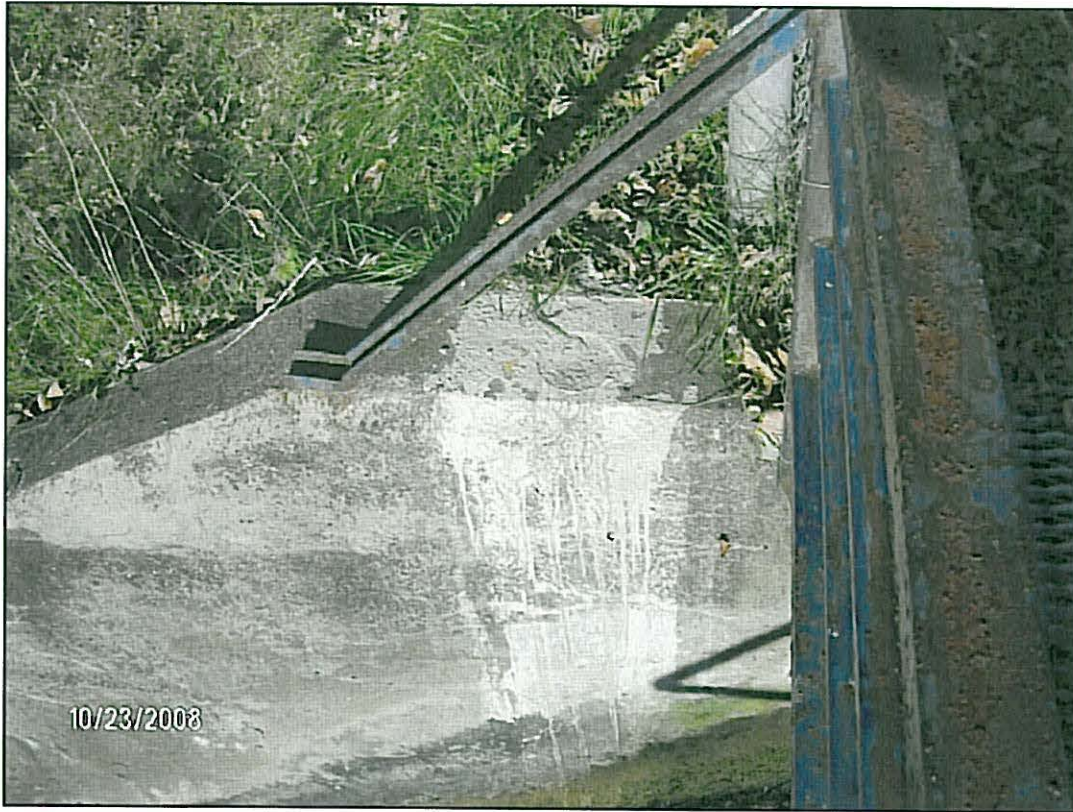
**Photo 13:** Concrete corehole at east wall.

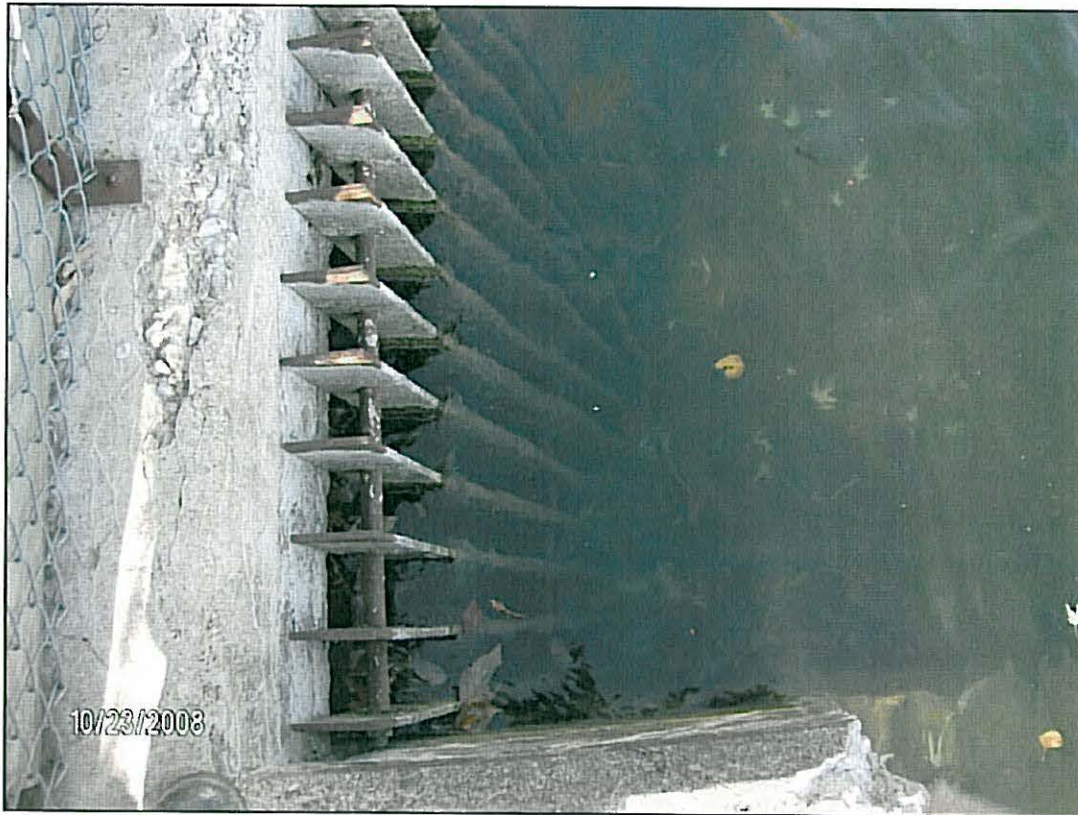
**Photo 14:** Culvert inlet at west wall.

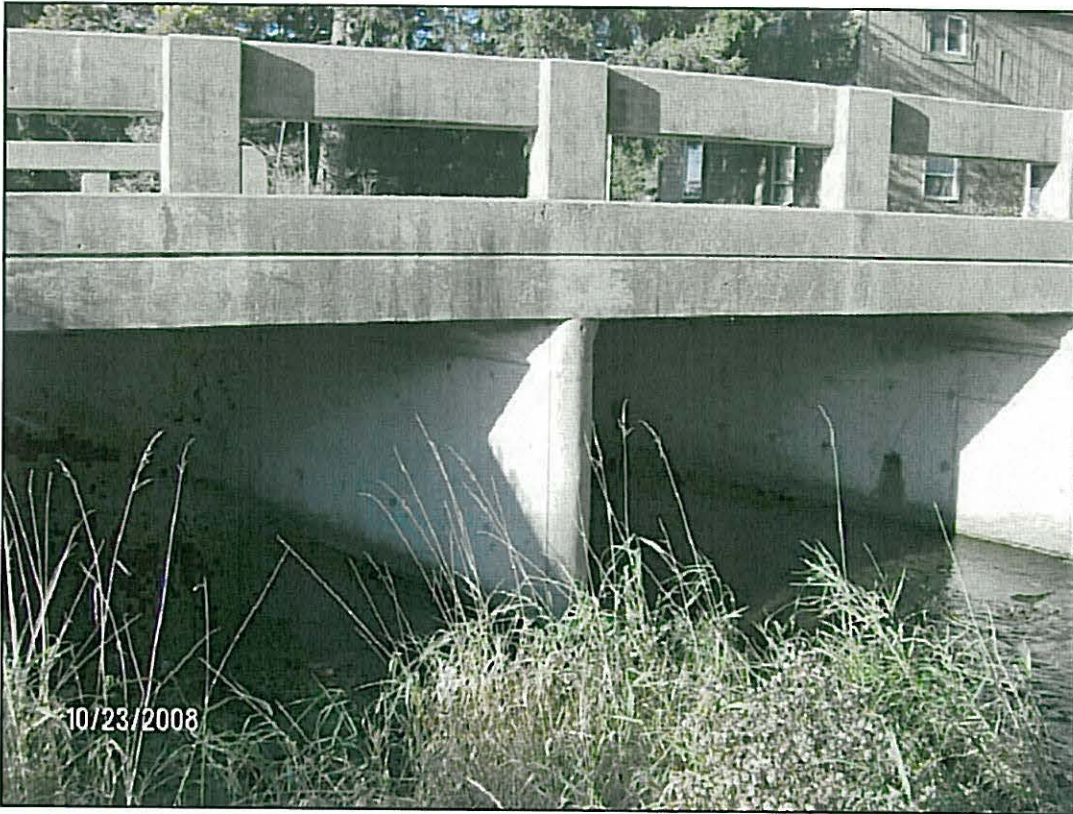
**Photo 17: Twin box culvert at Road 28.**

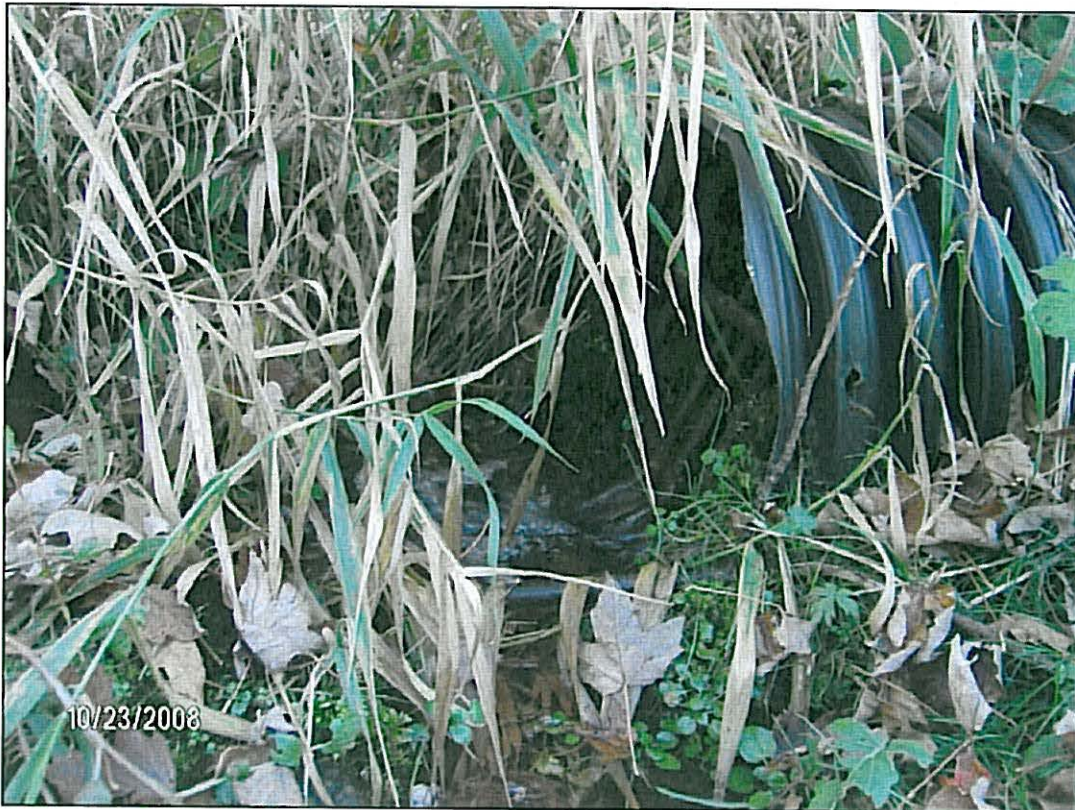
**Photo 18: Artesian well outlet pipe located near twin box culvert.**
