Springbank Dam North Embankment Repairs
prepared for the
Upper Thames River Conservation Authority

Riggs Engineering Ltd.

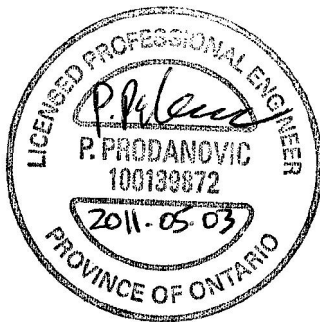
Pat Prodanovic, Ph.D., P.Eng.
Water Resources and Marine Engineer

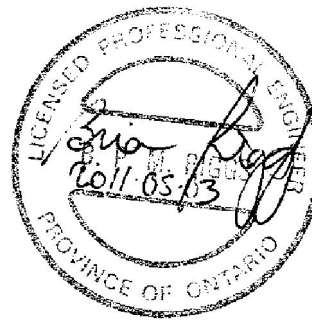
Brian Riggs, P.Eng.
Principal, Riggs Engineering Ltd.

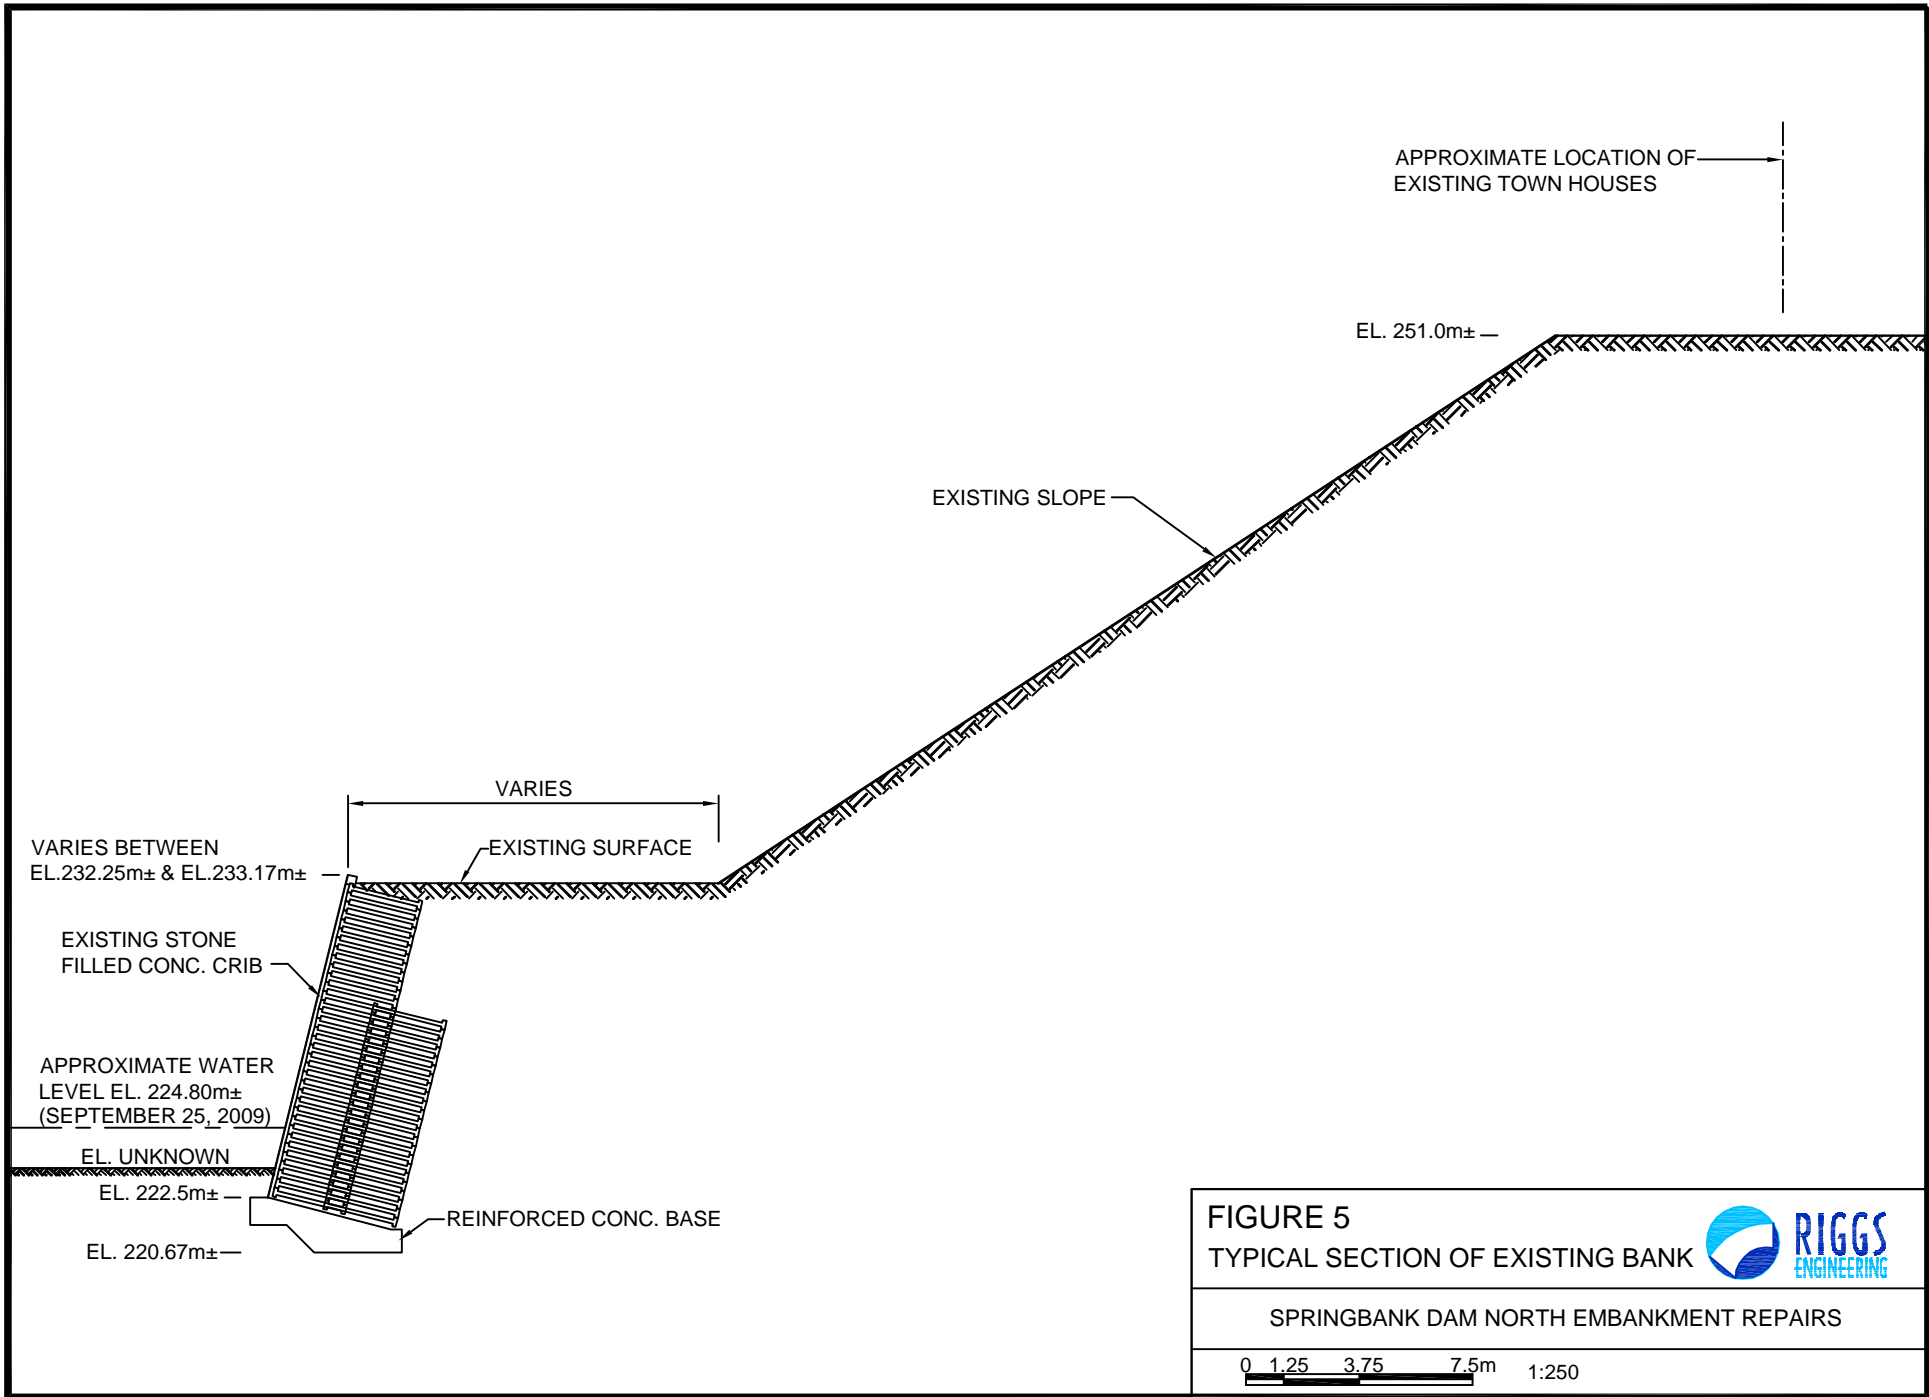
pads for the precast concrete pieces making up the crib. Although filter fabric was not specified in the original drawing, it is visible over some sections of the crib. Figure 5 shows the crib as well as top of slope.

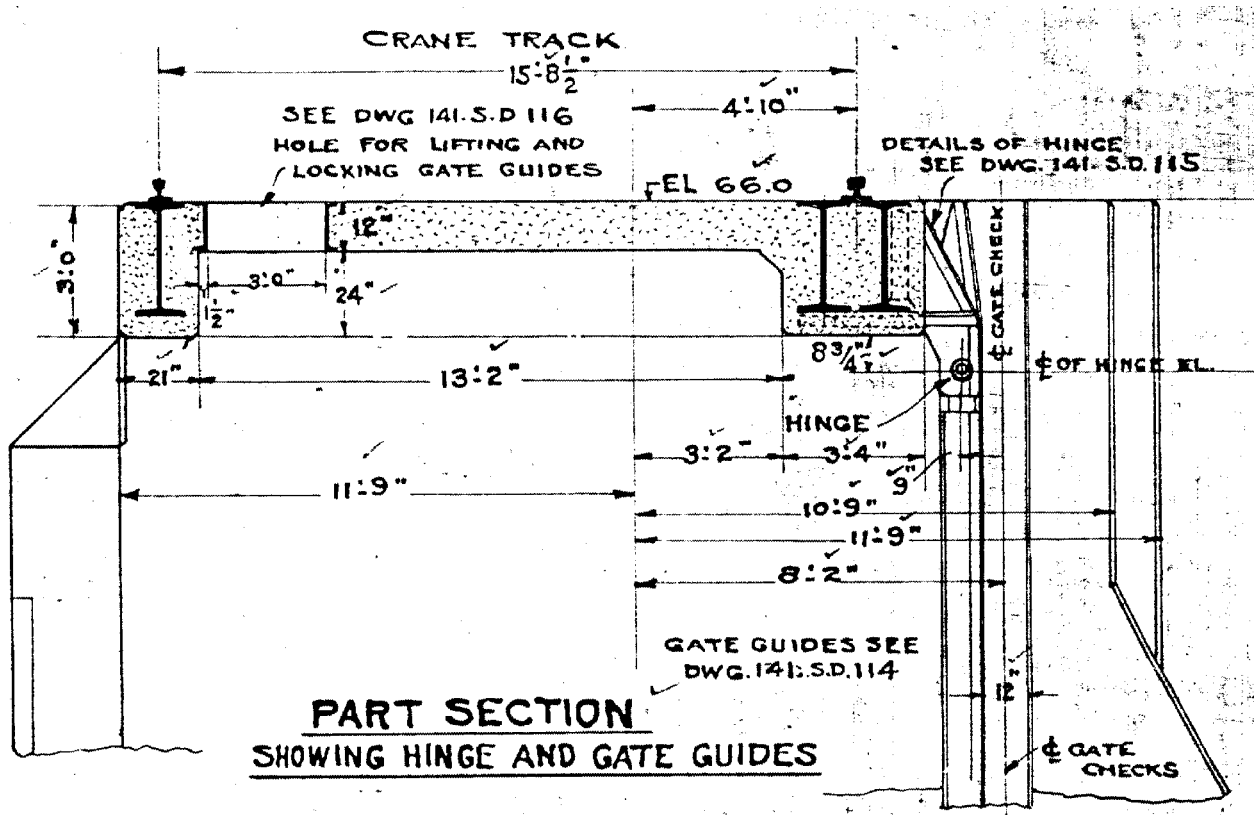
Figure 6: Typical section of the deck, extracted from 1928 drawings

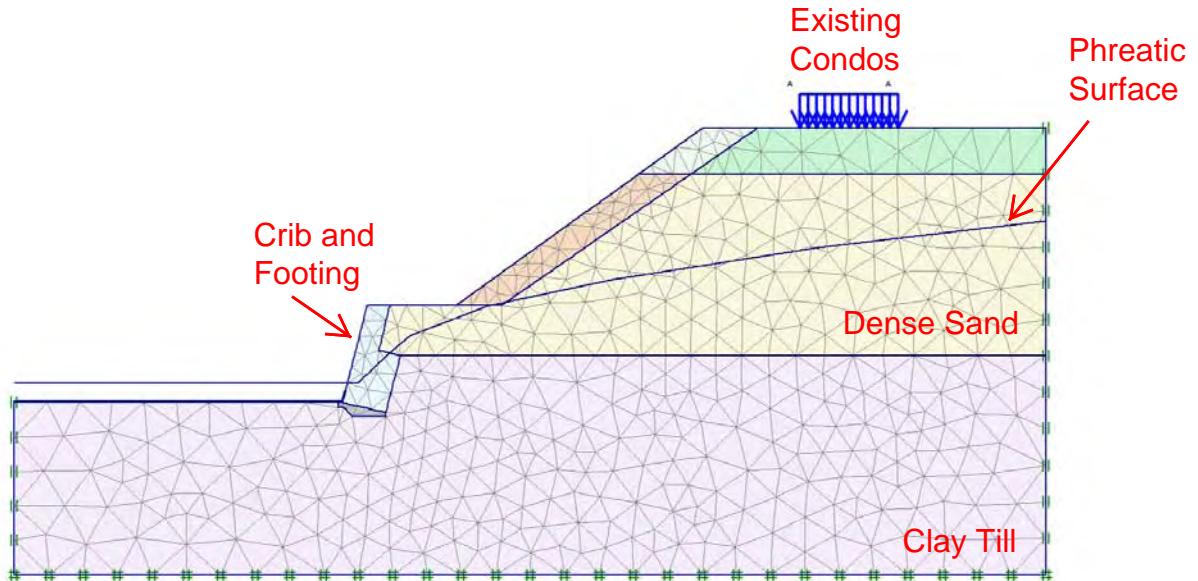
Figure 7: Geometry of the Plaxis 2D finite element model. Approximately 5 m zone of soil was modelled as elastic material to take prevent shallow slope failures (i.e., sloughing)

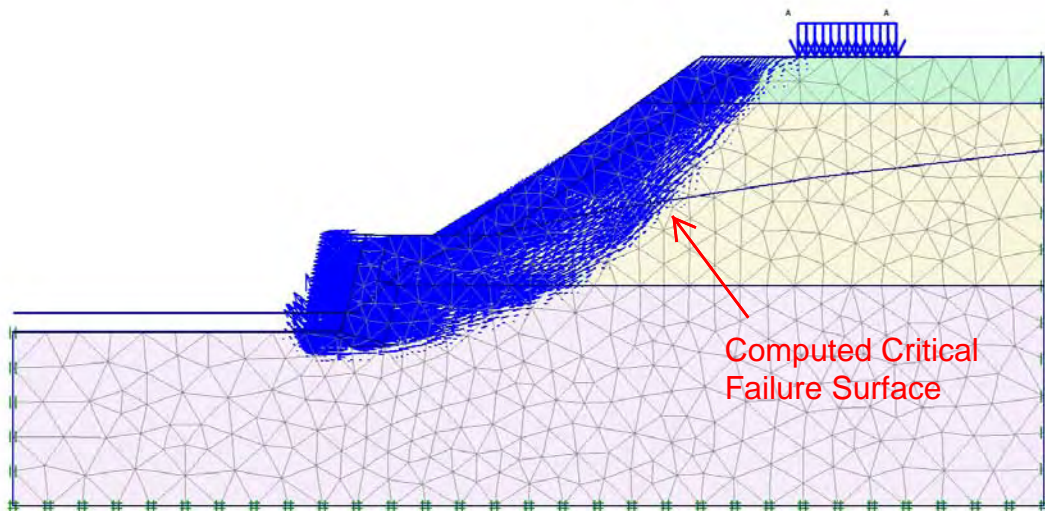
Figure 8: Non-circular failure surface extending through the base of the footing as computed by Plaxis 2D (SF = near unity)

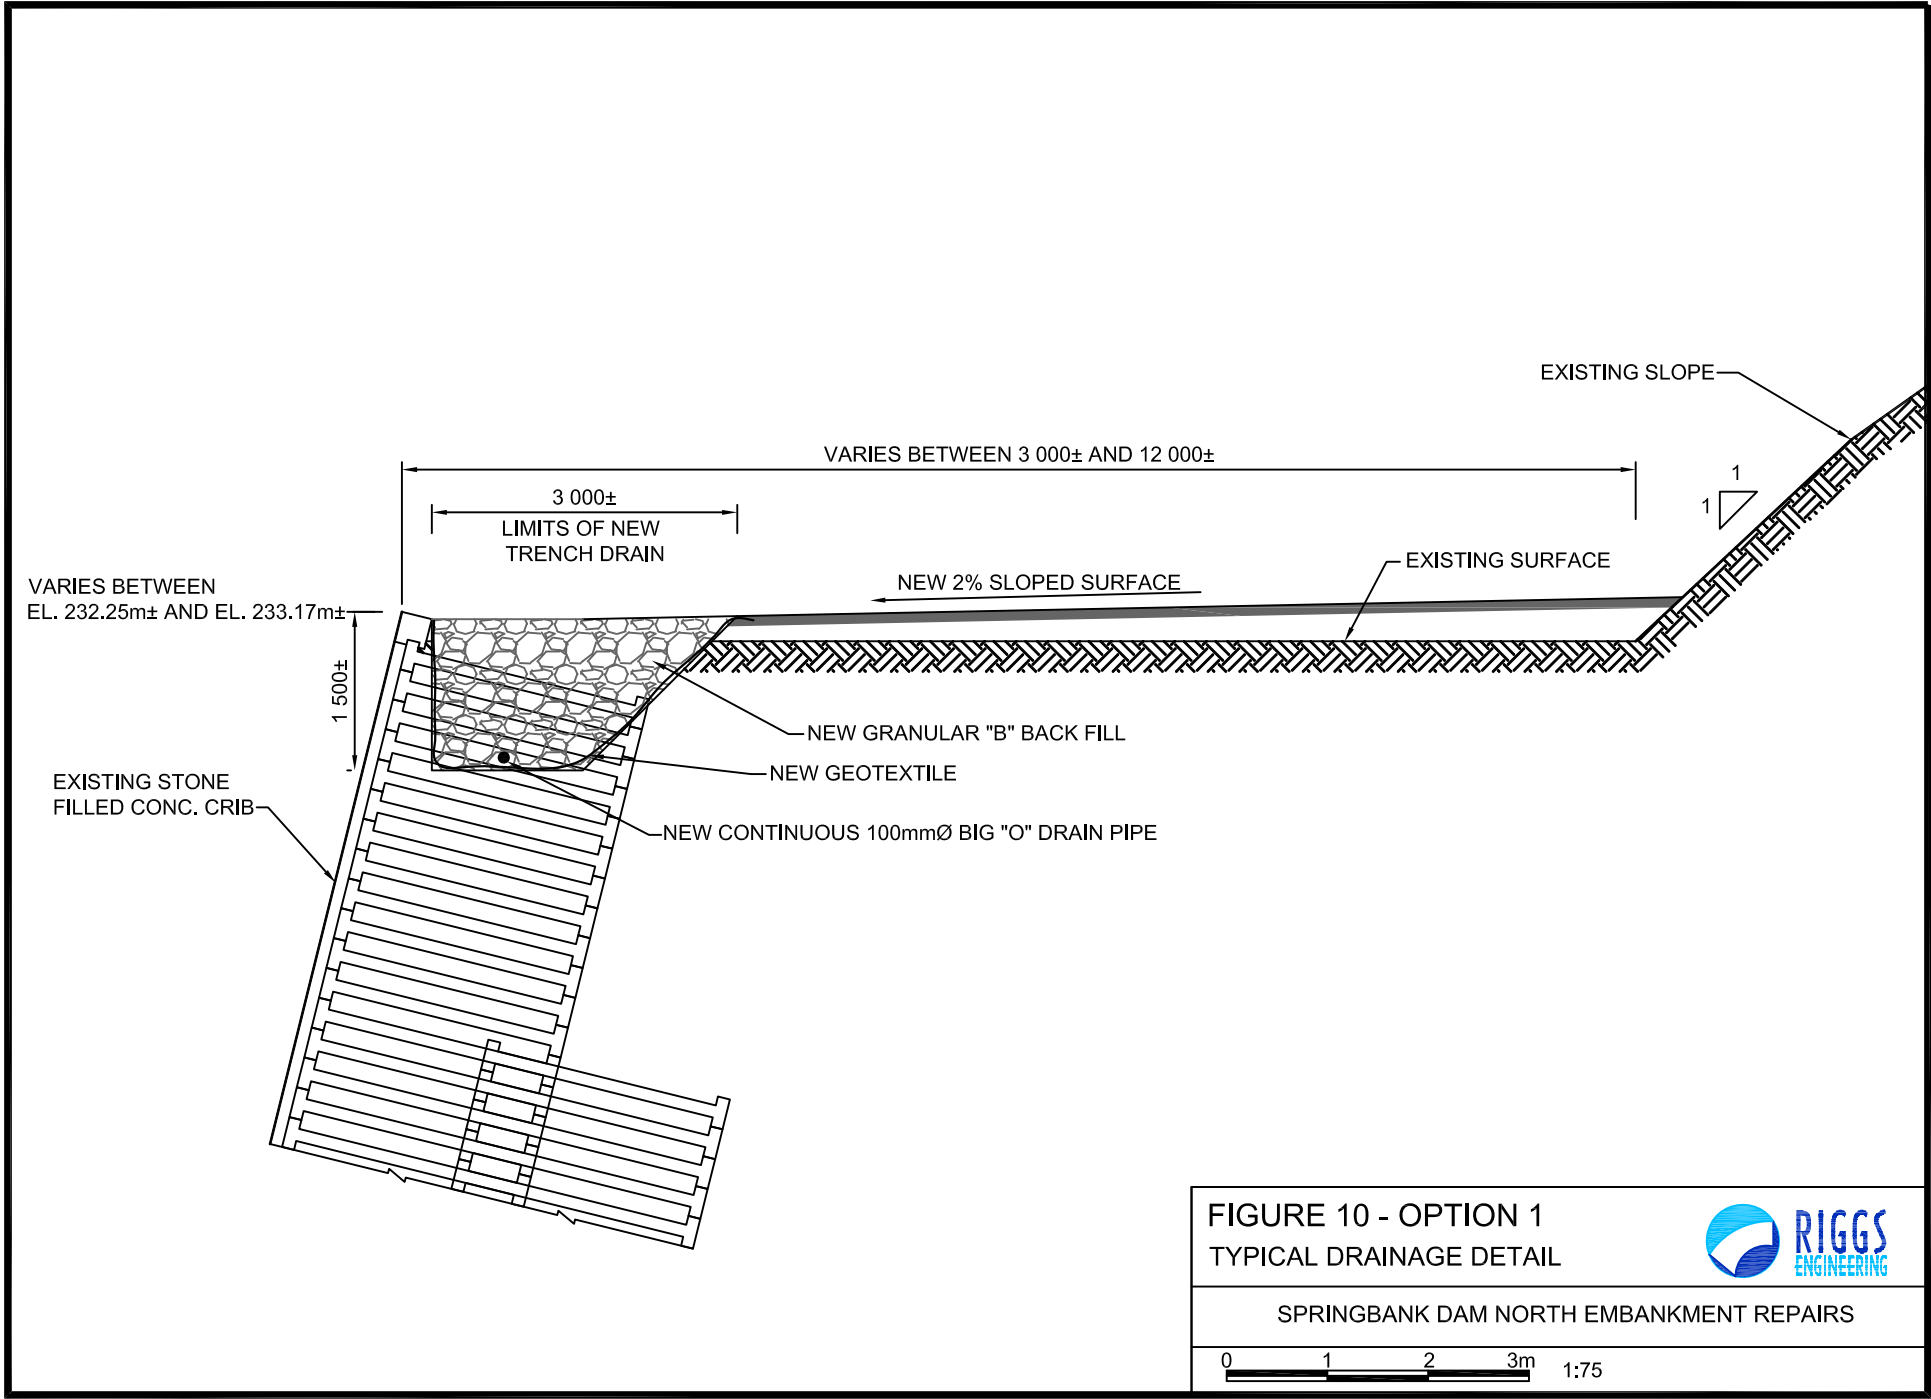
5.2 Option 2 – French drain

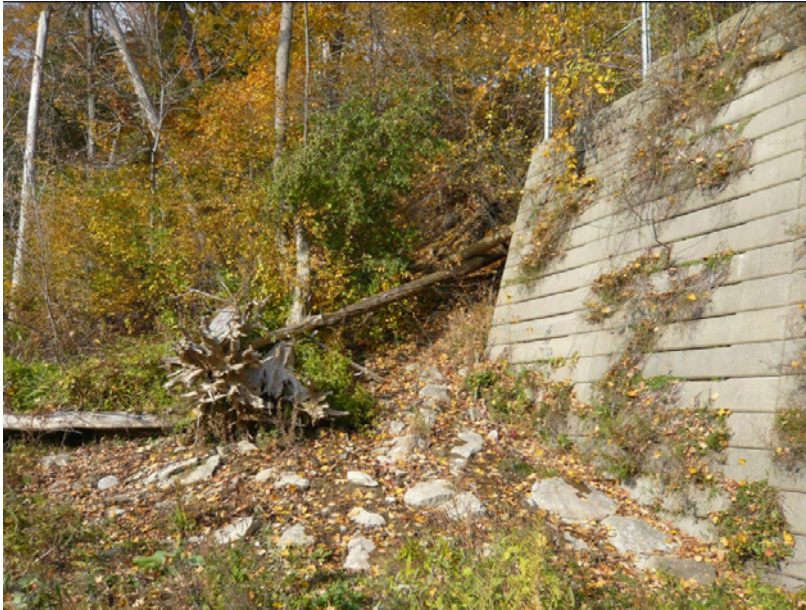
Photo 1: North embankment crib, downstream portion (standing on bottom and looking downstream). Most of the surface runoff flows bypasses the crib.

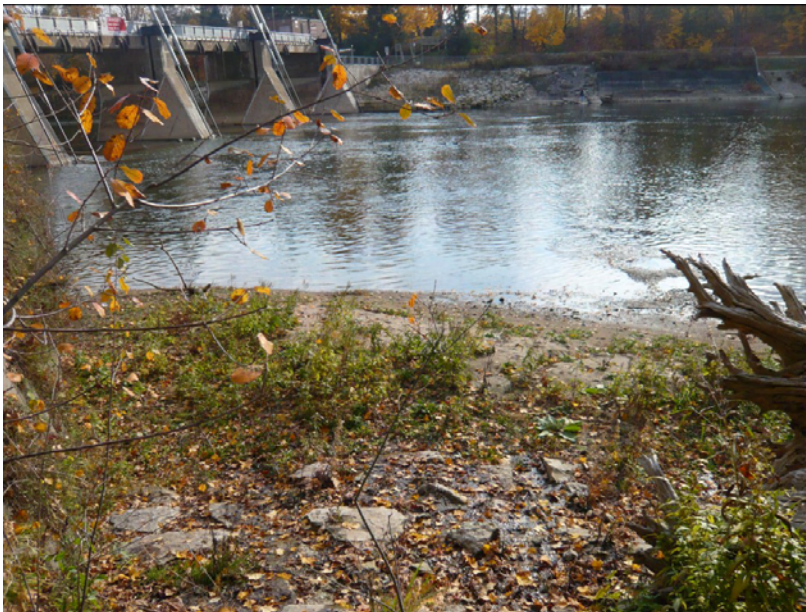
Photo 2: Downstream end of the crib, looking towards the south. Water on the bottom shows the surface runoff bypassing the downstream portions of the crib.

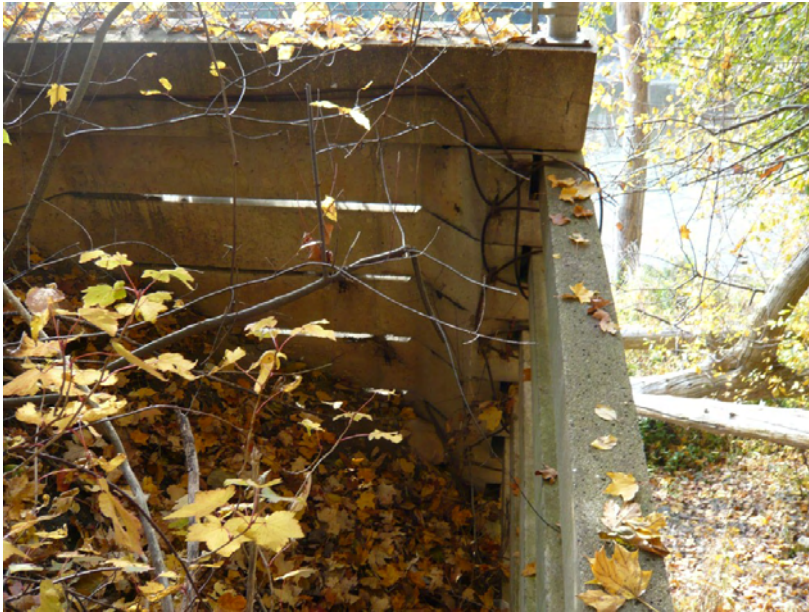
Photo 3: Downstream end of the crib. Note the material lost.

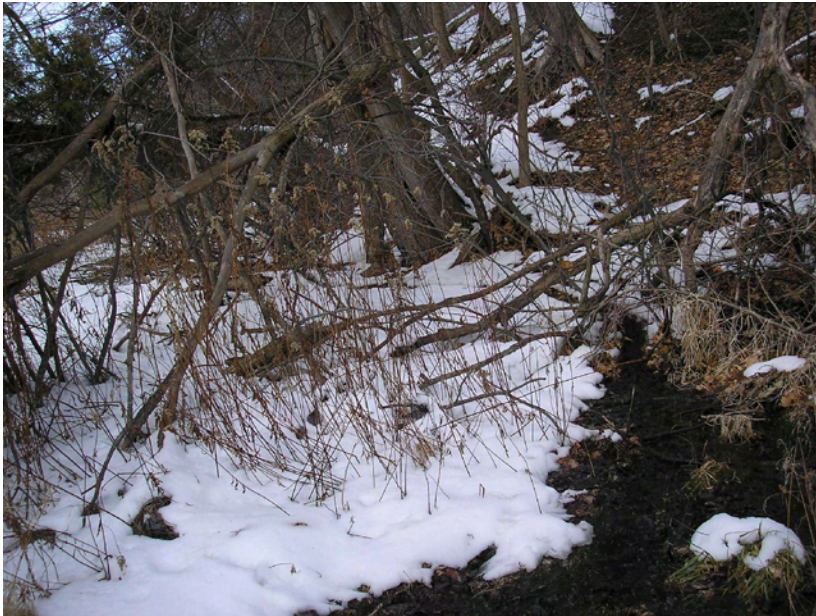
Photo 12: Toe of slope upstream of the dam, standing on top of crib. Again seepage from the slope drains in a less defined channel (due to trees) and eventually empties at the upstream side of the crib

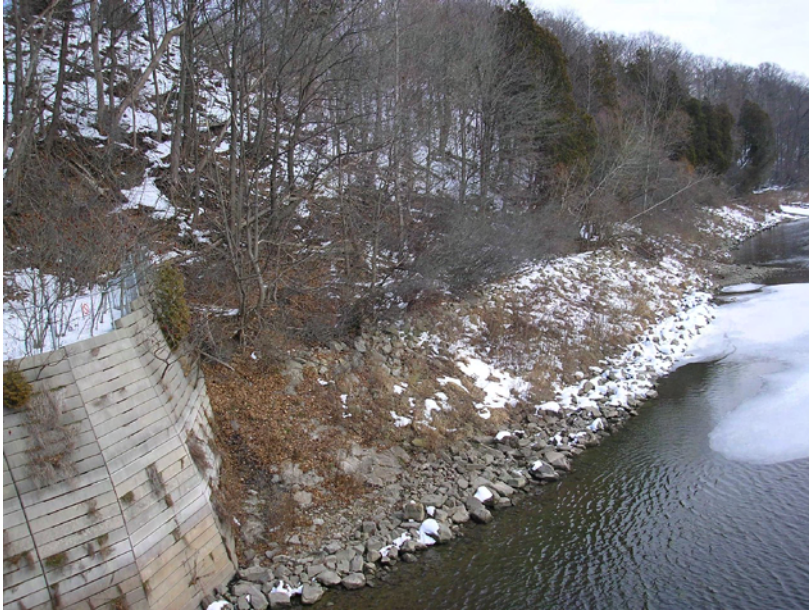
Photo 13: Riprap on the upstream side of the crib, standing on dam and looking upstream. Seeping water is evident on the outer side adjacent to the crib. Evidence of seepage has also been observed at the treeline (top of riprap).

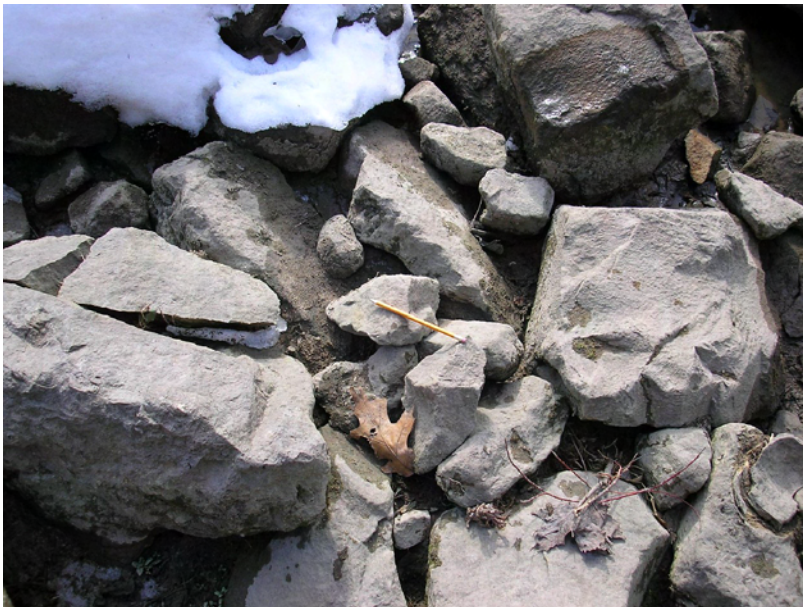
Photo 14: Riprap protection at the upstream side of the crib (stone diameter varies from 0.1 to 1.0 m). Some cracking in the stones is evident, but the riprap is in generally good condition

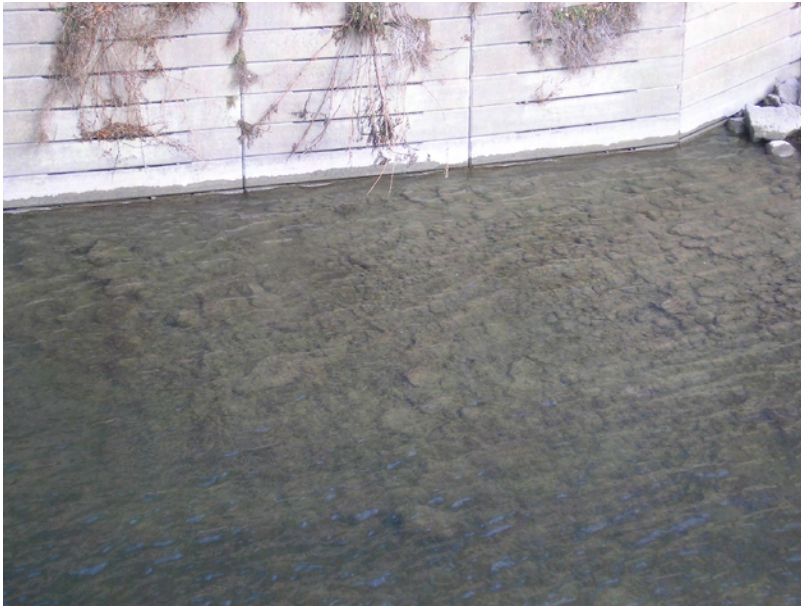
Photo 15: Riverbed stone upstream on the upstream side of the dam adjacent to the crib shows no localized undermining

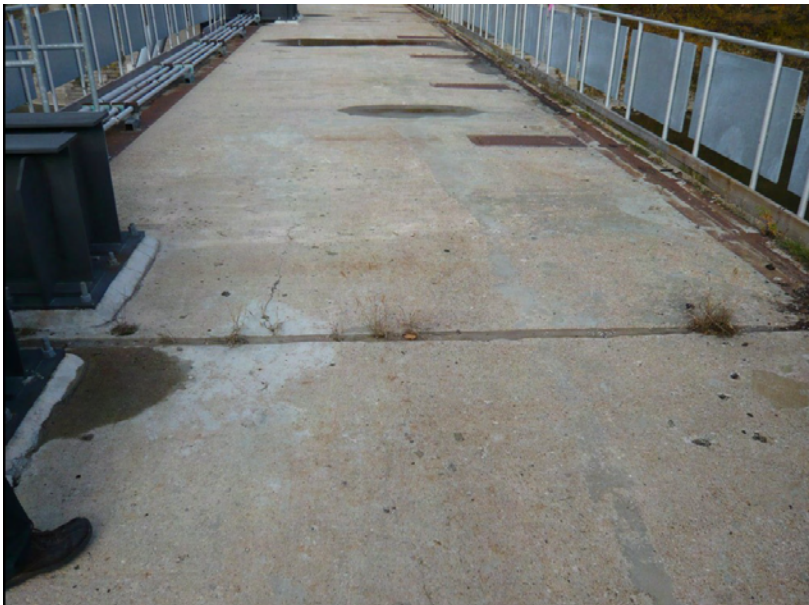
Photo 16: Springbank Dam bridge deck, looking north. Note the holes in the concrete for the old gate guides (welded shut by thin plates).

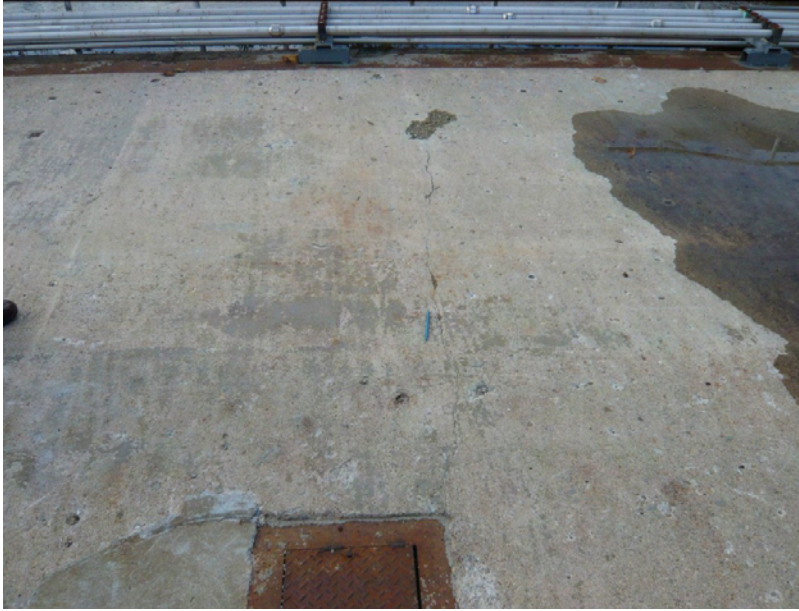
Photo 17: Typical view of the deck slab at the old gate guides (looking downstream). Note the crack running along the length of the slab from the pipes to the old gate guides (see pen for scale).

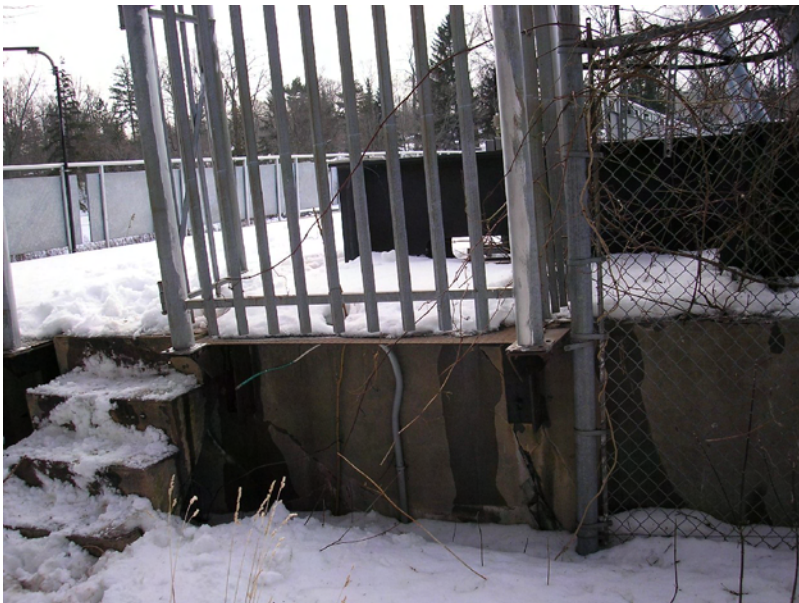
Photo 18: North end of the deck, vertical cracks are observed adjacent to the stairs and adjacent to the fence post.

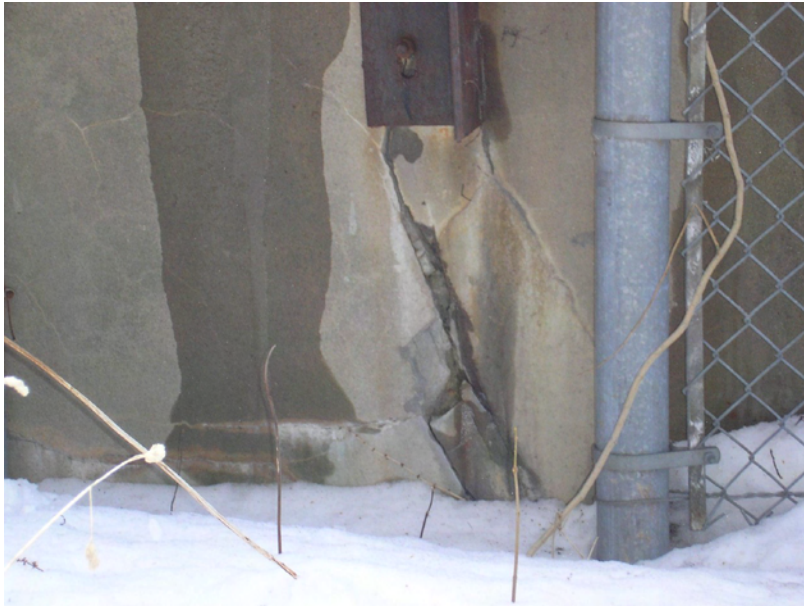
Photo 19: Vertical crack adjacent to the fence post on the north end of the deck.

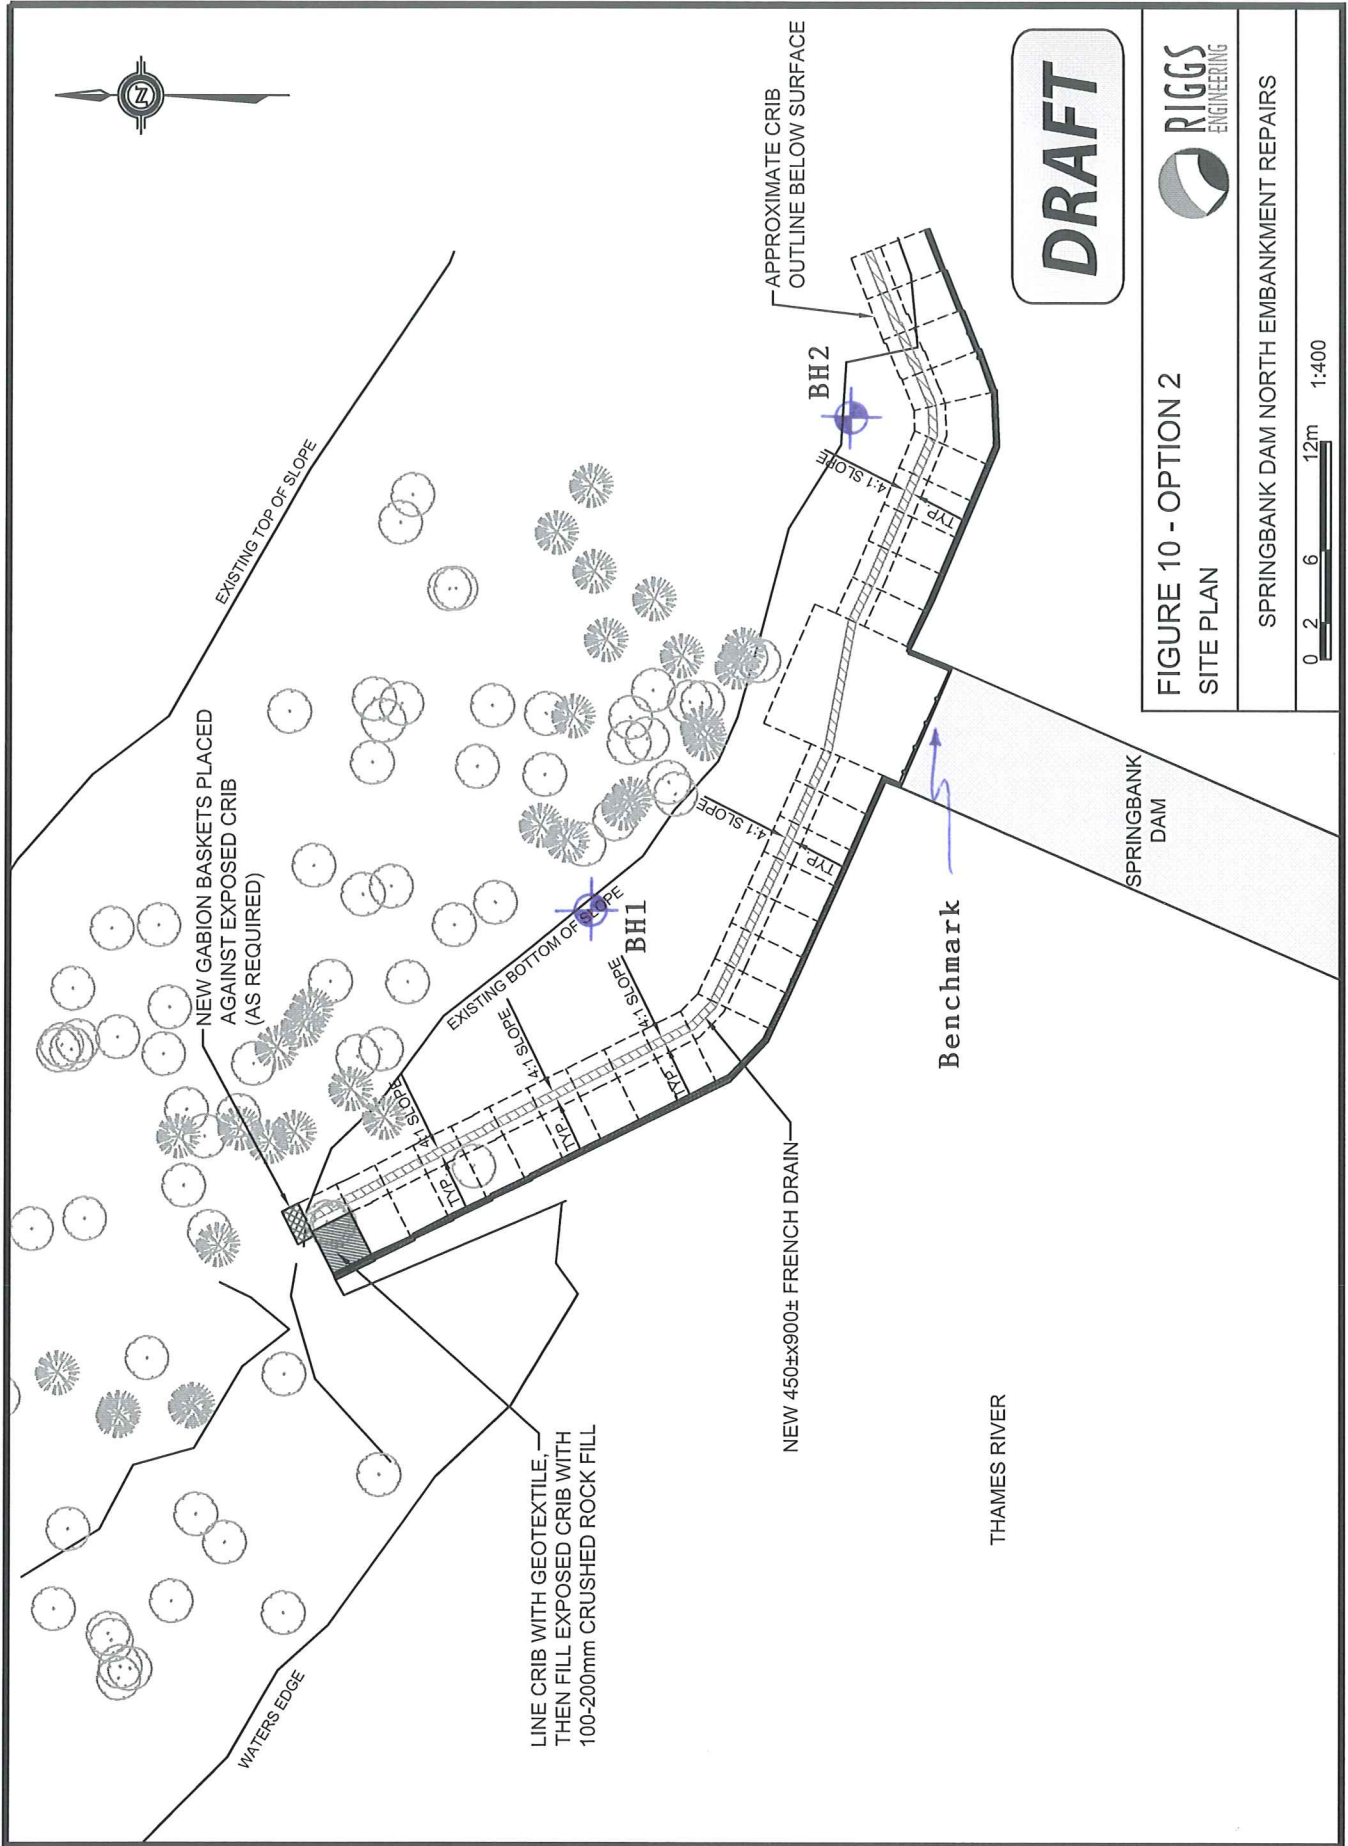
This report is applicable only to the project described in the introduction, constructed substantially in accordance with details of alignment and elevation quoted in the text.
