May 7, 2010

Mr. Rick Goldt, CET
Supervisor, Water Control Structures
Upper Thames River Conservation Authority
1424 Clark Road
London, Ontario
N5V 5B9

**Re: Springbank Dam, London, Ontario
South Bank Steel Sheet Pile Inspection 2010**

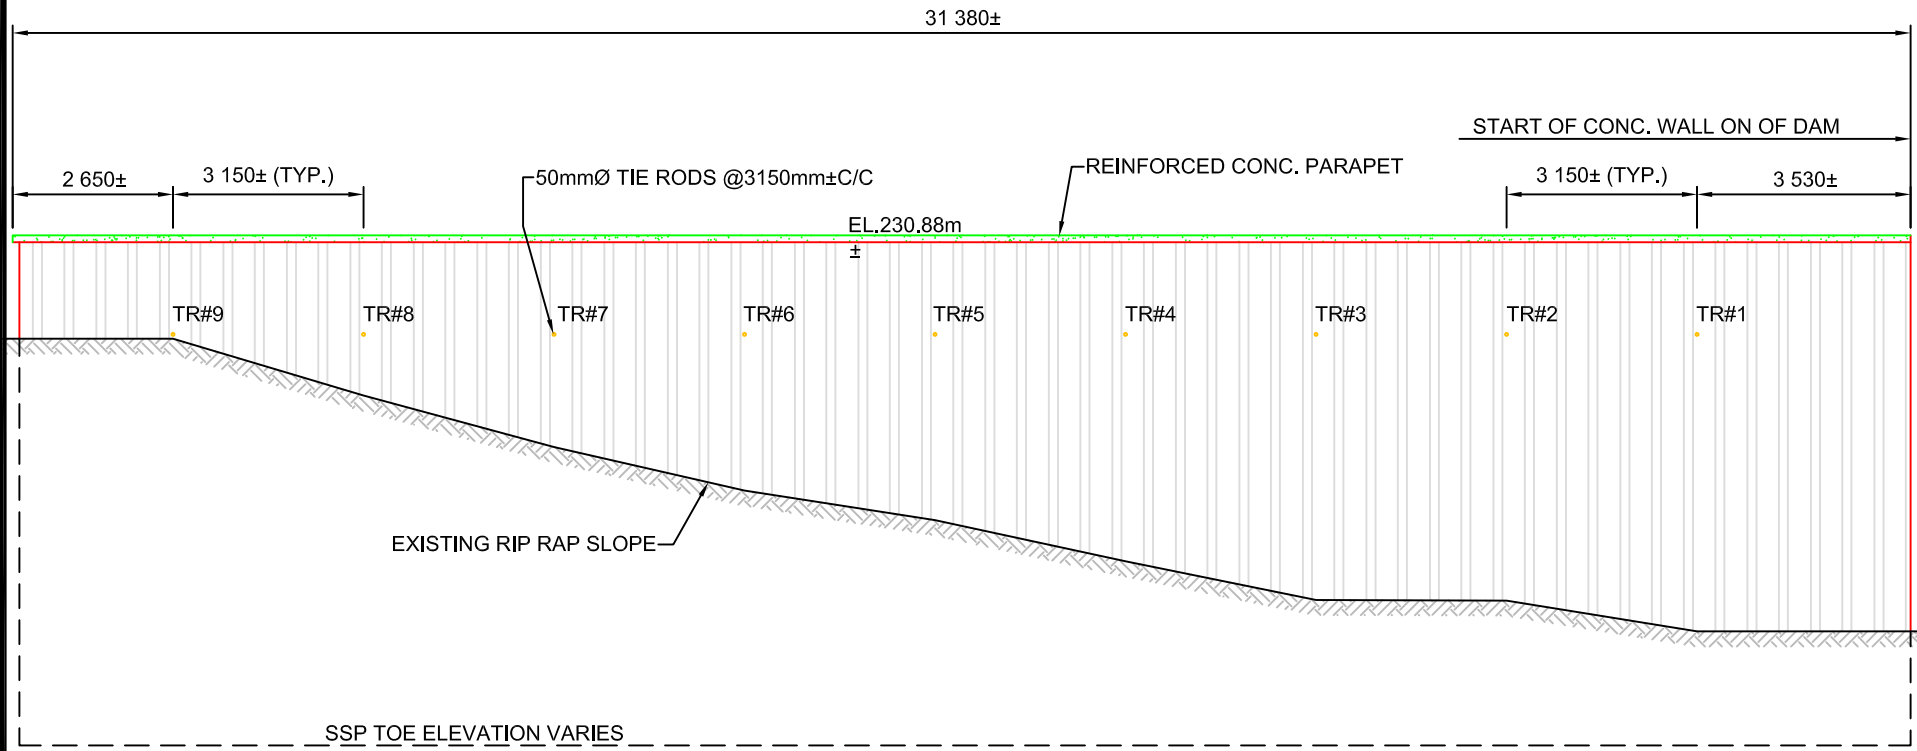
FIGURE 1
ELEVATION

We confirmed externally visible as built details from drawings dated July 21, 1969 for the Springbank Dam Rehabilitation during our inspection. Figure 1 and 2 attached show the elevation of the steel sheet pile wall and the typical cross section through the wall. An anomaly was noticed when reproducing Figure 2 and as built section through the wall. The anchor blocks on the as built drawing are not drawn to the elevation noted. Figure 2 shows the anchor block much deeper in accordance with the as built elevations. The length of the steel sheet pile wall measured from face of the dam east is some 31.27 metres. The concrete parapet on top of the steel sheet pile wall is 31.38 metres long and overhangs the east end of the steel sheet piling. There are nine tie rods along the length of the wall at a spacing of 3.15 metres or every third steel sheet pile inpan. The tie rods are 1.45 metres below the under side of the concrete parapet. The steel sheet pile is a Z shape profile. The distance between out pan flanges is 1.05 metres, which equates to 0.525 m between interlocks. The thickness of the flange and the web of a typical pile were measured above the high water mark, where there is no significant corrosion. The thickness was measured using an ultrasonic measuring device. The measured flange thickness was 12.4 mm and the web thickness was 10.0 mm. Conversions of the imperial measurements, on the as built drawings, indicate a flange thickness of 12.7 mm and a web thickness is 9.9 mm. We are confident that the steel sheet pile profile is a Hoesch 155 profile from these measurements. No legible mill markings were found to further confirm the steel sheet pile profile.

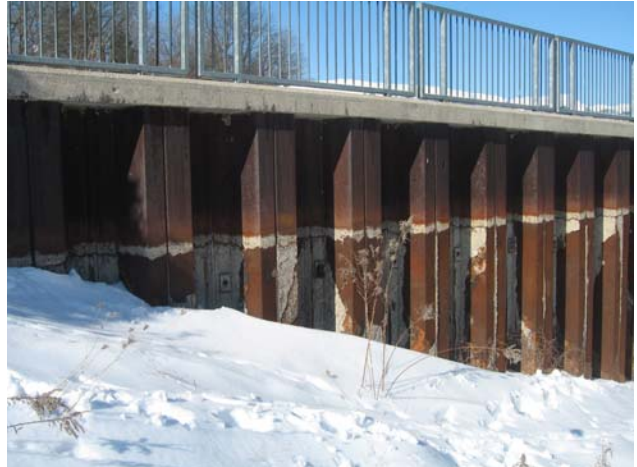
Photo #2 –Front Elevation, east end of wall at embankment. High water mark visible.

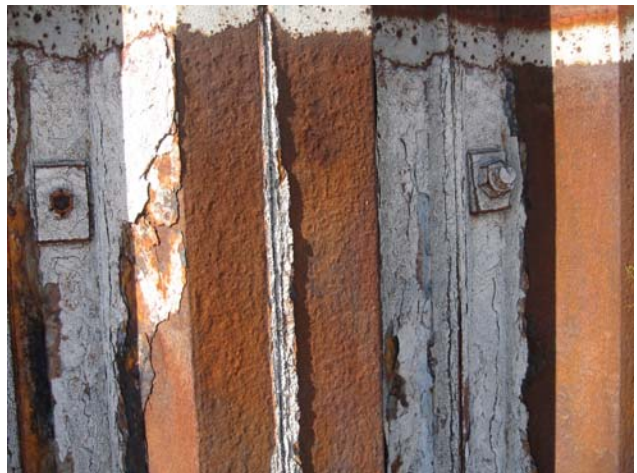
The wall is heavily corroded below the high water mark which was measured to be 1.04 metres below the underside of the concrete parapet. Generally, the rust scale from the corrosion remains attached to the steel sheet pile inpan flanges, partially on the webs of the piles and within the joint of the interlocks on the out pans. The surface of the steel has significant pitting. Inspection under the rust scale revealed the same surface condition. Only light surface corrosion exists above the high water mark. The typical condition of the wall may be seen in the attached photos log.

Photo #4 – Evident corrosion and pitting on face of outpans. Rust scale on inpans and partially on webs and interlocks.

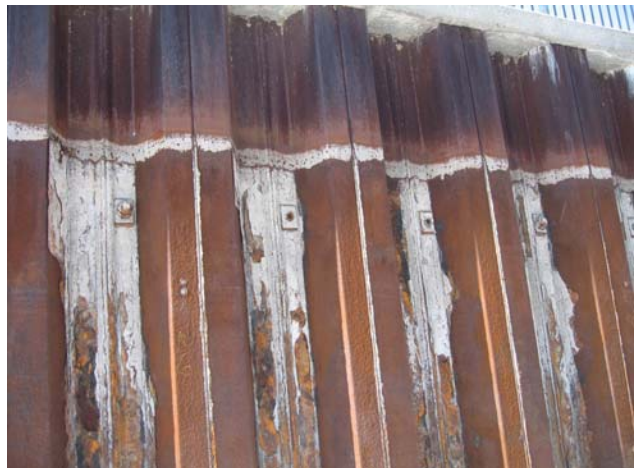
Photo #6 – Tie rod shown every third inpan. Heavy corrosion below high water mark.

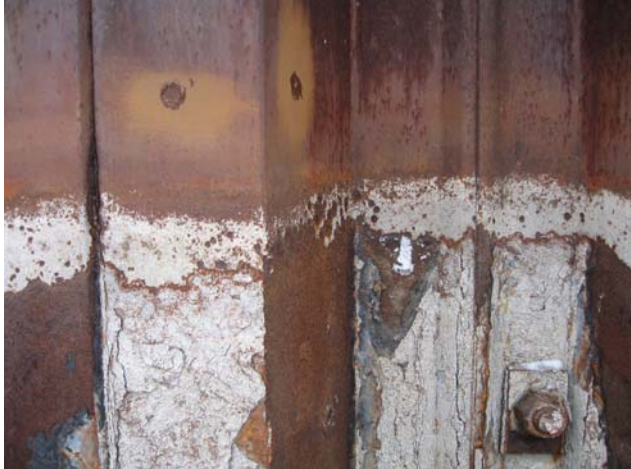
Photo #7 – Prepared surface for steel sheet pile thickness measurement at location T1 above high water mark.

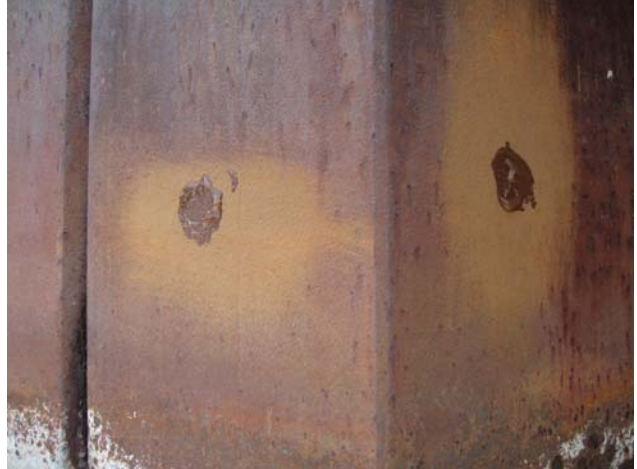
Photo #8 – Close up of prepared surface for thickness measurement at location T1 & T2.

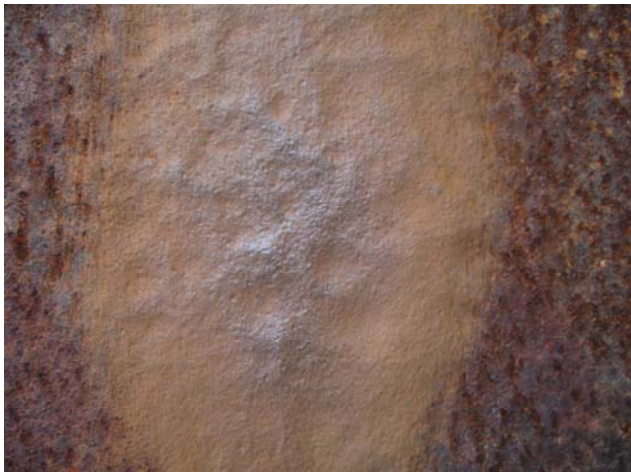
Photo #9 – Prepared surface for thickness measurement at location on T4 & T5 steel sheet pile web.

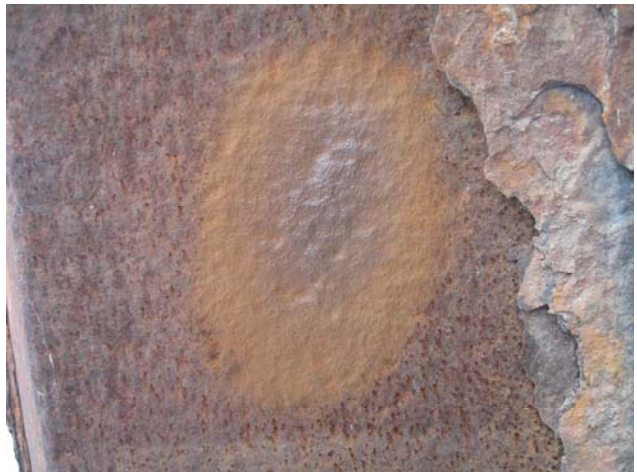
Photo #10 – Prepared surface for thickness measurement at location on T8 on web with rust scale to the right.

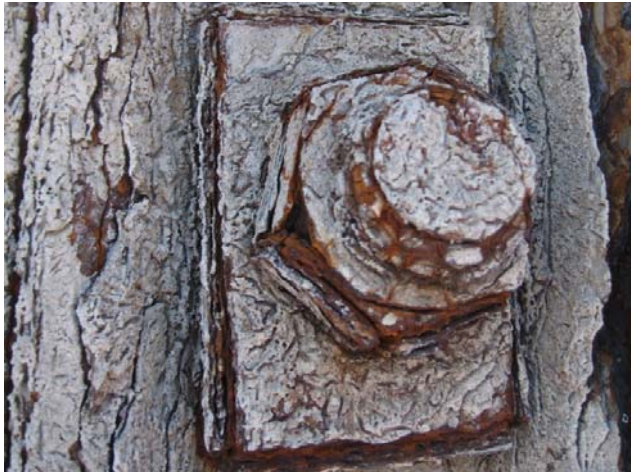
A thick rust scale exists on the exposed tie rods ends, nuts and beveled plate washers and on the wale bolts and plate washers. A typical tie rod, nut and beveled plate washer assembly was cleaned off and the tie rod diameter and the width across flats of the tie rod nut were measured to obtain a sense of steel loss on these elements. Photos 11 through 18 show these elements. The nominal diameter of the tie rod as shown on the plan is 50.8 mm (2"). The existing diameter was measured on the threaded tie rod portion beyond the nut using calibrated calipers. The diameter measured 42 mm (1²¹/₃₂"). The threads were very rounded with little distinction between the crest and root of the threads, as may be seen in Photo 14. The measured distance across the flats on the tie rod nut was 69 mm (2²³/₃₂"). Typically the distance across the flats of a nut for a 50.8 mm rod is 80 mm. These two measurements indicate a steel surface loss 4 mm and 5.5 mm, respectively. Similarly a measurement was taken across the flats of the head of the wale bolt. Typically for a 22 mm (7/₈") diameter bolt the distance across the flats on the bolt head is 33.3 mm (1⁵/₁₆"). A distance of 29.4 mm (1⁵/₃₂") was measured indicating a surface loss of 2 mm.

All bolts are secure at this time but further corrosion may lead to connection failure. Connection may be lost as threads corrode inside the tie rod nut. Also reduction in size of the wale bolt head may eventually result in bolt pulling through the wall or becoming slack. Determination of any loss in tie rod and bolt diameters requires excavation for inspection. This will also permit the double channel wale to be inspected. The wale serves as a beam element to distribute the individual tie rod loads to the steel sheet pile wall. The distribution occurs through the wale bolts that attach the wale to the steel sheet pile wall.

Photo #11 – Typical corroded tie rod, tie rod nut and bevelled washer at tie rod #7.

It is recommended that the tie rods and wale bolts inside the wall be exposed and inspected for corrosion to confirm their condition. This would require saw cutting and removal of the pavement surface and excavation of the backfill behind the wall to expose the wale, tie rods and wale bolts. The inside face of the steel sheet pile wall and double channel wale may be inspected for corrosion at the same time. After completion of this additional inspection more definitive recommendations regarding remedial measures may be made.

At this time without further inspection replacement of the wale bolts is anticipated along with reinforcing of the tie rod connections on the outside face. Further inspection may reveal the need to replace the waling. Also, localized reinforcement of the piling will be required in due time if corrosion continues.

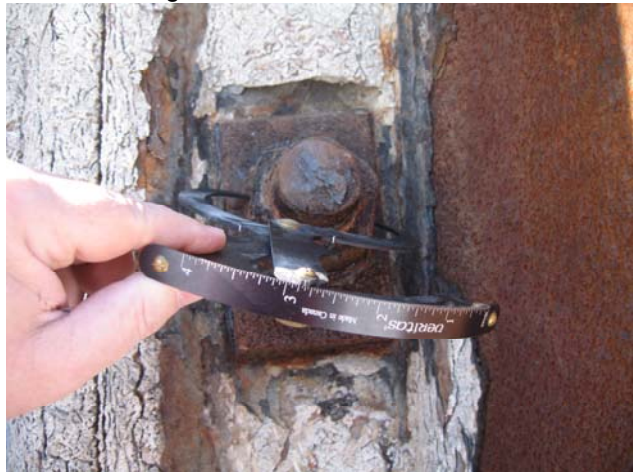
Photo #12 – Measurement across the flat on tie rod nut #7.

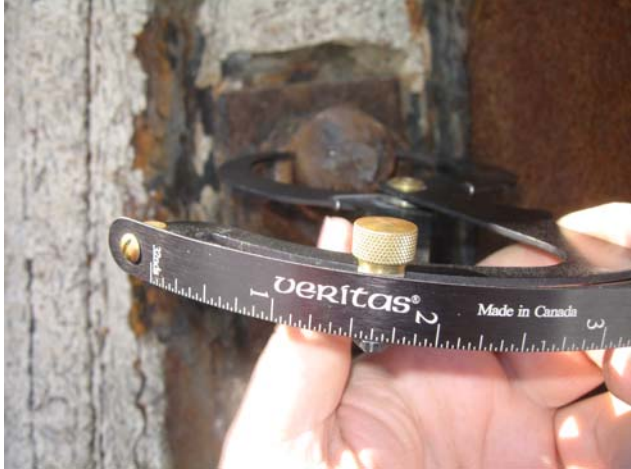
Photo #13 - Measurement across the tie rod on tie rod #7.

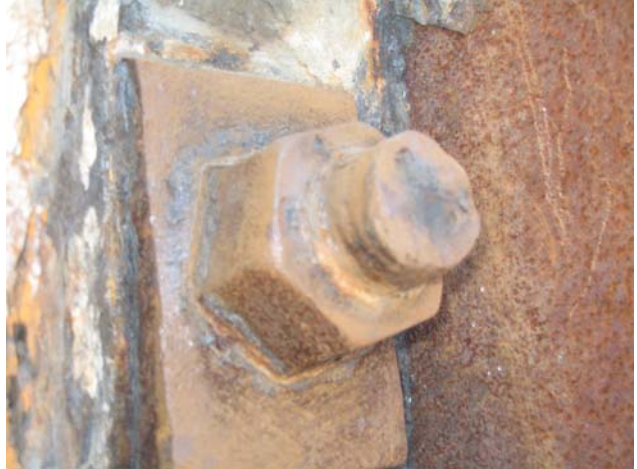
Photo #14 – Tie rod nut and assembly clean of rust scale. Tie rod thread root and crest rounded and barely visible.

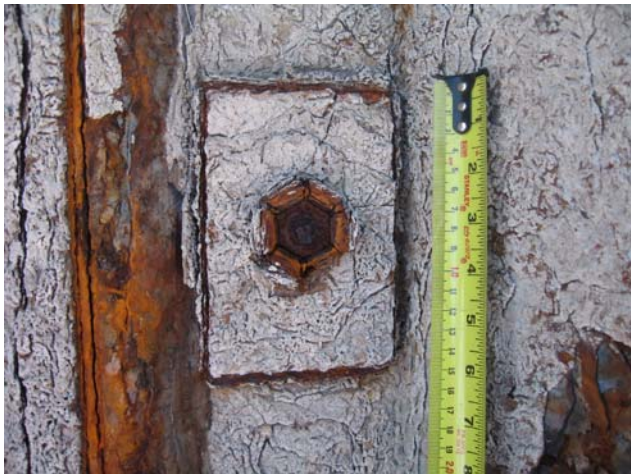
Photo #15 – Wale bolt assembly.

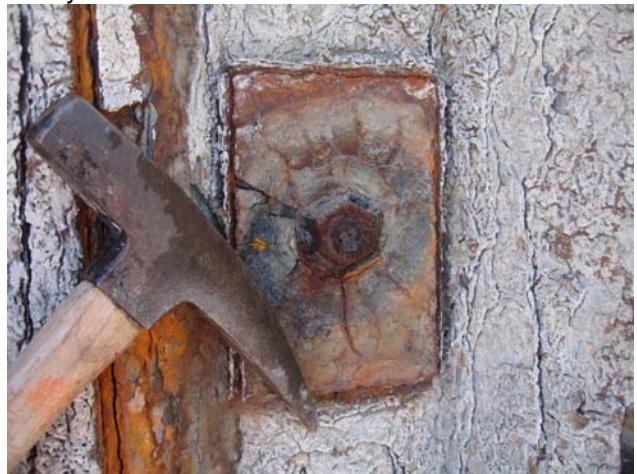
Photo #16 – Partially cleaned wale bolt assembly.

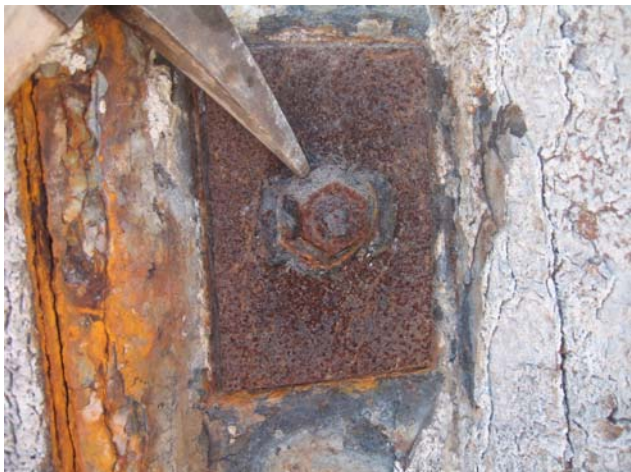
Photo #17 - Wale bolt assembly cleaned of rust scale.

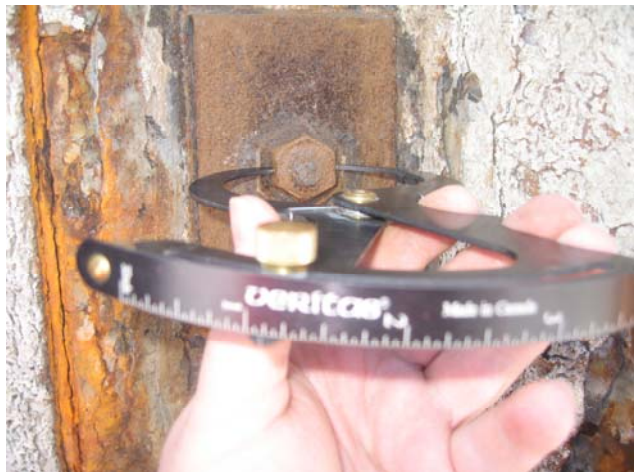
Photo #18 – Measurement across the flat of the wale bolt.

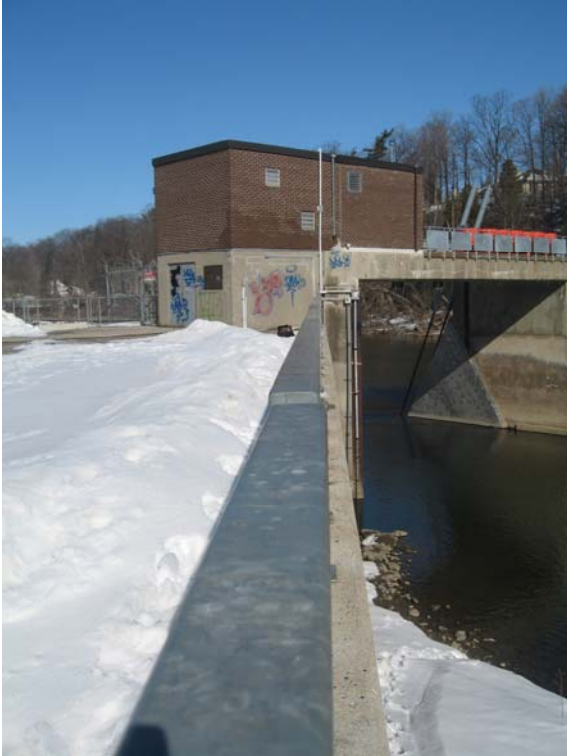
Vertical inclination of the steel sheet piling was measured to the west of several tie rods, to determine if the corrosion has increased the increased deflection of the steel sheet piles. The distance off vertical was measured in millimeters over the length of a 1,220 mm long spirit level. The verticality measurements are presented in Table 2, below. No excessive deflection in the vertical alignment was observed. A visual check along the length of the wall showed no irregular horizontal alignment. See Photos 19 through 21.

Photo #19 – Horizontal alignment of top of wall at rail height.

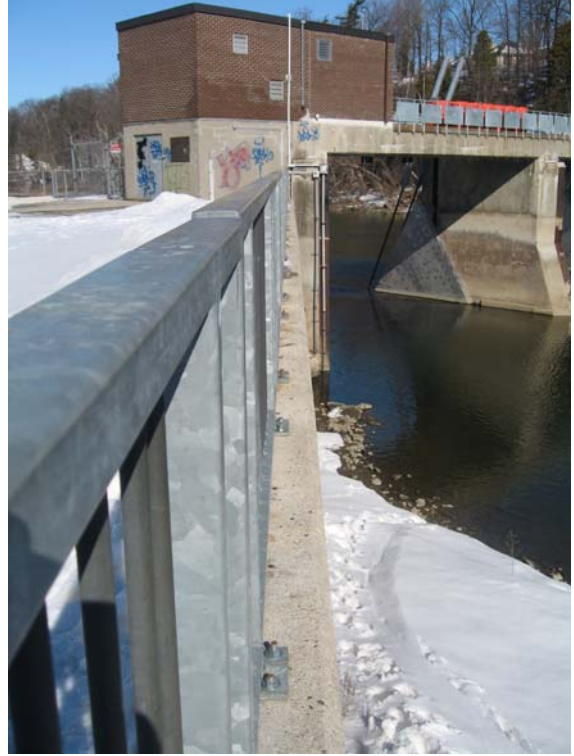
Photo #20 – Horizontal alignment of top of wall at concrete cap height.

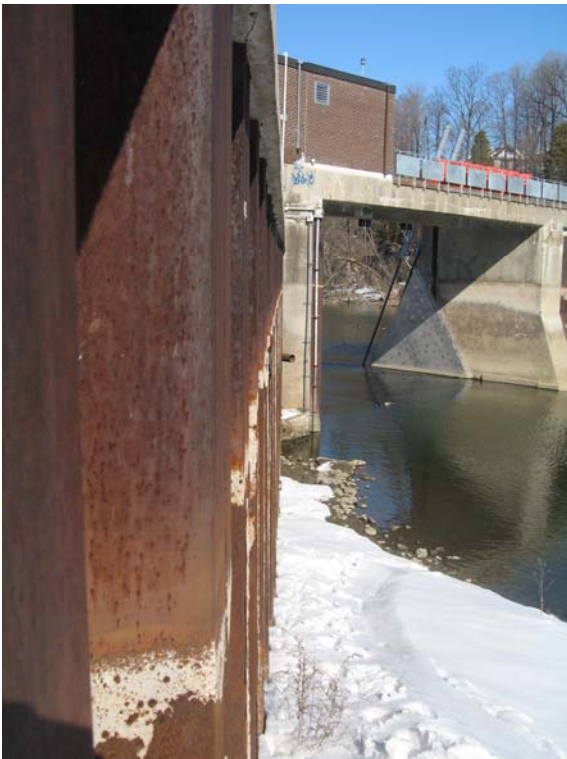
Photo #21 – Vertical alignment of face of wall, viewing west to dam

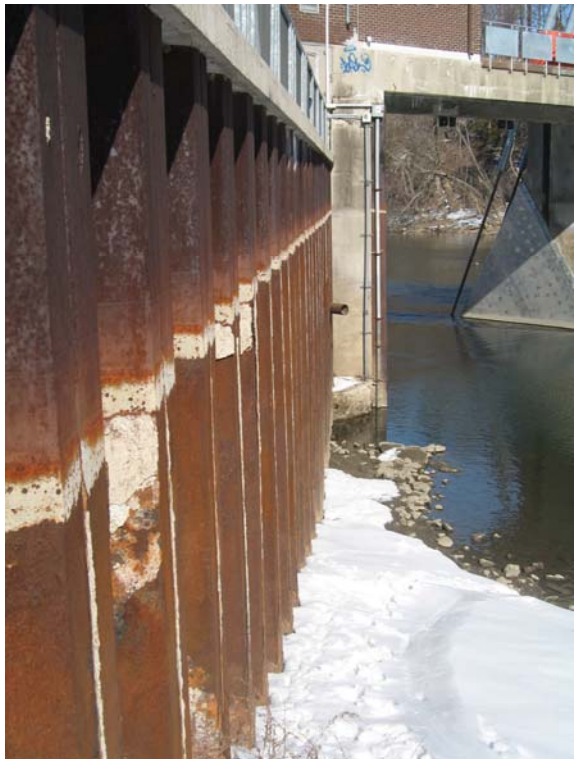
Photo #22 – Vertical alignment of face of wall along face of wall viewing west to dam.
