Condition Survey Report (2011) Springbank Dam

Prepared by:

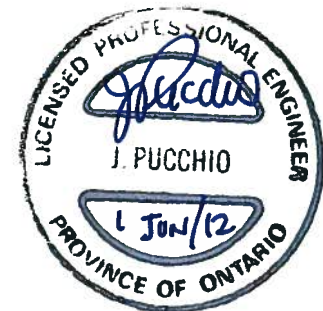
John Pucchio, P.Eng.
Senior Structural Engineer

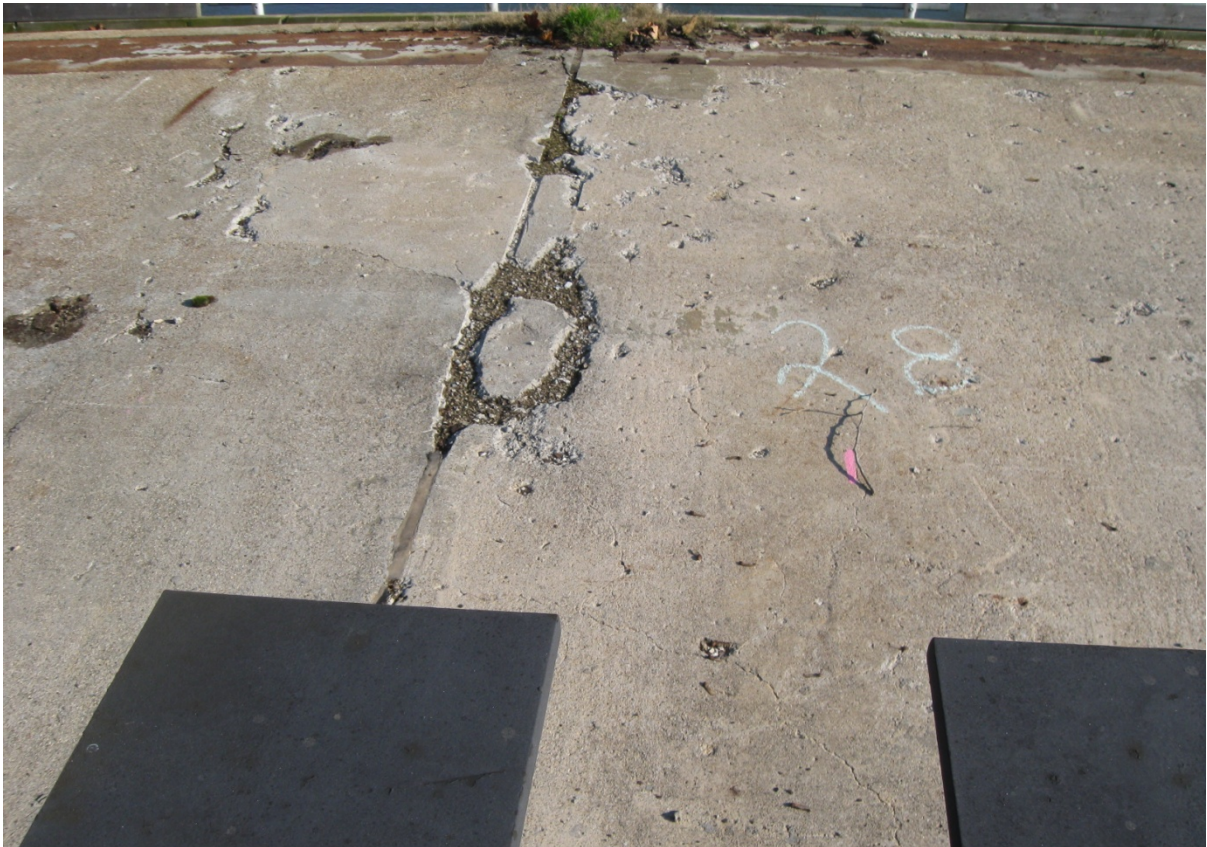
Photo 6 – Spalling at deck joints

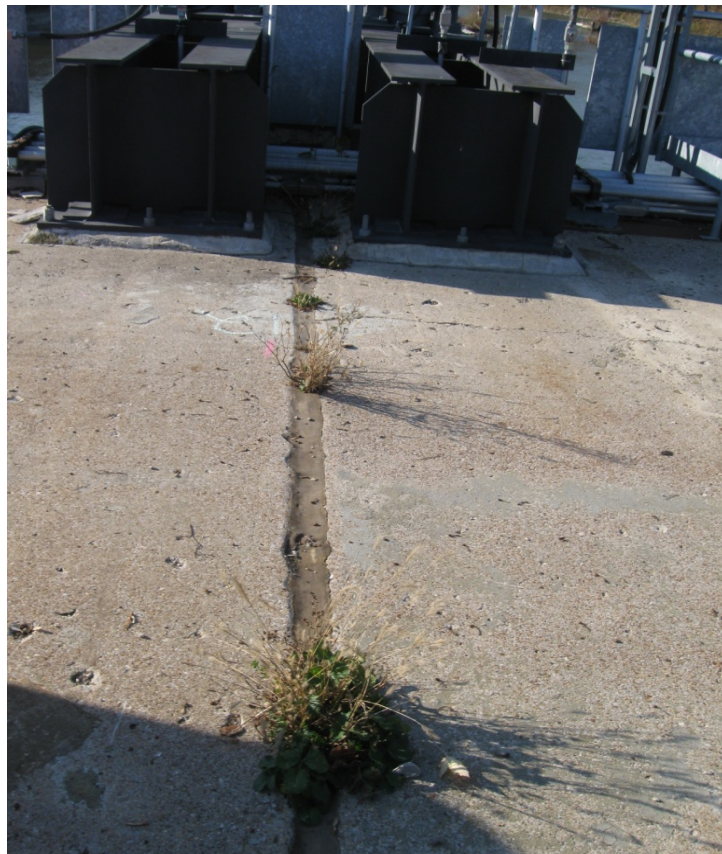
Photo 7 – Vegetation growth in the expansion joint sealant

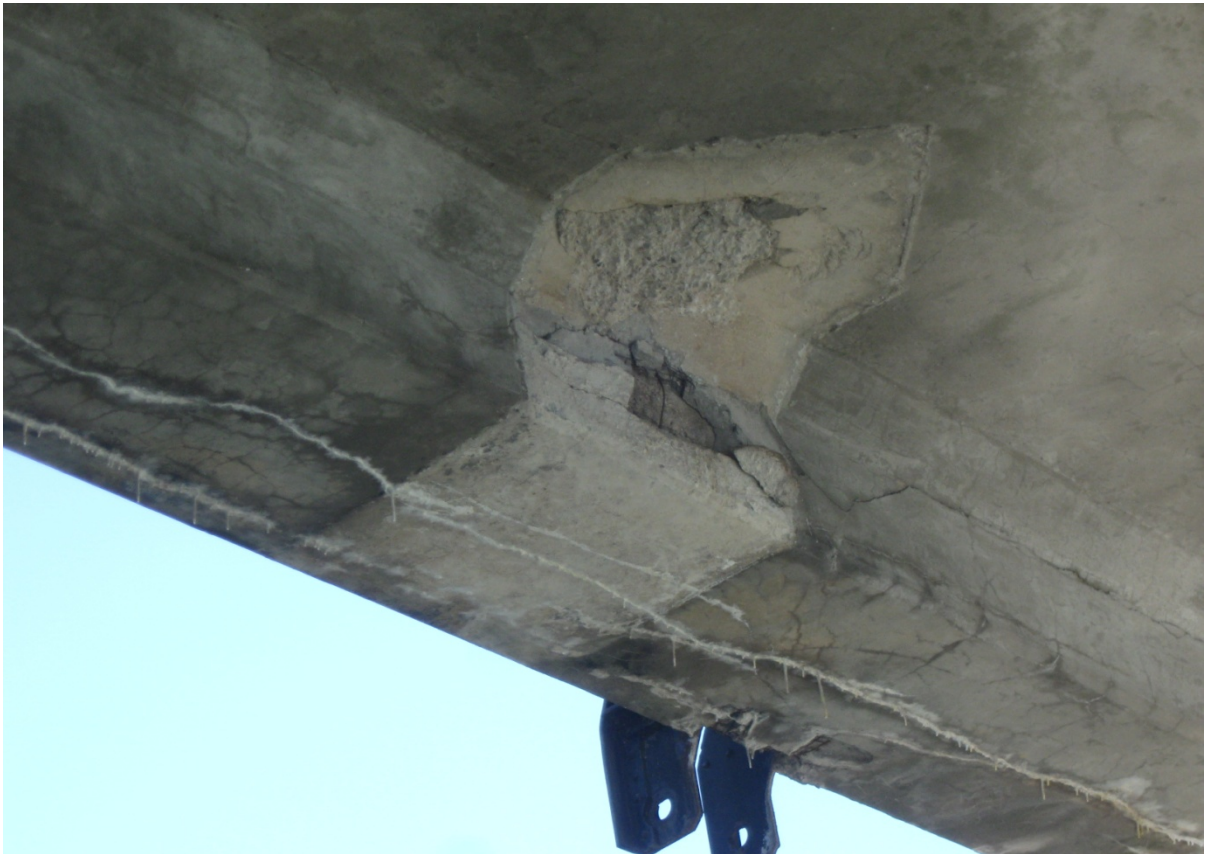
Photo 9 – Close-up of spalling at south span

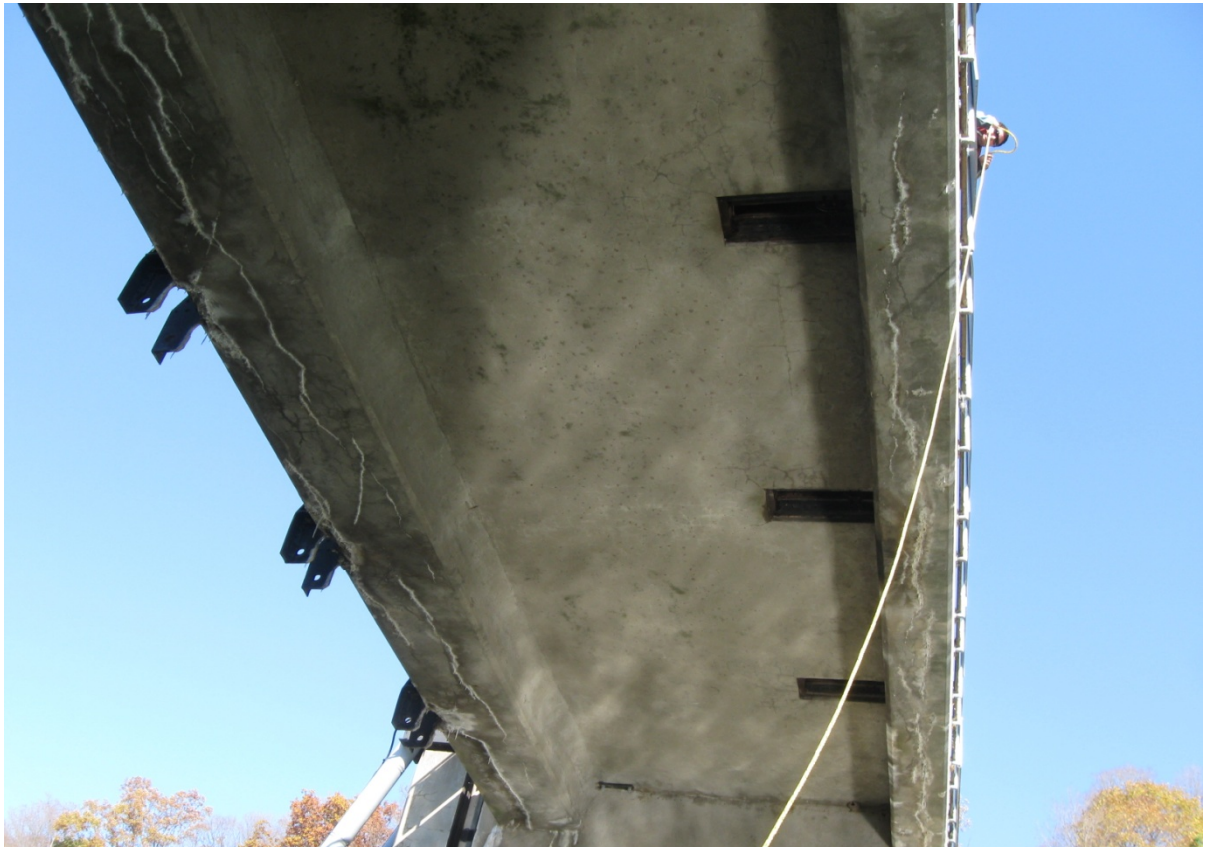
Photo 10 – Soffit of 2nd span from south end

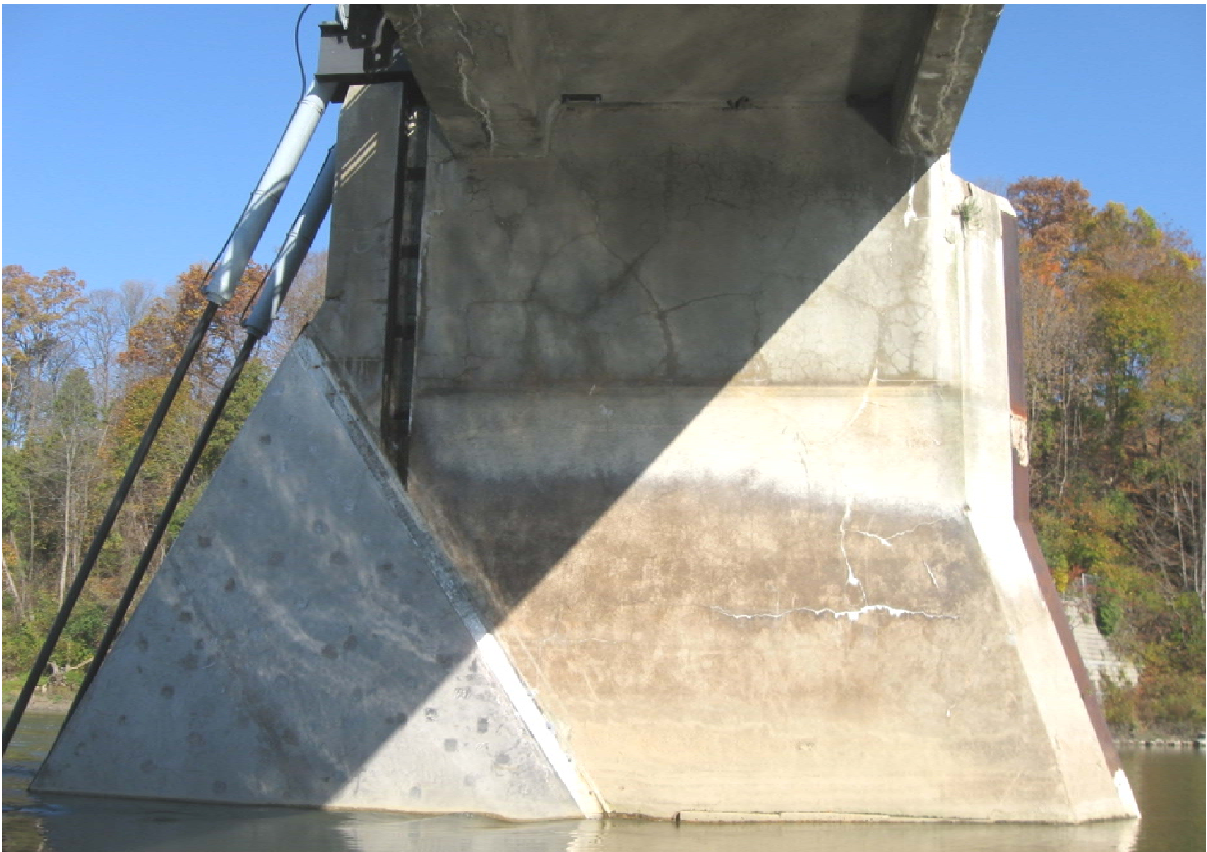
Photo 21 – Typical pier condition, south elevation of south pier

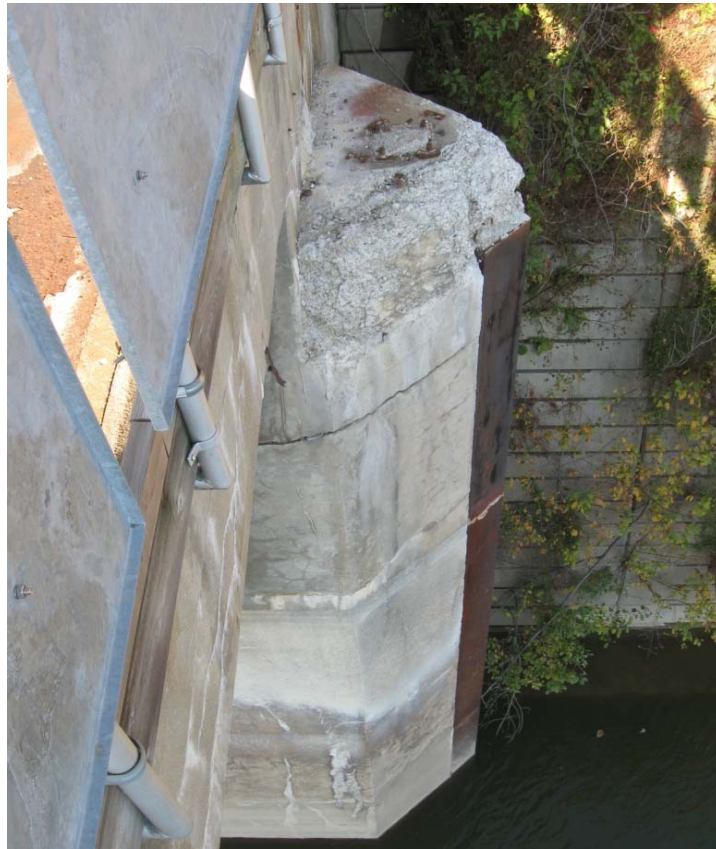
Photo 22 – Severe scaling top of north pier, upstream side

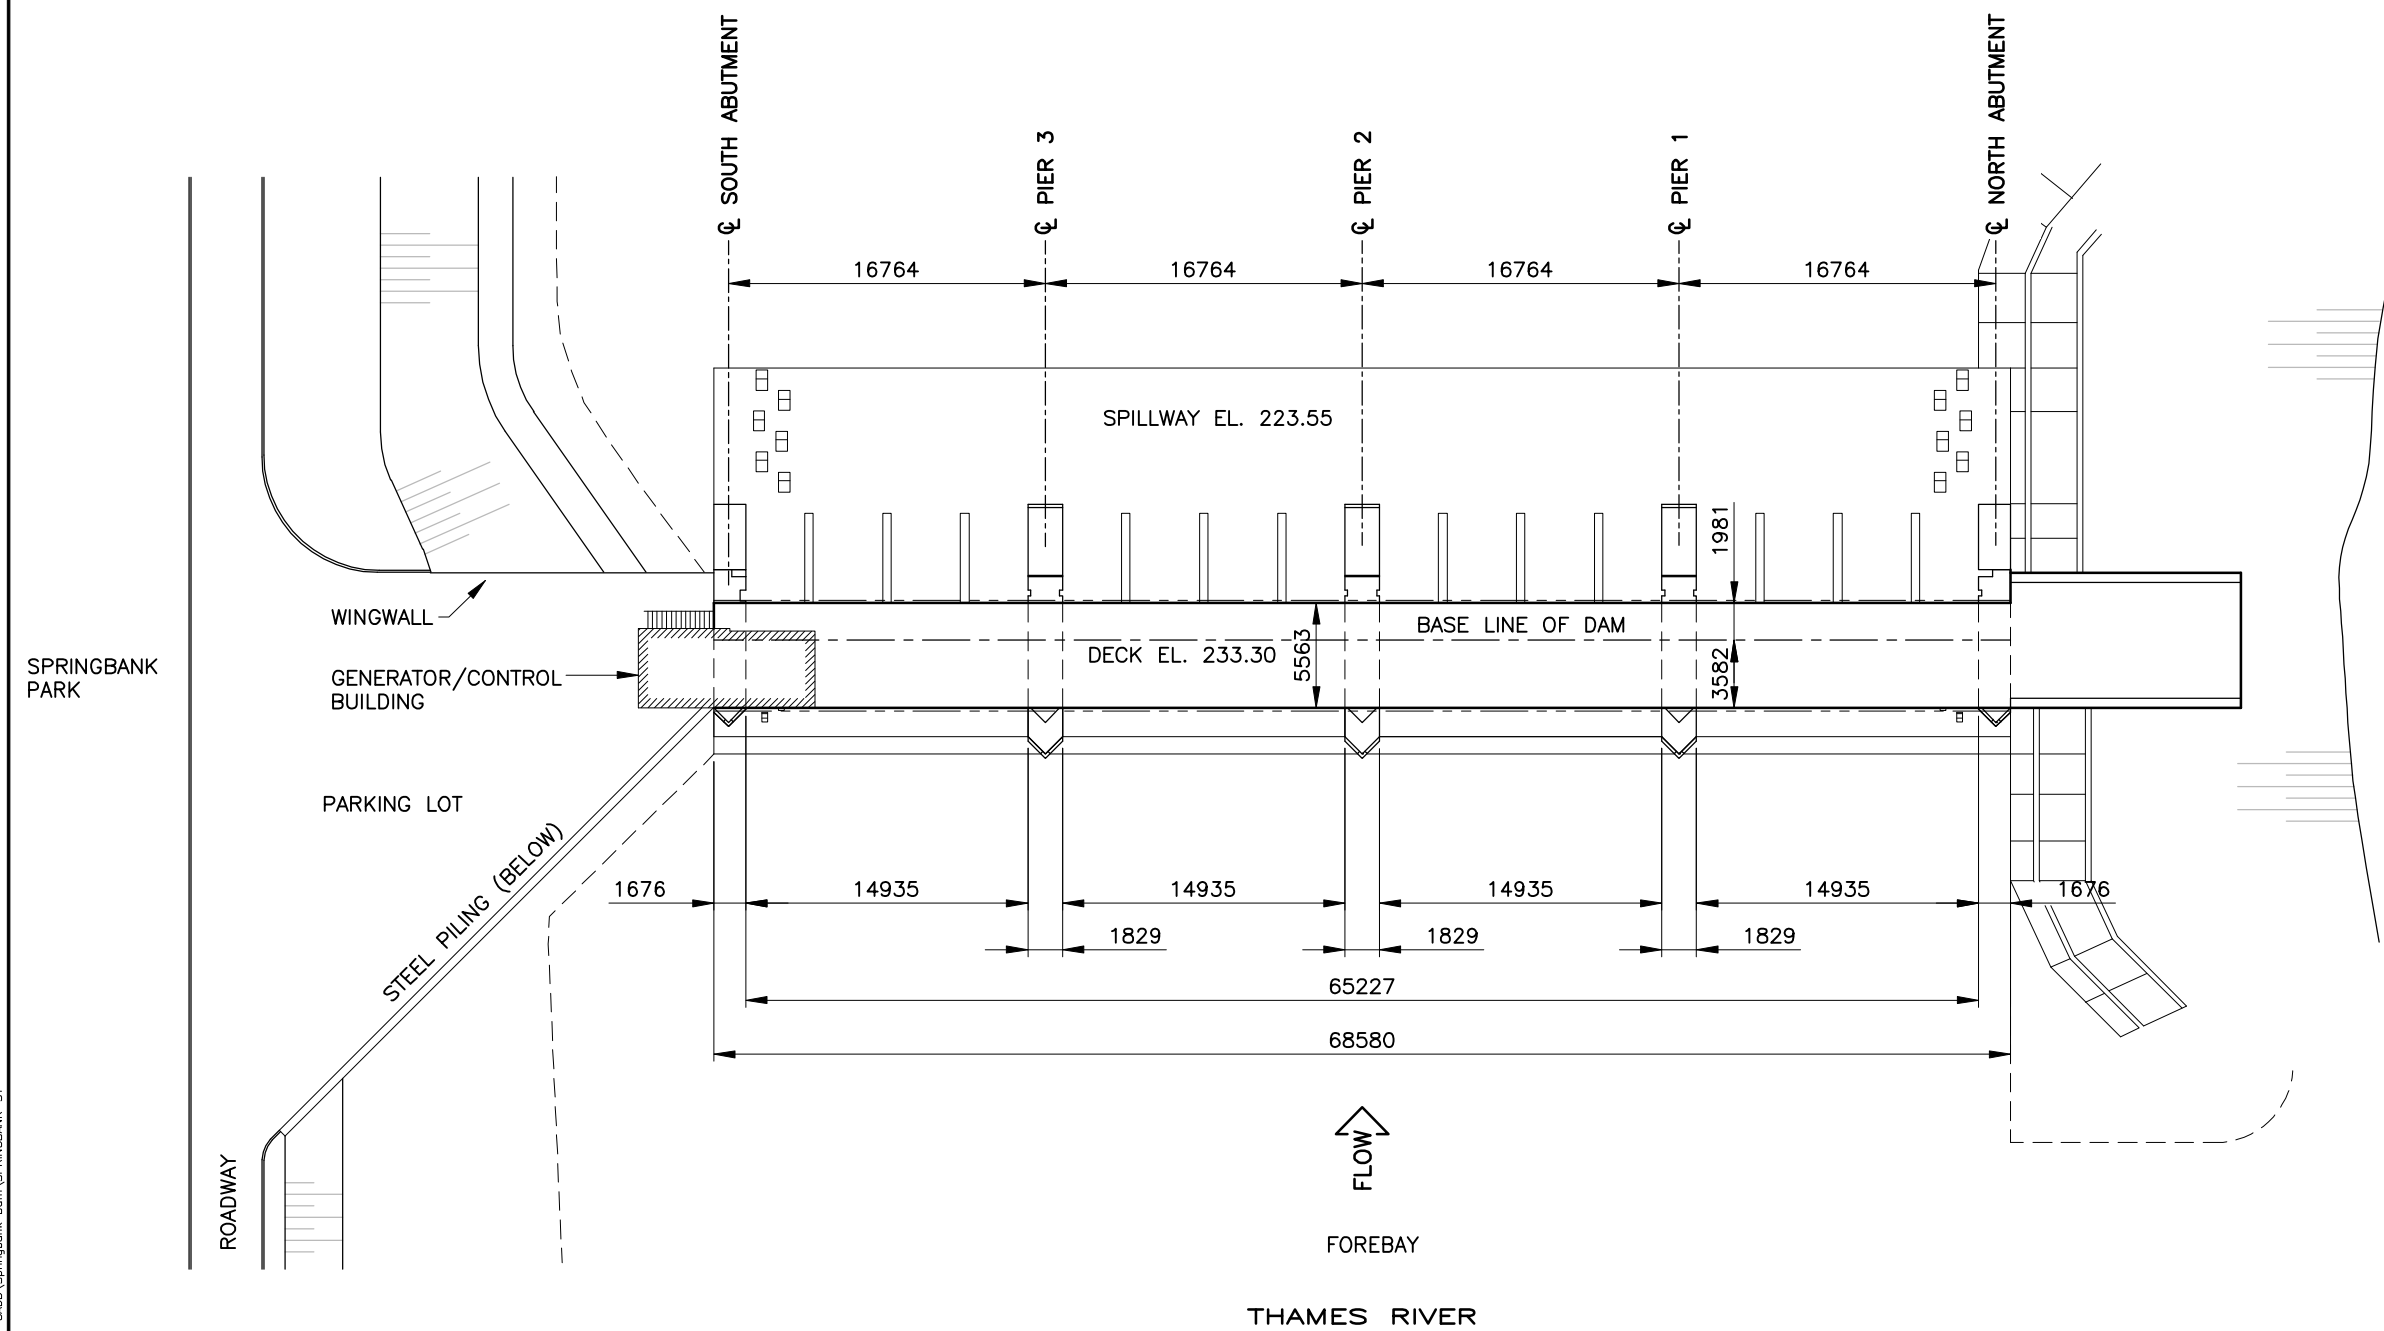
- LEGEND :**
- M MEDIUM CRACK
 - W WIDE CRACK
 - M MEDIUM STAINED CRACK
 - W WIDE STAINED CRACK
 - LIGHT SCALING
 - MEDIUM SCALING
 - SEVERE SCALING
 - VERY SEVERE SCALING
 - SURFACE RUST STAINS
 - EXPOSED REINFORCING STEEL
 - DELAMINATIONS
 - SPALLS
 - PATCHED SPALLS
 - HONEYCOMBED AREAS
 - WET AREAS

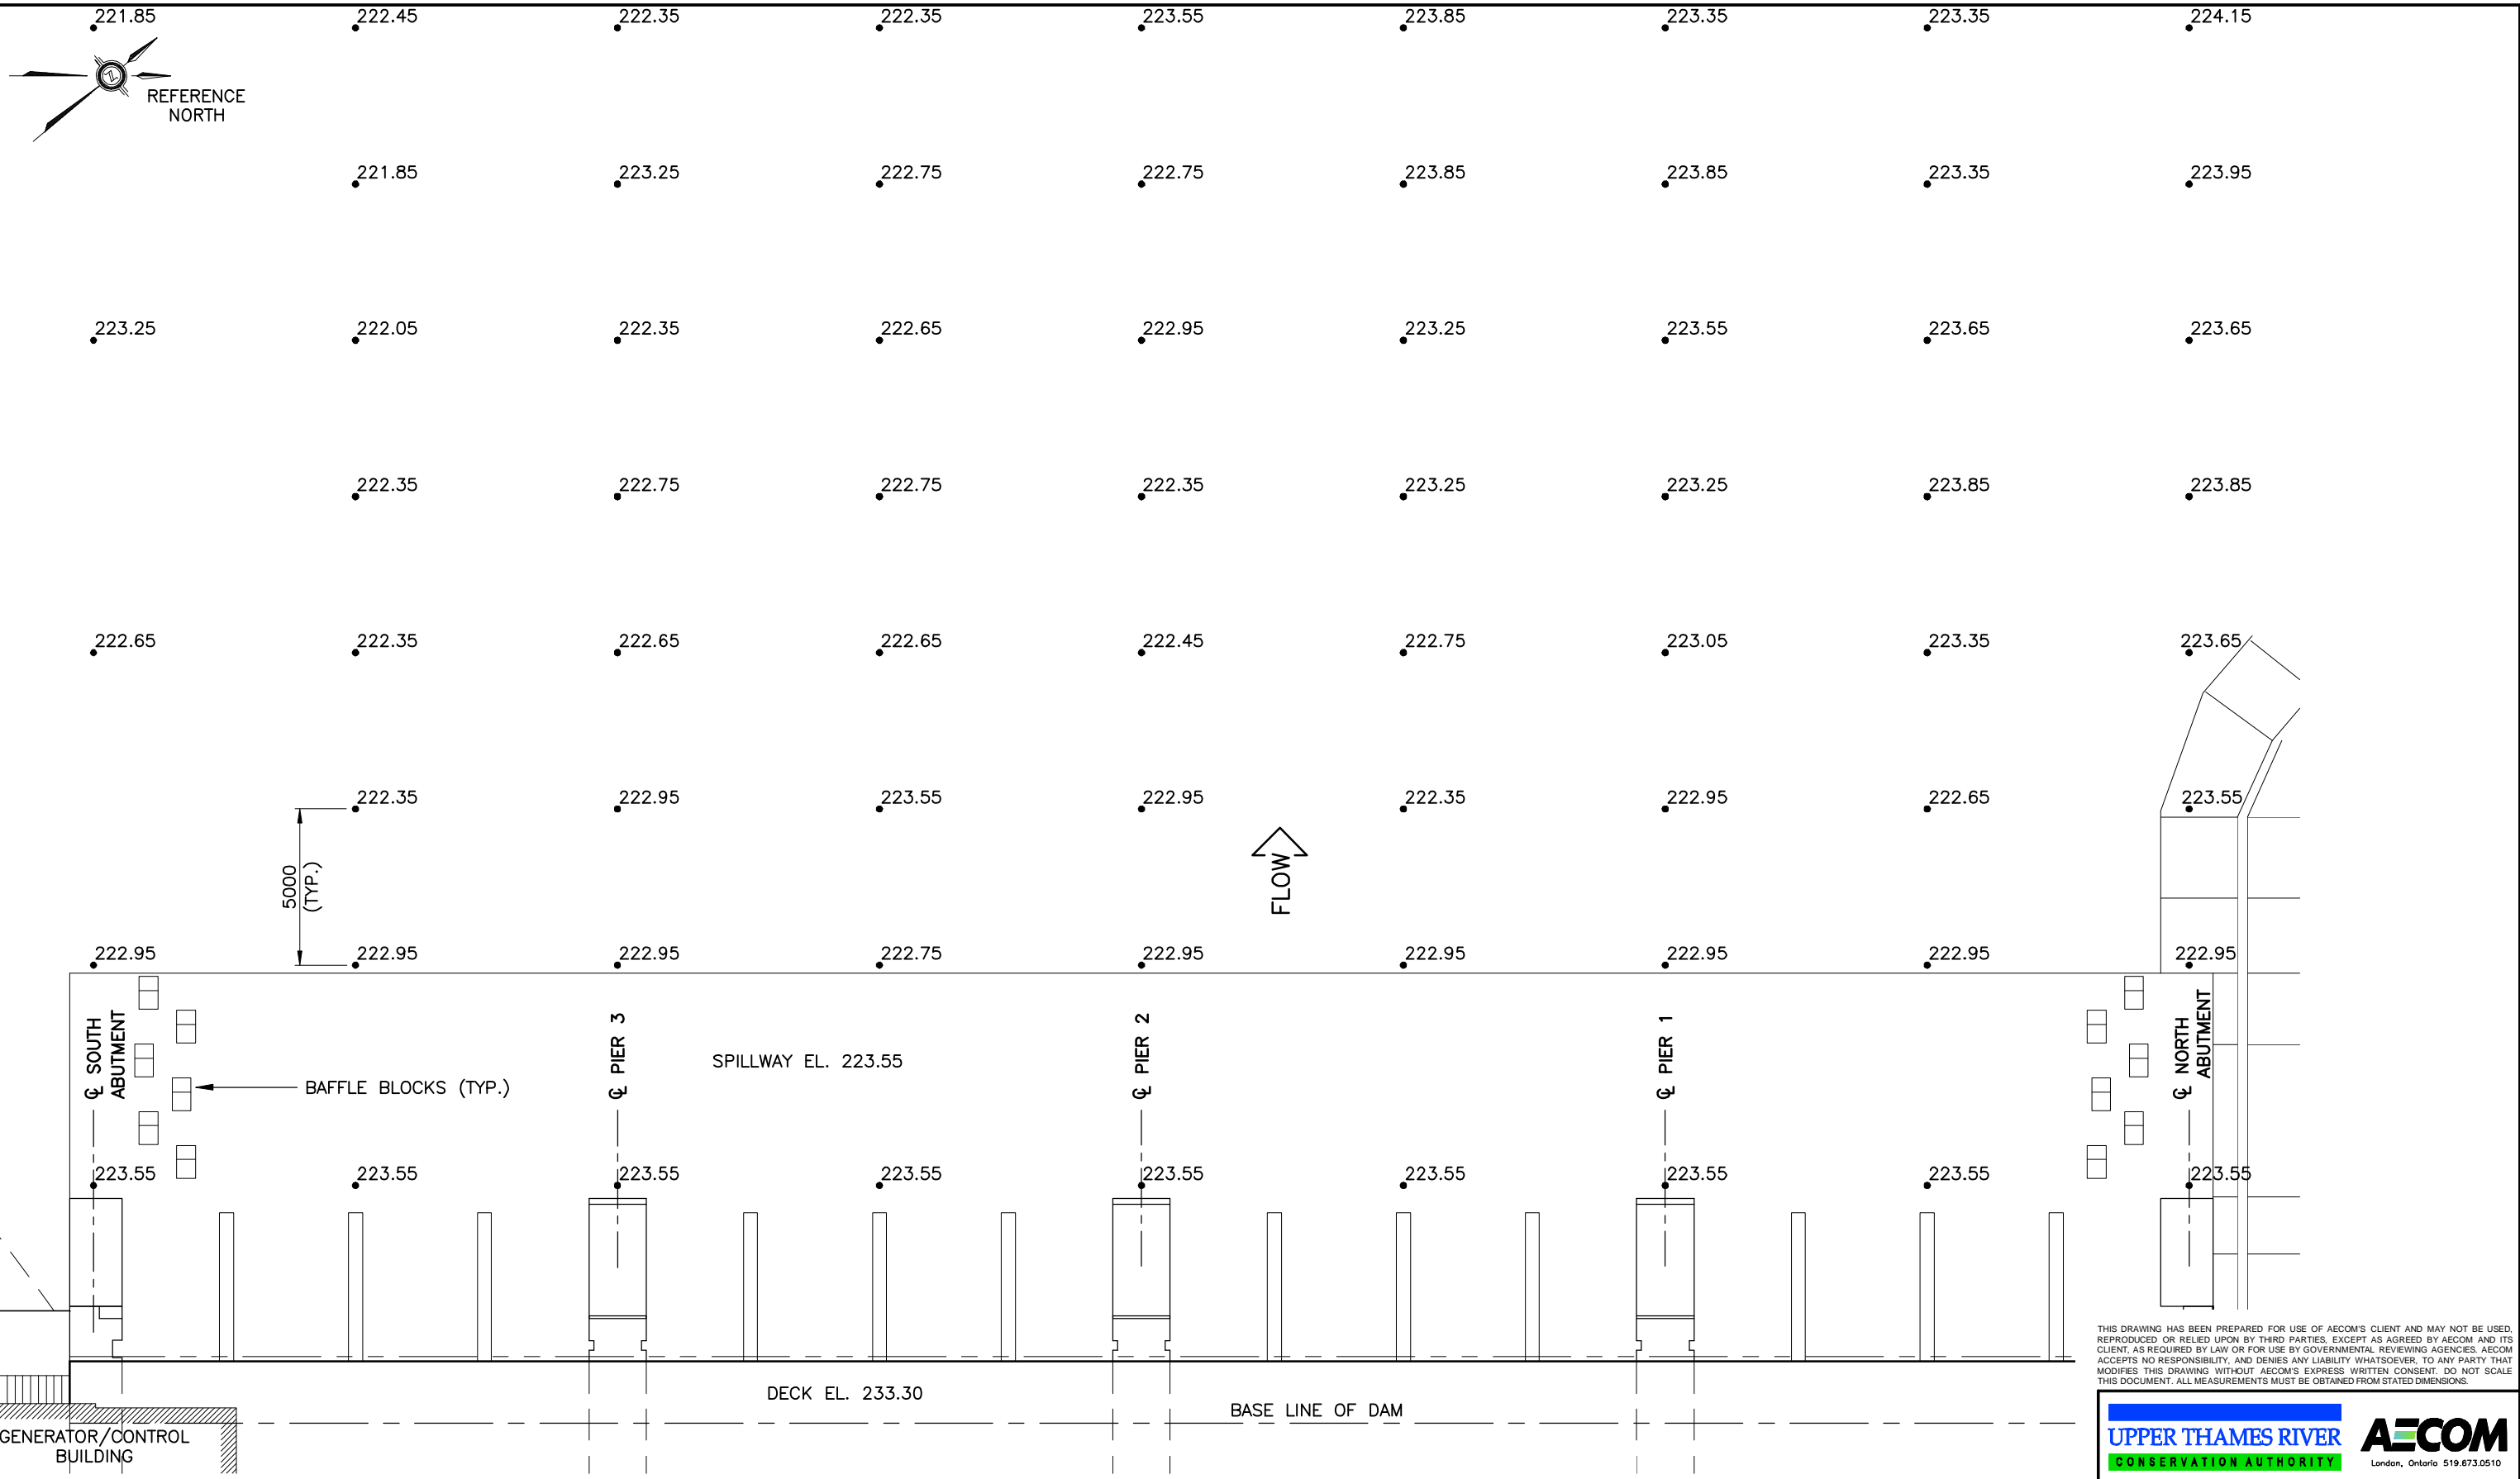
DRAWING FILE: P:\G0225556\000-CADD\Springbank Dam\SPRINGBANK-S2
DATE: 6/1/2012 11:14:53 AM

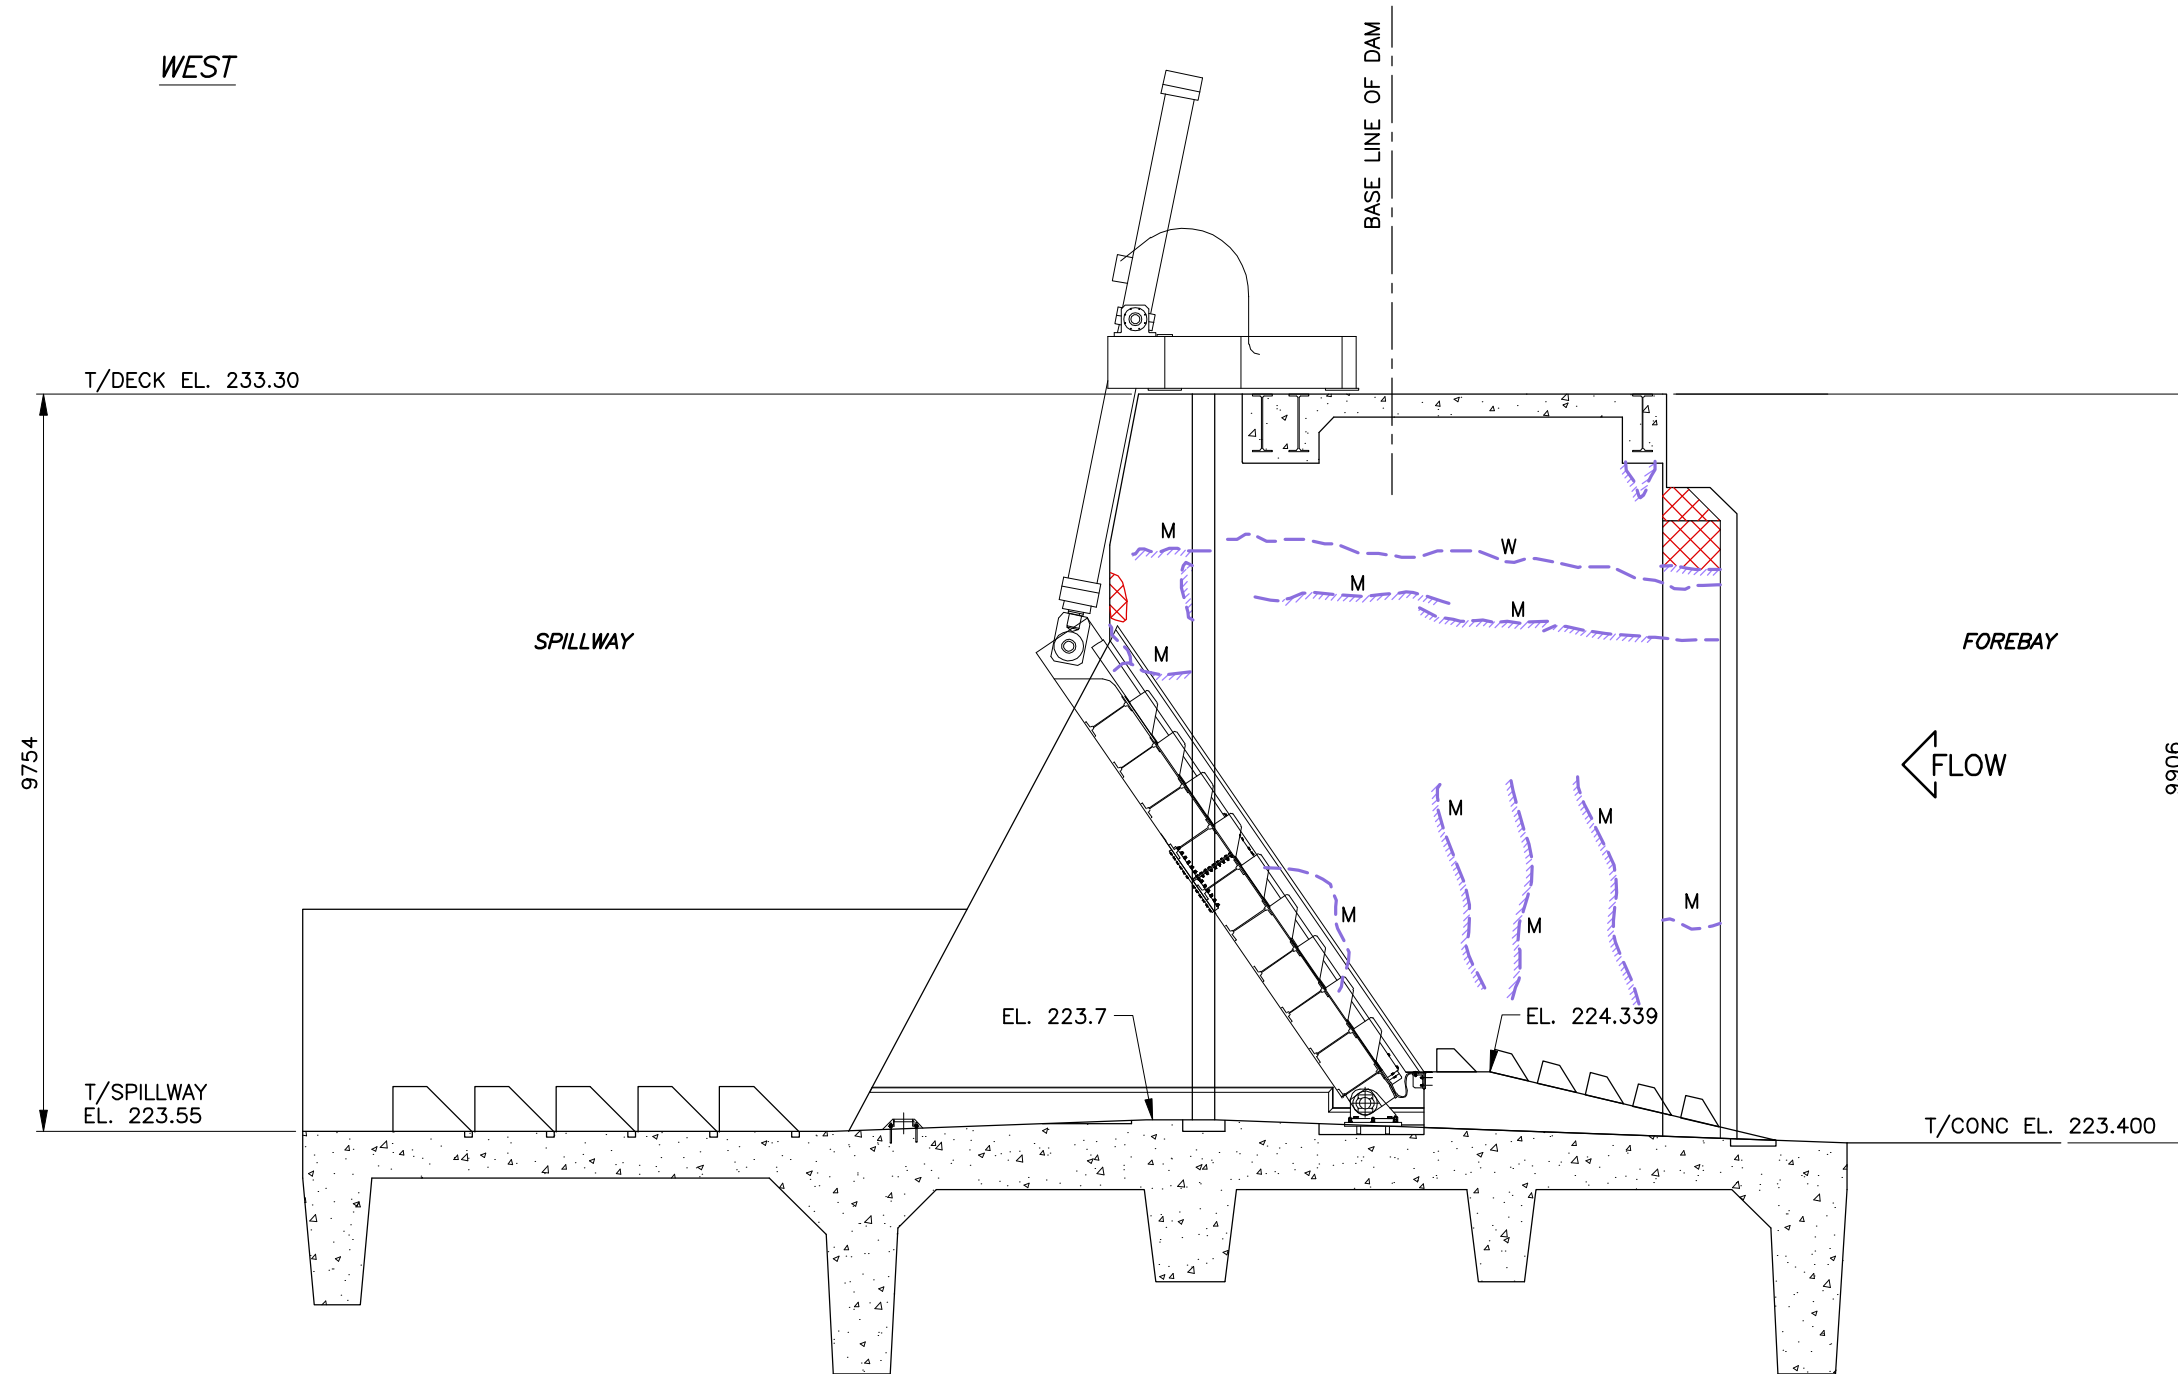
NORTH ABUTMENT ELEVATION

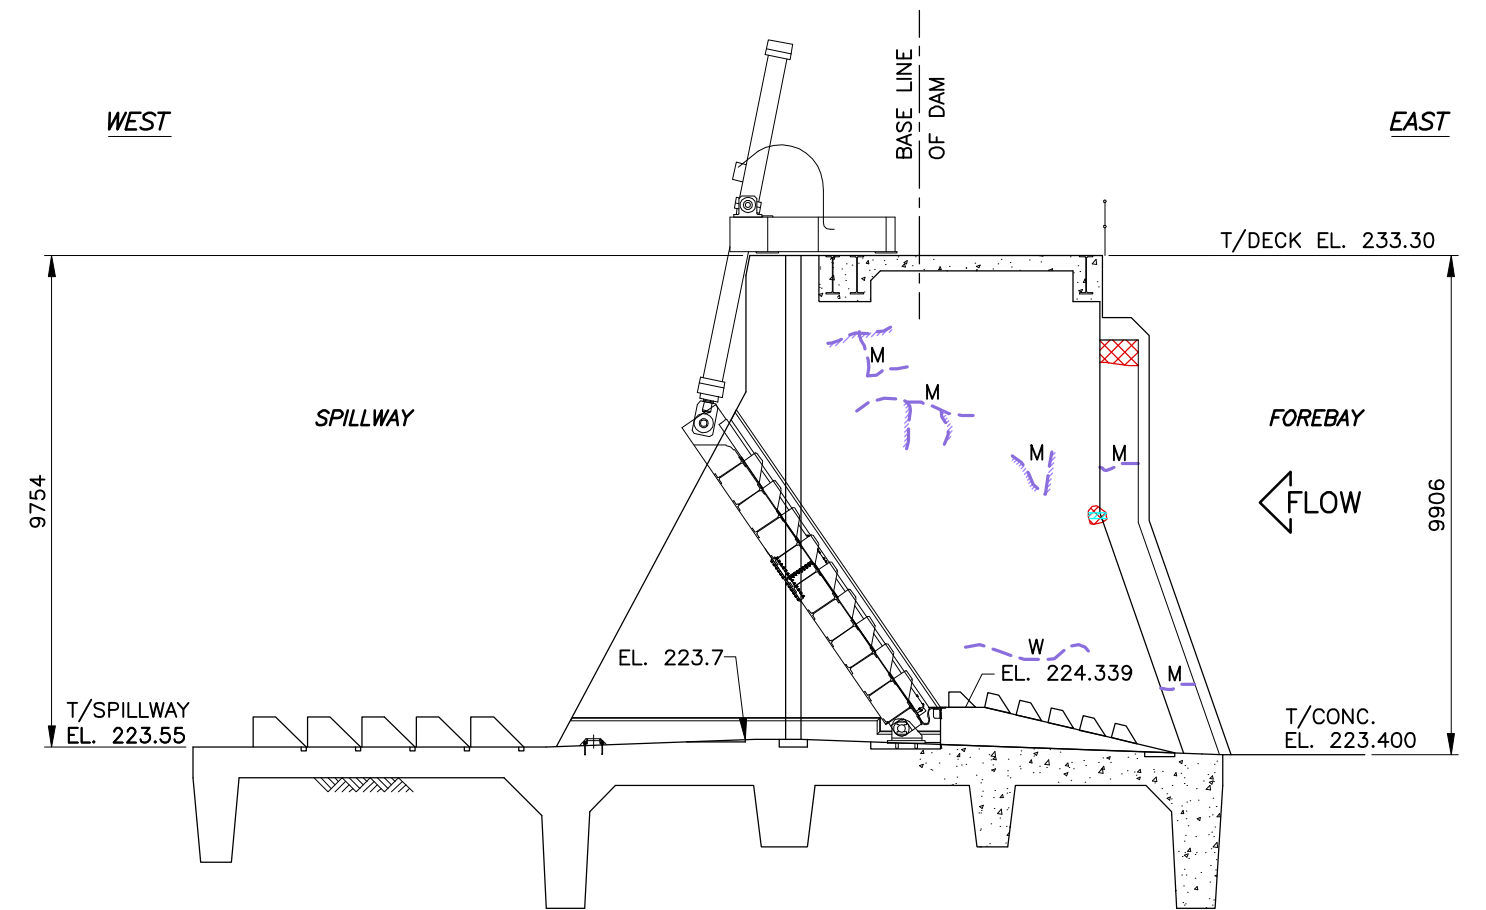
PIER 1 SOUTH ELEVATION

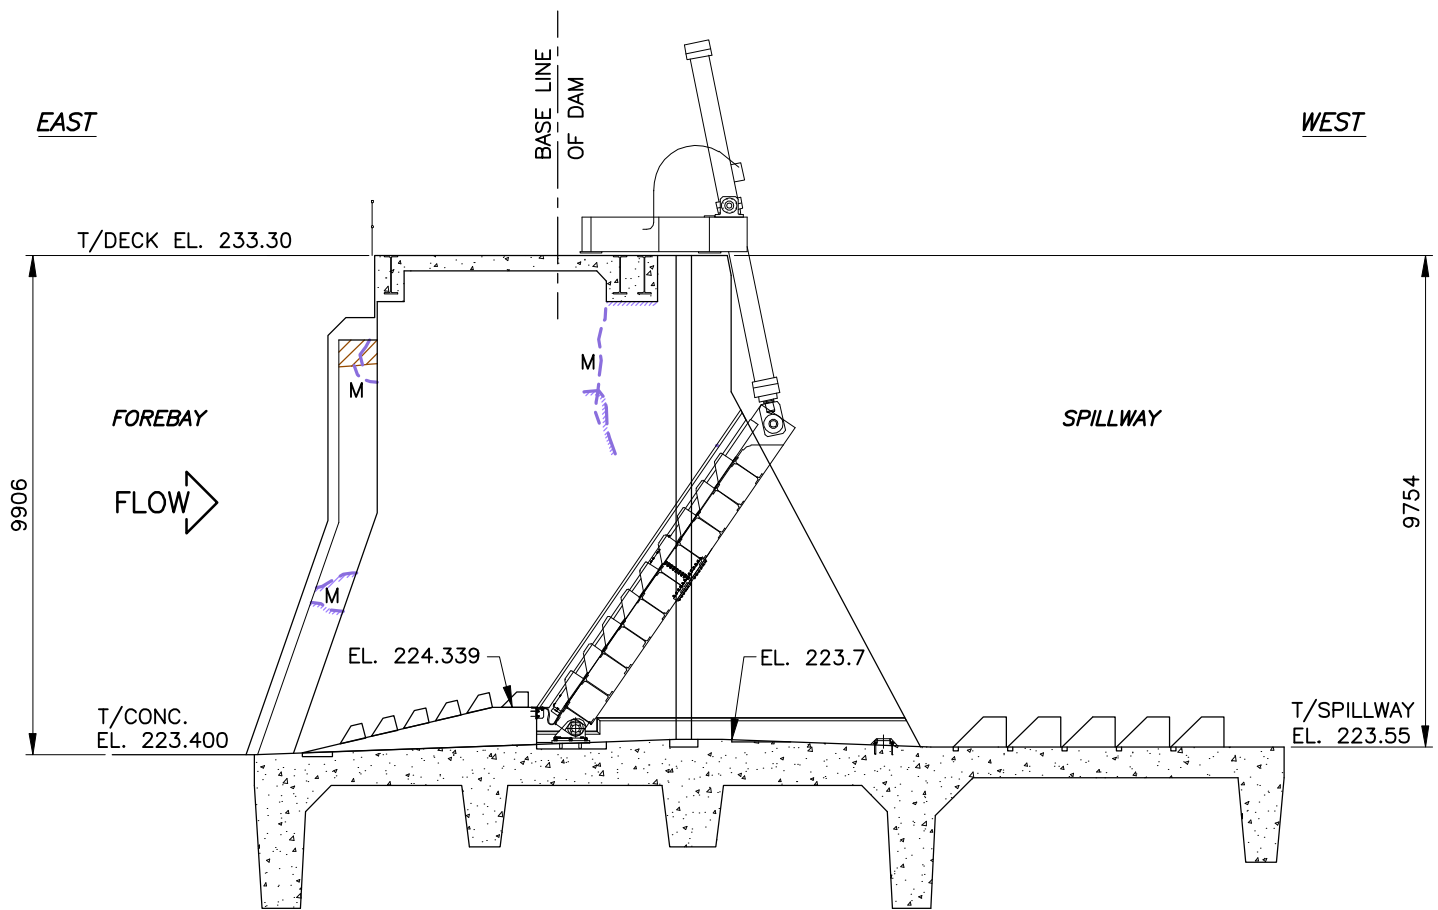
PIER 2 NORTH ELEVATION

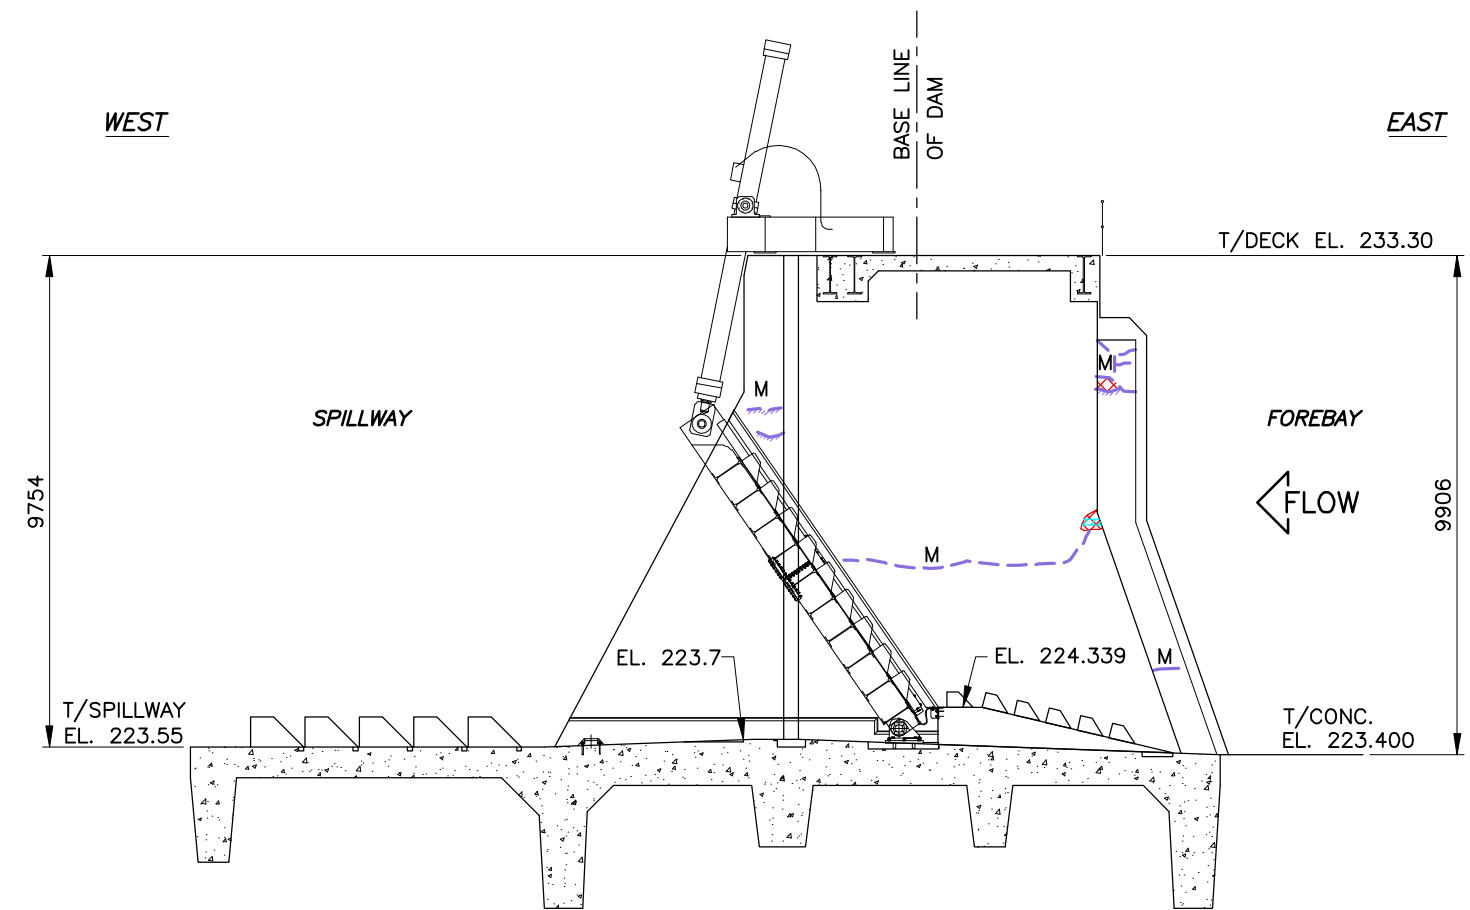
PIER 2 SOUTH ELEVATION

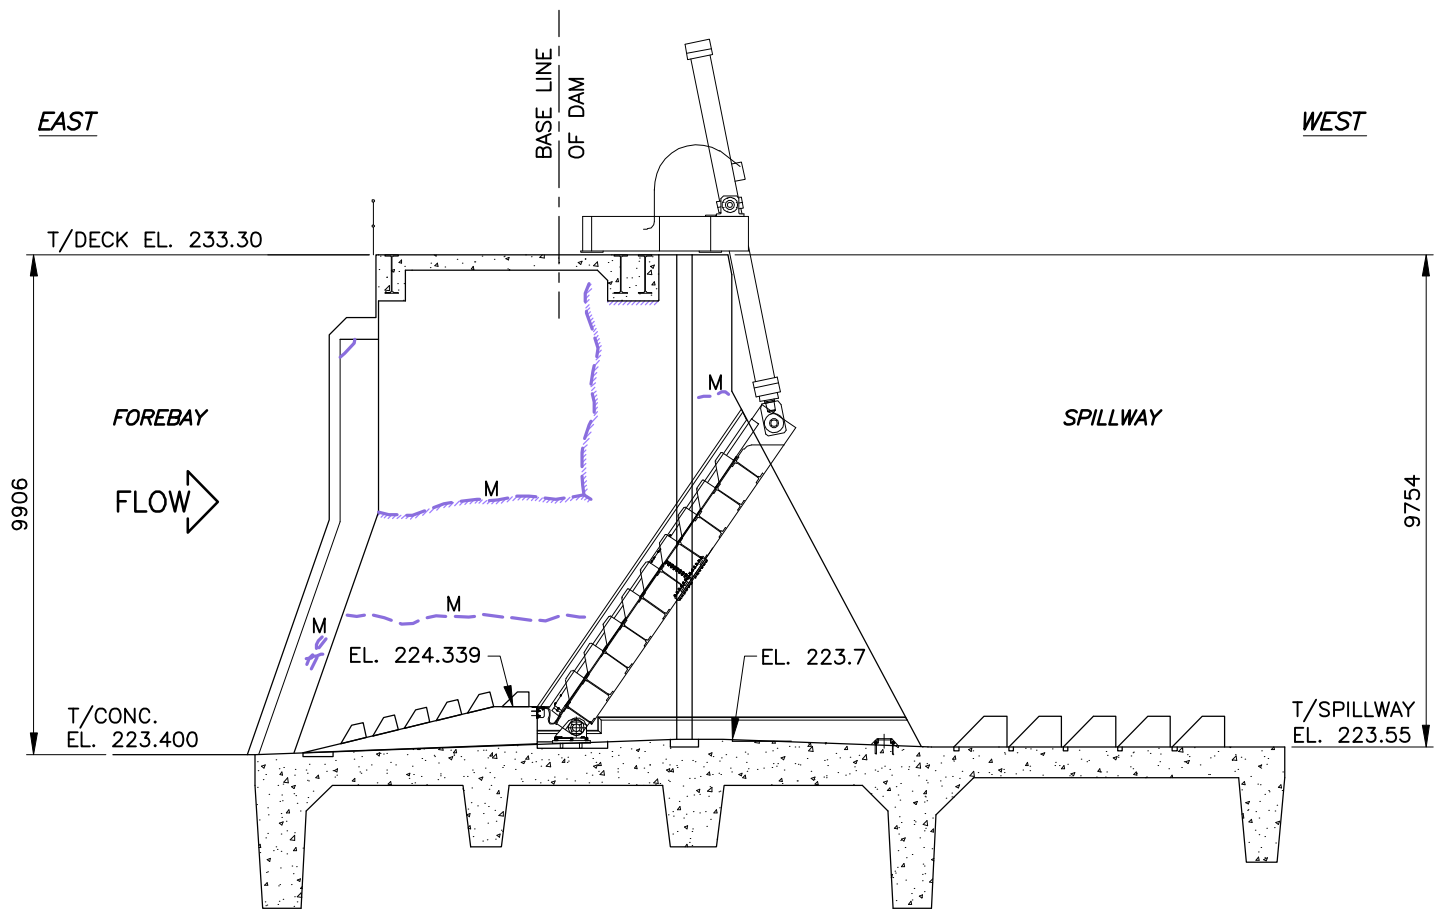
PIER 3 NORTH ELEVATION

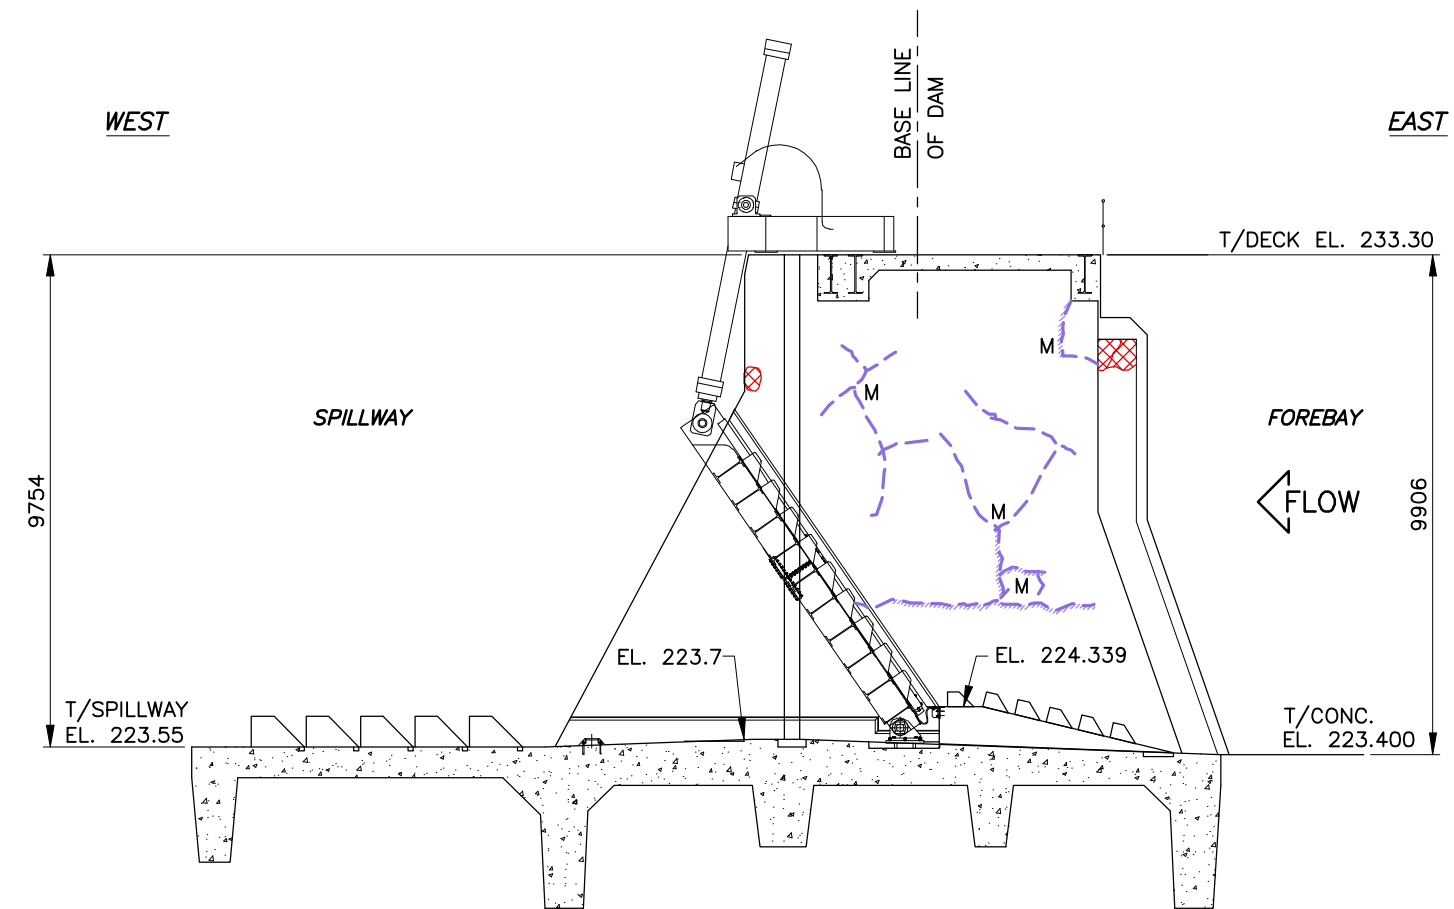
PIER 3 SOUTH ELEVATION
