Condition Survey Report (2011) Springbank Dam

Prepared by:

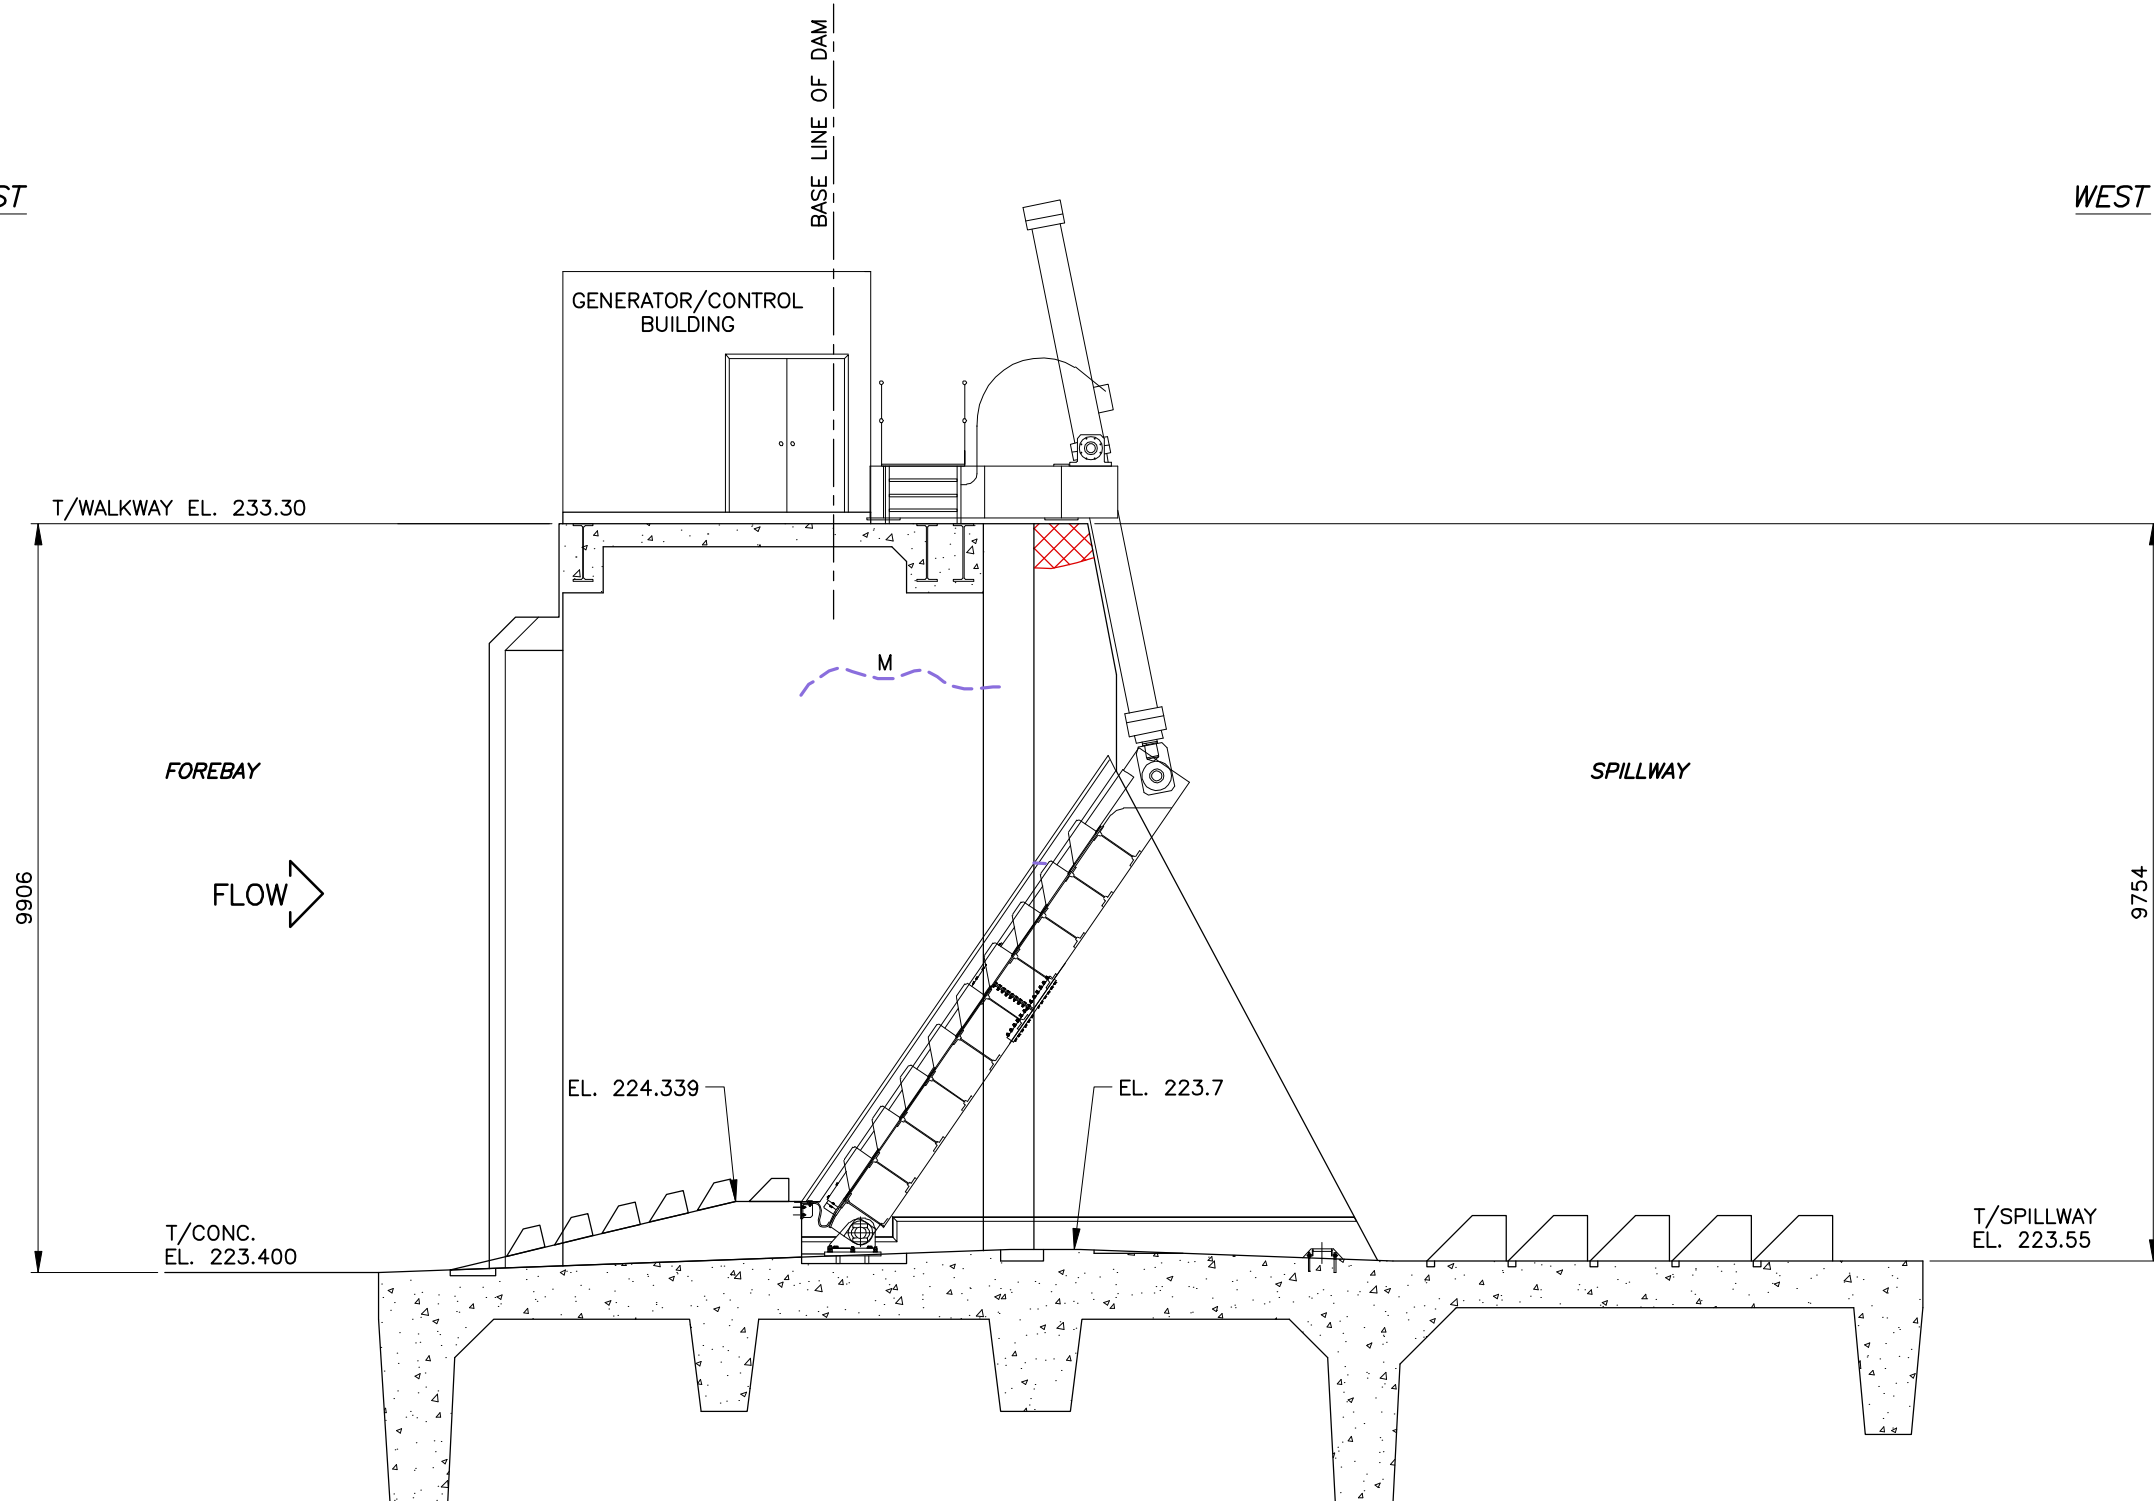
NOTE :
HAIRLINE CRACKING THROUGHOUT.

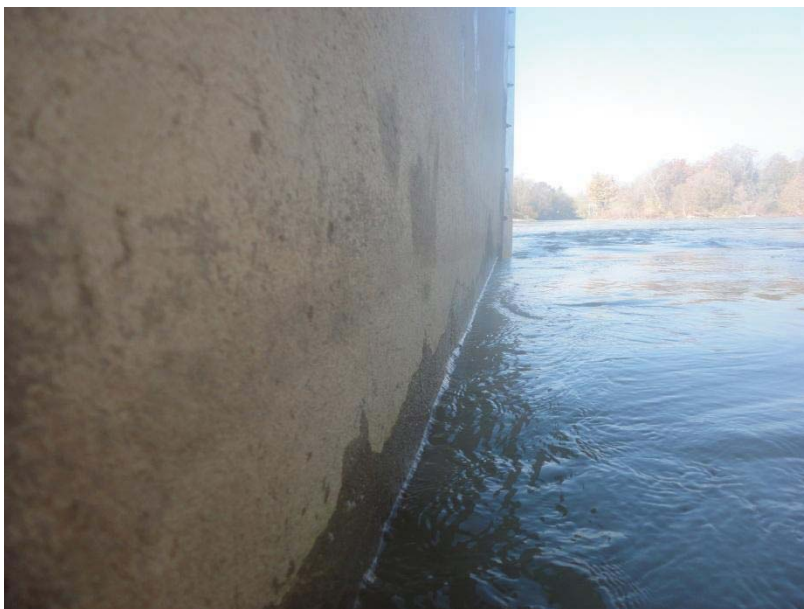
Downstream view of the Springbank Dam

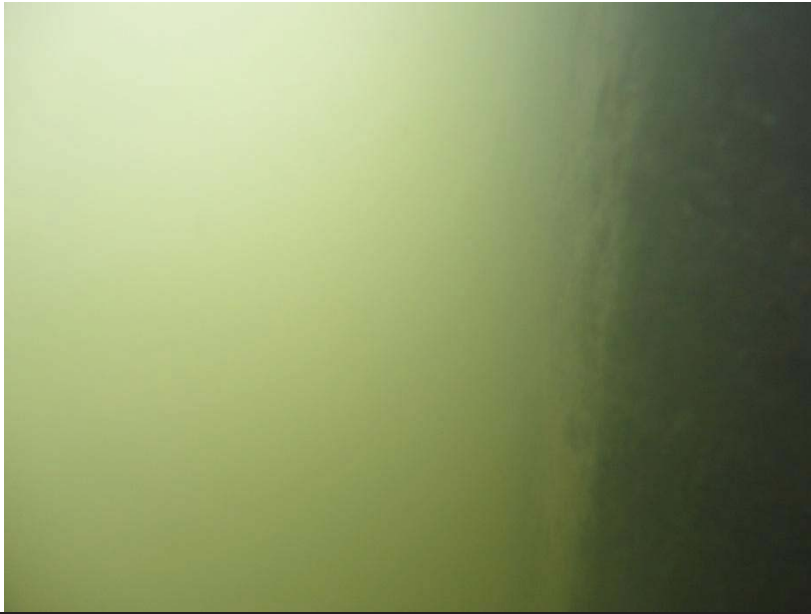
Pier 1 typical concrete condition

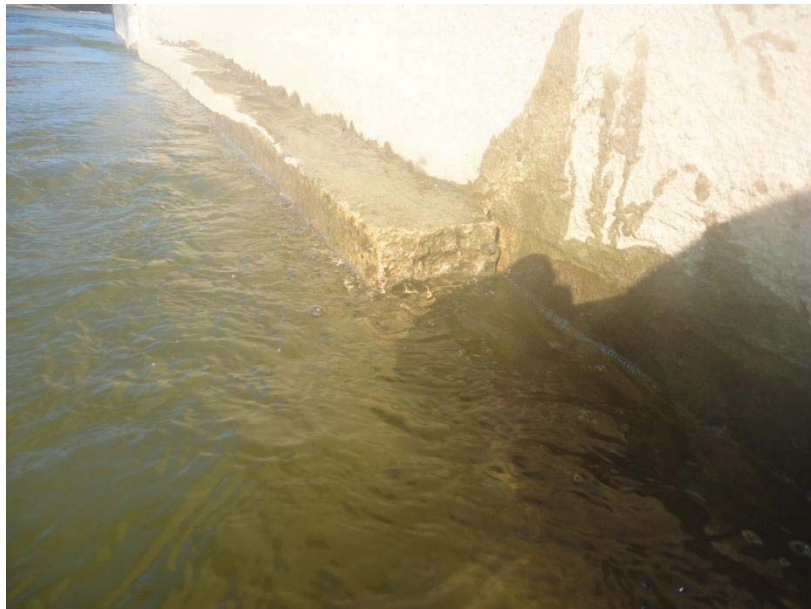
Pier 1 typical concrete condition underwater

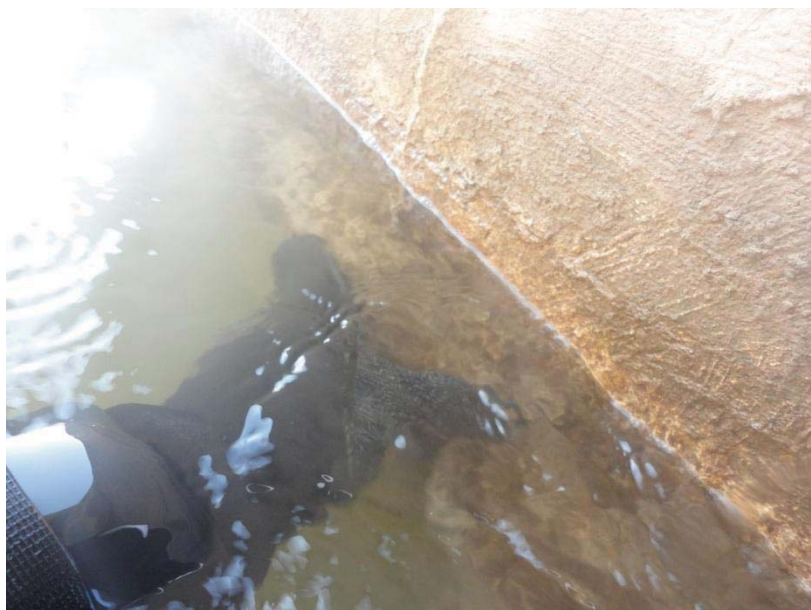
Pier 3 typical concrete condition

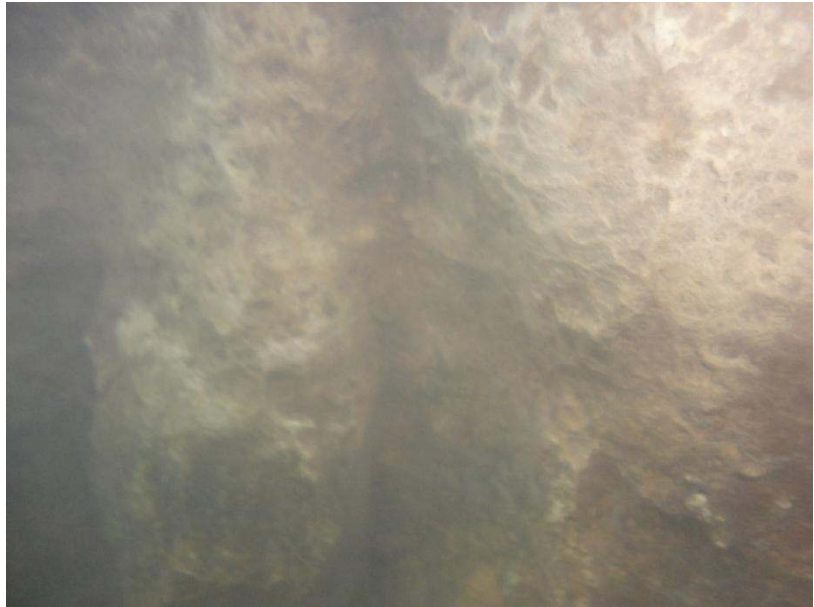
<p>PHOTO # 7</p> <p>Pier 3 typical concrete condition underwater</p>

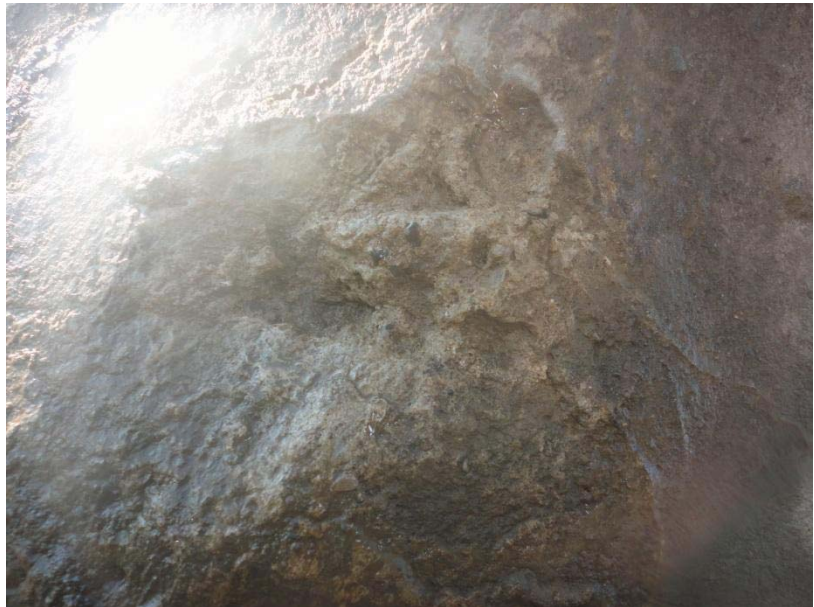
<p>PHOTO # 8</p> <p>Spalled corner on Pier 3 at the water level</p>

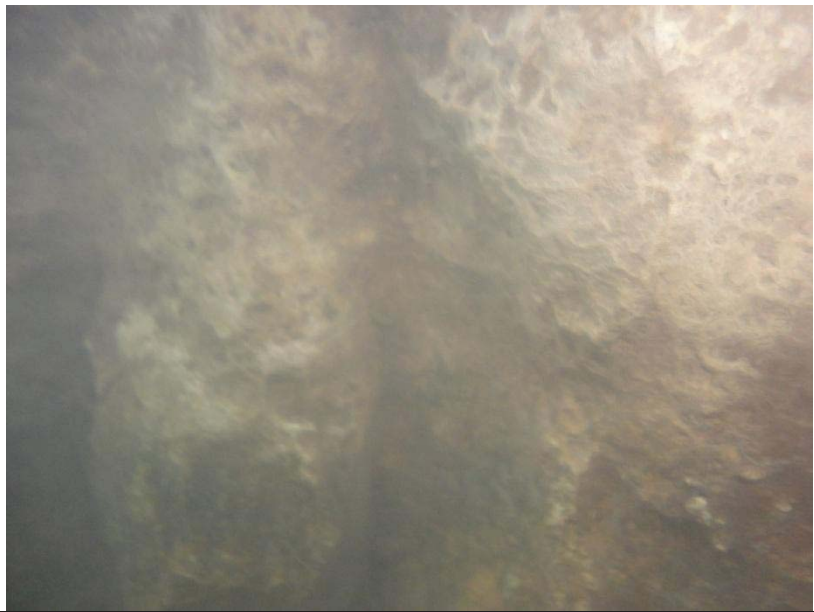
<p>PHOTO # 9</p> <p>Spalling on Pier 3 just below water level</p>

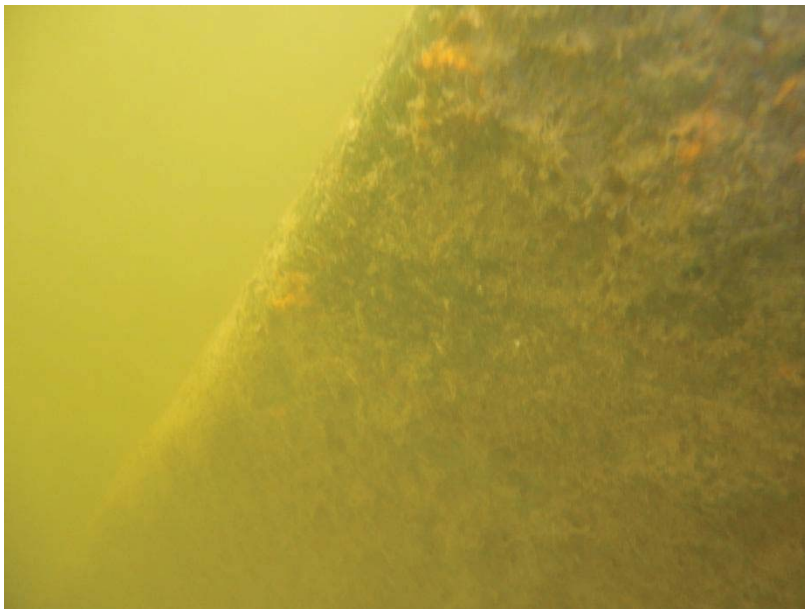
Pier 4 typical concrete condition

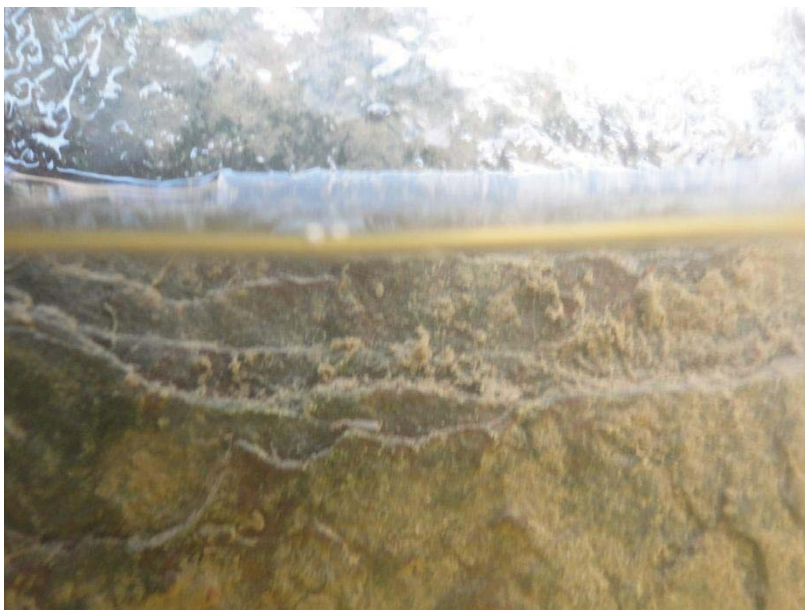
Pier 4 typical concrete condition underwater

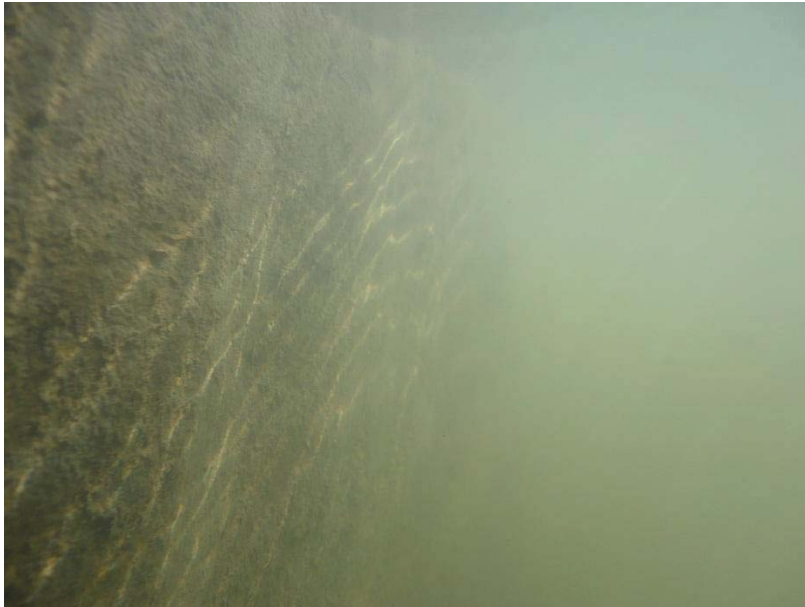
Pier 4 concrete nosing at water level

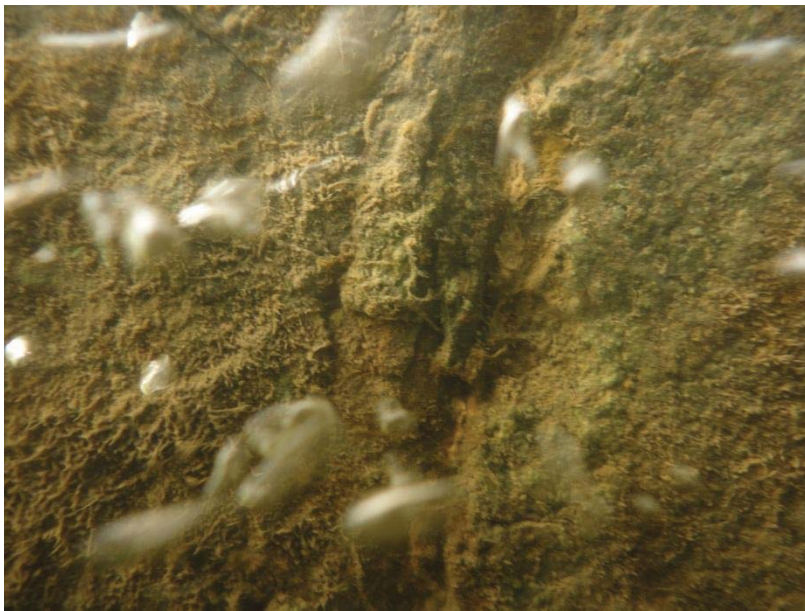
Pier 5 typical concrete condition underwater

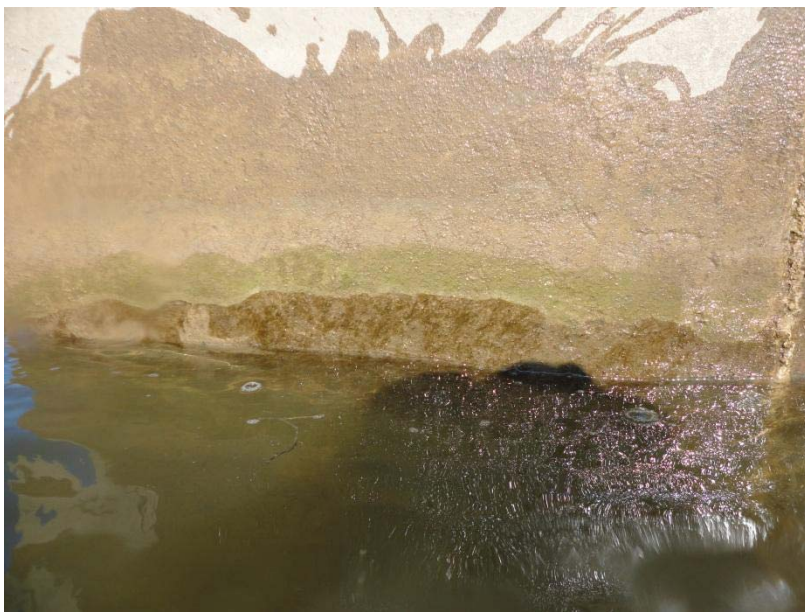
Pier 5 concrete condition near nosing, small area of spalling

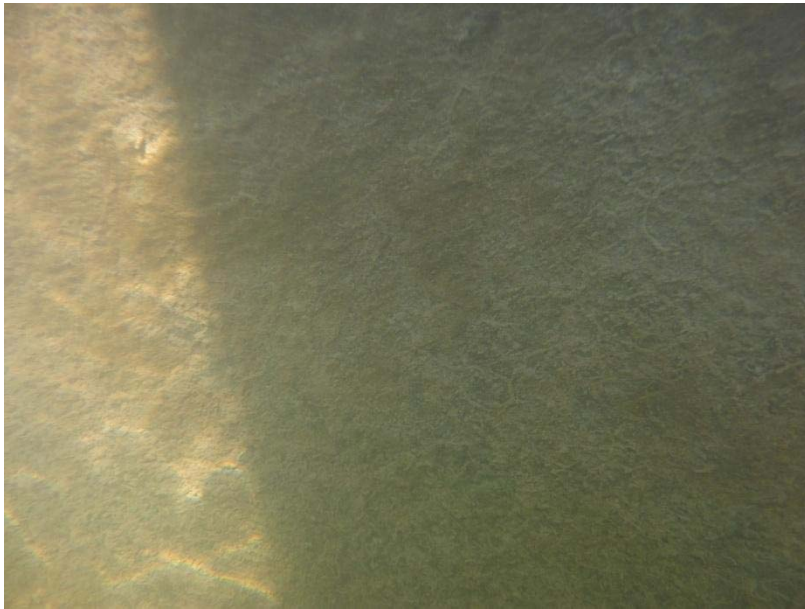
Pier 6 typical concrete condition at water level

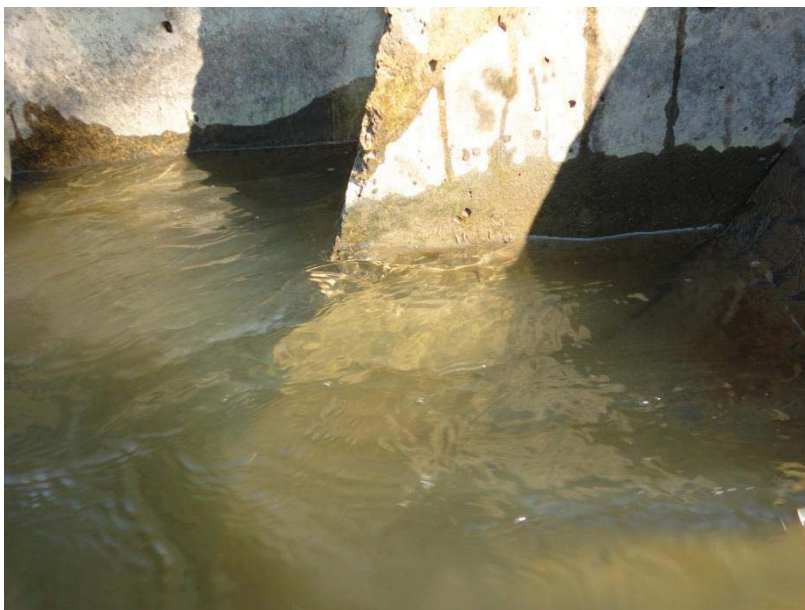
Pier 6 typical concrete condition underwater

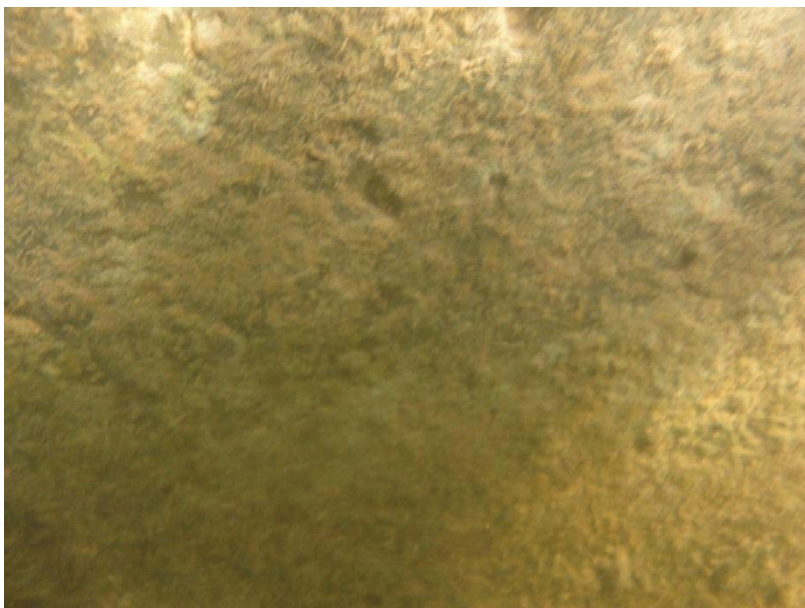
Typical condition of new concrete on the north wingwall

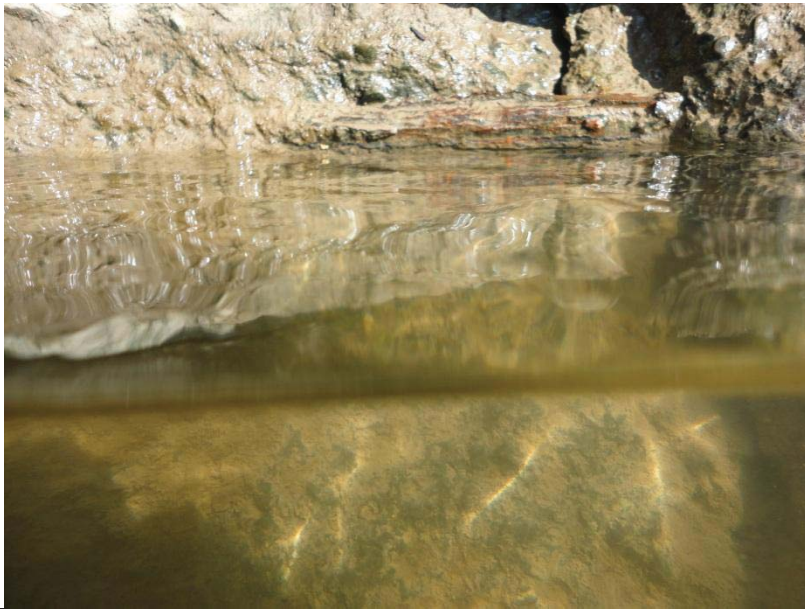
Typical condition of new concrete on the north wingwall underwater

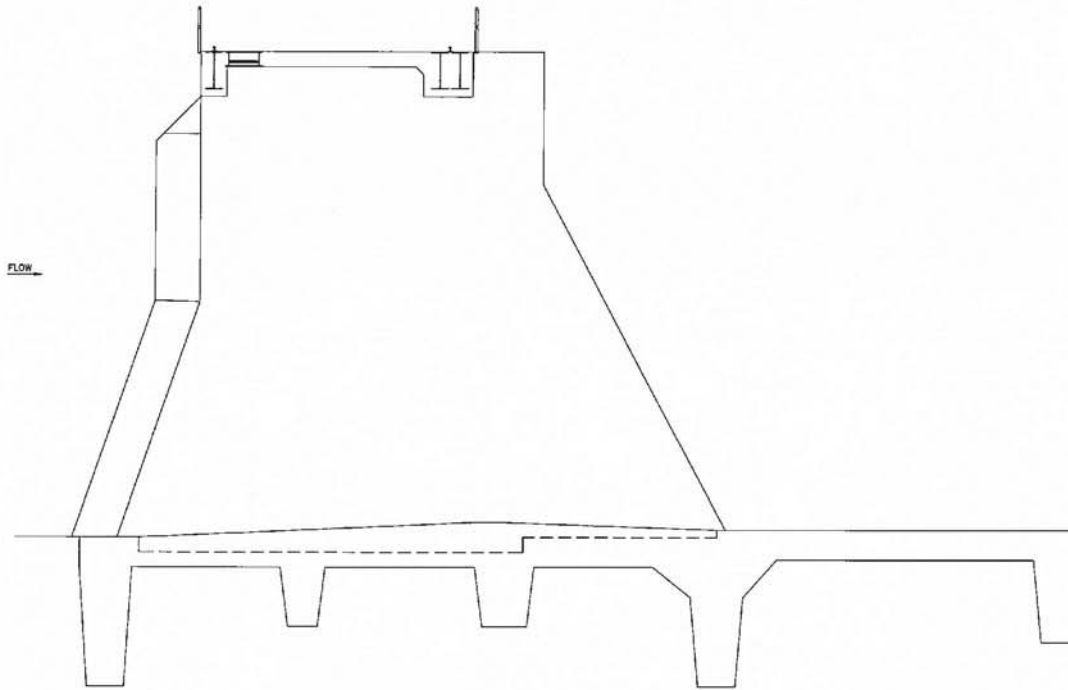
SOUTH END PIER 6 ELEVATION
