West London Dyke Master Repair Plan

Stantec Consulting Ltd.

February 2016

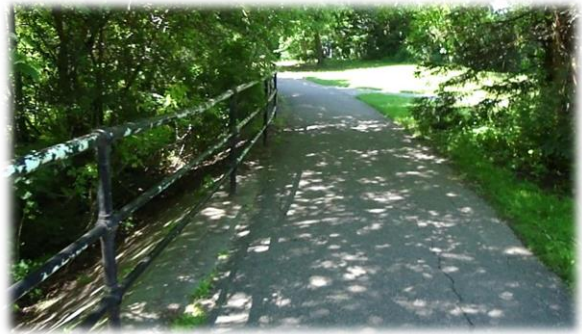
The path in this section is slightly narrower than the City's standard width of 3 m, and access via stairs or ramps exist at all abutting streets. Sections of the railing along the pathway are in relatively poor condition and do not meet current standards. They are interspersed by old cast iron streetlight bases, which have an attractive design and historical pedigree, but are generally in poor condition (rusting, chipped paint, broken fronts) and tend to be used for garbage.

Figure 4.12: Natural Bank (Facing South)

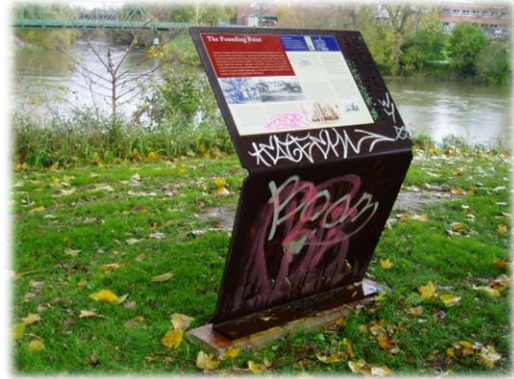
The existing dyke and pathway system has been subject to numerous acts of vandalism over the years (Figure 7.21). A reduction in vandalism can be achieved through appropriate lighting and site design. CPTED principles should be considered during design development in order to reduce occurrences of vandalism. Vandal-resistant site furnishings are available and should be used wherever possible.

Figure 7.21: Existing Sign Damaged by Vandals

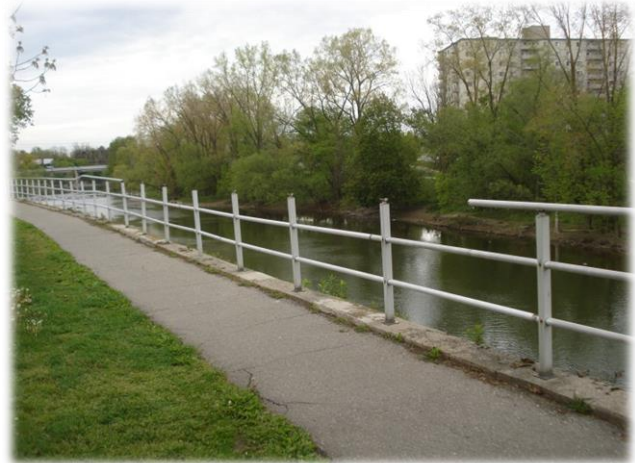
Given the current condition of the handrail, it is recommended that the City and UTRCA consider a yearly replacement program. This program could be funded through an ongoing maintenance budget for the dyke structure, similar to the current road rehabilitation programs within the City. For continuity, the same style railing design could be implemented as was used in the 2007 Phase 1 and 2009 Pathway construction. Installation of the railing would be via a bolt-on design in order to allow for ease of removal and reinstallation as part of any subsequent repair or replacement work for the dyke. By implementing a yearly replacement program, the replacement cost would be spread over a longer period of time, reducing the initial capital cost of replacing the entire length of rail at once.

Figure 10.1: Handrail Deficiency

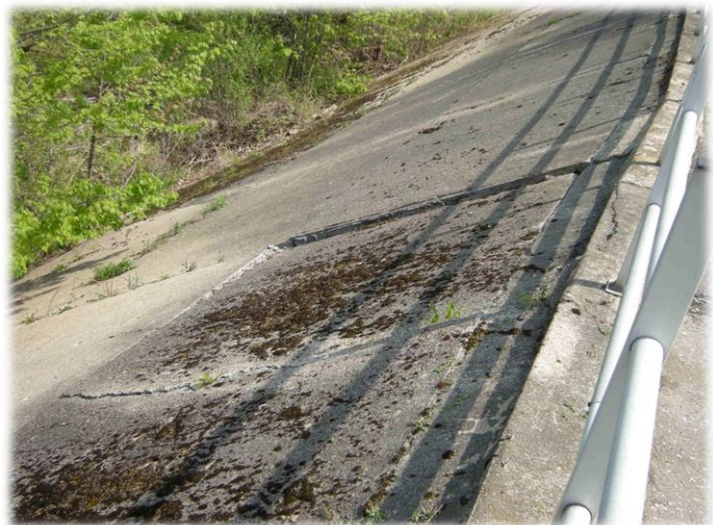
Figure 10.2: Panel Deficiency Noted During Inspection

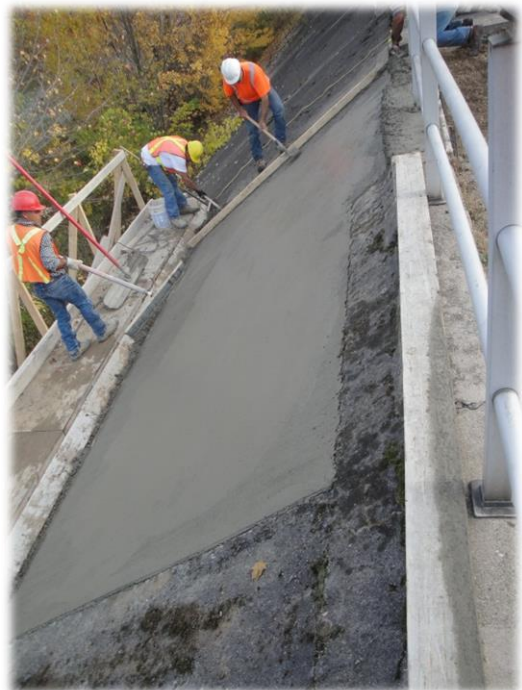
Figure 10.3: Panel Deficiency Repair
