LID Construction

Kyle Vander Linden, MES
Water Resource Specialist
Integrated Water Management
Credit Valley Conservation

Meadows in the Glenn

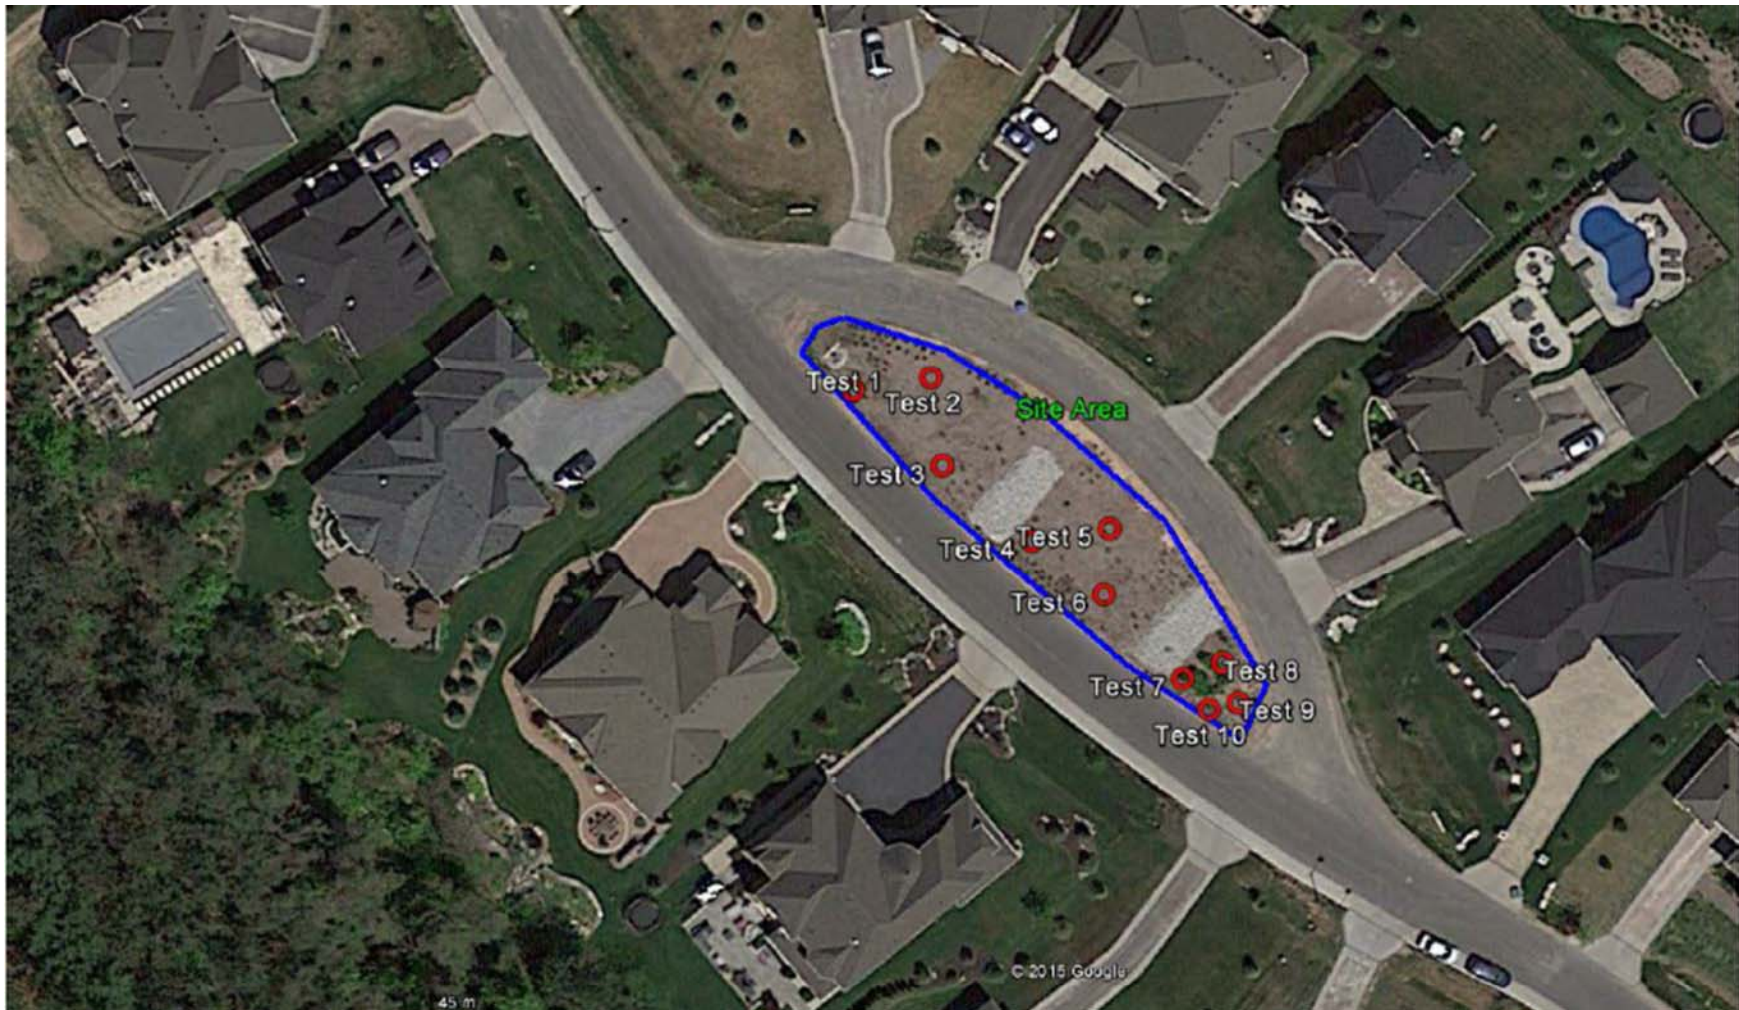
Infiltration Testing Locations

The results are summarized in the table below:

Sample ID	Location of Test	Depth (m)	Soil Type	Hydraulic Conductivity (mm/hr)
Test 1	Upstream Cell (near inlet)	0.23	Sandy Loam	284
Test 2	Upstream Cell	0.17	Sandy Loam	174
Test 3	Upstream Cell	0.21	Sandy Loam	184
Test 4	Middle Cell	0.19	Sandy Loam	154
Test 5	Middle Cell	0.22	Sandy Loam	307
Test 6	Middle Cell	0.22	Sandy Loam	169
Test 7	Downstream Cell	0.20	Sand, Some Silt	54
Test 8	Downstream Cell	0.23	Sandy Loam	154
Test 9	Downstream Cell	0.18	Sand, Some Silt	19
Test 10	Downstream Cell	0.40	Sand, Some Silt	38

Infiltration Testing Results (25 mm/hr Minimum Infiltration Rate)

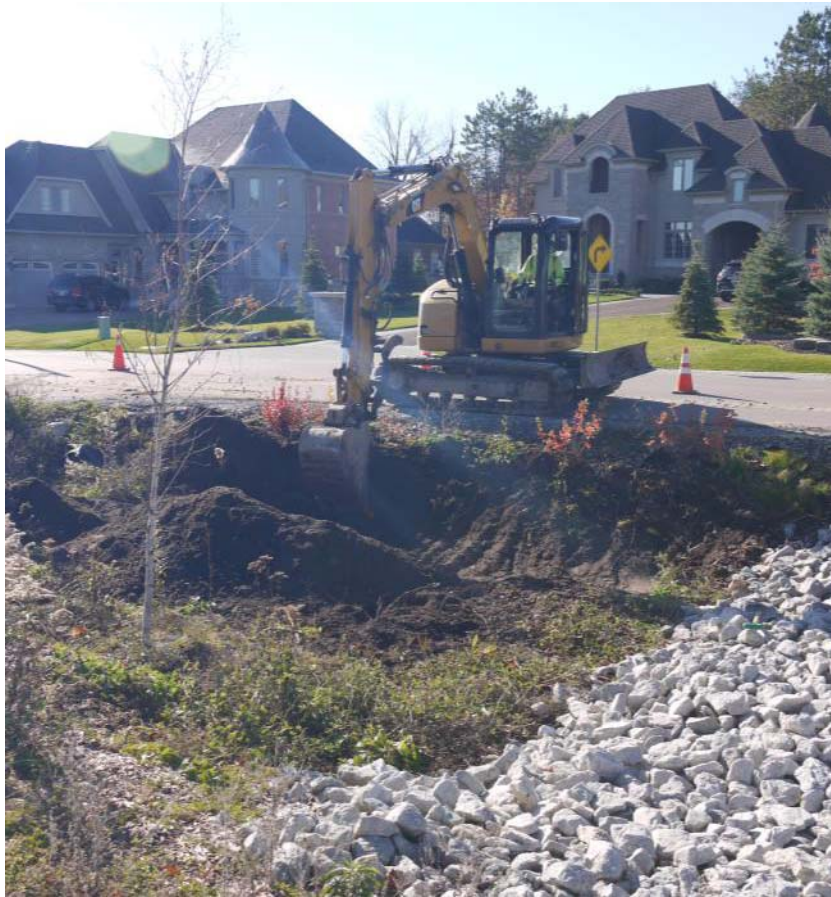
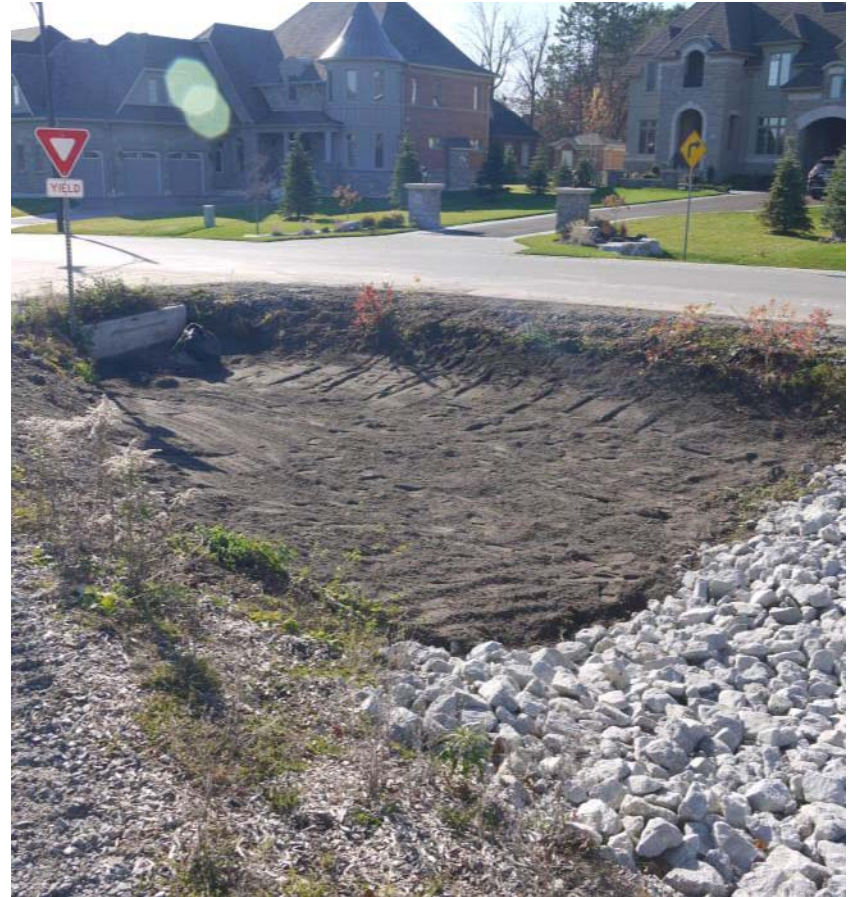
Replacement of Lower Cell Biomedia

322 mm/hour
