# **Fullarton Dam Environmental Assessment Natural Heritage Baseline Existing Conditions Report**

March 16, 2023

Prepared for:  
UTRCA

Prepared by:  
Stantec Consulting Ltd.

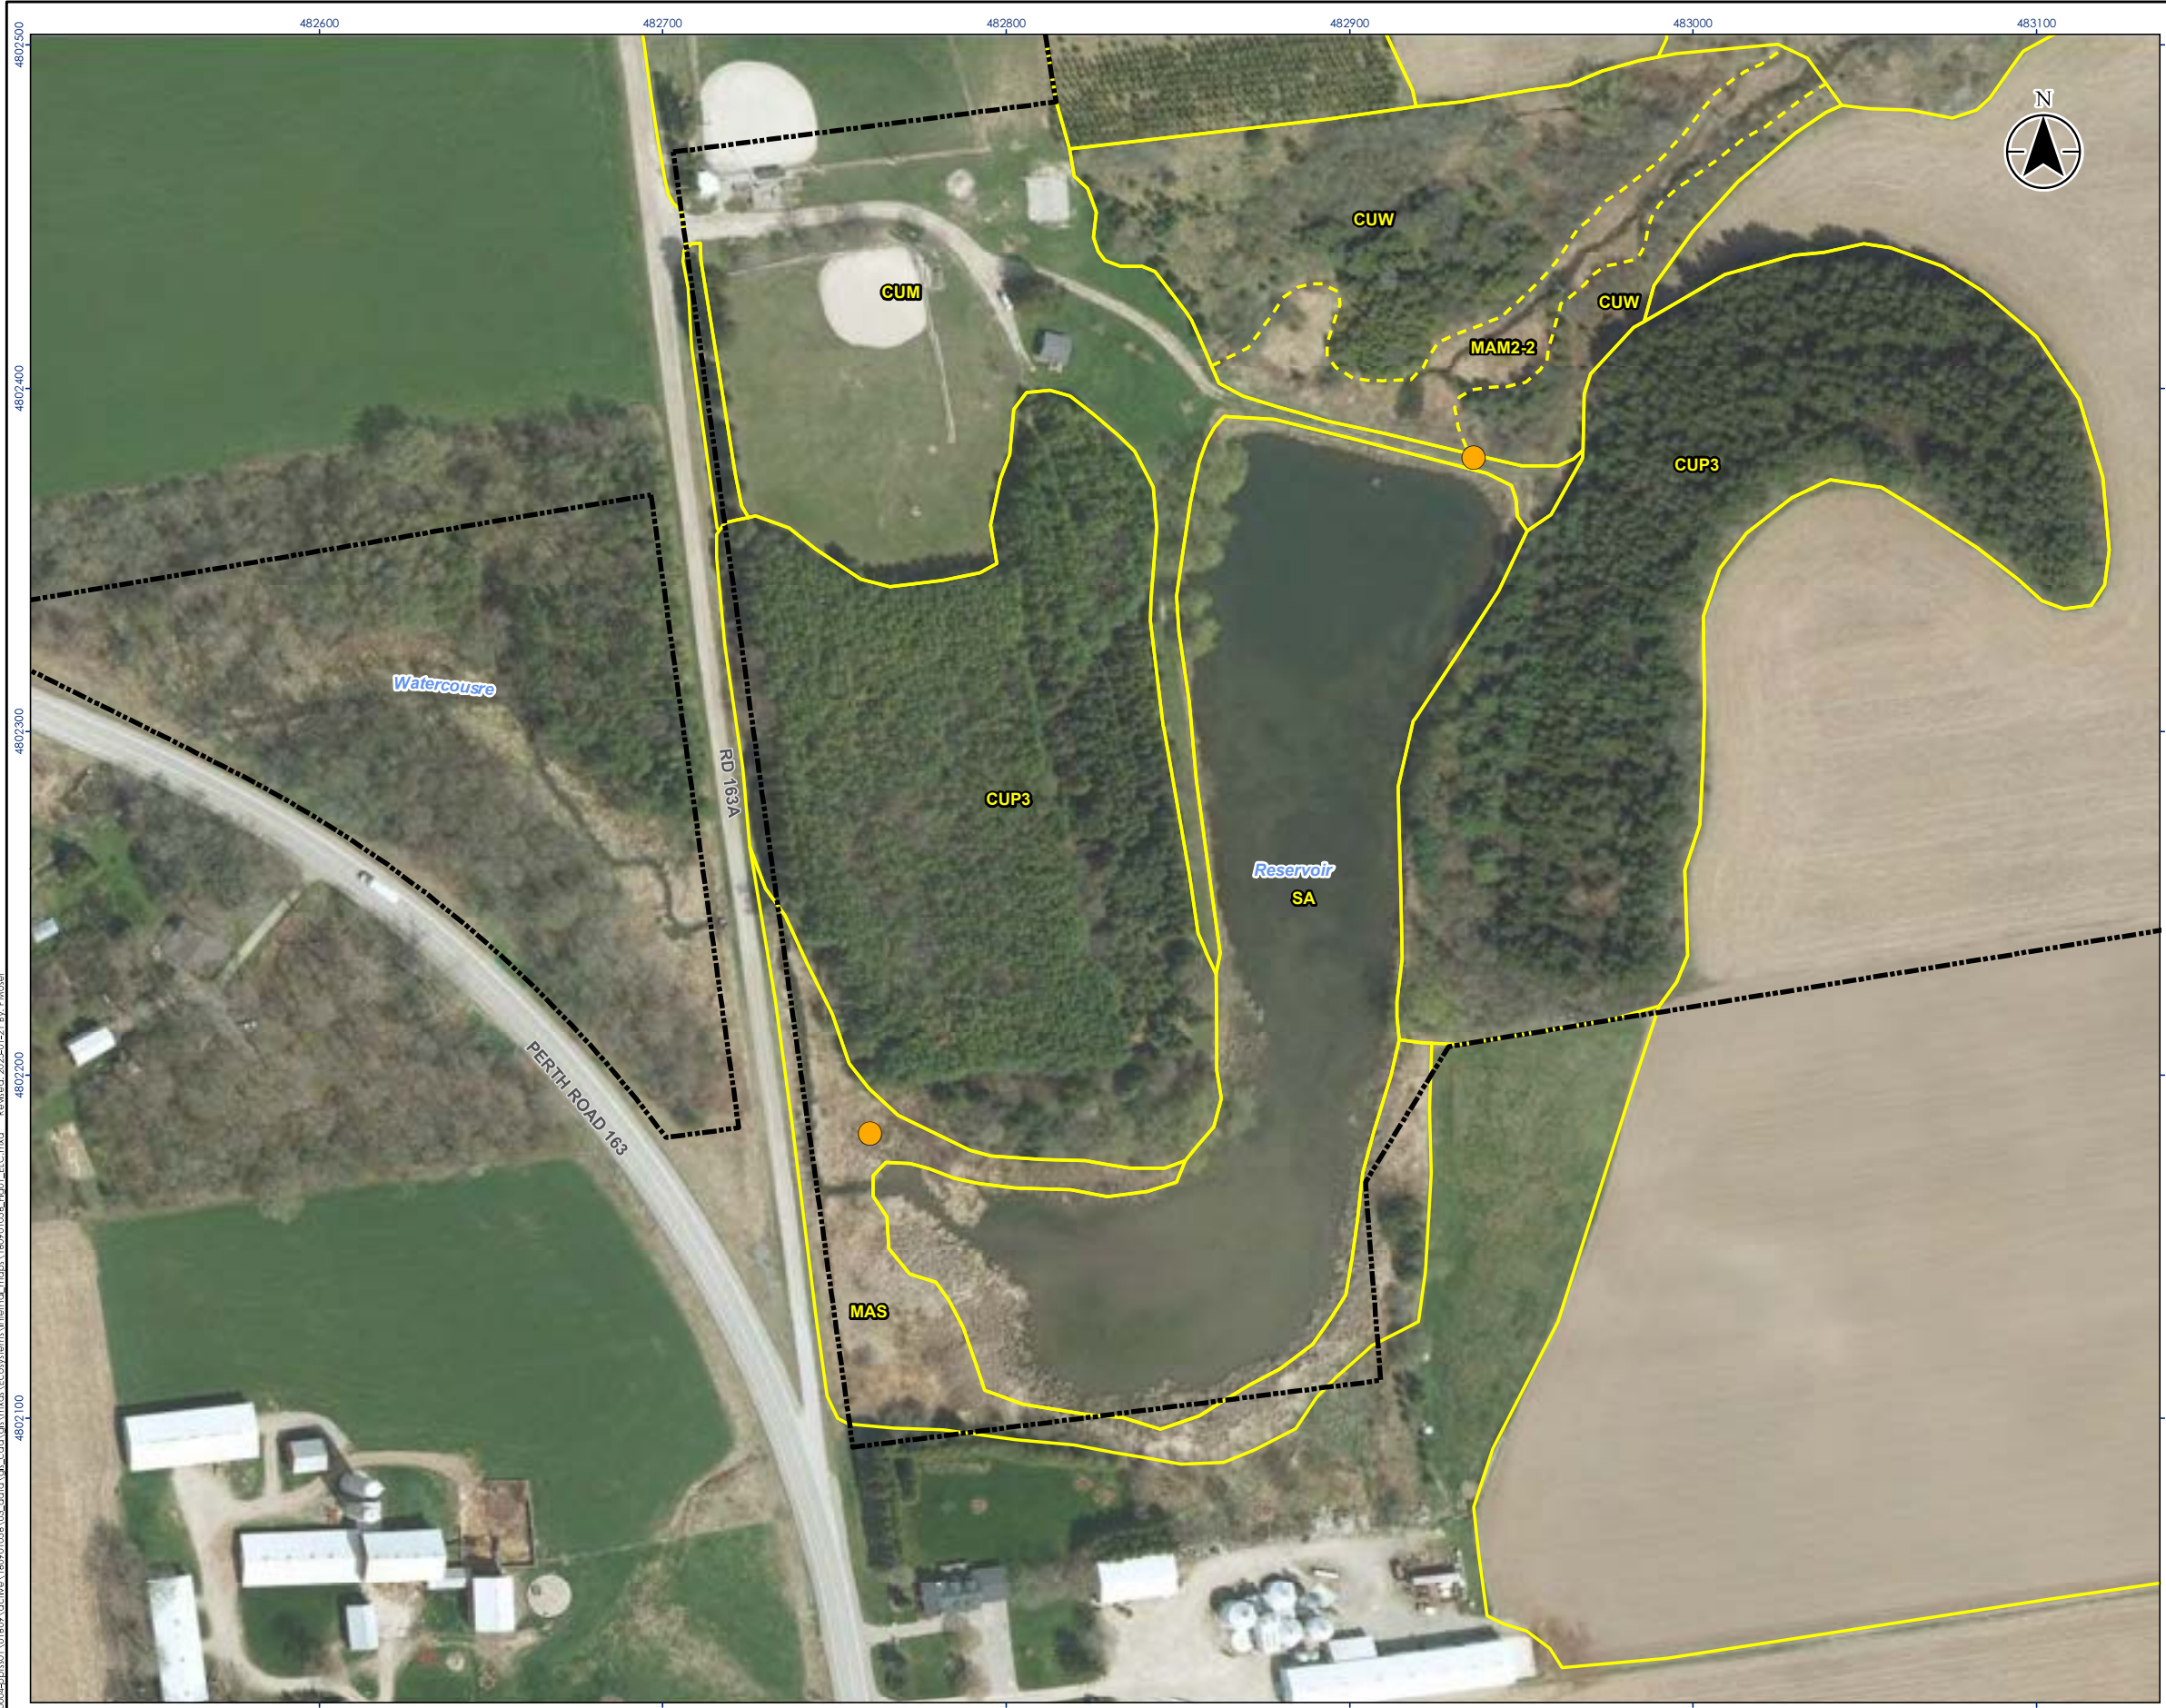
**Appendix A:            Figure 1 - Ecological Land Classification  
and Survey Locations**

The 2023 results demonstrated that the previous ELC analysis remains valid. However, it should be noted that an inclusion of Reed-canary Grass Graminoid Mineral Meadow Marsh Type (MAM2-2) is located within the cultural woodland that was identified on Figure 1 of UTRCA's findings report (2016). The perimeter of the MAM2-2 community aligns with the Ecologically Important Meadow layer on Figure 2 of UTRCA's findings report (2016). This community has been highlighted as an inclusion on **Figure 1, Appendix A**.

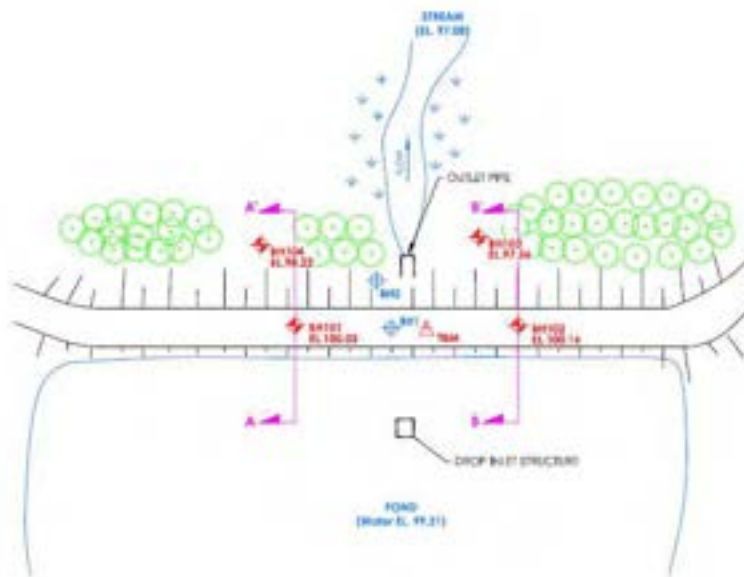
Figure 3-2: Borehole Locations (Naylor Engineering Associates, 2006)

During the 2005 field investigation, four (4) boreholes were drilled. BH 101 and 102 were drilled on the crest of the dam and two other boreholes BH103 and BH104 were located at the downstream toe (see Figure 3-2).

During 2005 field investigation, it was found that there was a layer of peat under the dam foundation (BH102) and some pockets of peat were found within the dam fill (BH101) (Naylor, 2006).

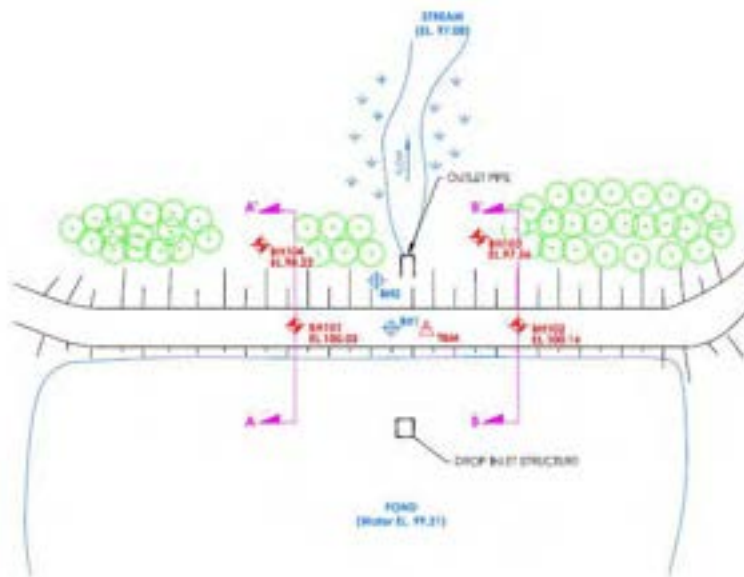
Figure 3-2: Borehole Locations (Naylor Engineering Associates, 2006)

During 2005 field investigation, it was found that there was a layer of peat under the dam foundation (BH102) and some pockets of peat were found within the dam fill (BH101) (Naylor, 2006).
