Embro Dam Class Environmental Assessment

Prepared for: **Upper Thames Conservation Authority**

Prepared by: **Montrose Environmental Solutions Canada Inc.**

Version 4.0
March 2026
Guelph, Ontario

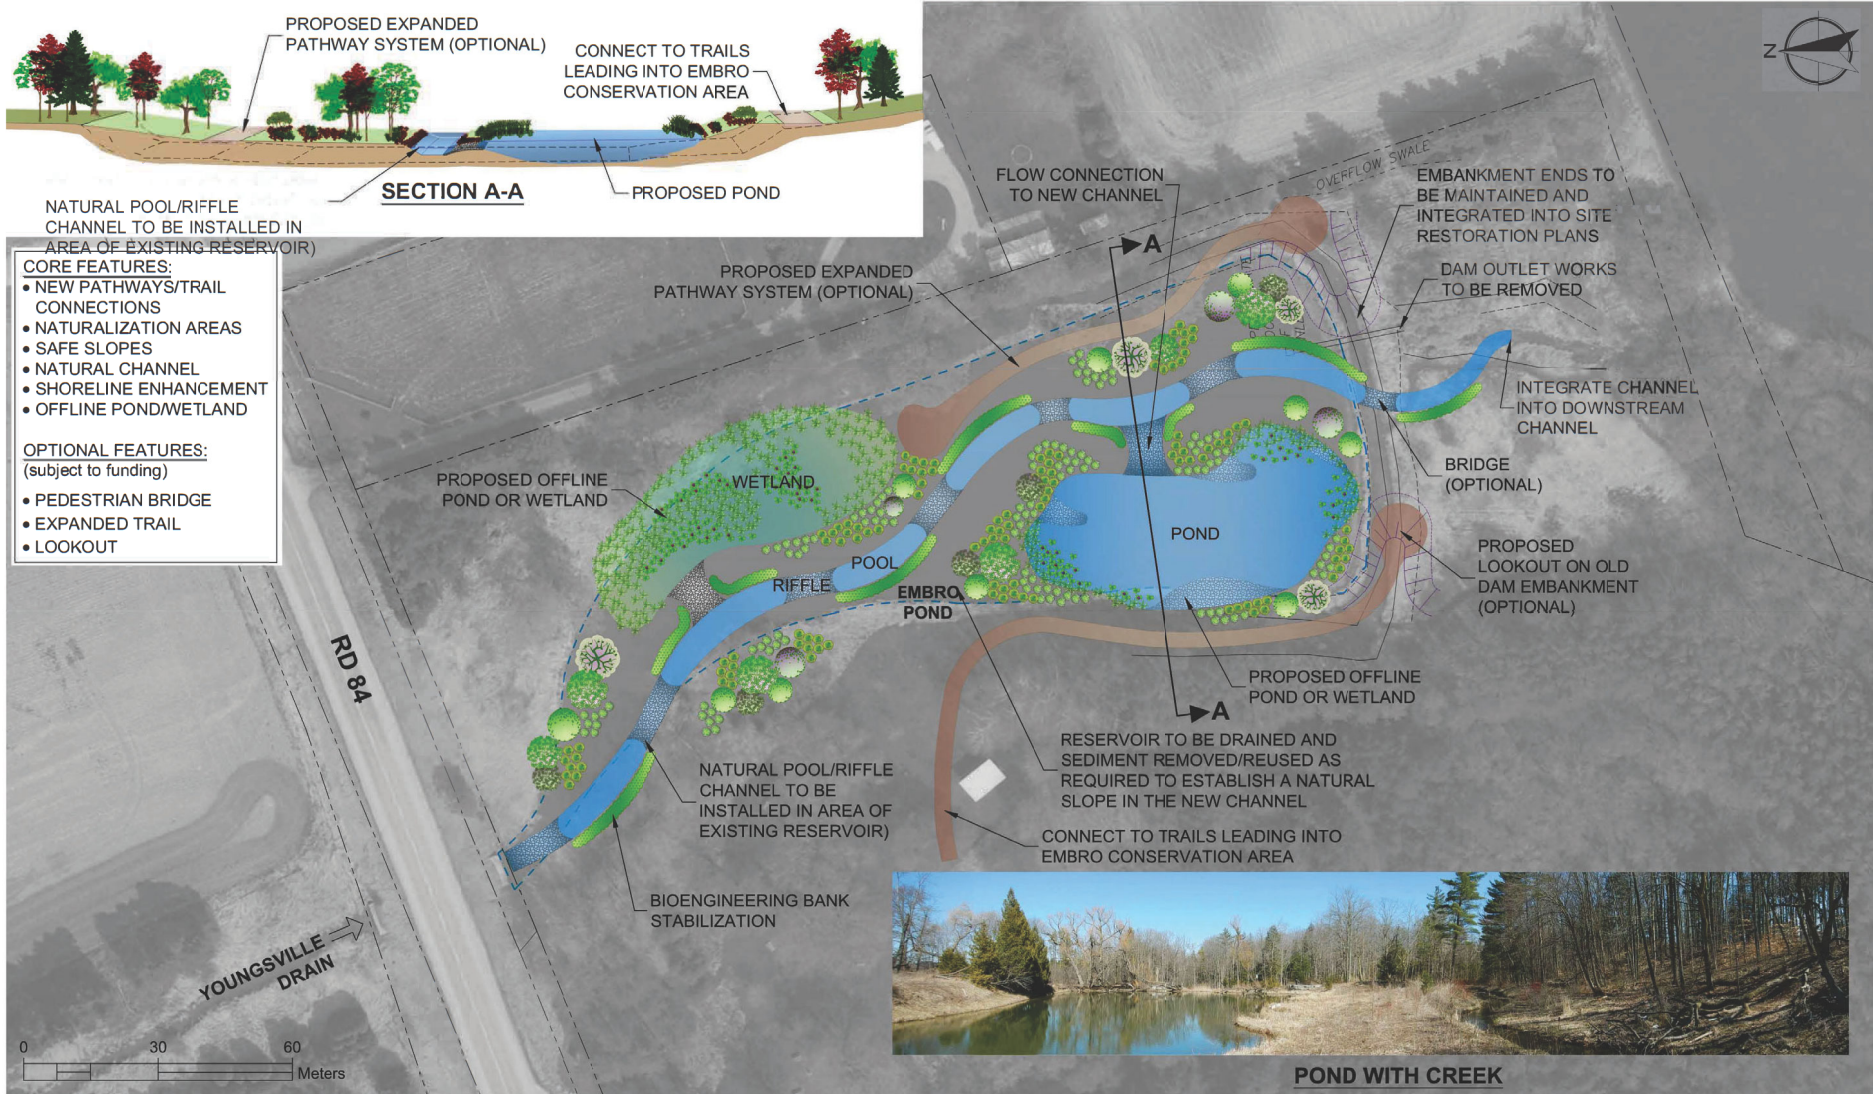
Figure ii Preferred Alternative

Subsequent to Public Information Centre 3, a member of the public proposed an additional alternative. This alternative was reviewed and considered by the study team. That alternative shows thoughtful consideration for the reduction of liability and cost associated with any works in the area. The alternative included elements that are similar to Alternatives 2, and 5 and was thus not advanced to an additional alternative for inclusion in the evaluation process. Instead, draining the pond and lowering the dam crest to accommodate a fish ladder could be considered as a variation on Alternative 5 that incorporates elements of Alternative 3 (i.e., naturalized channel in area of exposed pond bottom).

Prior to development of detailed design, additional study is required to further characterize Youngsville Drain hydrology, reassess pond sediment quality, examine potential effects of pond removal on nearby groundwater wells, and undertake further archaeological assessment as outlined in the Archaeology Research and Associates (ARA 2015) report. A Community Liaison Committee has been established to allow for public participation in the design process. The detailed design should address and incorporate elements considered important by the community that include walking trails and viewing areas for birds, habitat creation for turtles and amphibians, and other resident wildlife.

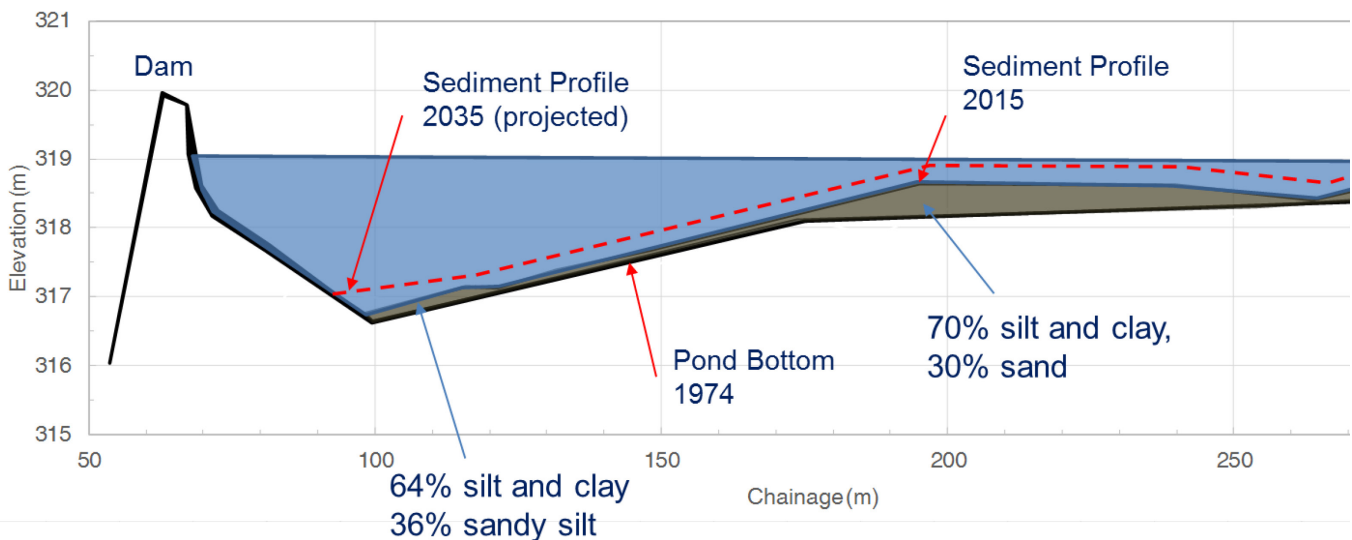
Figure 8 Sediment Profiles in Embro Pond

Results of the water depth assessments were plotted on a profile through Embro pond (Figure 8). The figure shows that infilling appears to have been greatest at the pond inlet; this is expected since sediment load from Youngsville Drain will drop from suspension as flows enter a slower velocity area.

The bathymetric data were used to quantify the volume of sediment in the pond (i.e., difference between top of sediment as determined through sediment probing). The total volume of sediment was 5,864 m³; based on the data, it is clear that the Embro pond is approx. 27 to 35% full of sediment. It is uncertain if the bottom of sediment represents 1974 or 1959 conditions. If the bottom of sediment represents 1974 conditions, then the average rate of infilling is 143 m³/year and complete infilling of the pond at this rate would occur in 124 years. If the bottom of sediment represents 1959 conditions, then the average rate of infilling is 104.7 m³/ year; complete filling-in of the pond at this sedimentation rate would occur in approx. 172 years. It is important to keep in mind that the impetus for this study is the safety of the dam structure and not the sedimentation.

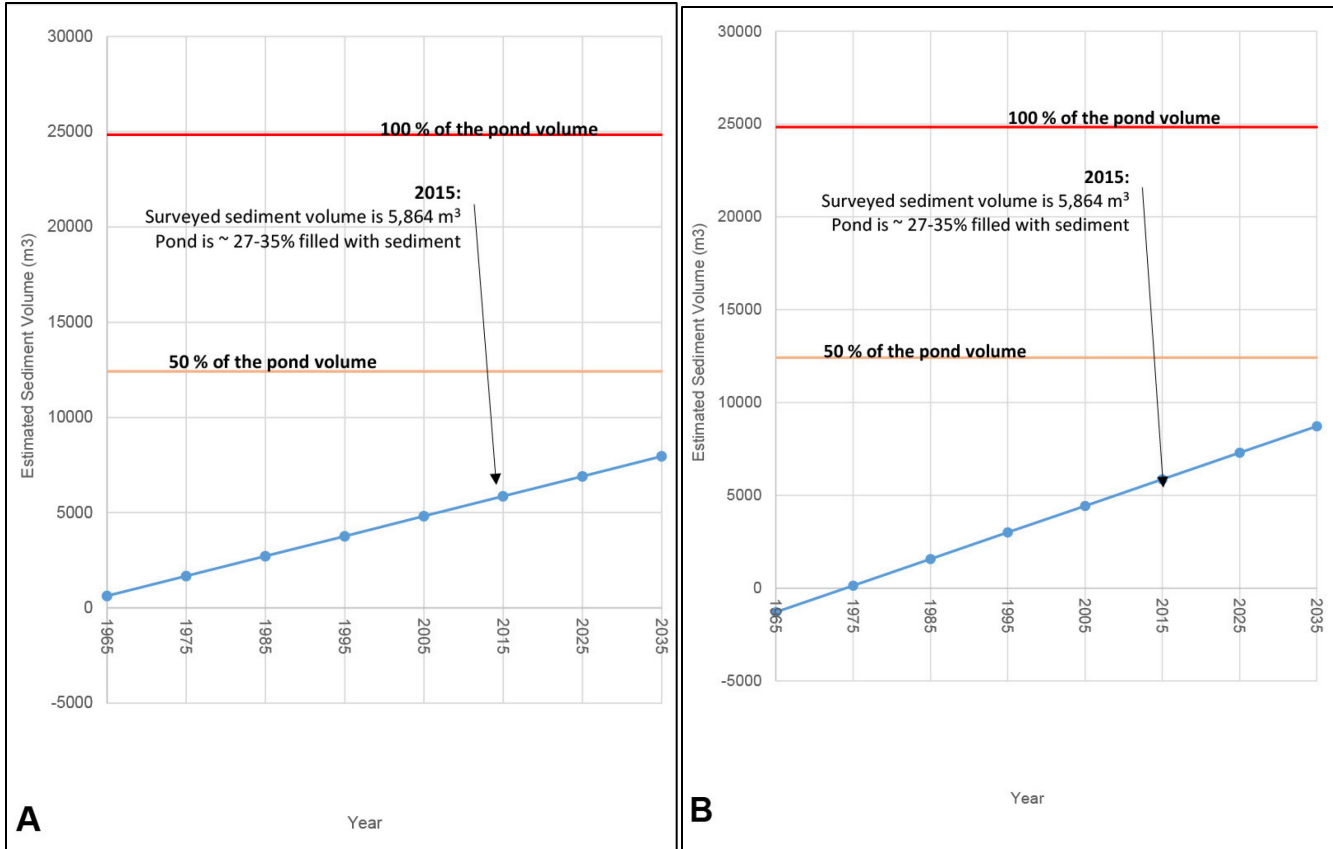
Figure 9 Rate of Pond Infilling

(based on A: 1959-2015 and B: 1974-2015 sedimentation rates)

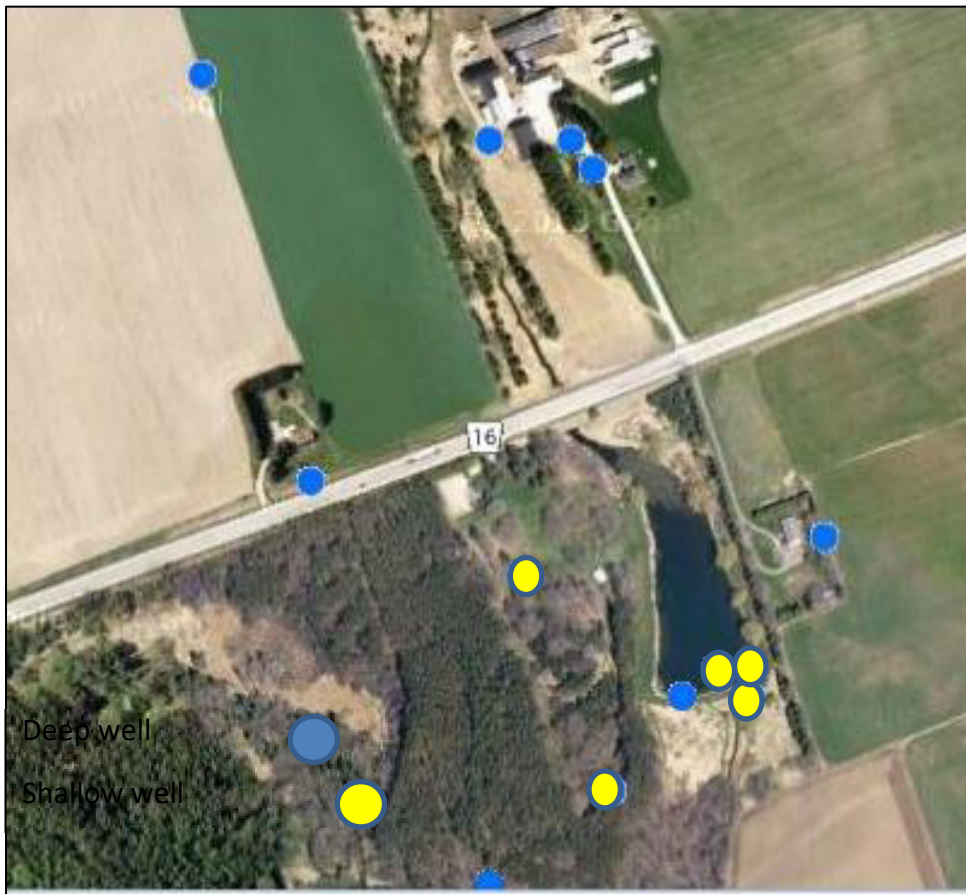
Figure 10 Known Wells in the Area of Embro Conservation Area (UTRCA 2016)

(Data Source: MECP; Appendix A; deep wells are in blue, shallow wells are yellow)

The UTRCA reviewed internal thematic mapping and Ministry of the Environment, Conservation and Parks (MECP) well records to characterize the general hydrogeological setting of ECA and the local surrounding area. The well records were examined and classified as shallow or deep on Figure 10. The shallows wells generally represent those that were drilled in association with field studies rather than those used for other purposes (drinking water).

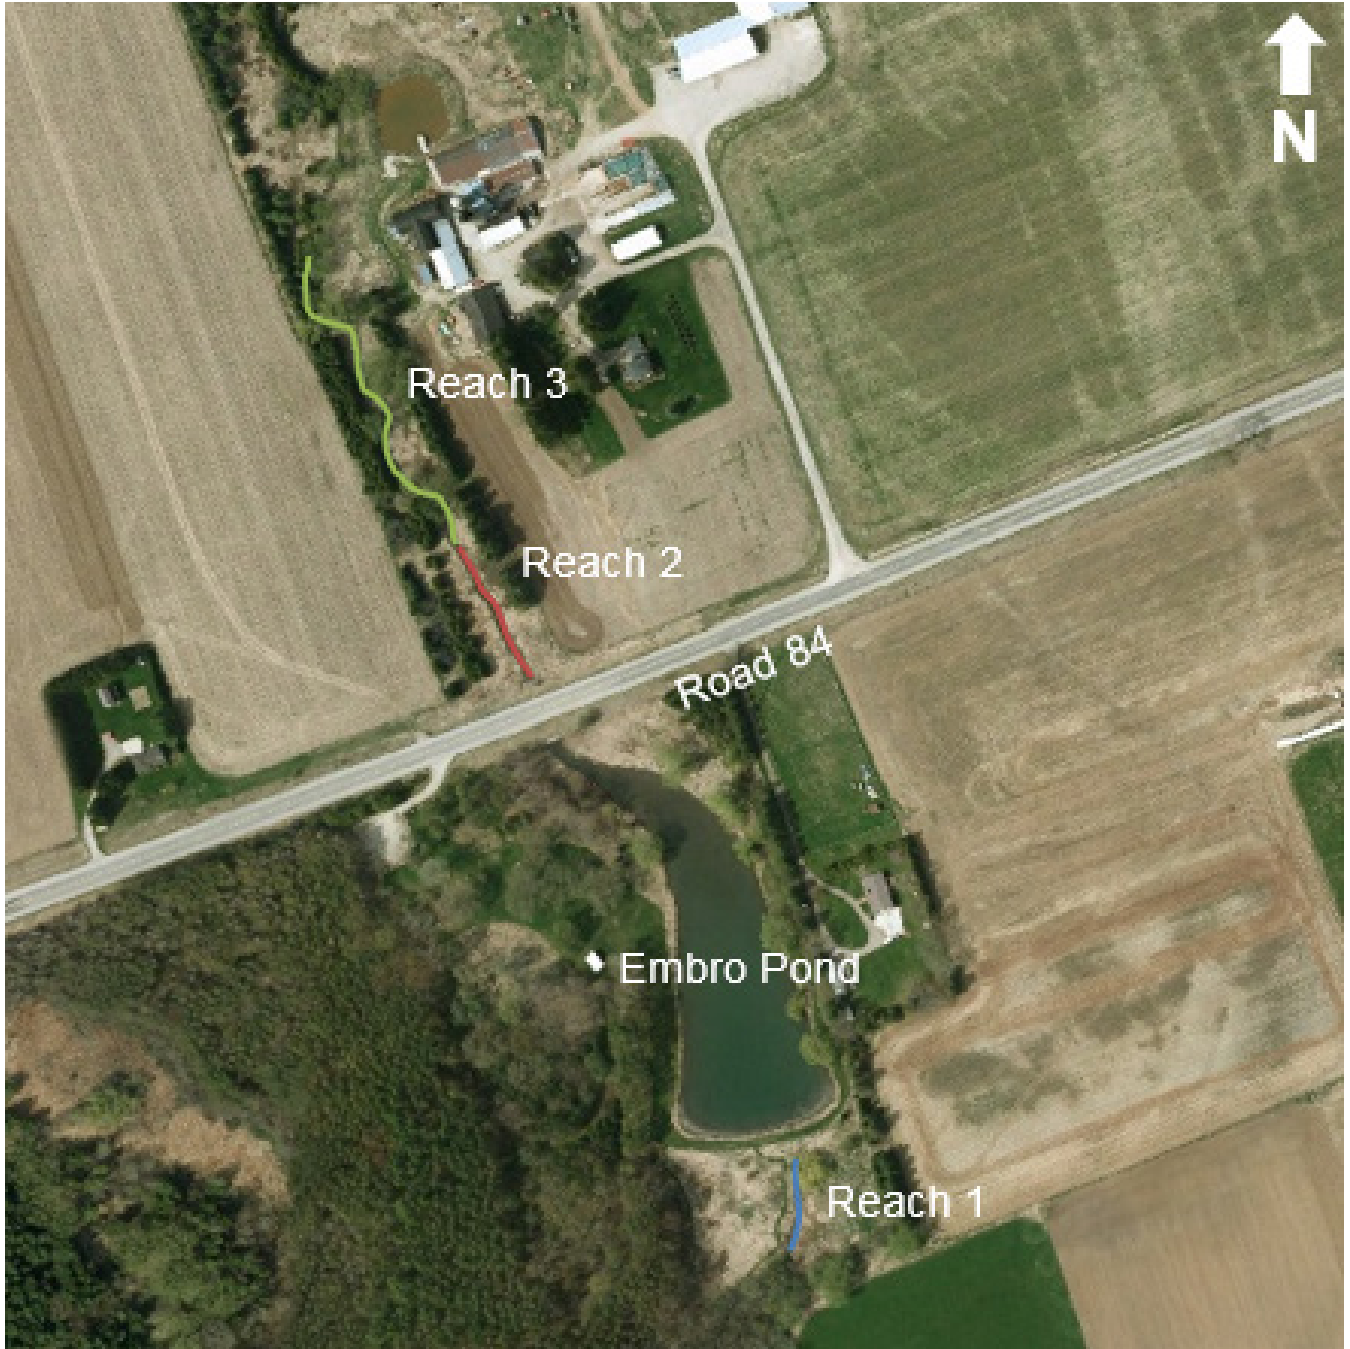
Figure 14 Reach Delineation Along Youngsville Drain

A geomorphic field investigation was undertaken on June 11, 2015 to assess existing conditions along Youngsville Drain, both upstream and downstream of Embro pond. During the field assessment, three reaches were identified. A second field visit was completed on November 18, 2022, to reassess site conditions since the initial investigation. A brief description of dominant channel characteristics is provided by reach below. The reach delineation is demonstrated on Figure 14 the surveyed channel bed profile is illustrated in Figure 15 which includes a profile through Embro pond based on 2015 water depth mapping provided by the UTRCA.

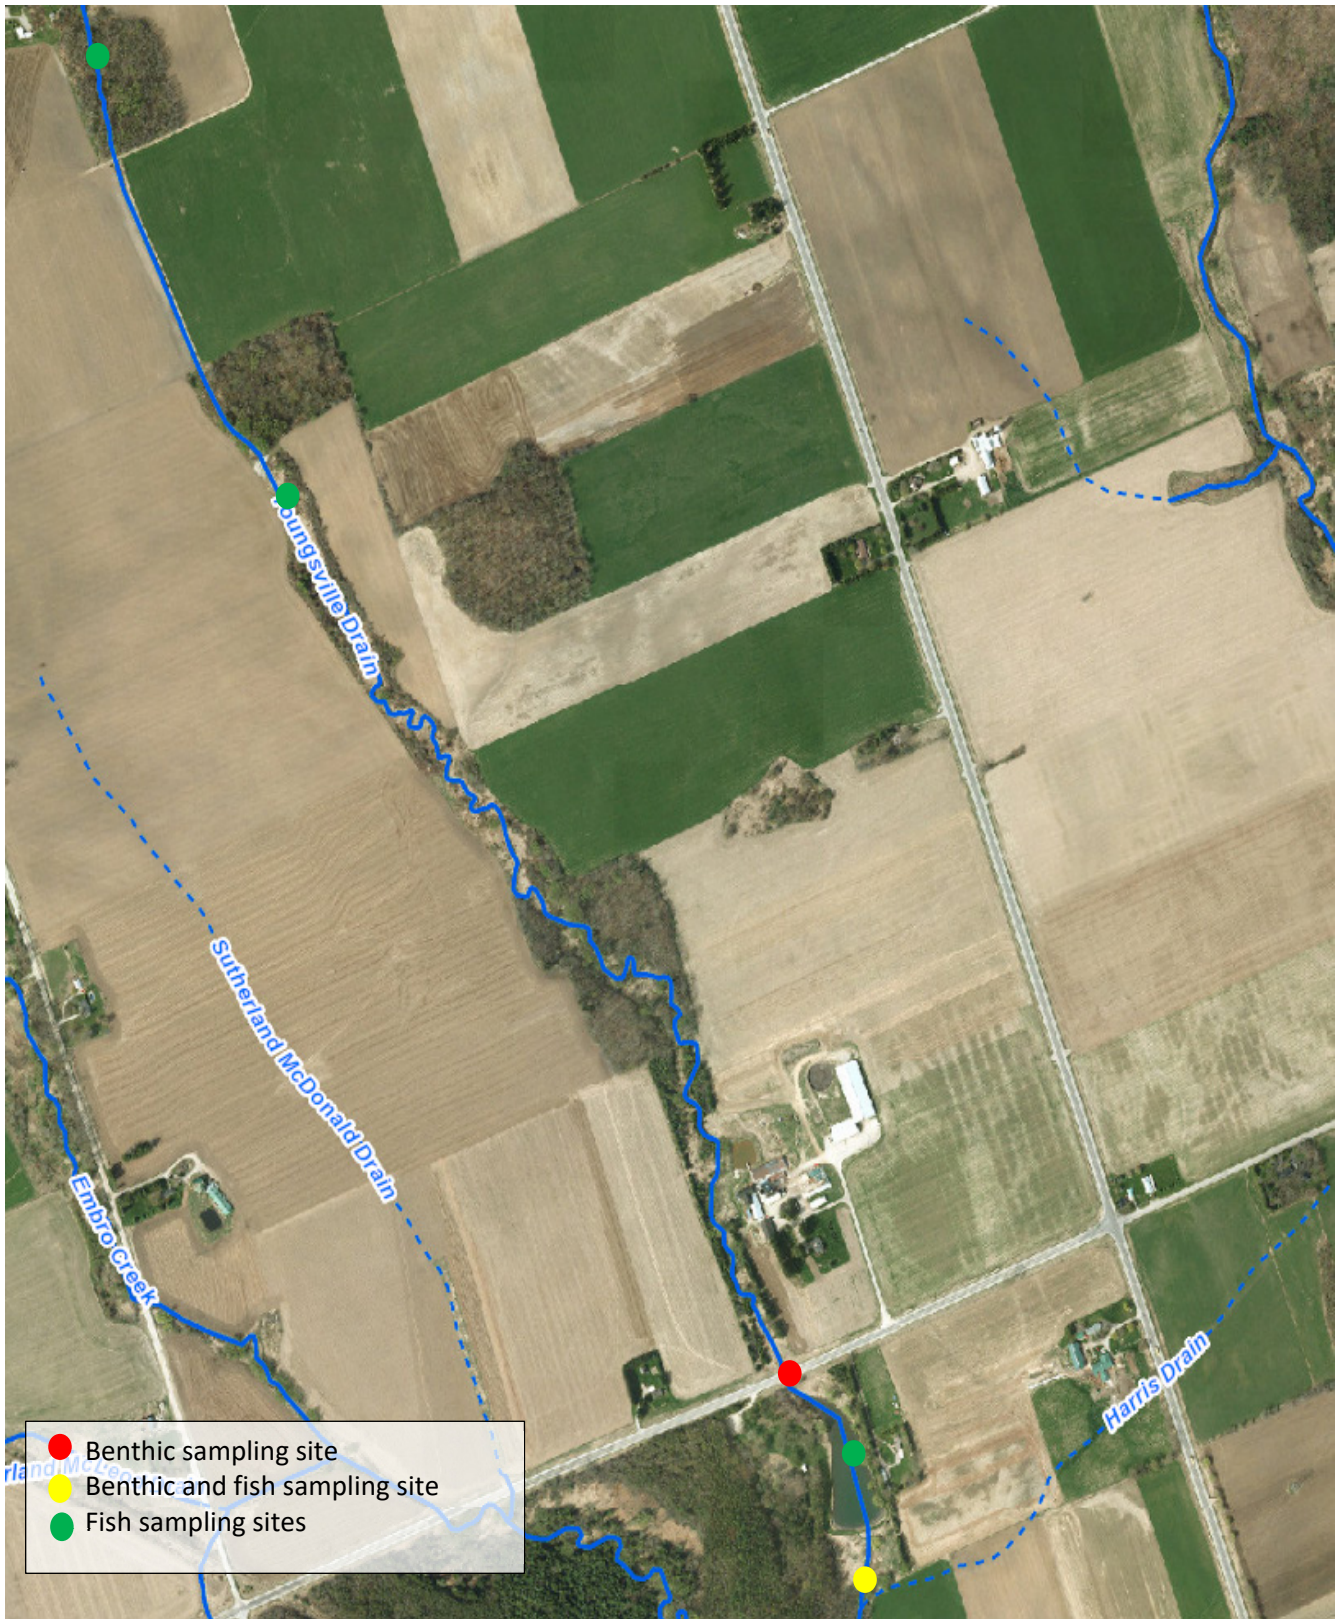
Figure 16 Embro Dam Area Benthic and Fish Sampling Sites (UTRCA 2016b)

Youngsville Drain has been sampled extensively in the past, both upstream and downstream of pond. From 2015 to 2022, upstream reaches were sampled for fish on 12 occasions and downstream of the dam was sampled 6 times. Sampling sites are shown on Figure 16.

Benthic invertebrate sampling was conducted in the spring (May 5) and fall (September 23) of 2015, May 2016, September 2017, September 2019, and September 2021 incorporating a riffle (if present) both up upstream of Embro pond and downstream of the dam. Sampling was conducted using a traveling kick and sweep method and a 500 µm D-frame net, and samples handled and analyzed using methods consistent with provincial (OBBN) and Federal (CABIN) protocols. Samples were preserved in the field (in ethanol), randomly subsampled in the laboratory and identified to the Family taxonomic level. Resulting data were entered into, and analyzed, using an MS Access database. Sample records (including historical records) with calculated Family Biotic Index (FBI) are provided in Appendix C. The water quality ranges for the FBI values can be seen in Table 1

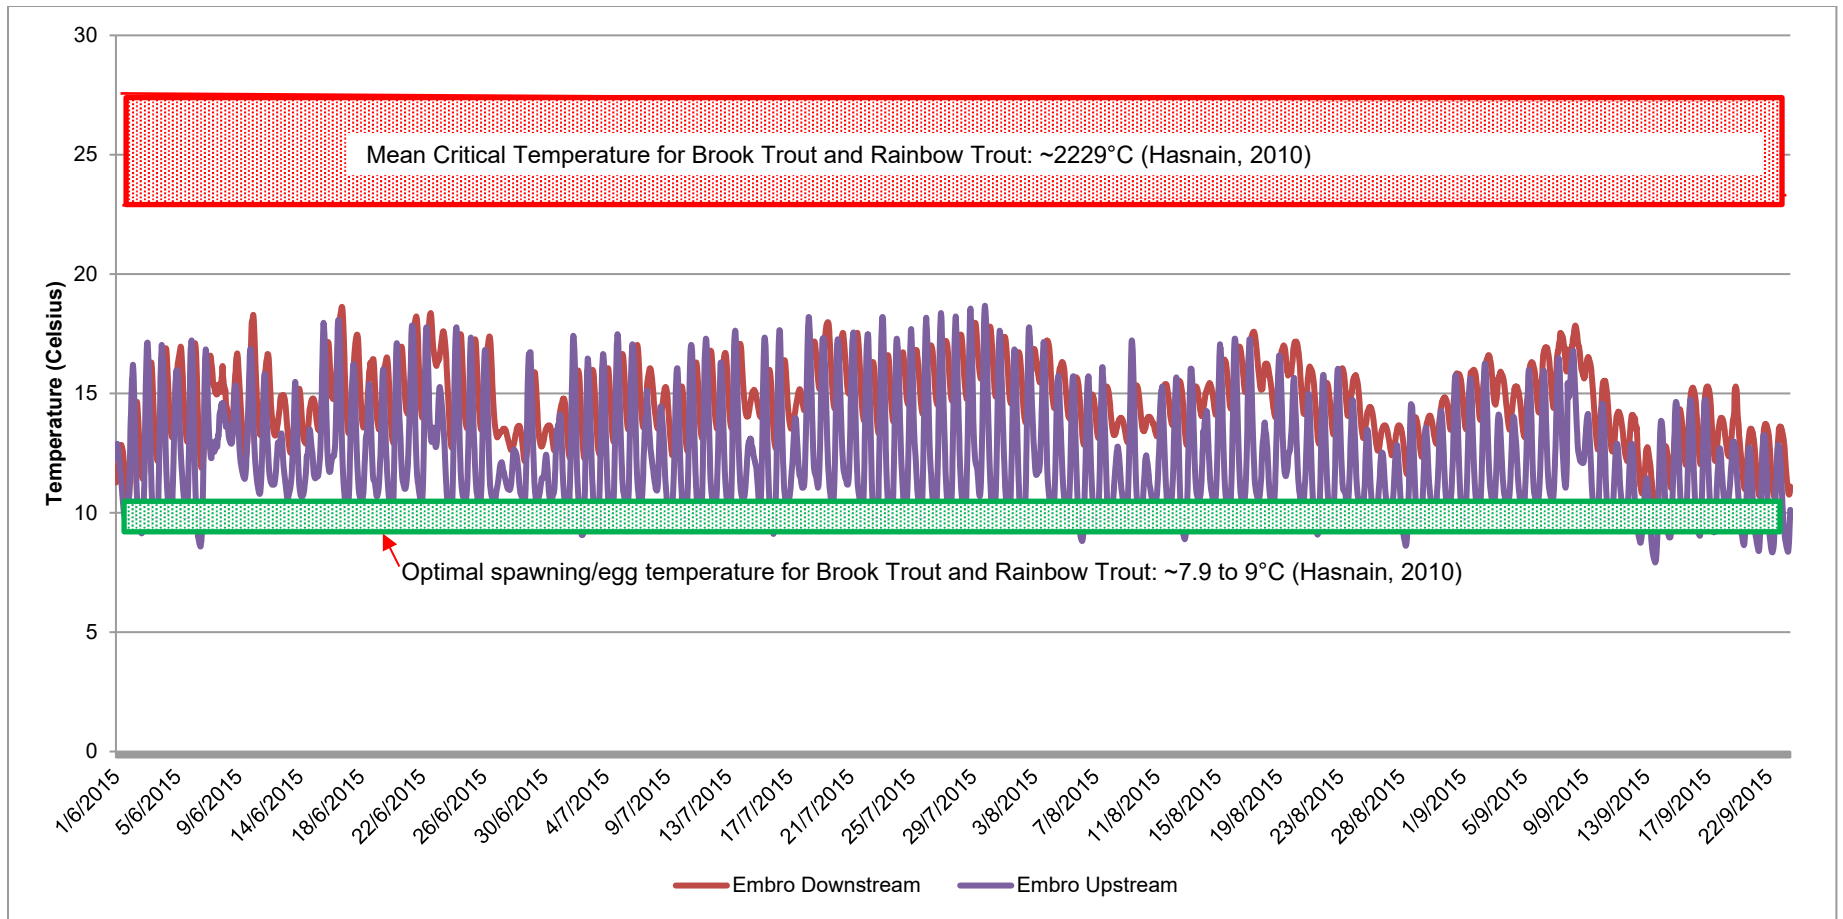
Figure 18 Temperature Upstream and Downstream of Embro Pond (UTRCA 2016c)

Temperature differences are apparent between upstream (lower) and downstream (higher) of the pond during the 2015 continuous monitoring, with consistently cooler temperatures upstream. Differences in temperature increased as the summer progressed and is considered attributable to the warming effect of the pond. During the 2015 sampling, temperature differences between upstream and downstream ranged from 0°C to over 7.0°C, with an average difference of 2.5°C between locations.

Water temperature affects aquatic habitat and the survival potential of eggs and health of fish. For example, on Figure 18, the optimal temperature range for Brook and Rainbow Trout spawning/egg survival, and the mean critical temperature for fish survival as defined by Hasnain (2010) are plotted on the temperature graph. Results clearly demonstrate that the water is often warmer both upstream and downstream of the dam than the optimal spawning/egg survival temperatures.

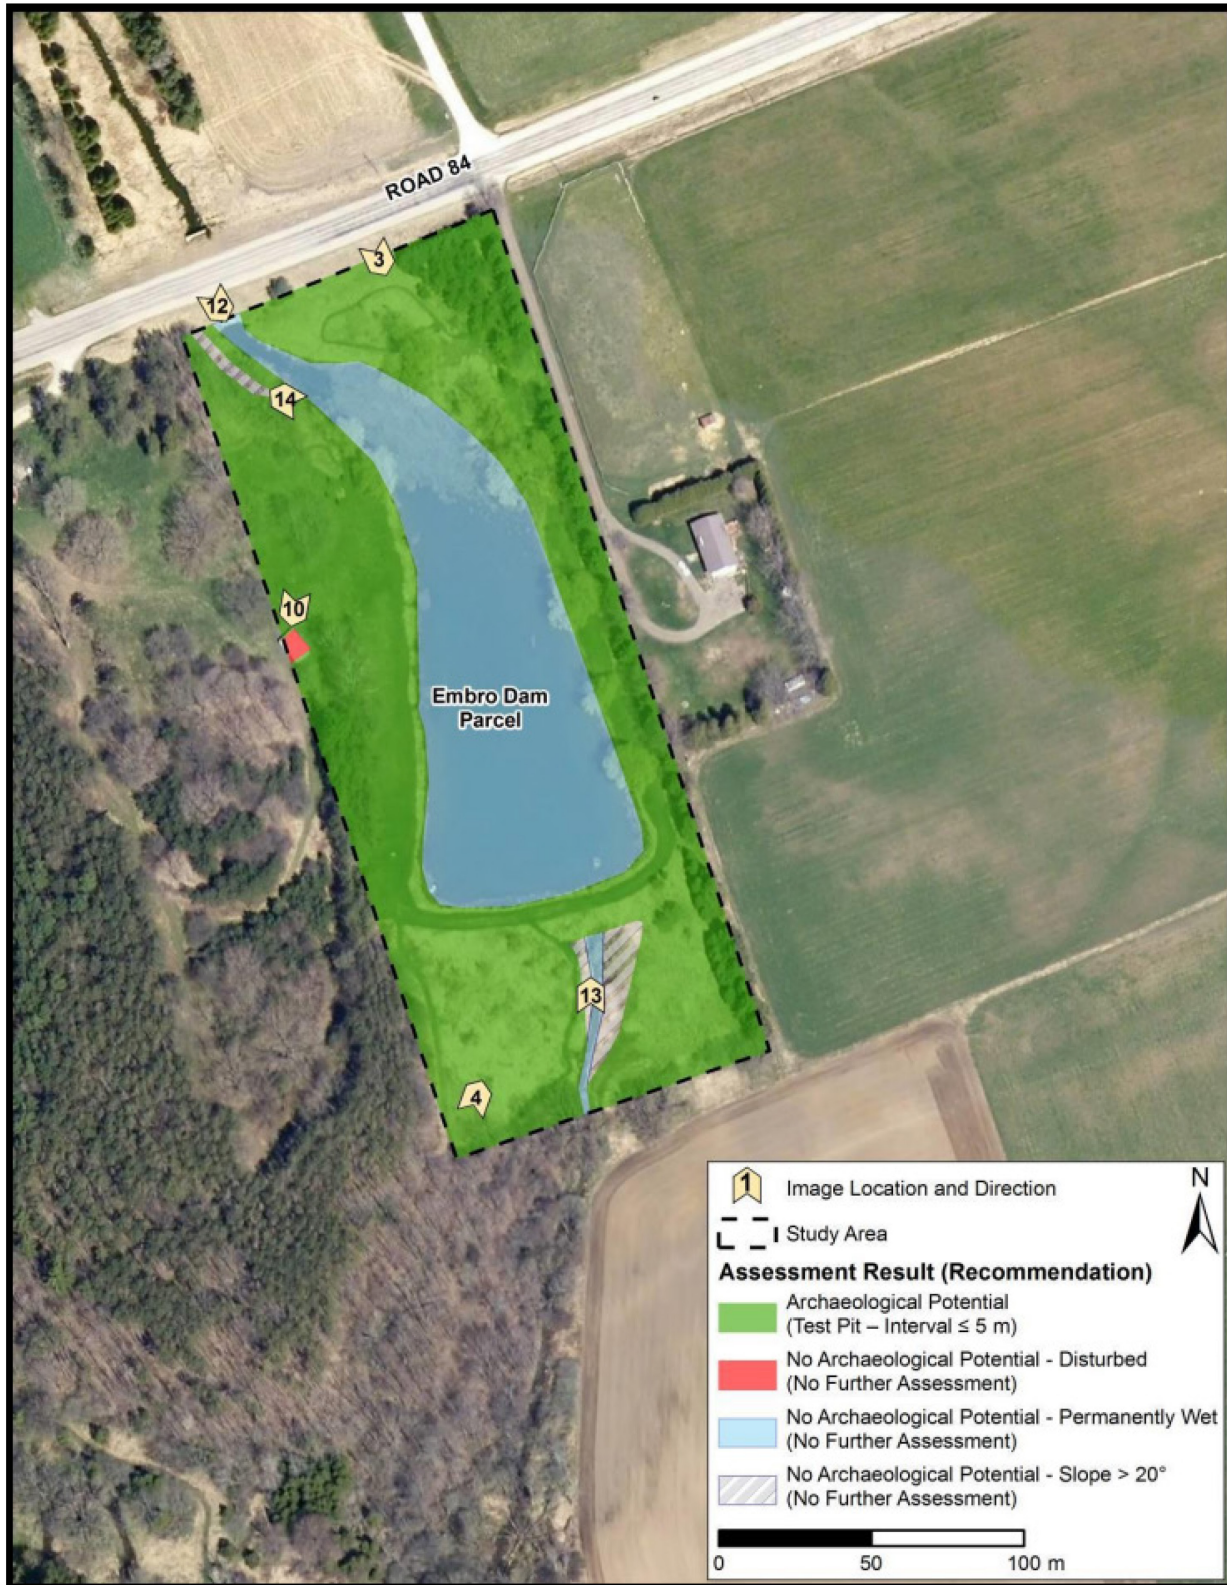
Figure 20 Archaeological Assessment Results for Embro Dam Conservation Area (ARA 2015)

A Stage 1 Archaeological Assessment (under Project Information Form number P007-0690-2015) was undertaken on December 6, 2015, by Archaeological Research Associated Ltd. to determine the archaeological potential of the study area. This includes identification of previously known archaeological sites, if any, and to provide recommendations for further assessment if necessary. The results of the archaeological assessment for Embro Dam are summarized in Figure 20 and in Appendix G.

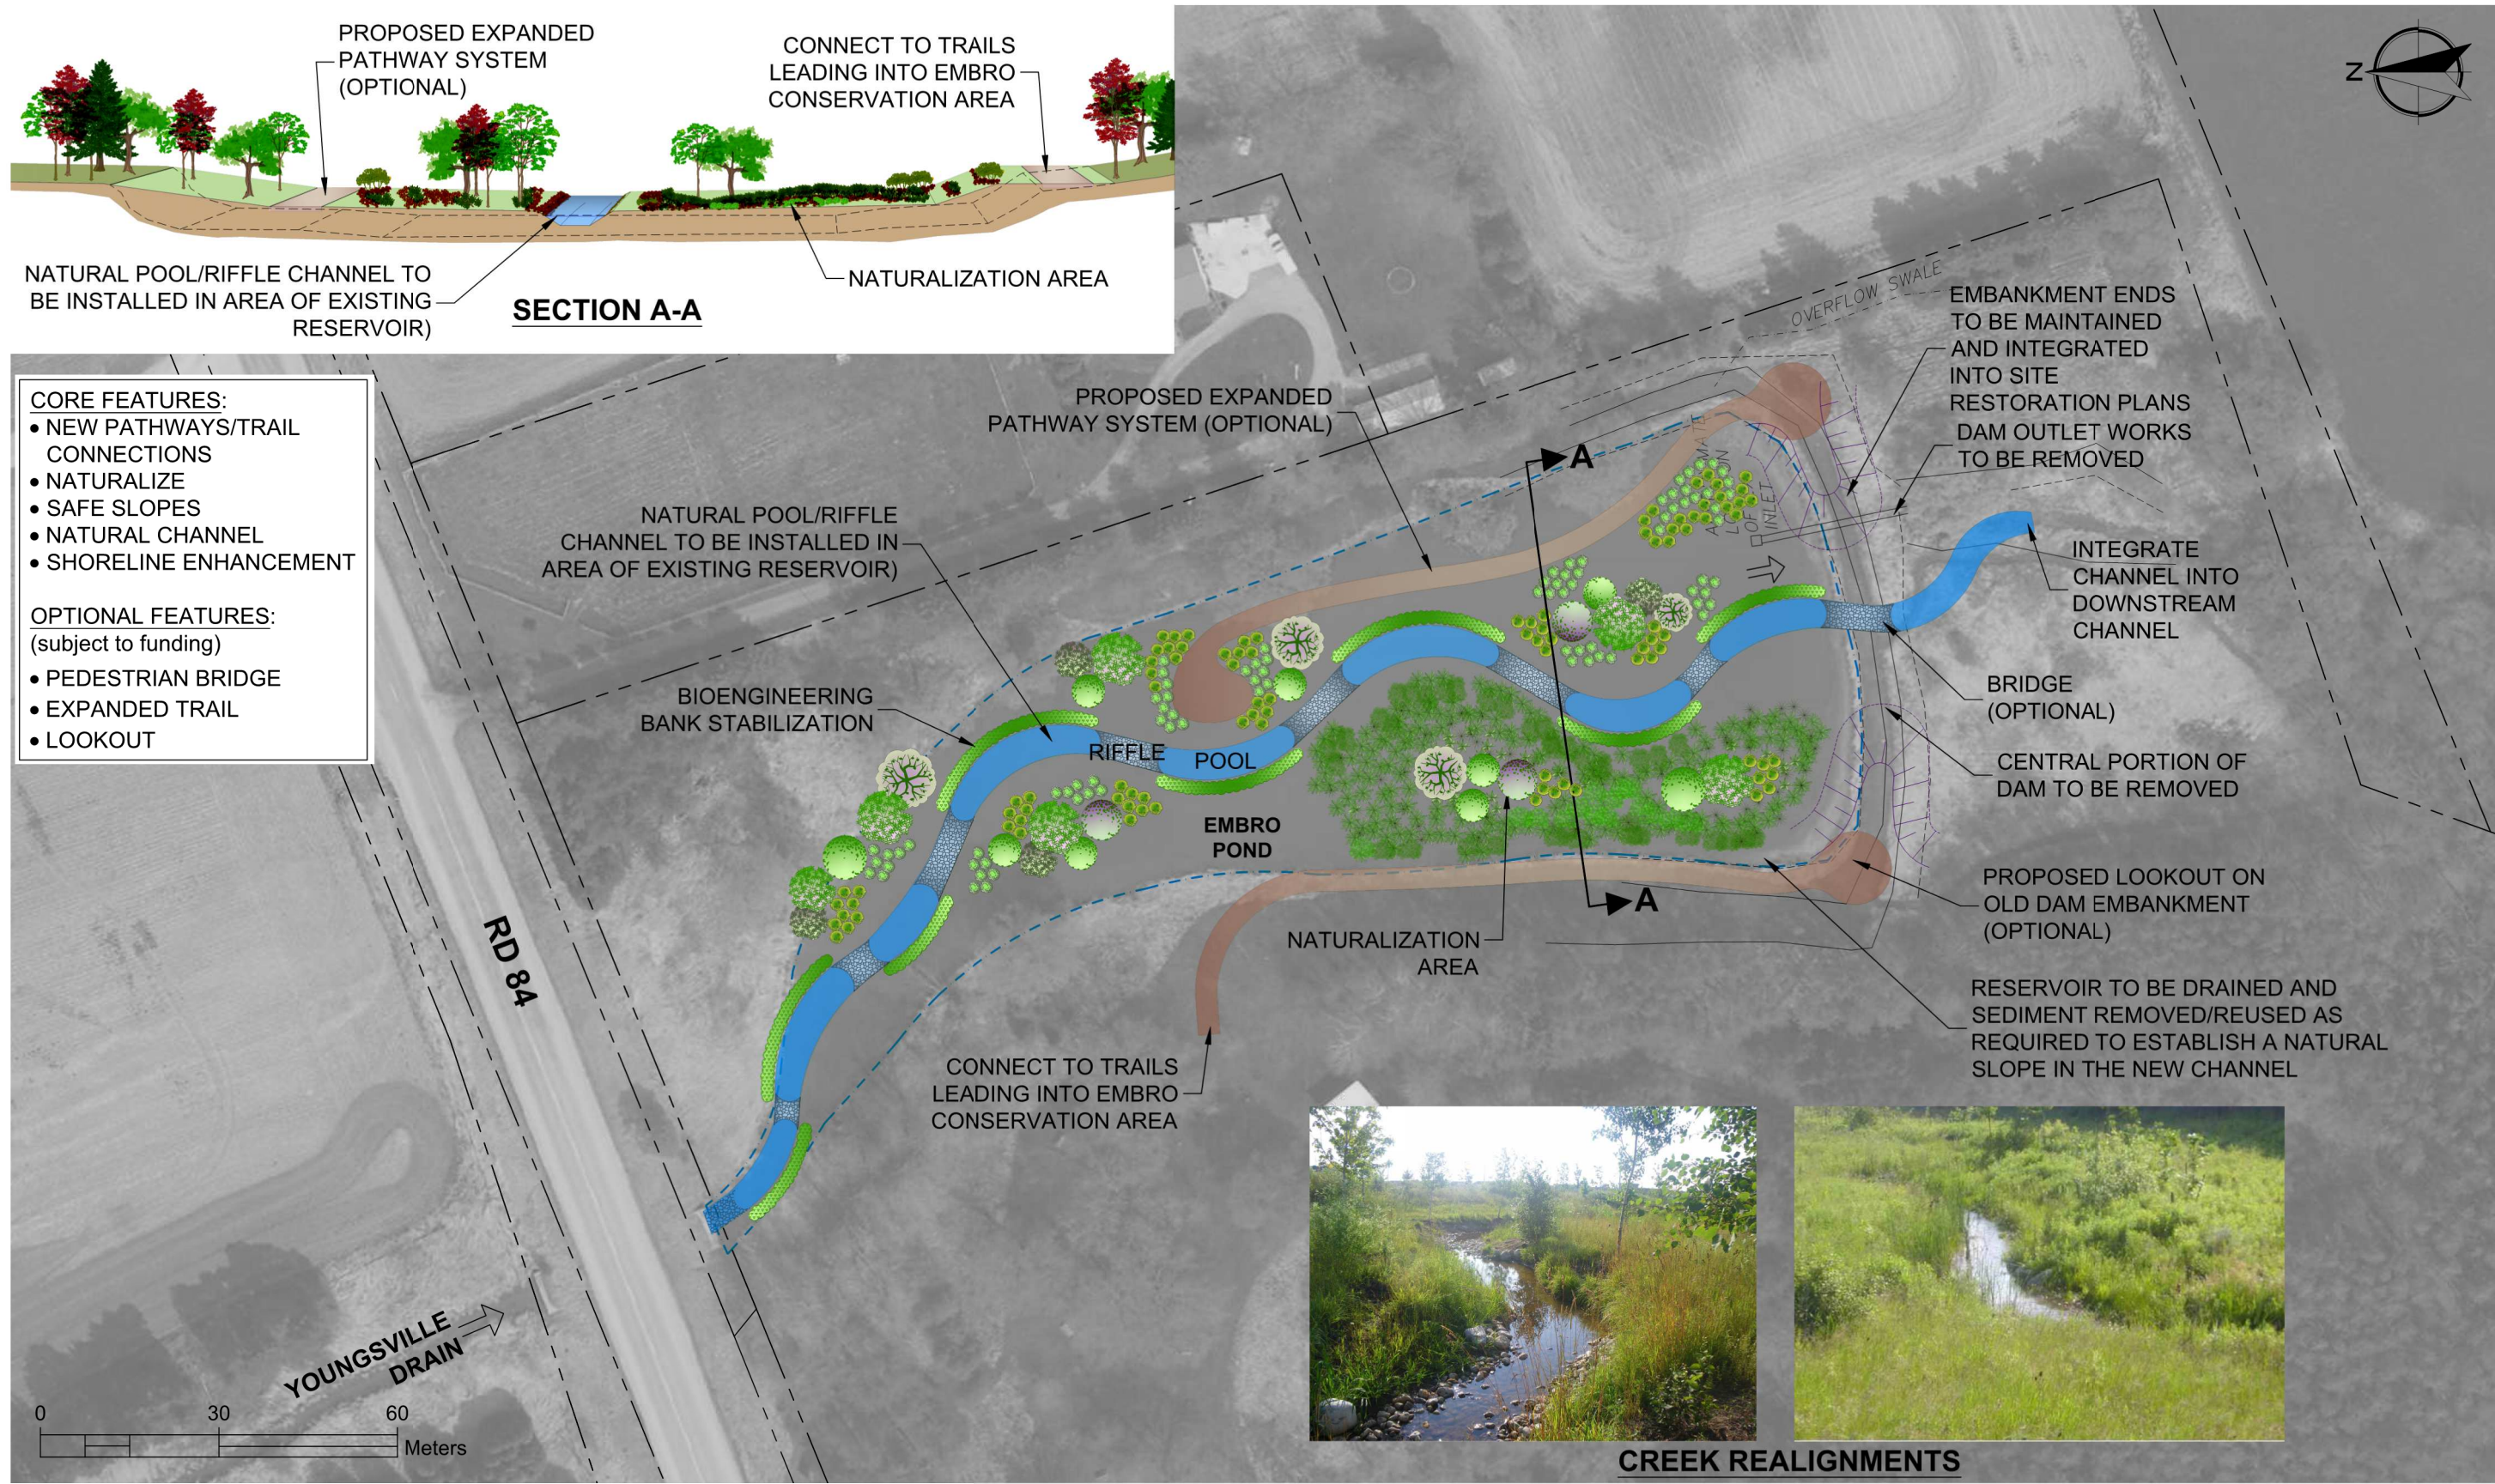
Figure 23 Alternative 3: Remove Dam and Construct Natural Channel
