February 2018 Thames River Flood

Event Highlights

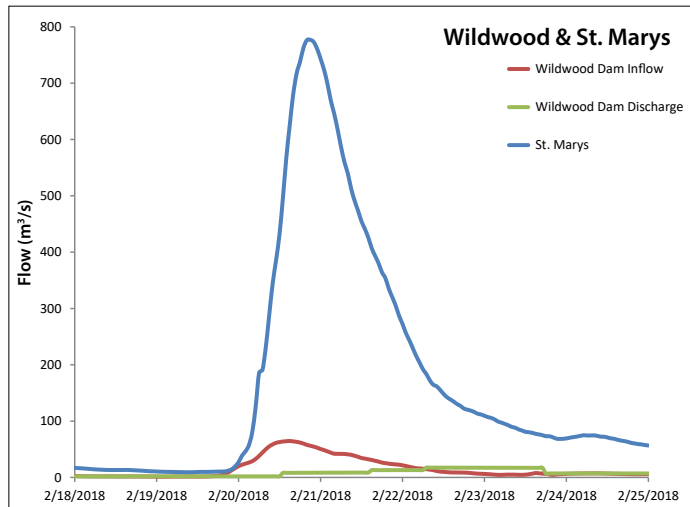
The red line represents flows in Trout Creek entering Wildwood Reservoir, on February 18-25.

The green line shows flows passing through Wildwood Dam. Dam operations reduced maximum flows on Trout Creek from 65 m³/sec to 21 m³/sec and delayed its peak flow until the North Thames, downstream in St. Marys, began to drop.

The blue line represents flows in the North Thames River at the St. Marys monitoring station, including water from Trout Creek (controlled by Wildwood Dam) and five other tributaries. The river peaked at a record high of 777 m³/s.

Without Wildwood Dam, it is estimated that the North Thames River in St. Marys would have peaked at 830 m³/sec (instead of 777 m³/sec). These higher flows would have reached close to the top of the St. Marys Floodwall.

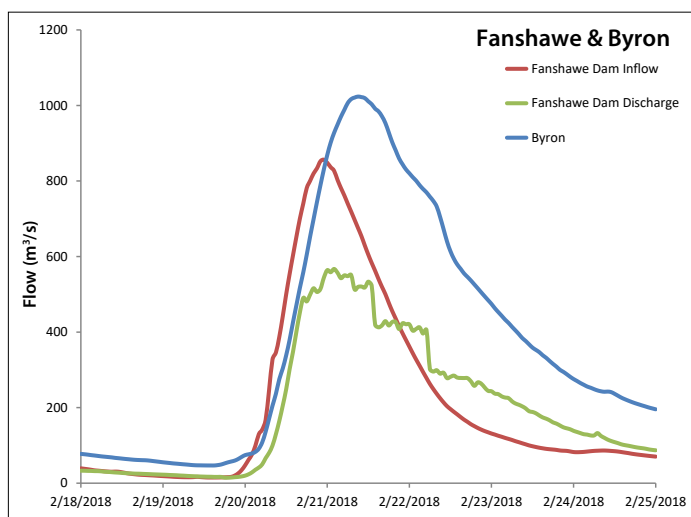
The red line represents flows in the North Thames River entering Fanshawe Reservoir in London, on February 18-25.

The green line shows flows passing through Fanshawe Dam. Dam operations reduced flows from 856 m³/s to 567 m³/s.

The blue line shows the flows recorded at the Byron monitoring station, located along the main Thames River.

Flows recorded at Byron peaked at 1024 m³/s due to the amount of water coming in from the North and South Branches of the Thames River.

Without Fanshawe and Wildwood Dams, it is estimated that the maximum flow at Western University would have exceeded 1100 m³/sec. The unregulated flow would have caused flooding in the Broughdale area and would have likely overtopped the lowest sections of the West London Dyke.

Without Fanshawe, Wildwood and Pittock Dams, it is estimated that the maximum flow at Byron would have exceeded 1400 m³/sec (instead of 1024 m³/s). This flow would have threatened areas behind the other dykes downstream of the Forks.
