2009 Cedar Creek Water Quality Study

Prepared by the Upper Thames River Conservation Authority for the City of Woodstock

March 2010

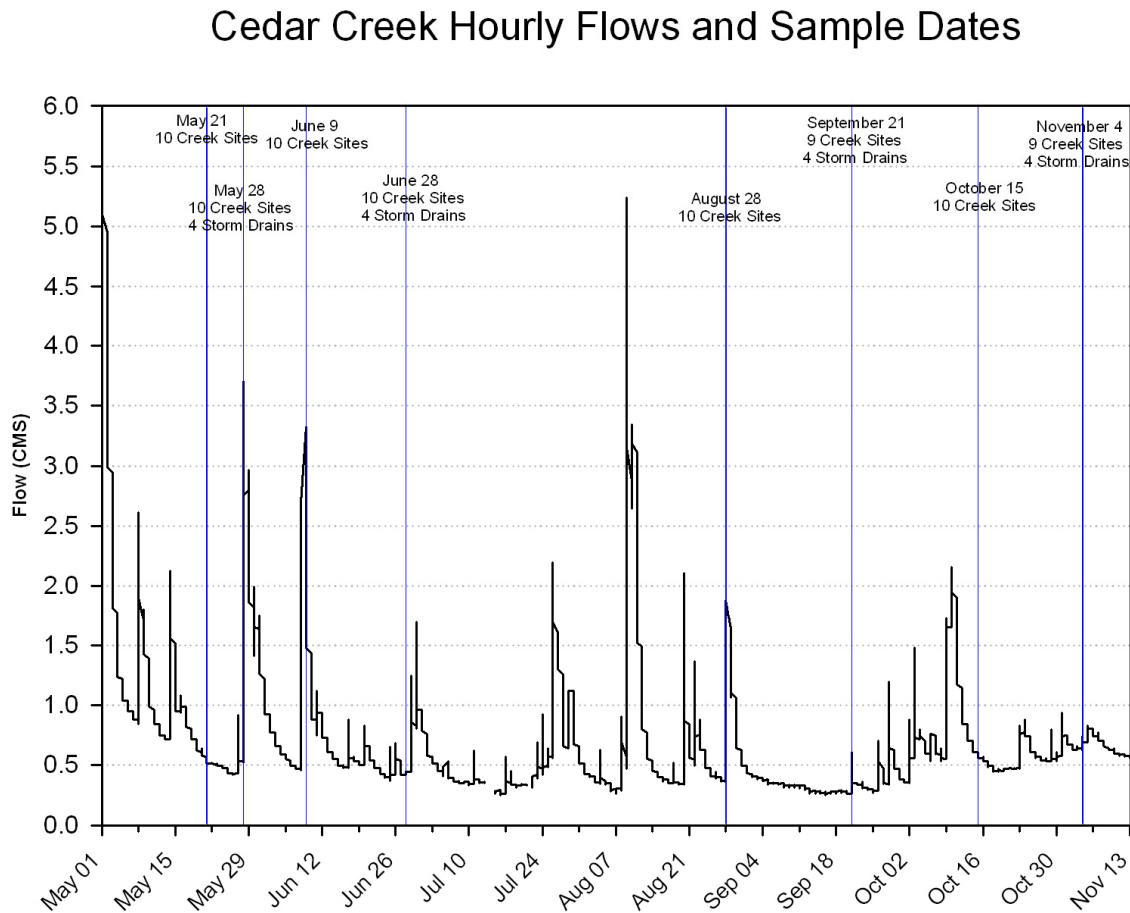
Figure 1. 2009 Sample Dates and Cedar Creek Flows (from flow monitoring station in Southside Park)

An effort was made to collect samples through a range of flow conditions including low flow and rain events (Figure 1). Storm drains were sampled on four occasions. There was generally a short window of time through a rain event when the four storm drain outlets would all be flowing. One observation of note was the relatively low volume of discharge from storm drain B during rain event monitoring. A number of peak rain events in August to October that occurred on Friday evening and Saturdays were not sampled because of laboratory restrictions in analyzing bacteria samples through the weekend. Site conditions are outlined in Appendix A.

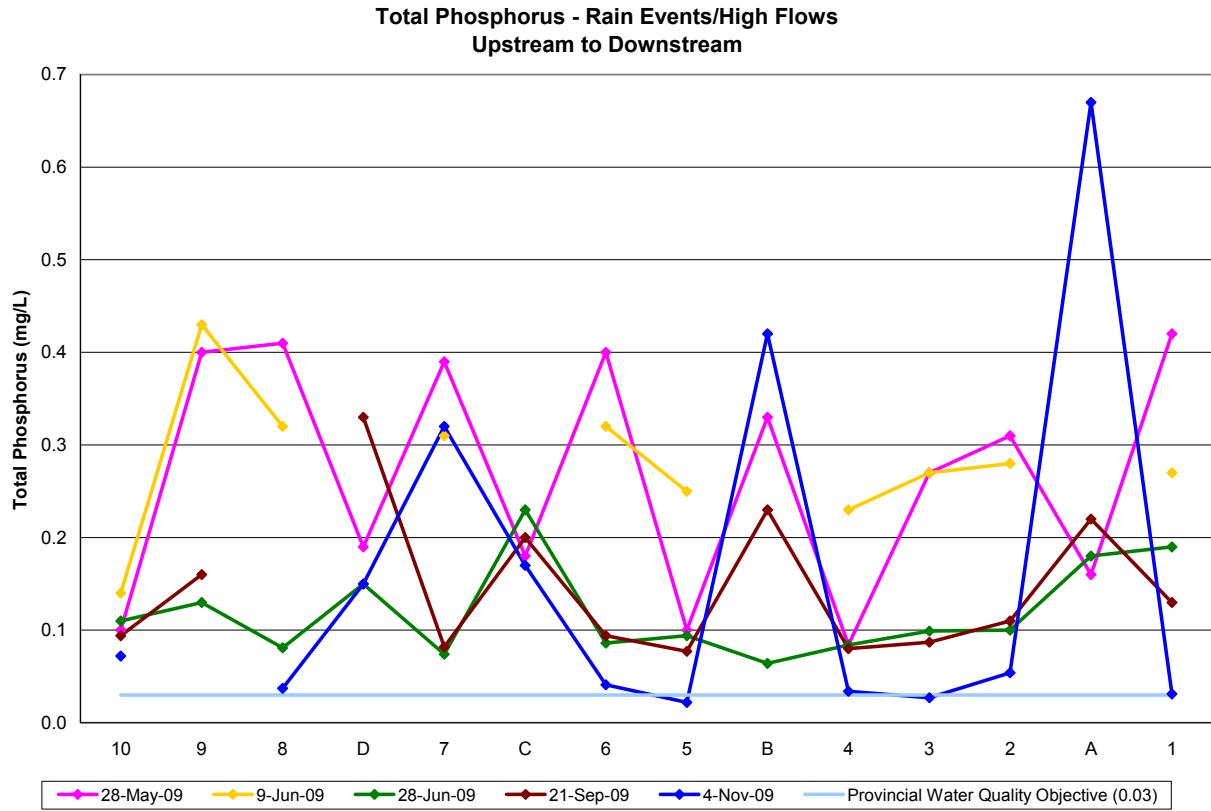
Figure 3b. Total Phosphorus Concentrations from Upstream to Downstream for Rain Event Conditions

- Concentrations of total phosphorus routinely exceed the Provincial Objective for the protection of aquatic life at all sampled sites for baseflow conditions (concentrations one to four times PWQO) and rain event conditions (one to 13 times PWQO).

- Storm drain B in Southside Park discharged higher concentrations of total phosphorus than levels in Cedar Creek at that location on three of four rain event samples but, at time of sampling, samples do not show storm drain B raising total phosphorus levels in the creek between stations 5 and 4. Storm drains A, C and D discharged total phosphorus levels significantly higher than adjacent creek concentrations on two of the four sample dates.

- Samples taken upstream and downstream of Southside Pond show a small decrease in total phosphorus, indicating some nutrient retention/uptake in the pond.

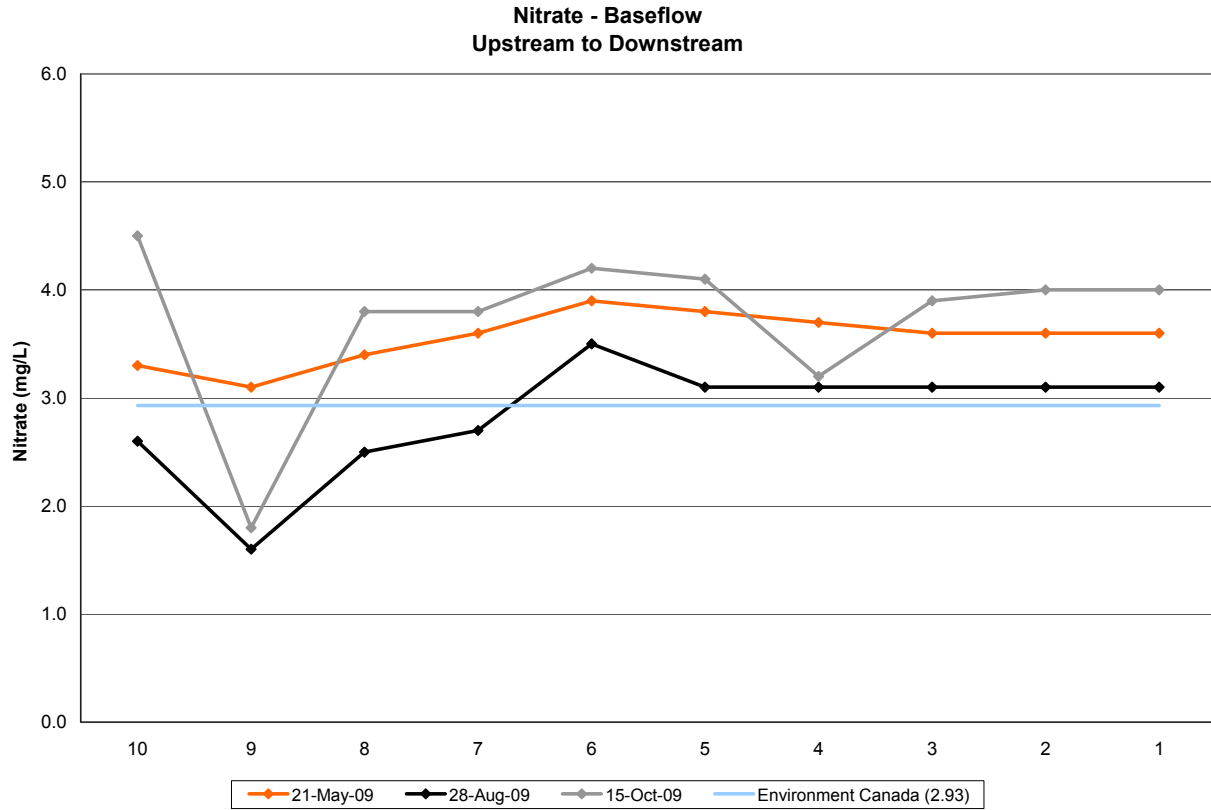
Figure 4a. Nitrate Concentrations from Upstream to Downstream for Baseflow Conditions

- Storm drains A, B, C and D all show low nitrate levels, below the aquatic life guideline and lower than creek concentrations. However the ammonia data shows the reverse with peaks in ammonia levels at the storm drains. It is expected that nitrogen in the form of ammonia is high in storm drain runoff and is converting to nitrate in the creek.
- 70% of the creek nitrate samples are above the aquatic life guideline but are generally lower compared to many sites across the UTRCA⁸
- There is relatively low overall change in nitrate levels from upstream (site 8) to downstream (site 1).

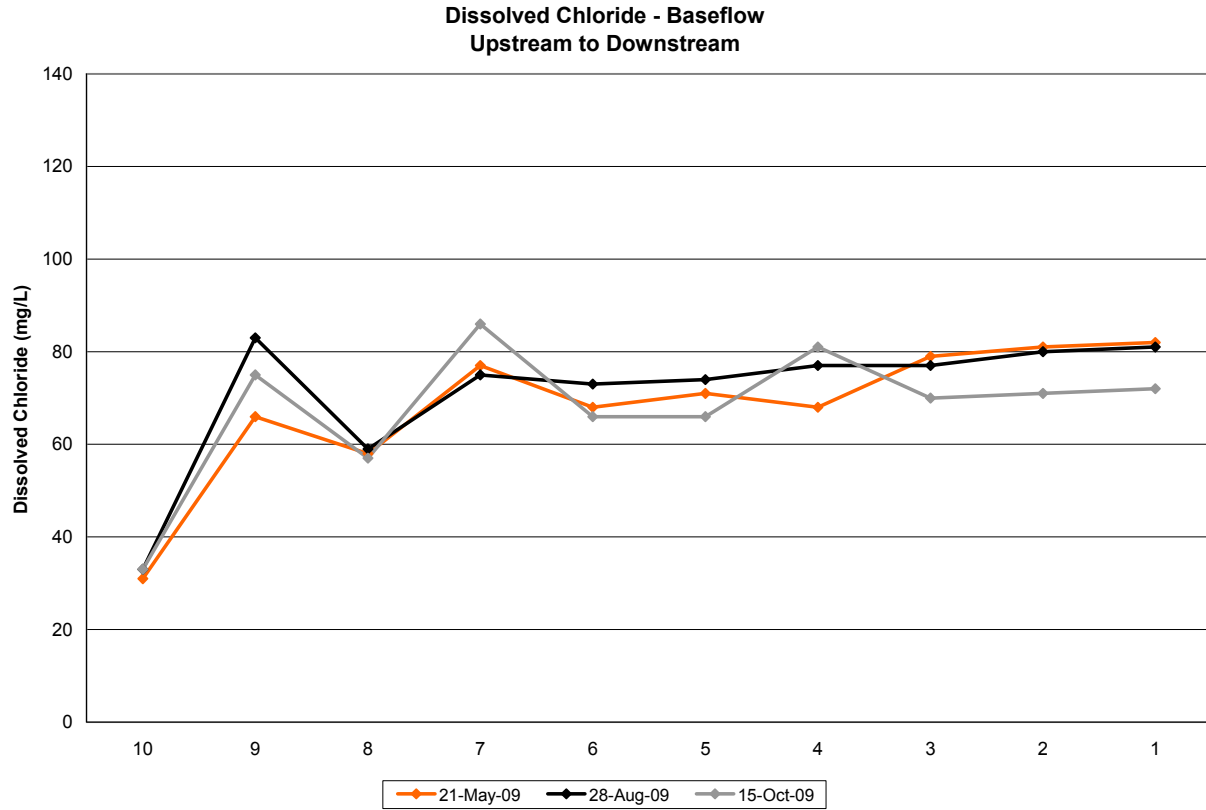
Figure 6a. Chloride Concentrations from Upstream to Downstream for Baseflow Conditions

- All samples had concentrations well below the Environment Canada toxicity guideline.
- For the majority of samples, the storm drains had much lower chloride levels than the main creek.
- There were fairly consistent creek concentrations from upstream (site 8) to downstream (site 1). The lowest chloride levels were in upstream site 10.
- The timing of sampling for this study does not provide data for winter or early spring runoff when chloride levels would be expected to be highest as a result of road salt runoff. Since the 1980s, chlorides have been increasing in Cedar Creek, a trend seen in many locations locally and across Ontario.

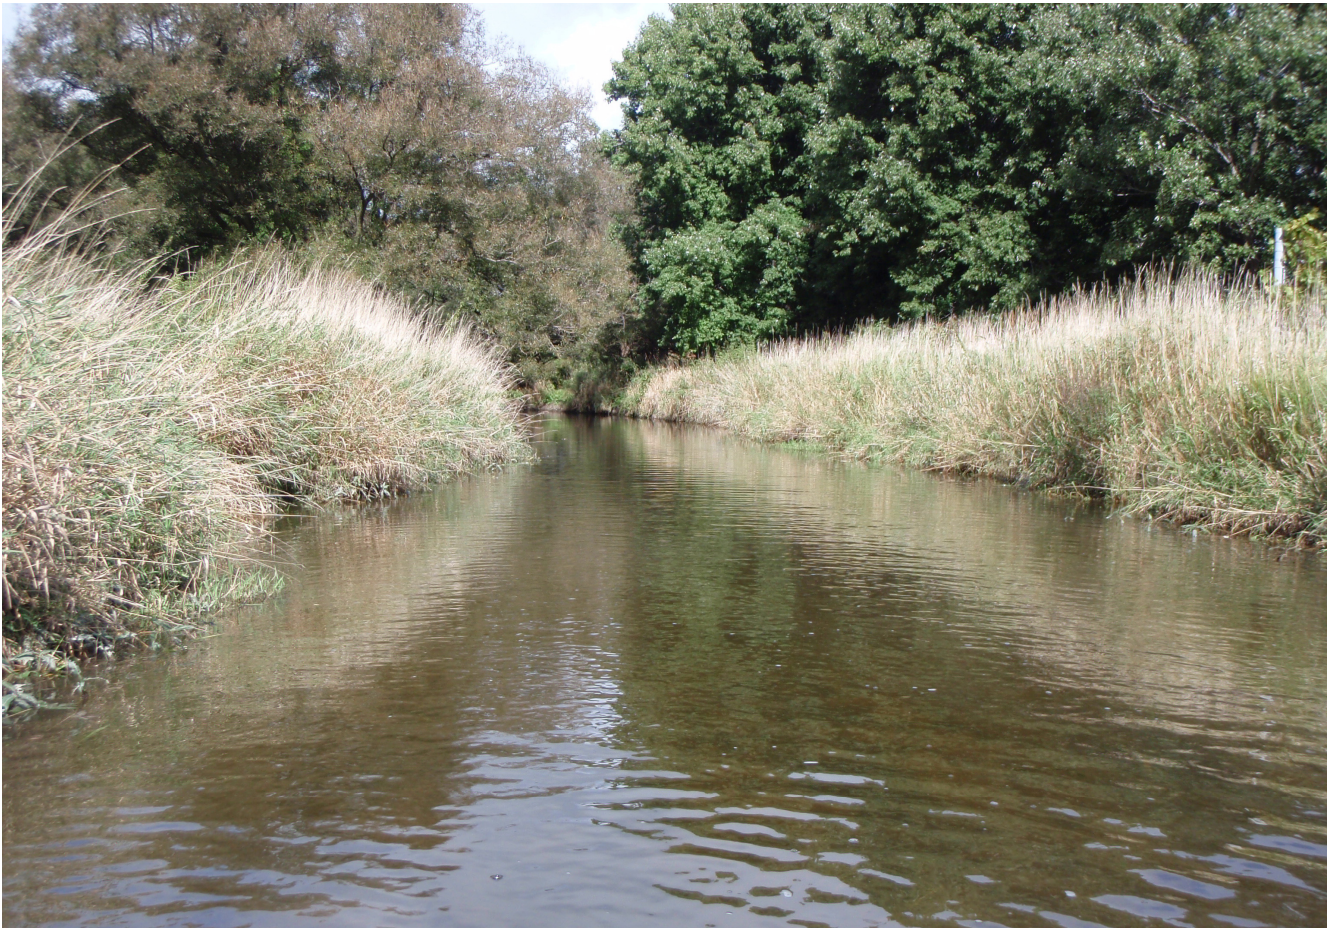
Table 1 provides the FBI values for the samples collected in 2009. The detailed information for this table is provided in Appendix B. In addition to the 2009 data, FBI values from 51 samples conducted at 12 sites in the Cedar Creek watershed from previous years are available in a separate document. Figure 12 outlines 2009 benthos FBI results, arranged from headwaters to outflow.

Methods of analyzing benthos data are diverse, ranging from simple metrics such as Taxa Richness (the total number of different families found in the subsamples) to complex multivariate analyses. For this study, Hilsenhoff's⁹ Family Biotic Index (FBI), a relatively simple and fairly consistent and reliable metric, has been utilized. The FBI assigns a biotic index value to each benthos family through a range of 0-10, with 0 being families requiring pristine conditions while those assigned a 10 can survive in severely impacted conditions. A weighted average of the biotic index values of all BMI identified is calculated for each sample. This FBI allows placement of the sample in various water quality/stream health categories from excellent (<4.25) to very poor (>7.5).
