# Fullarton Dam and Conservation Area

## Existing Environmental Conditions

March 2017 Draft

UPPER THAMES RIVER  
CONSERVATION AUTHORITY

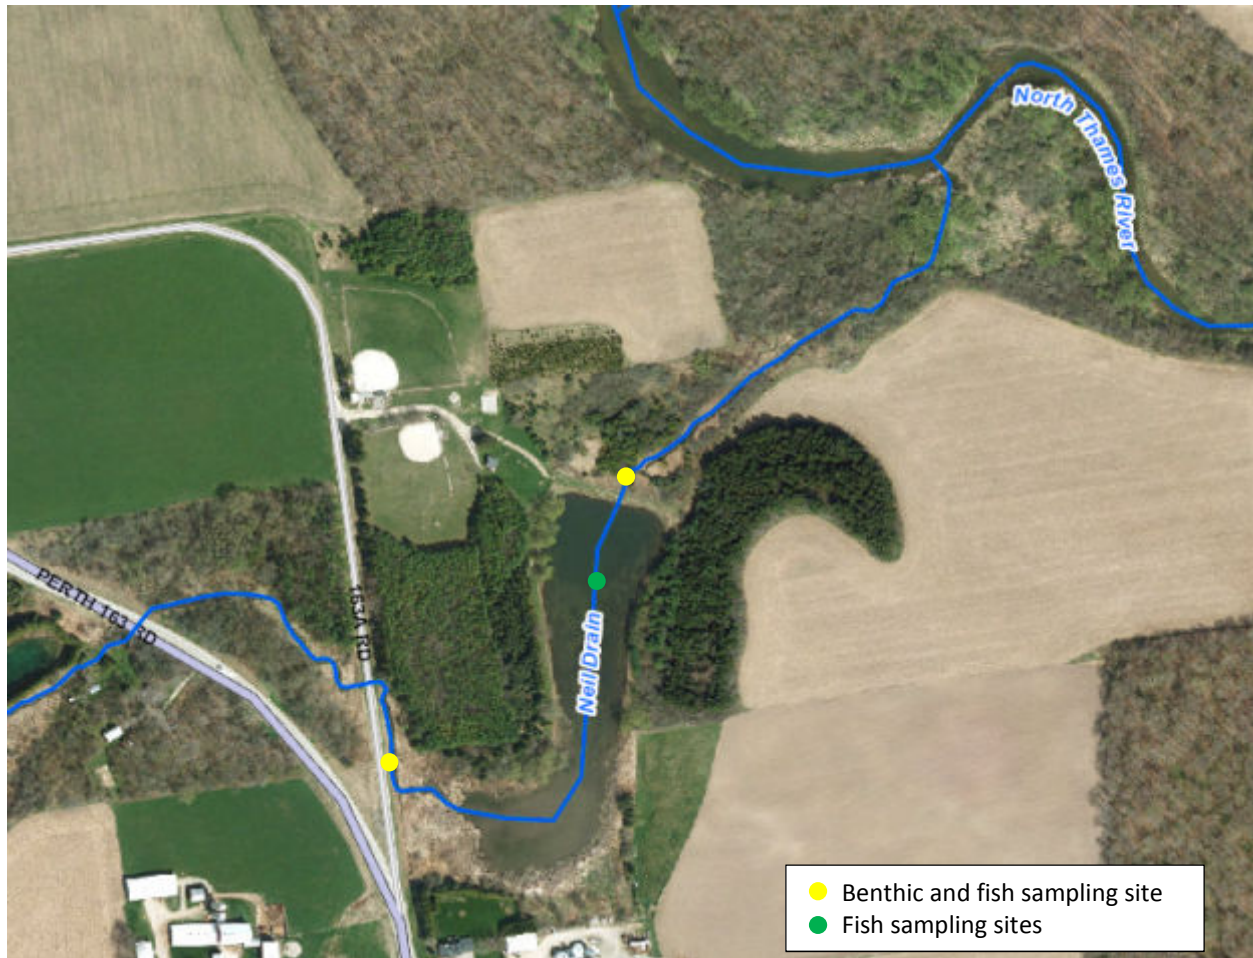
Figure 10: Fullarton Dam area benthic and fish sampling sites (Source: UTRCA)

Electrofishing and benthic surveys were carried out during 2015 and 2016. The map in Figure 10 shows the different sampling sites. A list of recorded fish and benthic species, separated into sampling location, is provided in Appendix D: Fullarton CA Fish and Benthic Records.

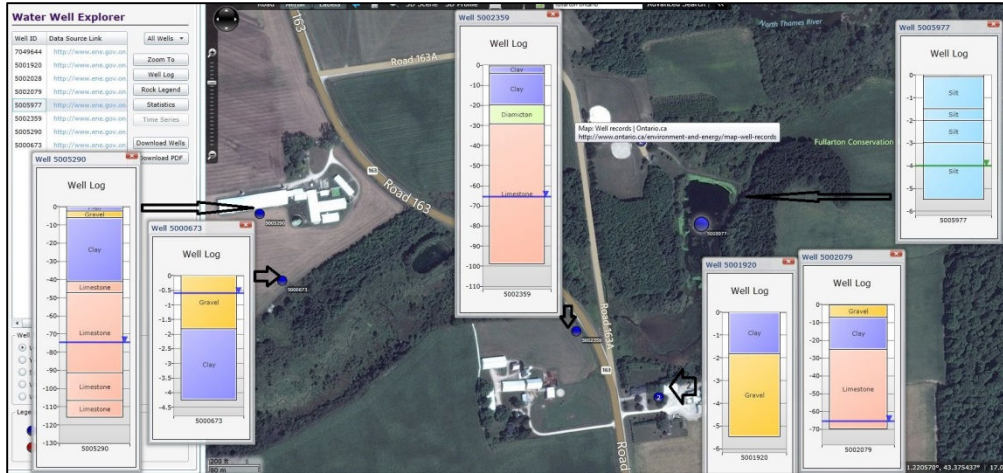
Figure 2: Location of wells in the area and the nature of the aquifers at depth. There are both shallow overburden wells (less than 15 m depth) and deep bedrock wells tapping water between 70 and 120 m depth. The graphic superimposed on the aerial photography is a representation of the materials encountered at depth as described by the well driller. The colour indicates material and the aquifers are represented by gravel and limestone, depth of the well is indicated in meters. (<http://analysis.gw-info.net/gin/publicgin.aspx>)

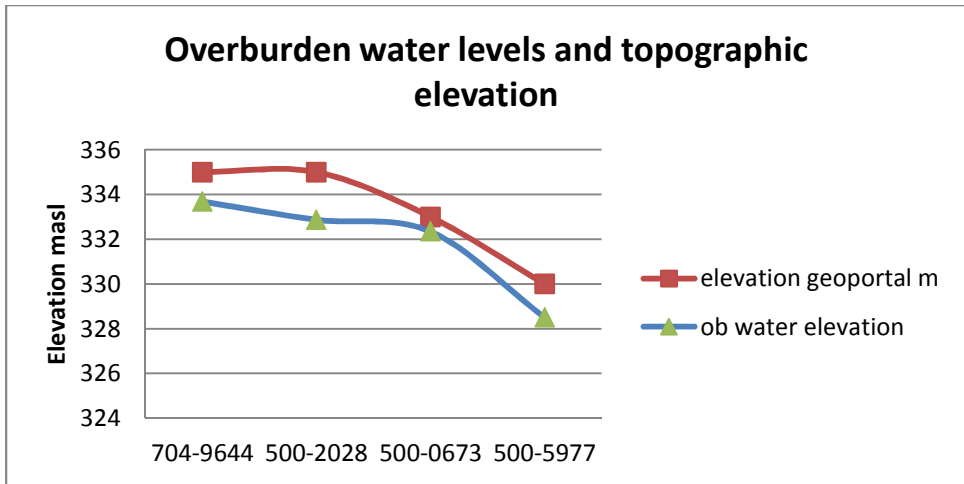
Figure 4: Ground elevation versus shallow water table based on MOECC well logs.

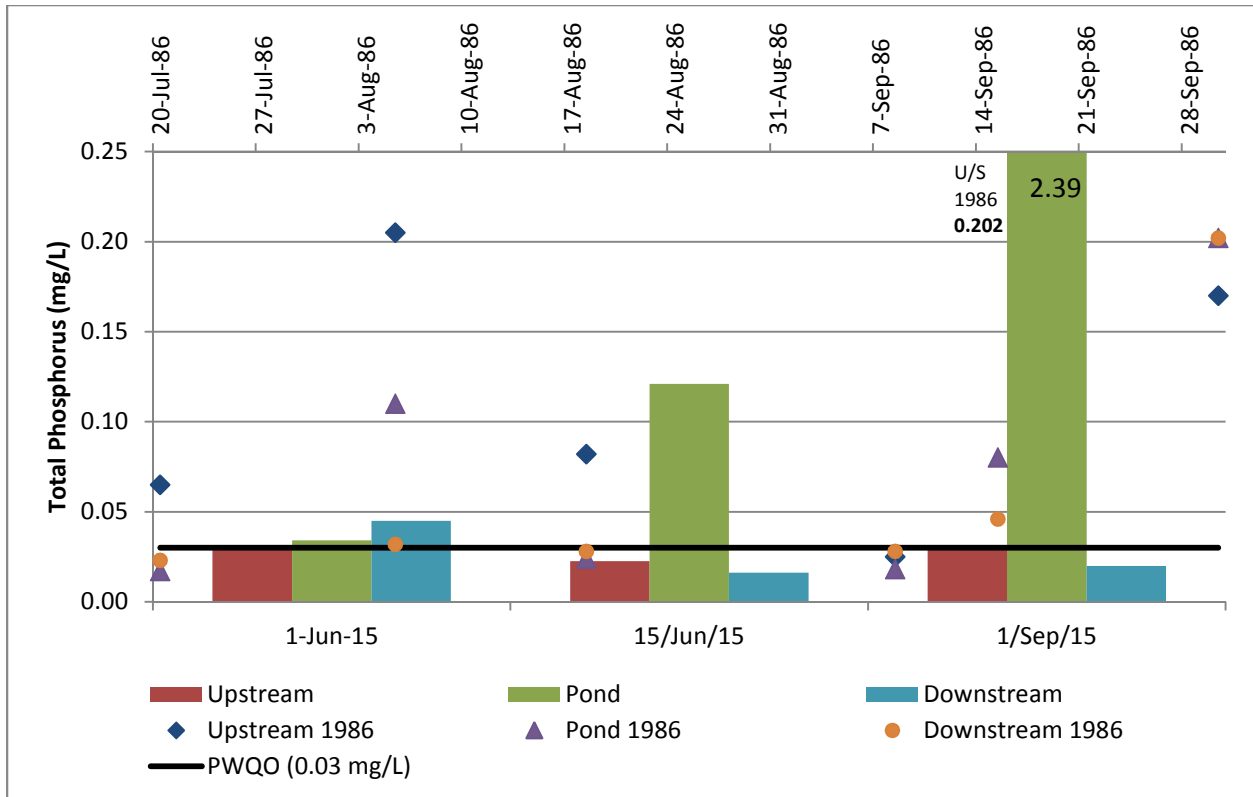
Figure 5: Total Phosphorus 1986 and 2015

- In 2015 concentrations of total phosphorus were low and close to the Provincial Objective except for the pond site which was elevated on June 15 and September 1.
- The 1986 levels were varied with more than half above the Provincial Objective. The upstream site was generally higher than the pond and downstream levels.
- Orthophosphate levels are low. The lowest numbers are in the mid to late summer and early fall when plant uptake of this more biologically available form of phosphorus is at its peak. The 1986 levels were also low except for the September levels on the 15<sup>th</sup> and 30<sup>th</sup> when the levels became elevated.

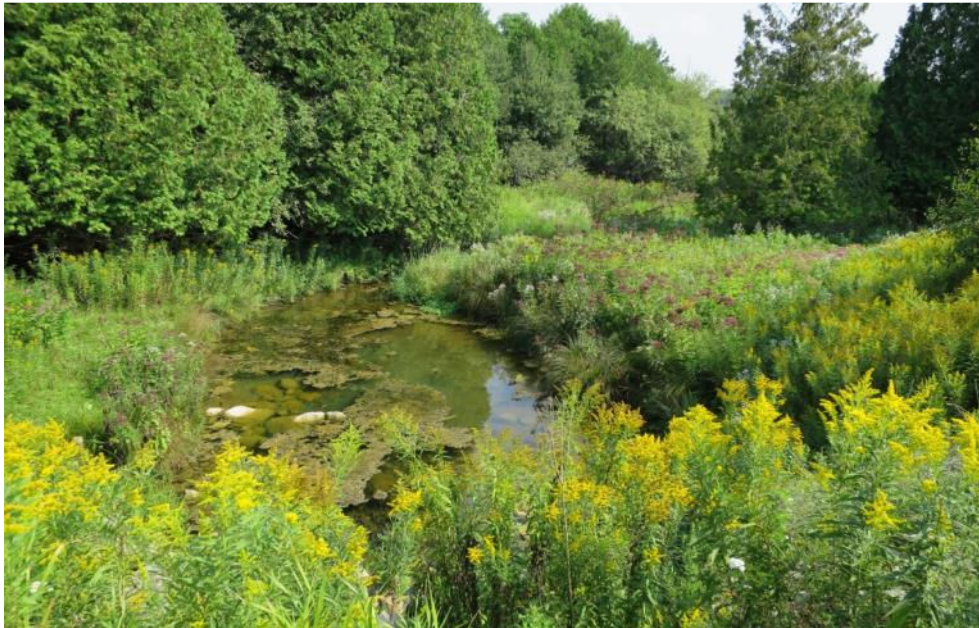
Photo 1. Community 1 — View looking downstream from the dam crossing, with goldenrods and Joe Pye-weed in bloom.

Mature trees include White Cedar, ash, Black Walnut, spruce and pines. There are a variety of shrubs including dogwoods, nannyberry and highbush cranberry. In the sunnier areas along the creek there was a wide range of wildflowers, both native and non-native, including asters, goldenrods, Spotted Joe Pye-Weed, touch-me-nots, Field Mint and a variety of grass species.

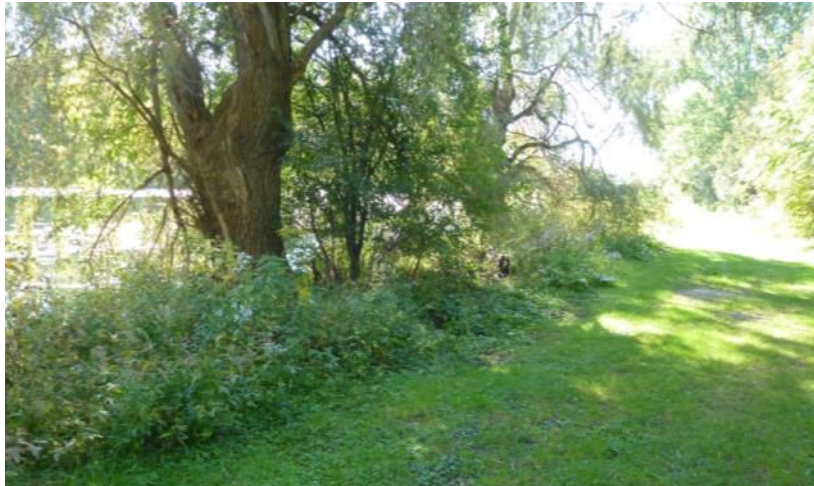
Photo 2. Community 2 — Cultural meadow (lawn) along the edge of the reservoir.

Pond shore plants include Swamp Milkweed, Field Mint, Peppermint, cattails, Joe-Pye-Weed, beggarticks, jewelweeds and the non-native Yellow-Flag (iris). These wetland plants are also represented in the shallow marsh of Community 4.

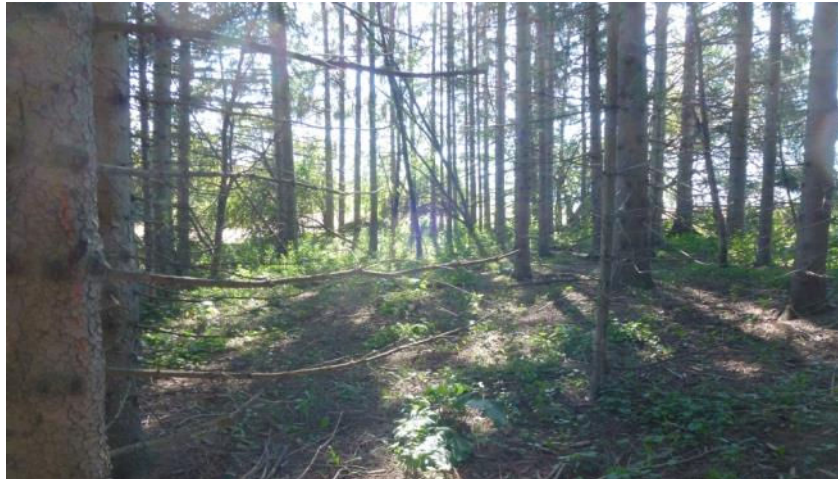
Photo 4. Community 3 – The large 50-year old pines create a lot of shade, limiting understory plants.

Dominant tree species include Norway Spruce and White Pine. There is a sparse understory of shrubs and herbaceous plants, typical of dark, shaded plantations. Species included hawthorns, apple, dogwoods, Red Elderberry, currants and raspberries. At the southwest end of this community is a low-lying forest consisting of apples, Manitoba Maple, ash, buckthorn, Silver Maple and willow.

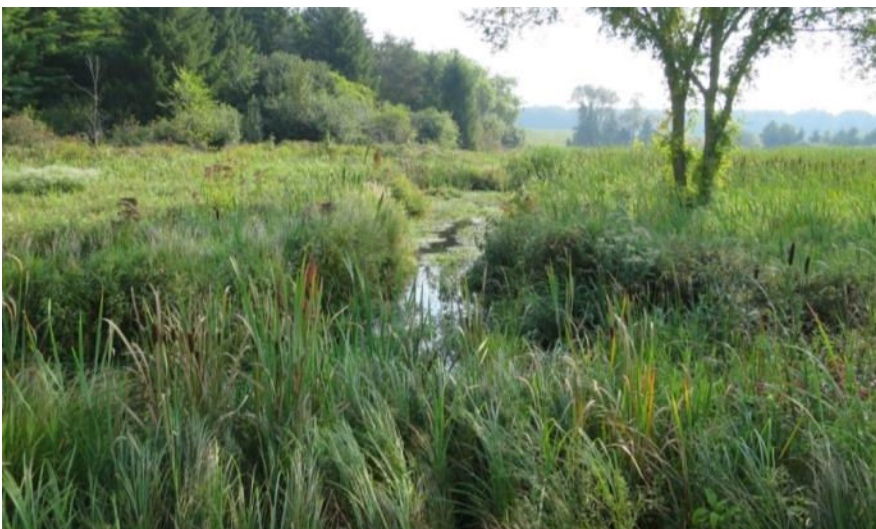
Photo 7. Community 4 – The shallow marsh grows along the inflowing Neil Drain

This community has developed along the upstream end of the reservoir where the water is shallow enough to support these emergent plants. As the creek (Neil Drain) enters the pond, it slows down and silt settles out. The pond has been filling up with sediment over the years, especially the lower end.

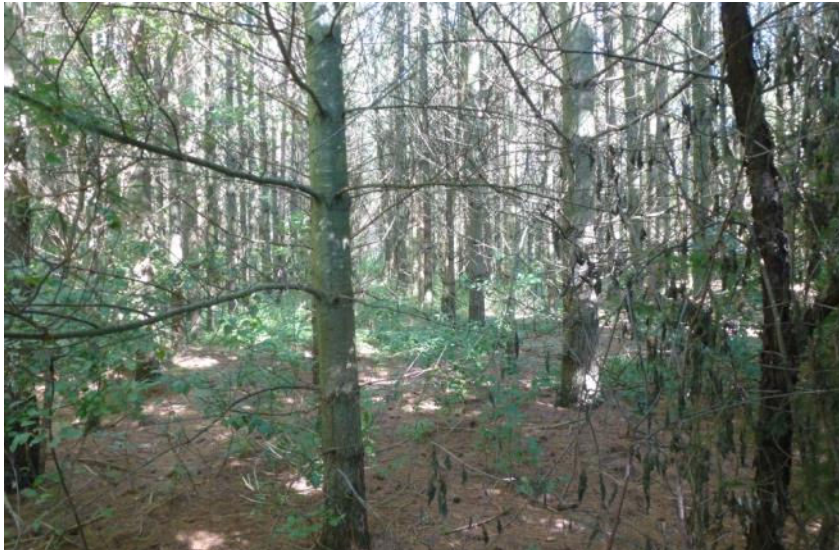
Photo 8. Community 5 is dominated by 35 year old White Pines.

Dominant tree species include White Pine, White Spruce, Norway Spruce with some Eastern White Cedar. A sparse shrub component consisted of dogwoods, young ash, Red Elderberry, and raspberries. The herbaceous layer was very sparse in the centre of the plantation, thickening up towards the edges where there is more sunlight.

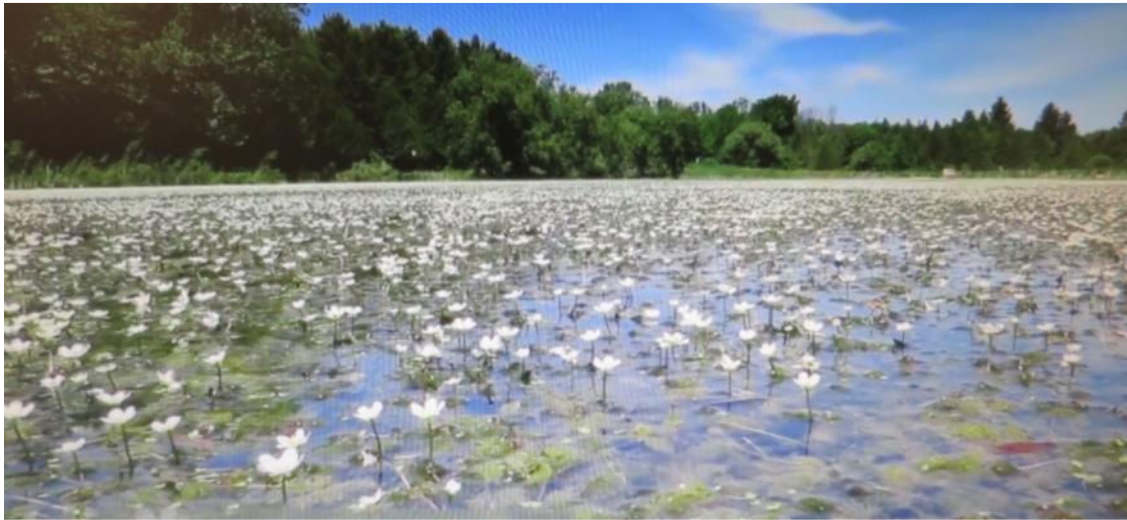
Photo 10. Community 6 – White Water-Buttercups blanket the Fullarton pond, June 9<sup>th</sup>, 2016.

The submerged and rooted pond plants were not surveyed. However, a native, rooted aquatic plant called White Water Buttercup (*Ranunculus aquatilis* (formerly *R. trichophyllus*) was seen on June 9<sup>th</sup> of 2016, the flowers blanketing the pond. This flower was not seen in 2015.

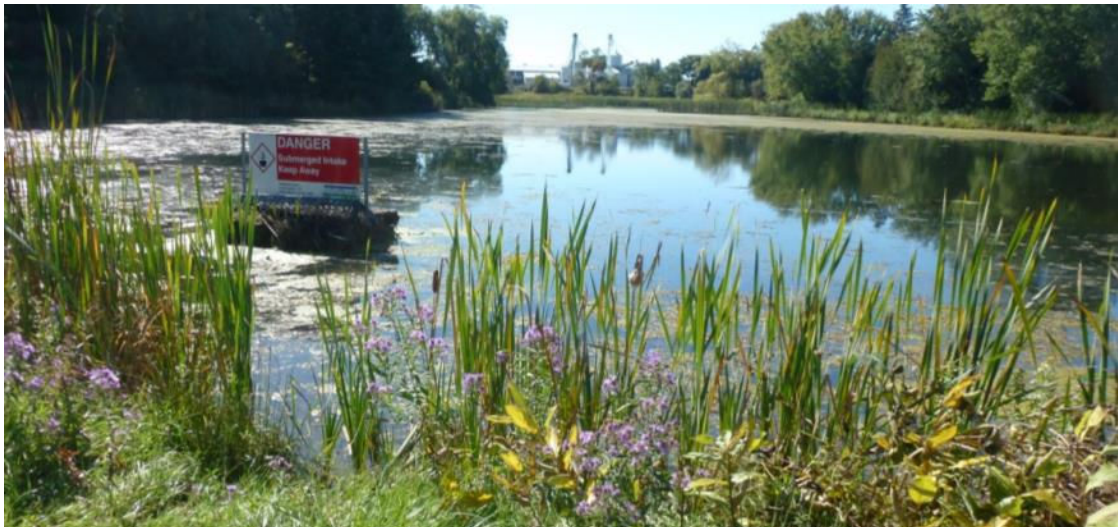
Photo 11. Community 6 – Floating algae is visible on the Fullarton pond/reservoir surface (2015). A narrow fringe of cattails line the bank. Asters and Common Milkweed grow adjacent to the pond on the drier ground in late summer.

Any shoreline vegetation is included in Communities 1 to 5. Aside from the shallow marsh at the south end of the pond/reservoir, there is only a narrow fringe of wetland emergent plants growing along the pond shore. The pond is steep sided and the water level permanent, so this does not permit the establishment of many wetland plants as they often require seasonal mudflats to germinate.

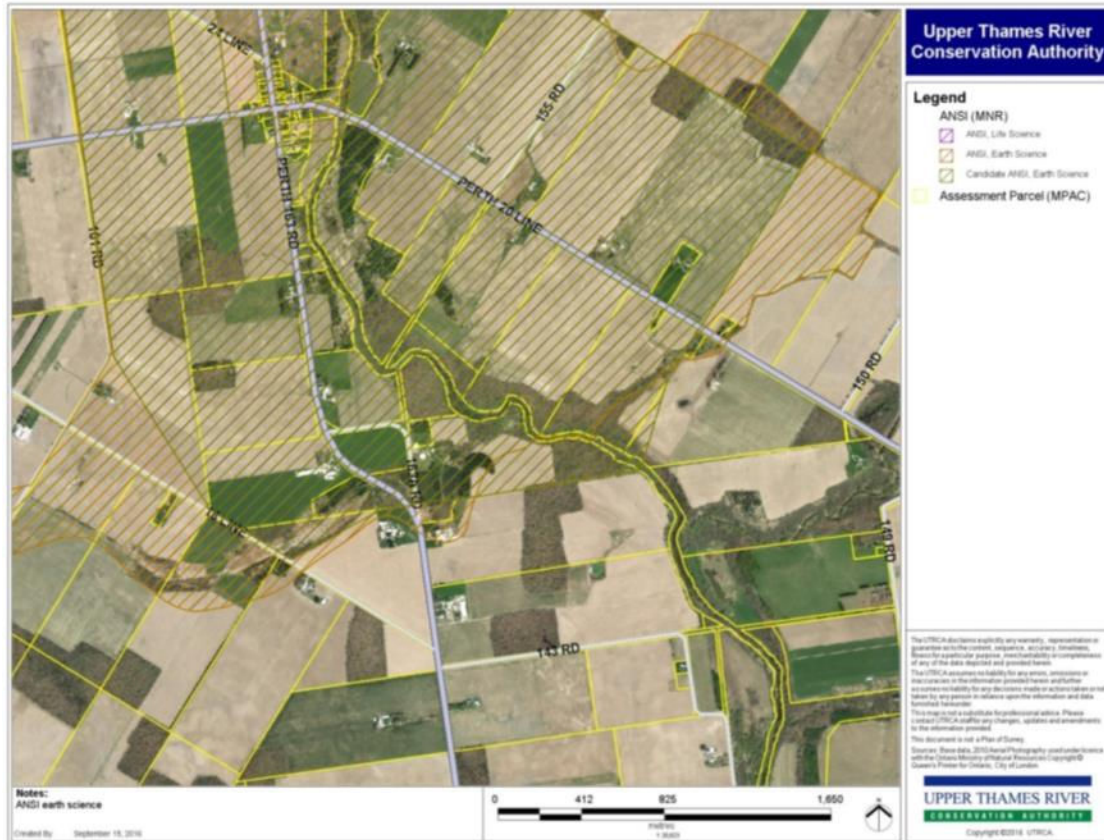
**Figure 5. Earth Science ANSIs near Fullarton CA**

**Earth science ANSIs** are geological in nature and contain significant examples of bedrock, fossils, landforms or ongoing geological processes. Figure 5 shows two overlapping earth science ANSIs in the Fullarton area: the North Thames Valley ANSI (orange hatch lines) and the candidate Fullarton Moraine ANSI (olive green hatch lines).

The removal of a man-made dam and restoration of the creek would not interfere with these ANSI features. The Fullarton CA receives tax exemption under the CLTIP (Conservation Land Tax Incentive Program) because it is situated on an earth science ANSI.

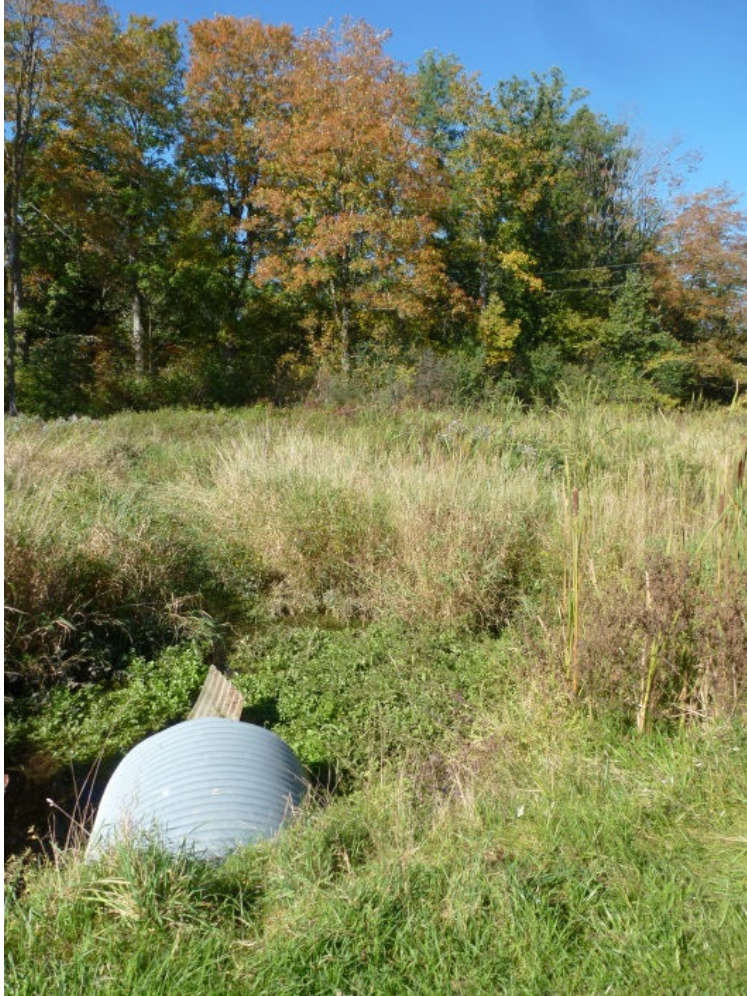
Photo 15. Road culvert on the Neil Drain upstream of Road 163A. A marsh/meadow habitat has established close to the water, with woodland farther back.

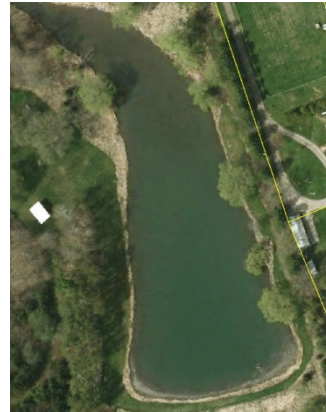
Pond Depth 1974

**Estimated loss in reservoir volume 1965 – 2015 = 30% to 35%**
