Emburo Dam and Conservation Area

Existing Environmental Conditions

Updated October 13, 2016

UPPER THAMES RIVER
CONSERVATION AUTHORITY

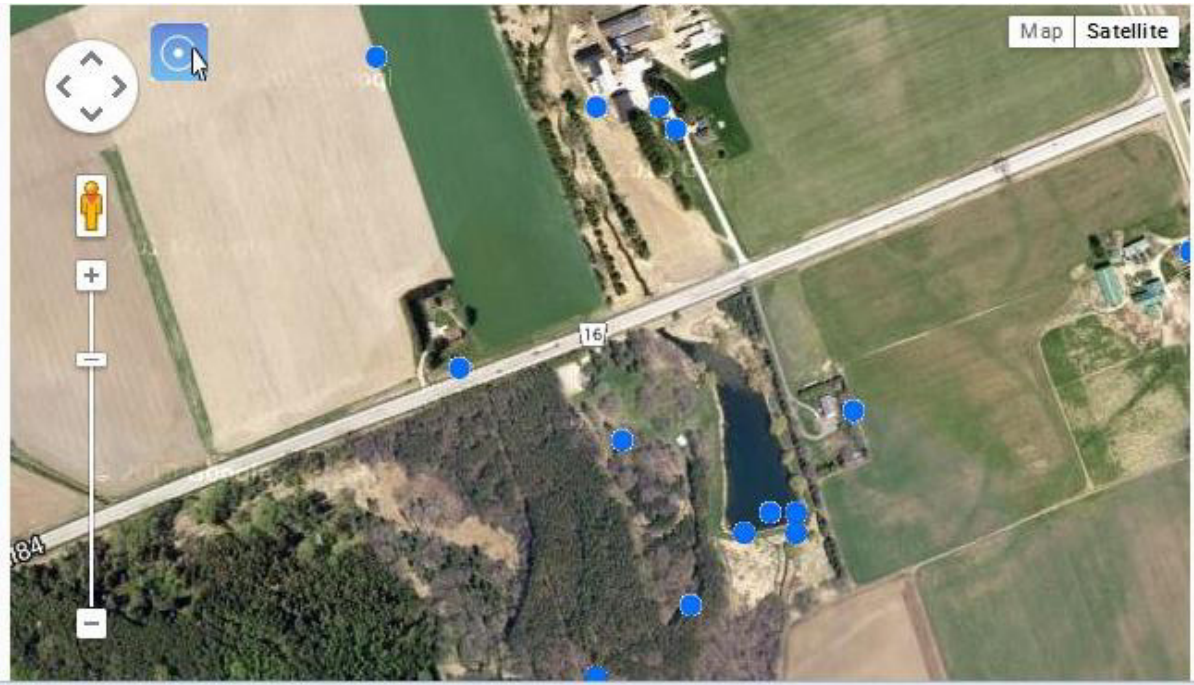
Figure 7 Known Wells in the Area of Embro CA (Source: MOECC)

All background information and individual well records were retrieved from the Ministry of the Environment and Climate Change (MOECC) and provided to Ecosystem Recovery Inc. for analysis by their sub-consultant Englobe (formerly LVM). Figure 7 shows the locations of the known wells in the area. The wells shown on the Embro Dam are Bore Holes for the past Dam Safety investigations.

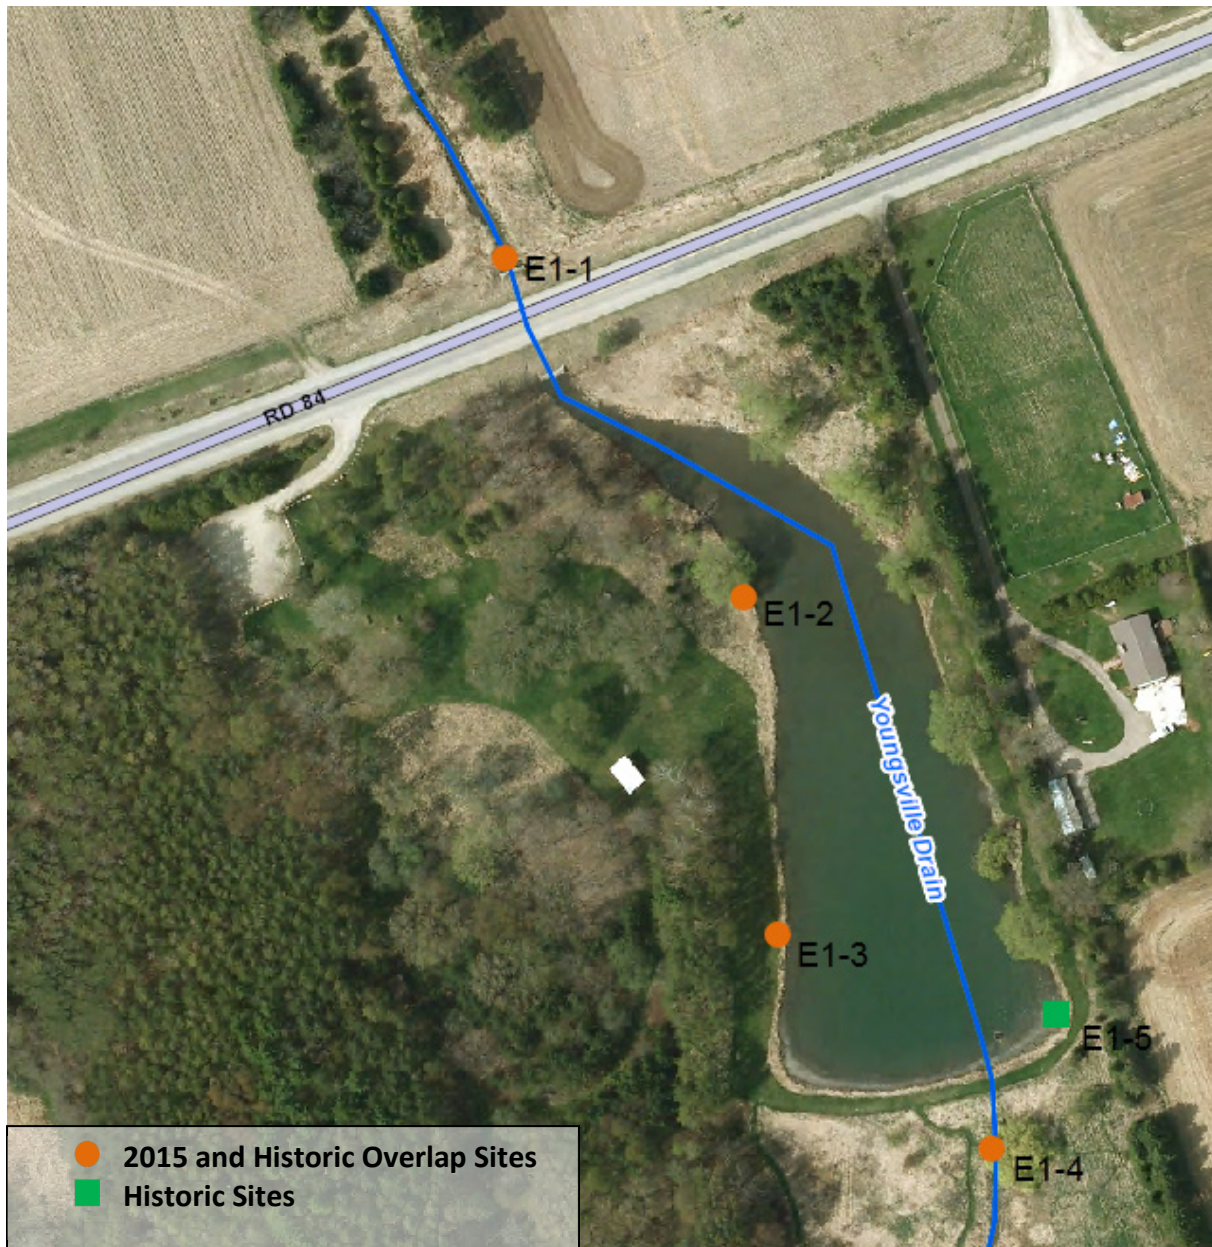
Figure 8 Embro Pond Water Quality Sampling Sites 2015 (Source: UTRCA)

A series of five water samples were collected at four locations in the area of Embro CA: one upstream of the pond, two in the pond, and one downstream of the dam (see map in Figure 8). This monitoring provides a snapshot of water quality, and is limited to the conditions of April to October 2015. Embro Pond was part of a past targeted watershed study and remediation work, with water monitoring occurring from 1986 to 1994. This data has been included in the evaluation of the results, which can be found in Appendix B: Embro Pond Water Quality Assessment.

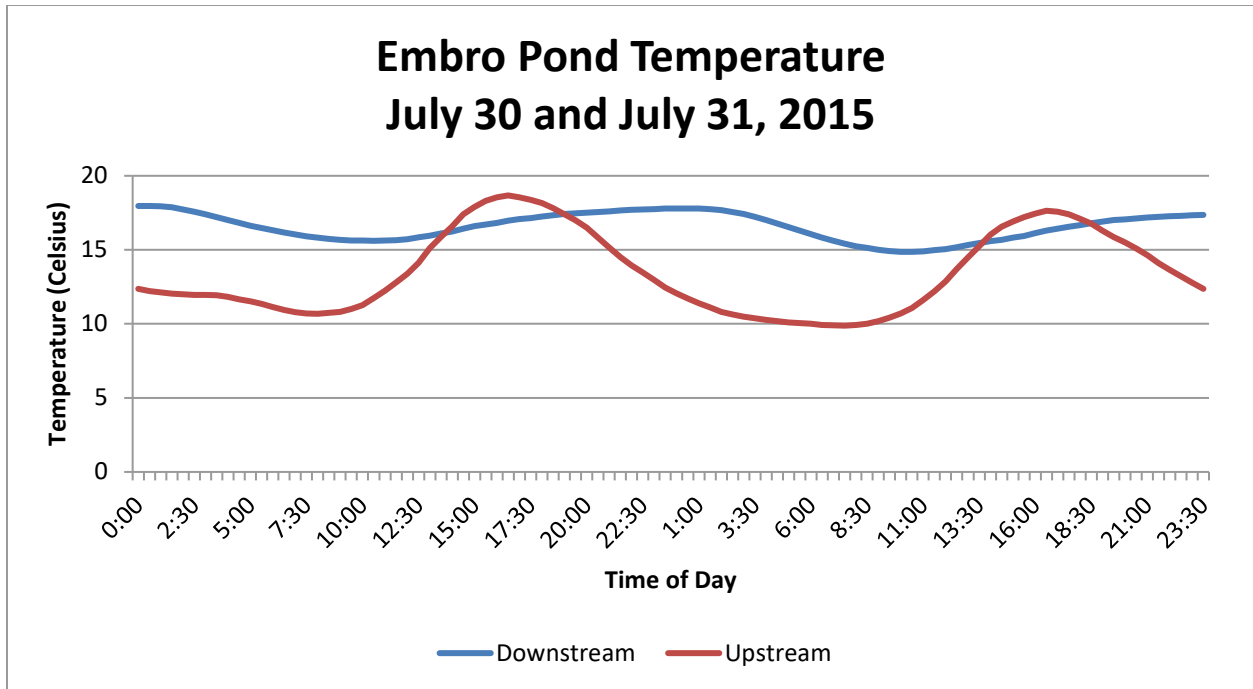
Figure 10 Temperature upstream and Downstream of Embroid Pond Showing in Detail the Diurnal Changes, July 30 – 31, 2015 (Source: UTRCA)

Both upstream and downstream temperatures show a diurnal pattern with daytime highs and night time lows. Upstream has a wider range of diurnal temperatures with approximately 6C change compared with 2-3C change downstream, as can be seen in Figure 10. Stream temperature data for June, July and August 2015 were taken during periods in which monthly air temperature averages were similar to historical monthly air temperature averages (ref. Environment Canada - London Airport). The September 2015 air temperature average was higher than historical September air temperature averages, which may have kept the water temperature higher than normal.

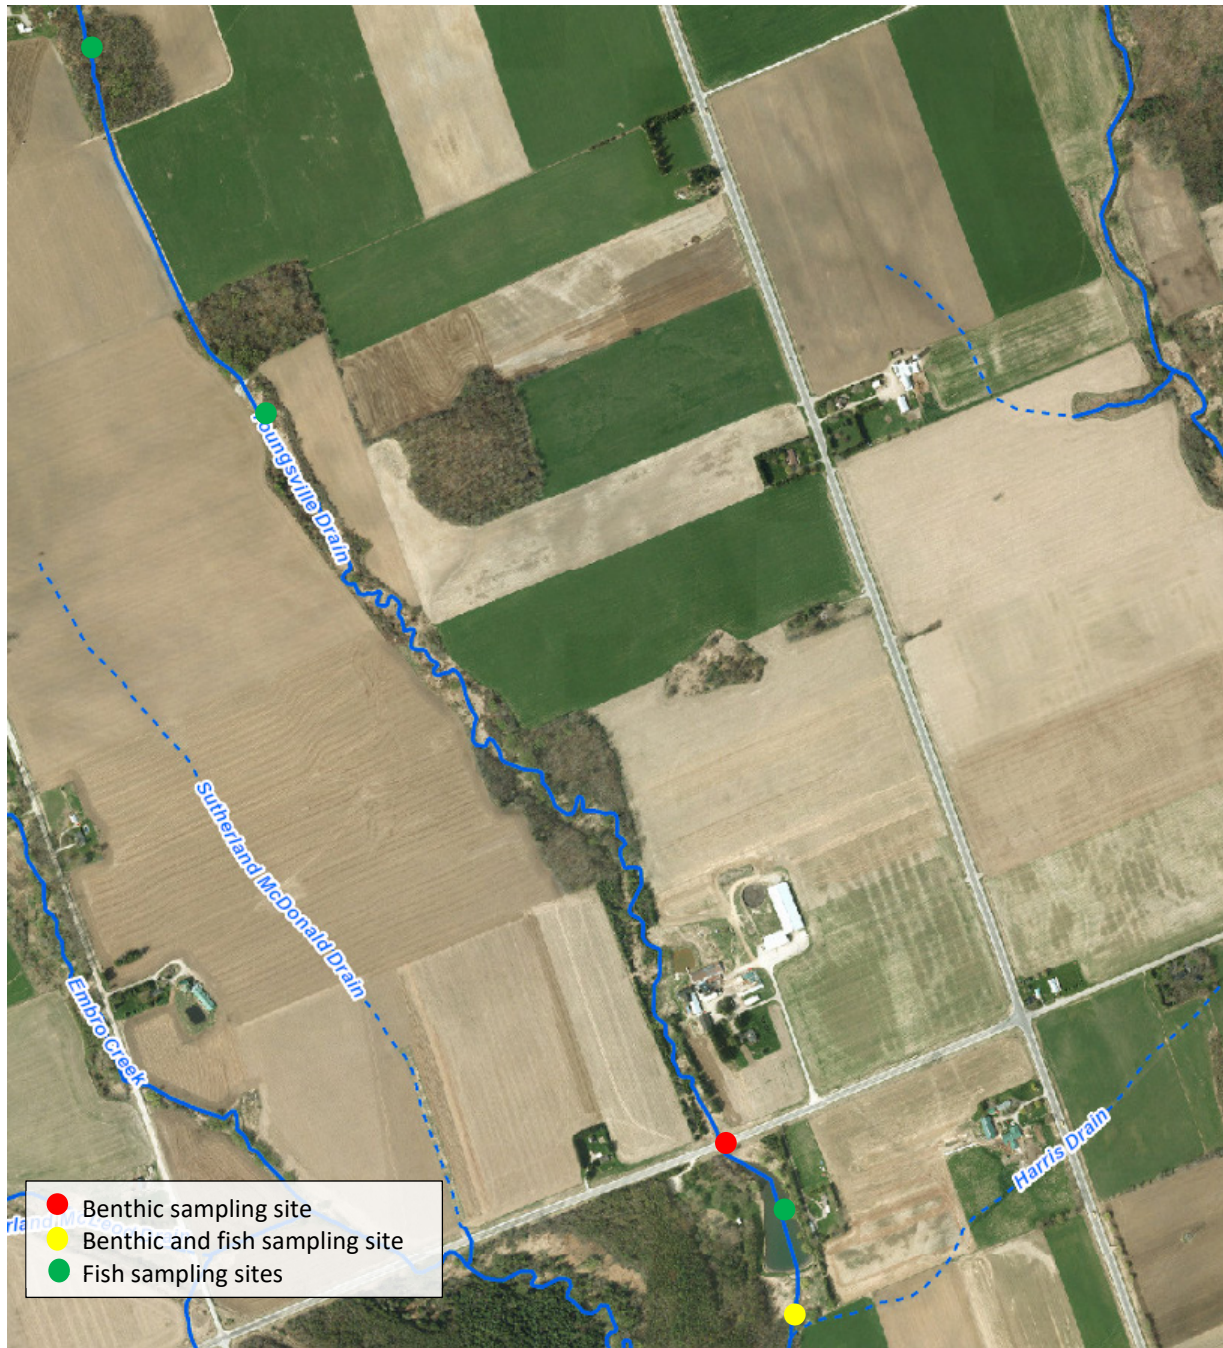
Figure 11 Embro Dam Area Benthic and Fish Sampling Sites (Source: UTRCA)

Electrofishing and benthic surveys were carried out during the spring, summer and fall of 2015. The map in Figure 10 shows the different sampling sites. A list of recorded fish and benthic species, separated into sampling location, is provided in Appendix C: Embroid Dam area Fish and Benthic Records.

An electrofishing survey of the Embro Pond as well as downstream of the dam was conducted on April 15, 2015. The site downstream of the dam was surveyed two more times, once on July 8, and once on October 19, 2015, to provide three season data. Youngsville Drain has been sampled extensively in the past, both upstream and downstream of pond, and found to support a fairly stable brook trout dominated community. Two samples on upstream reaches (May 7, 2015 and November 2014) were deemed adequate to confirm fish community composition. All specimens were identified to species, recorded, and released. Sample records, including historic records, are tracked in an MS Access database and provided in Appendix C: Embro CA Fish and Benthic Records.

Benthic invertebrate sampling was conducted in the spring (May 5) and fall (September 23), 2015, at sites on Youngsville Drain upstream of Embro Pond and downstream of the dam. Sampling was conducted using a traveling kick and sweep method, and samples handled and analyzed using methods consistent with Provincial (OBBN) and Federal (CABIN) protocols. Samples were preserved in the field, randomly subsampled in the lab and identified to the Family taxonomic level. Resulting data was entered into, and analyzed, using an MS Access database. Sample records (including historic records) with calculated Family Biotic Index (FBI) are provided in Appendix C: Embro Dam area Fish and Benthic Records.

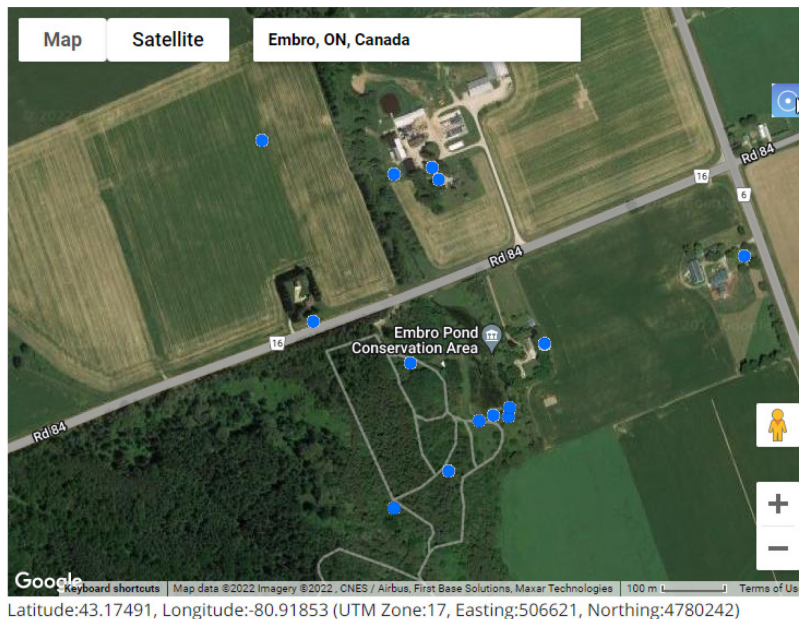
Image 1 MECP Well Records Map (<https://www.ontario.ca/page/map-well-records>)

A map of well records from well records map of the Ontario Ministry of Environment, Conservation and Park (MECP) was retrieved and reviewed for any updates. No changes to the well records were noticed.
