Embryo Dam
Class Environmental Assessment
Public Information Centre

STUDY OBJECTIVES AND CLASS ENVIRONMENTAL ASSESSMENT PROCESS

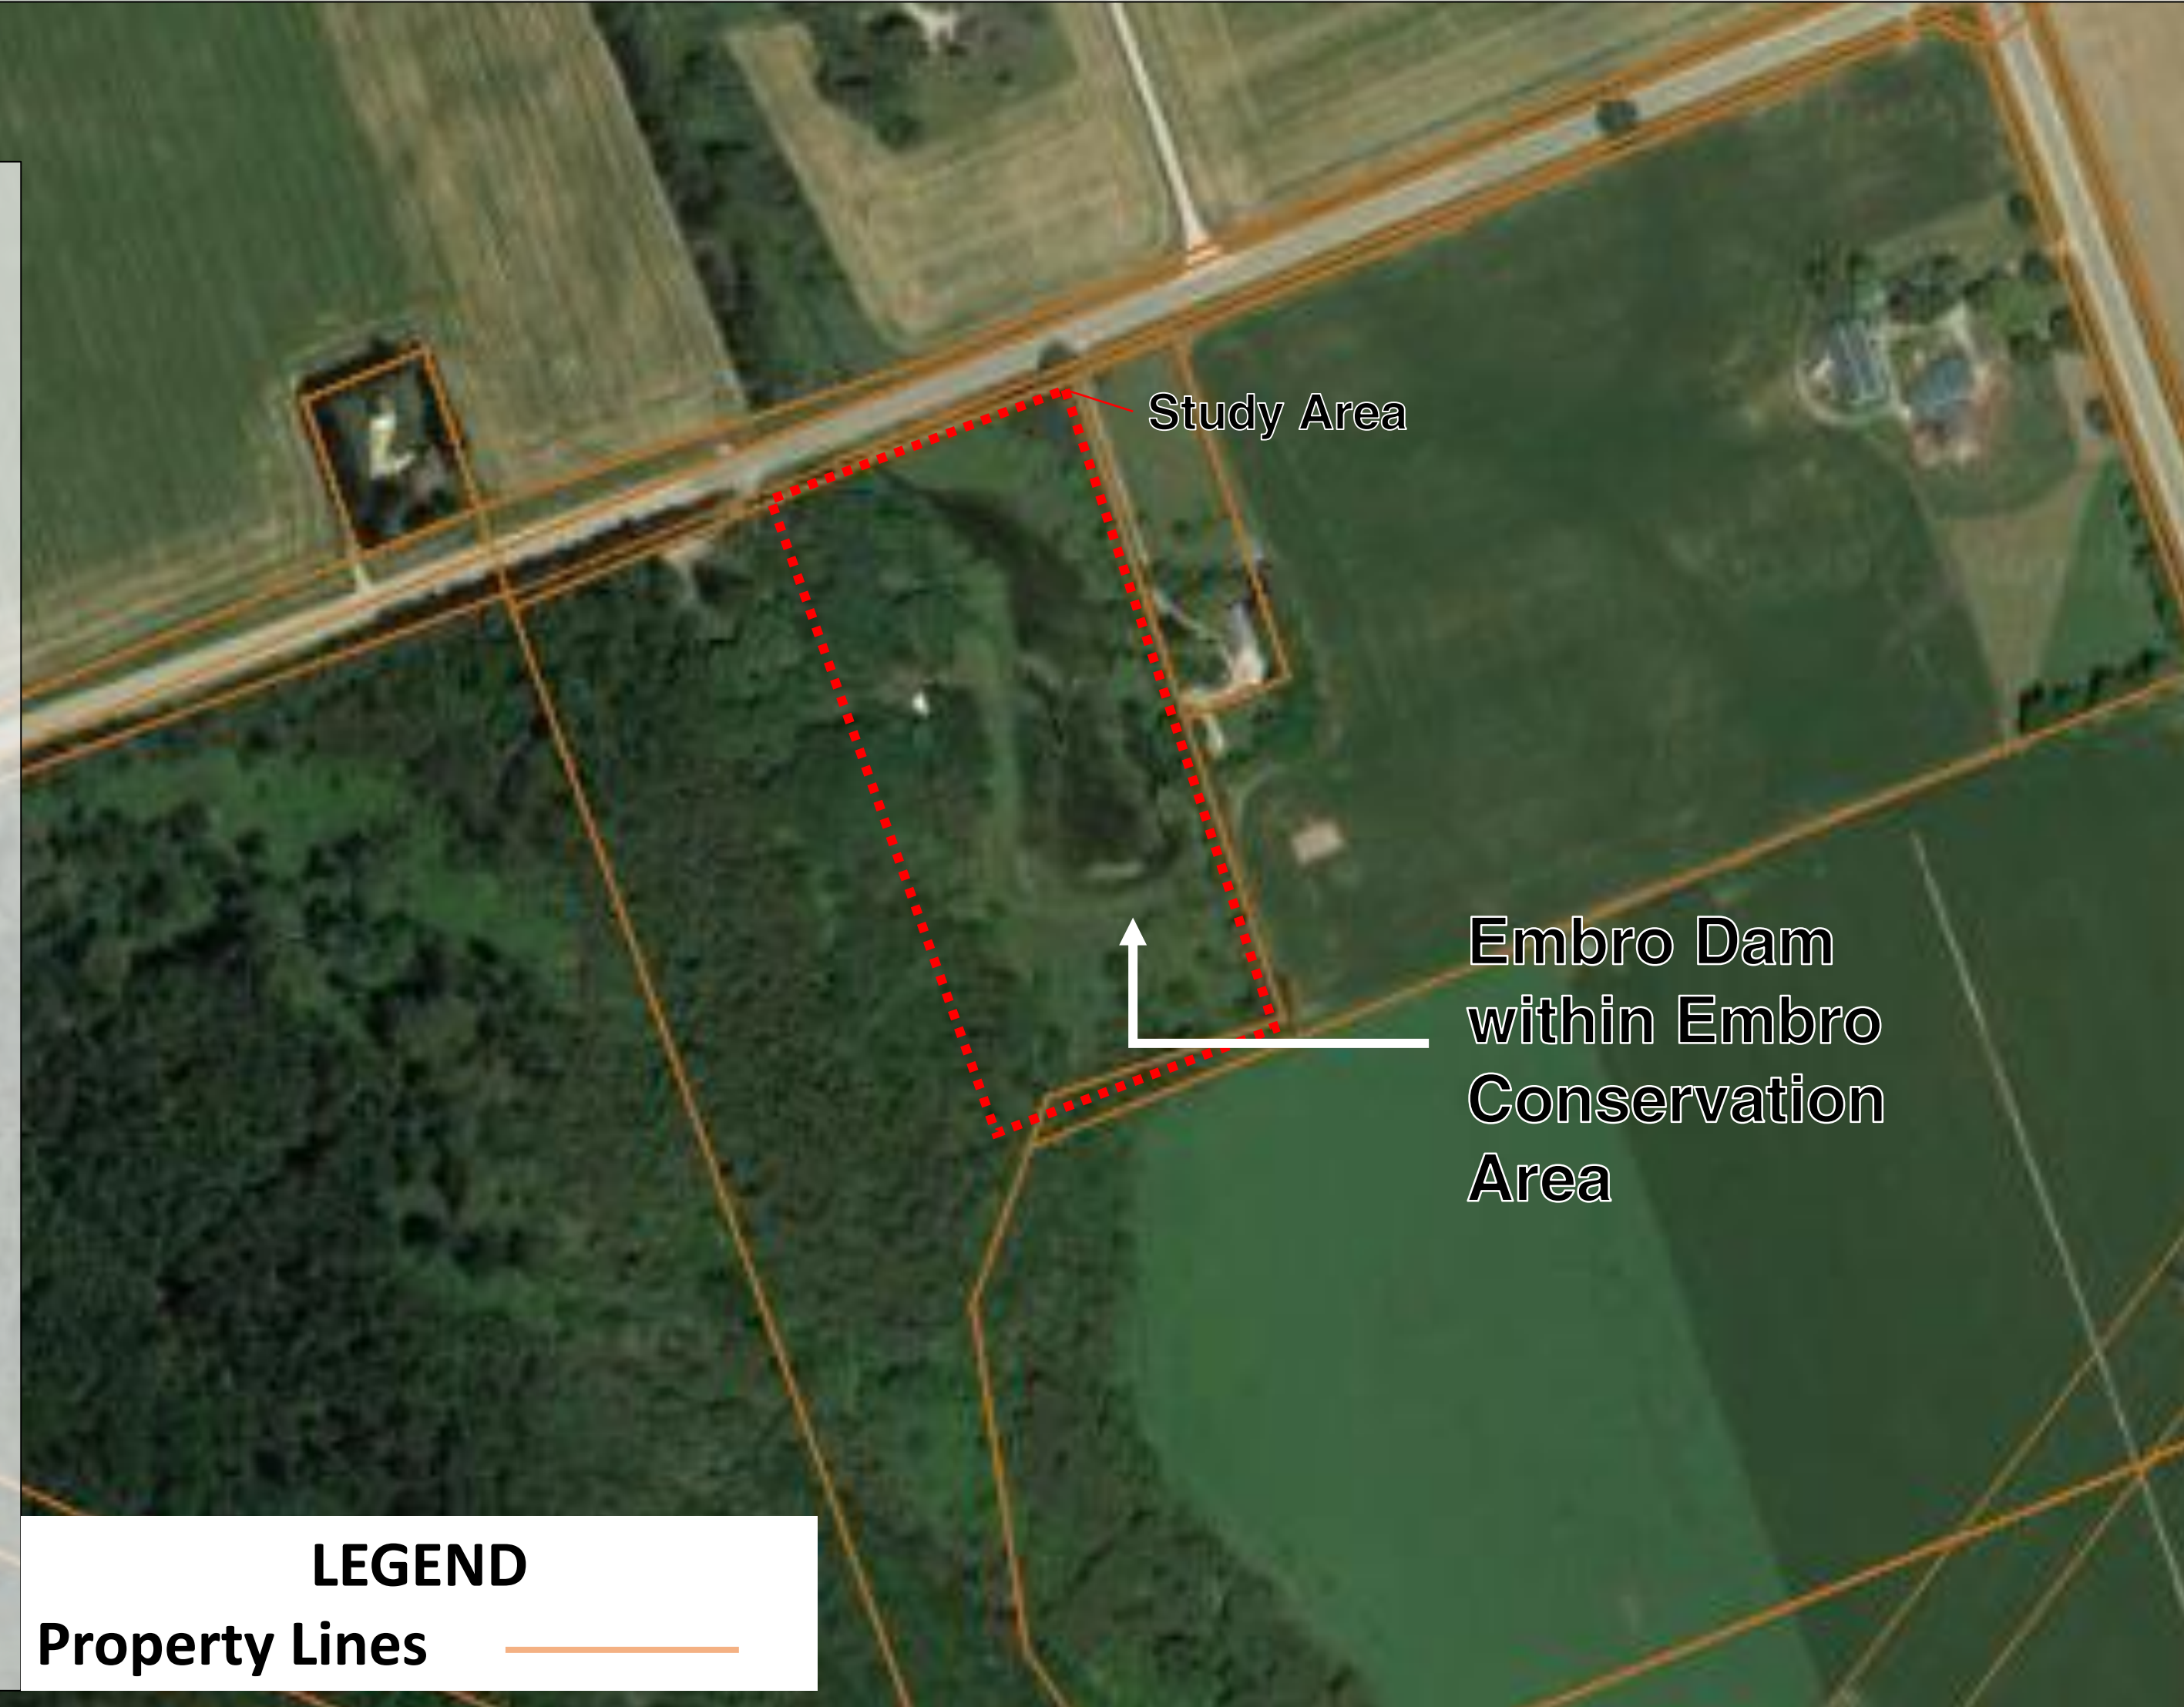
The dam structure consists of a 100 metre long earthen embankment (4.5 metres approx. height) with a concrete bottom draw inlet with an inverted V-shaped trash-rack anchored to the top of the outlet. An emergency spillway is located on the east embankment.

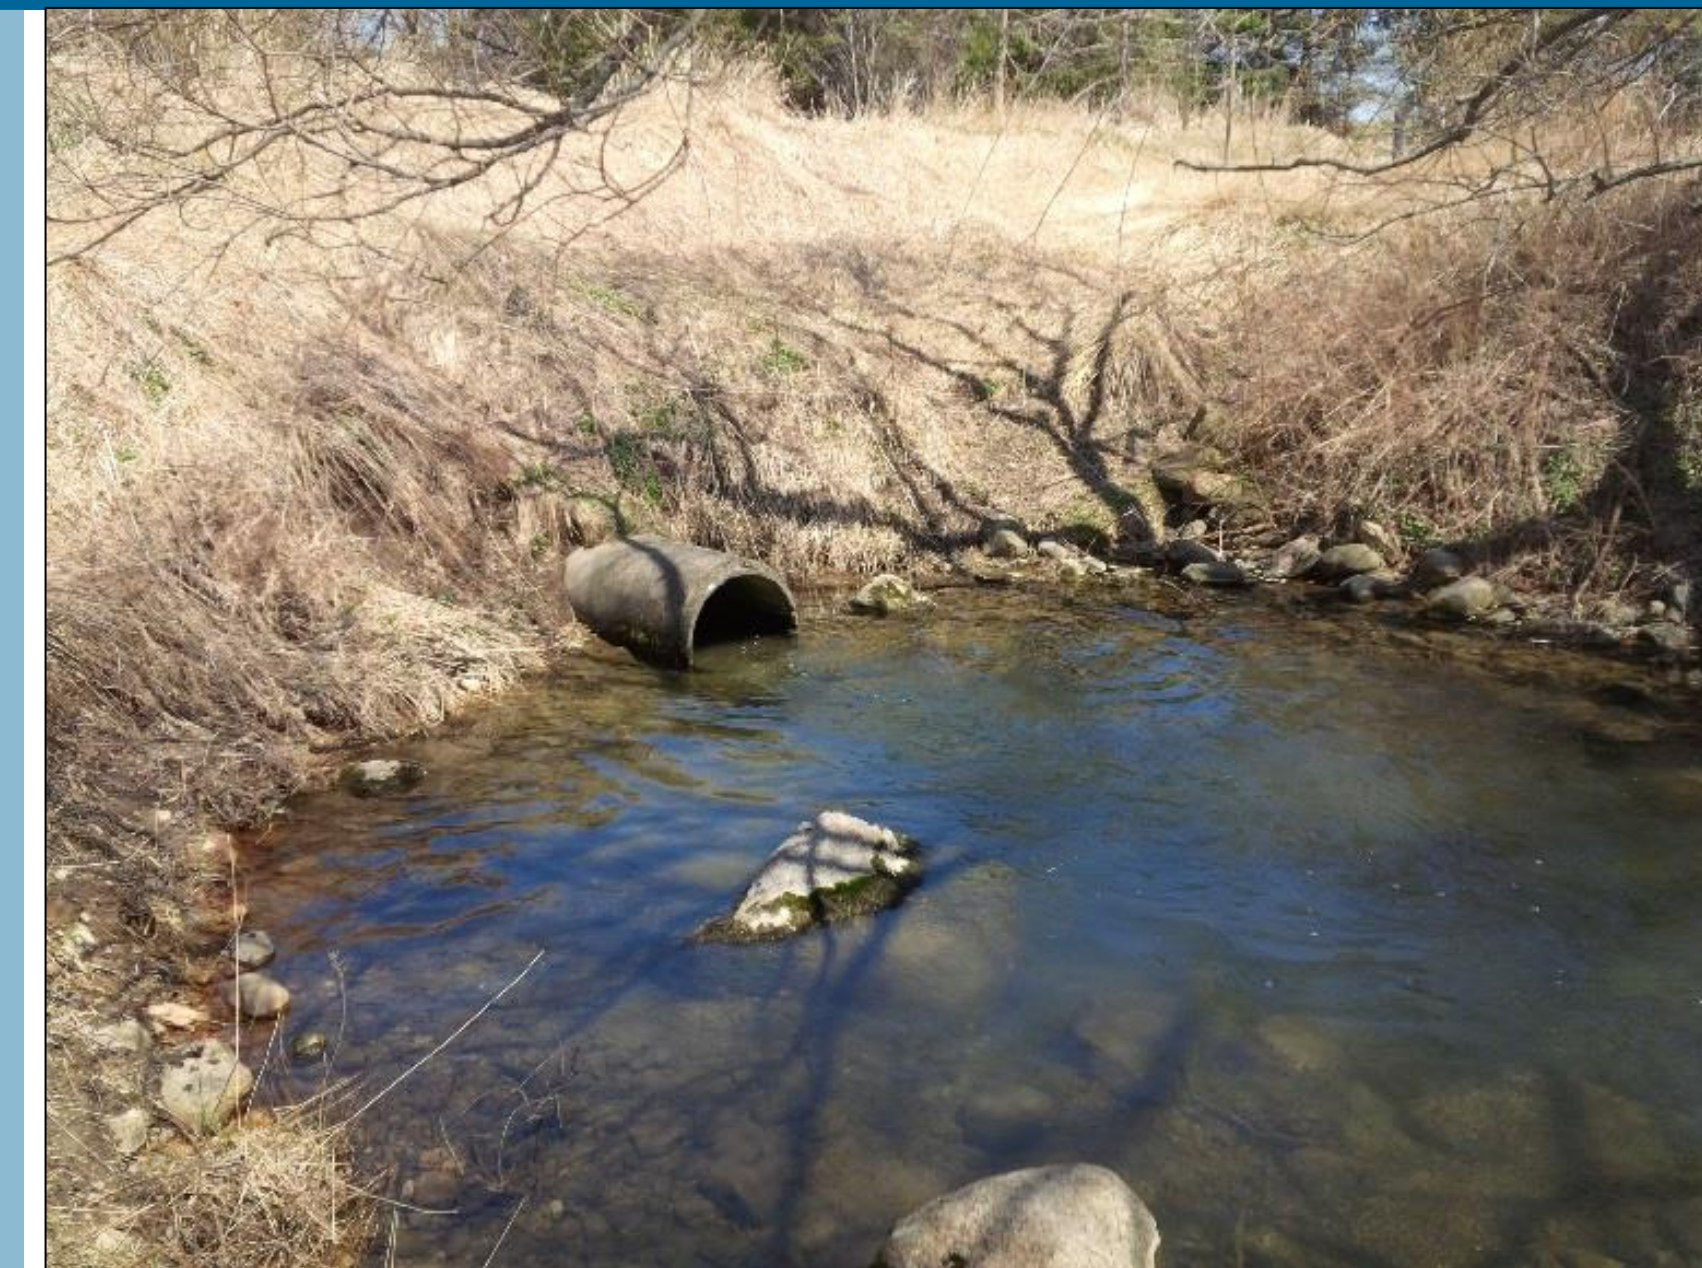
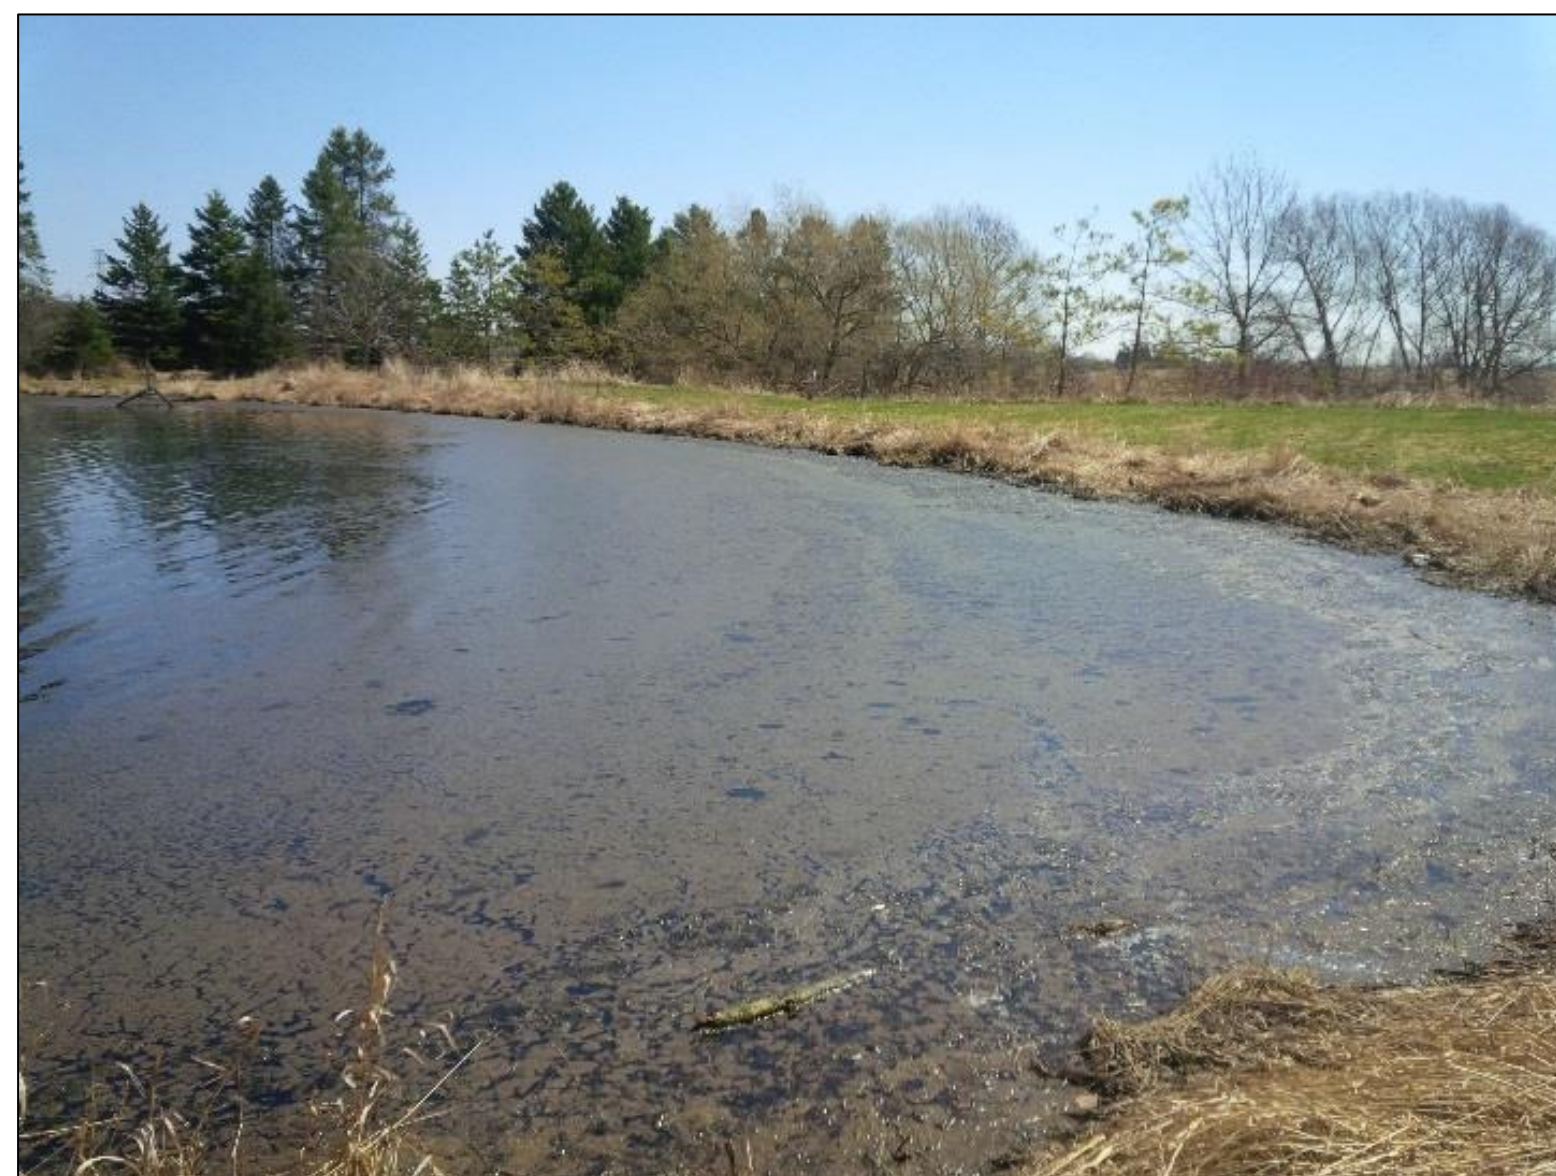
The dam has an impounded volume of 30,000 m³ and consists of a 100m long earth embankment. Spillway does not have the current capacity for inflow design flood (50-year, 8-day spring snowmelt). Upstream and downstream embankment slopes do not meet slope stability acceptance criteria. Flood flows are not adequately conveyed by the emergency spillway. Date of last repair is unknown.

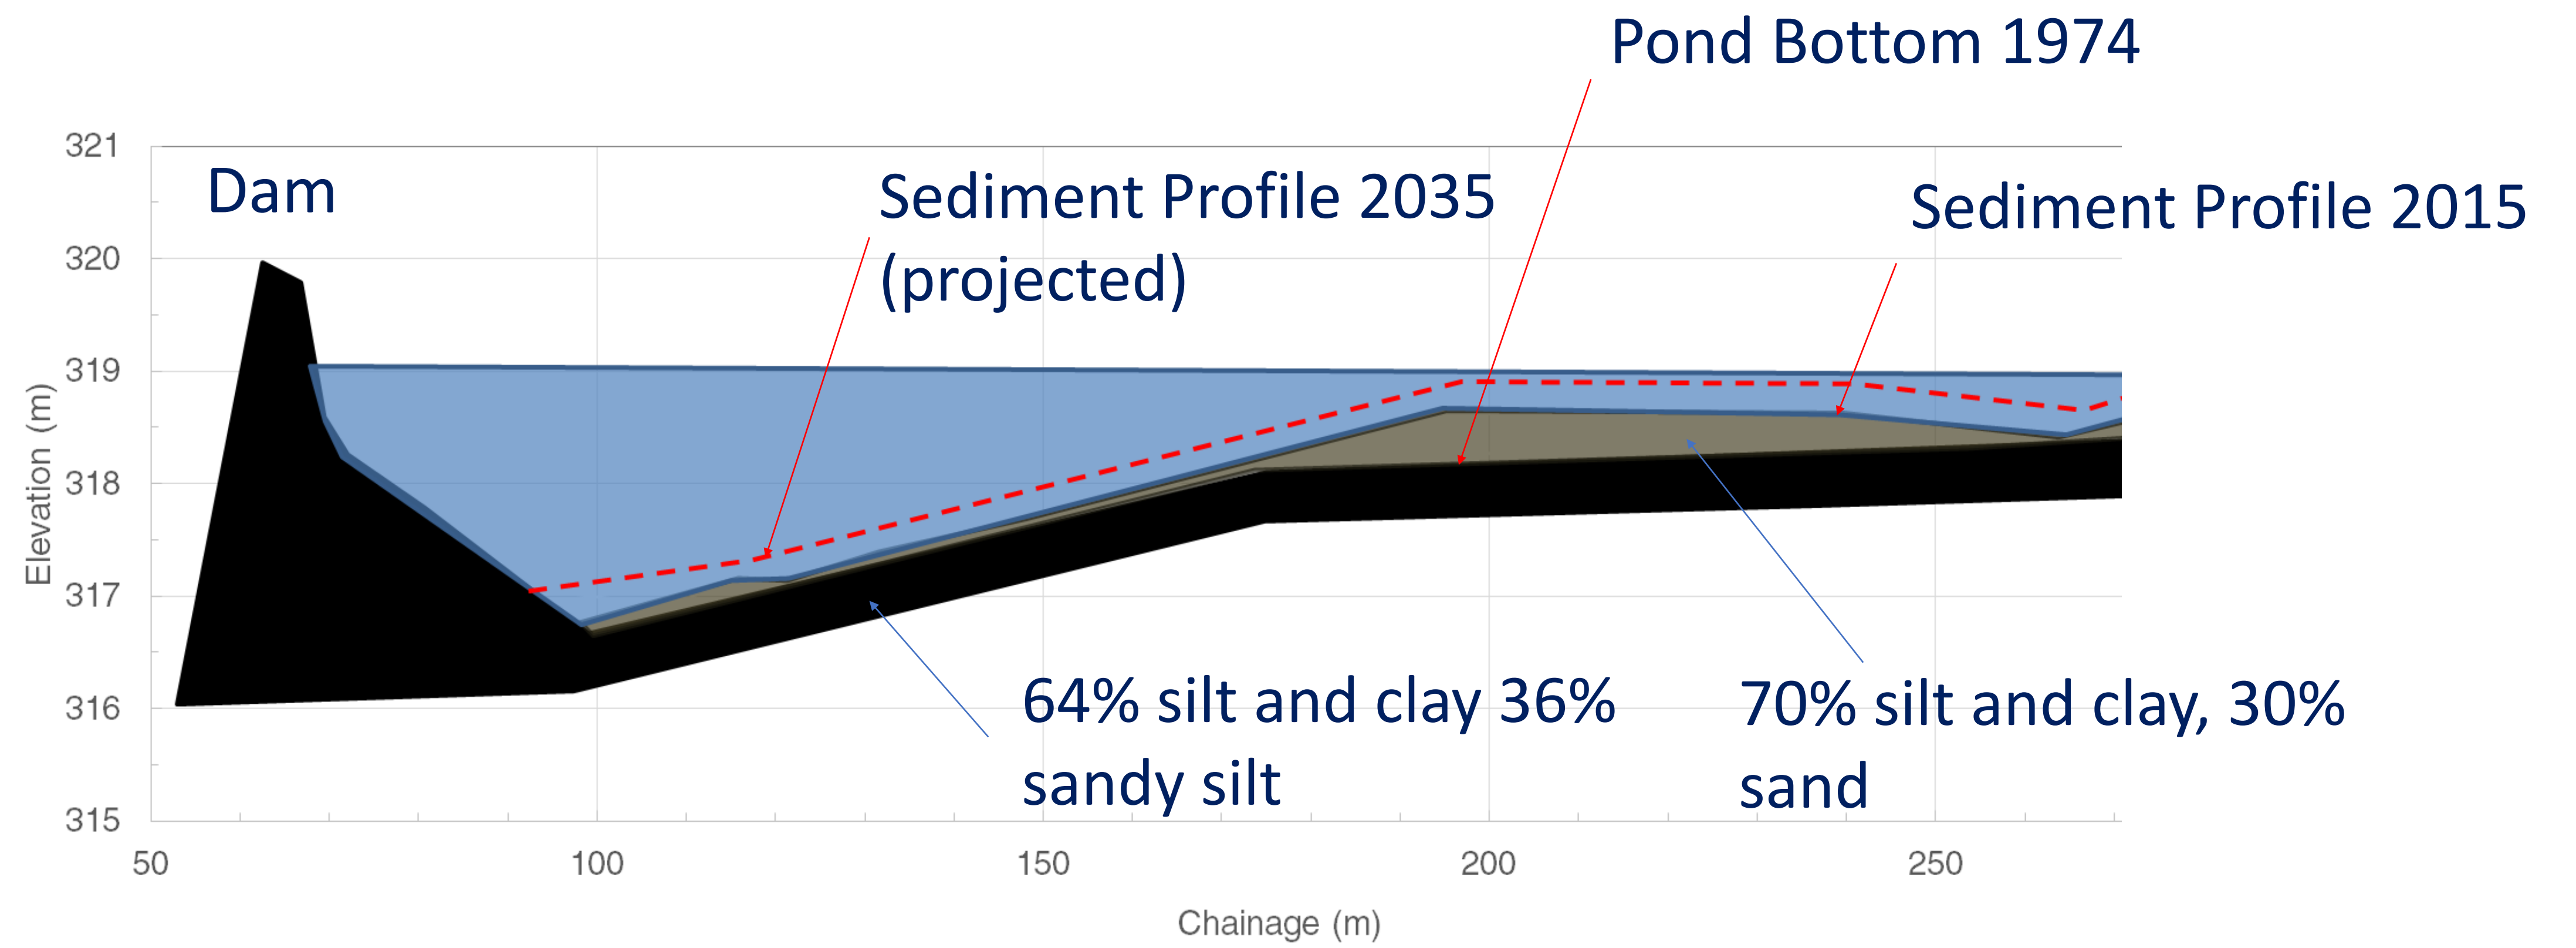
Sediment Profile

Sediment testing at the reservoir was completed in 2015. Results showed that a single tested parameter (cyanide) showed elevated concentrations as compared to Ministry of Environment standard tables. No further sediment testing was completed in 2022.

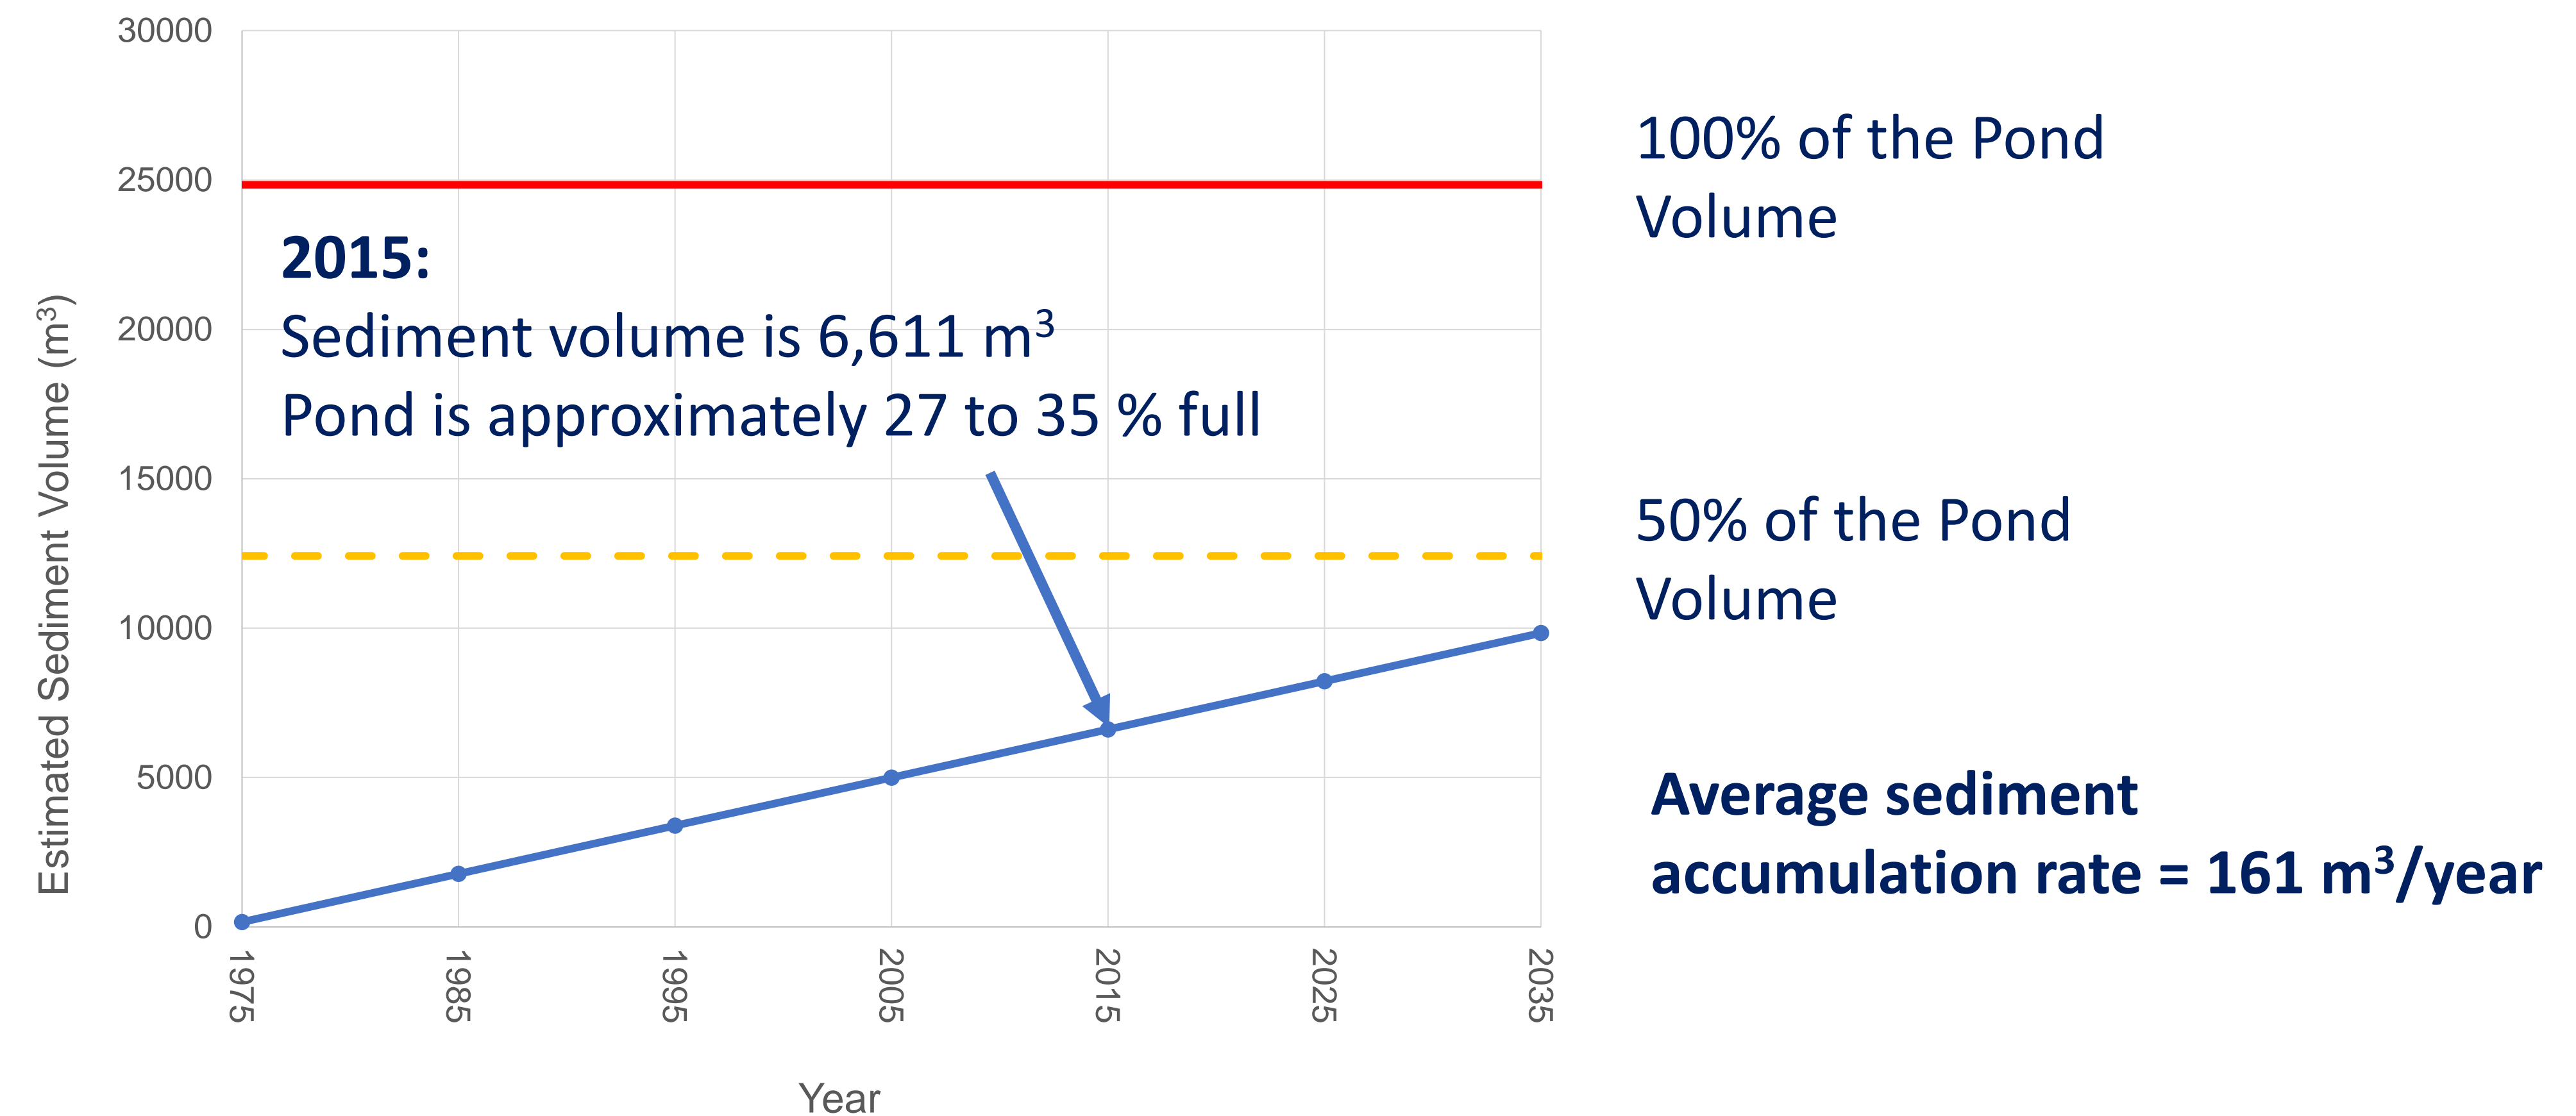
Pond Capacity and Sediment Infilling Rate

The dam forms a reservoir of approximately 0.5 ha (length of ~ 190 m) with an estimated volume of 30,000 m³. The dam has a height of approximately 4.5 m and freeboard of 1.1 m. Bathymetric surveys of Embro Pond showed that approximately 27-35% of the available pond volume has filled with sediment. The pond will continue to retain sediment transported from upstream drainage areas and require periodic dredging to maintain functional and aesthetic qualities.

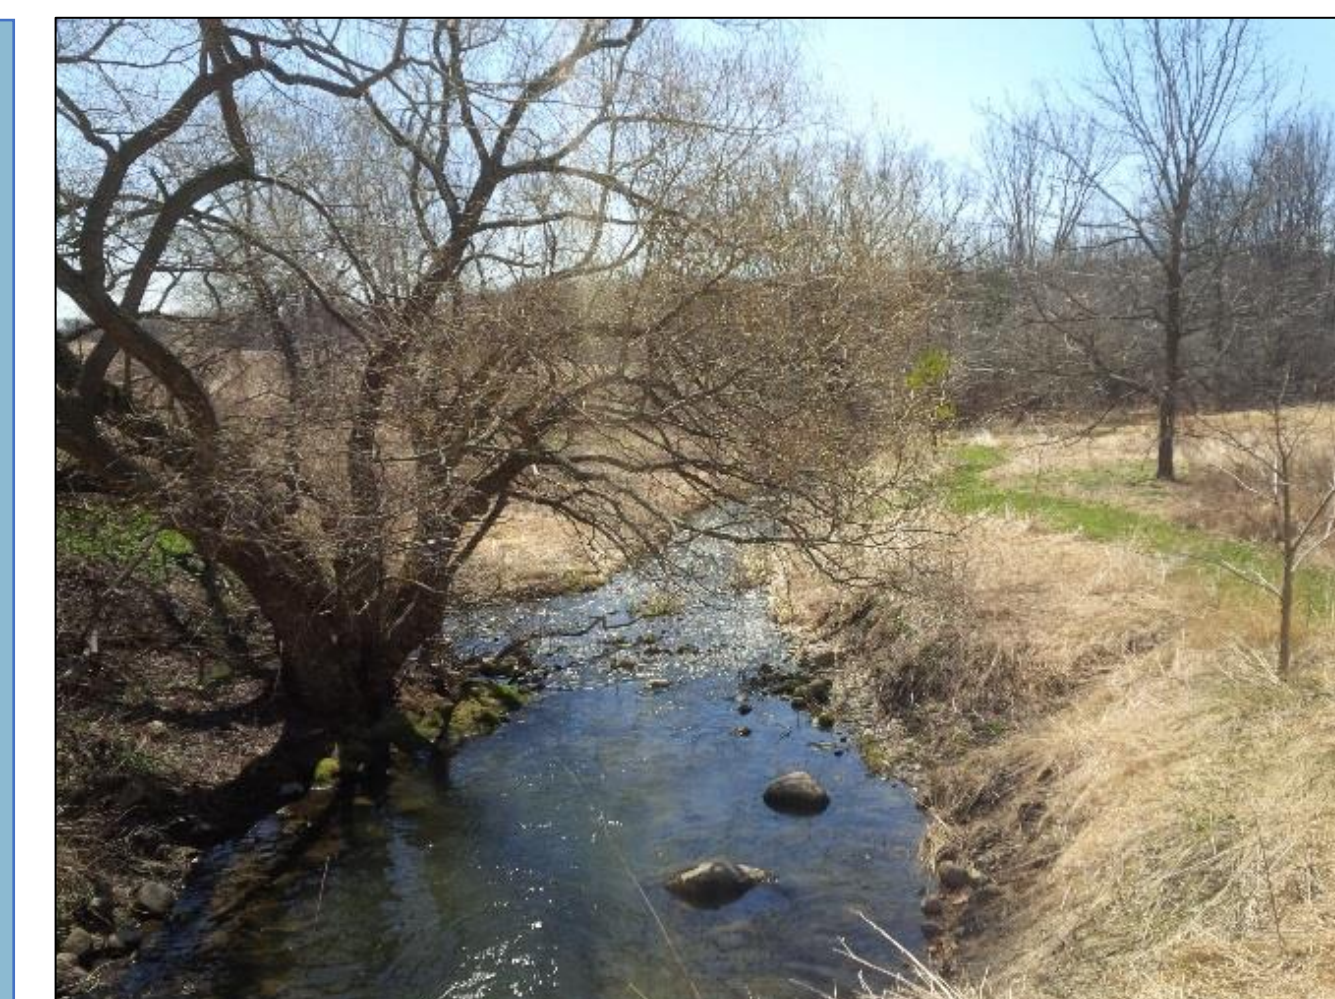
Water quality samples from 2015 showed the watercourse was within the range typically found in the Thames River watershed. The least, average, and maximum temperature differences from upstream to downstream were plus 0°C, 2.5°C, and 7.0°C respectively. No new water quality data collection was completed in 2022.

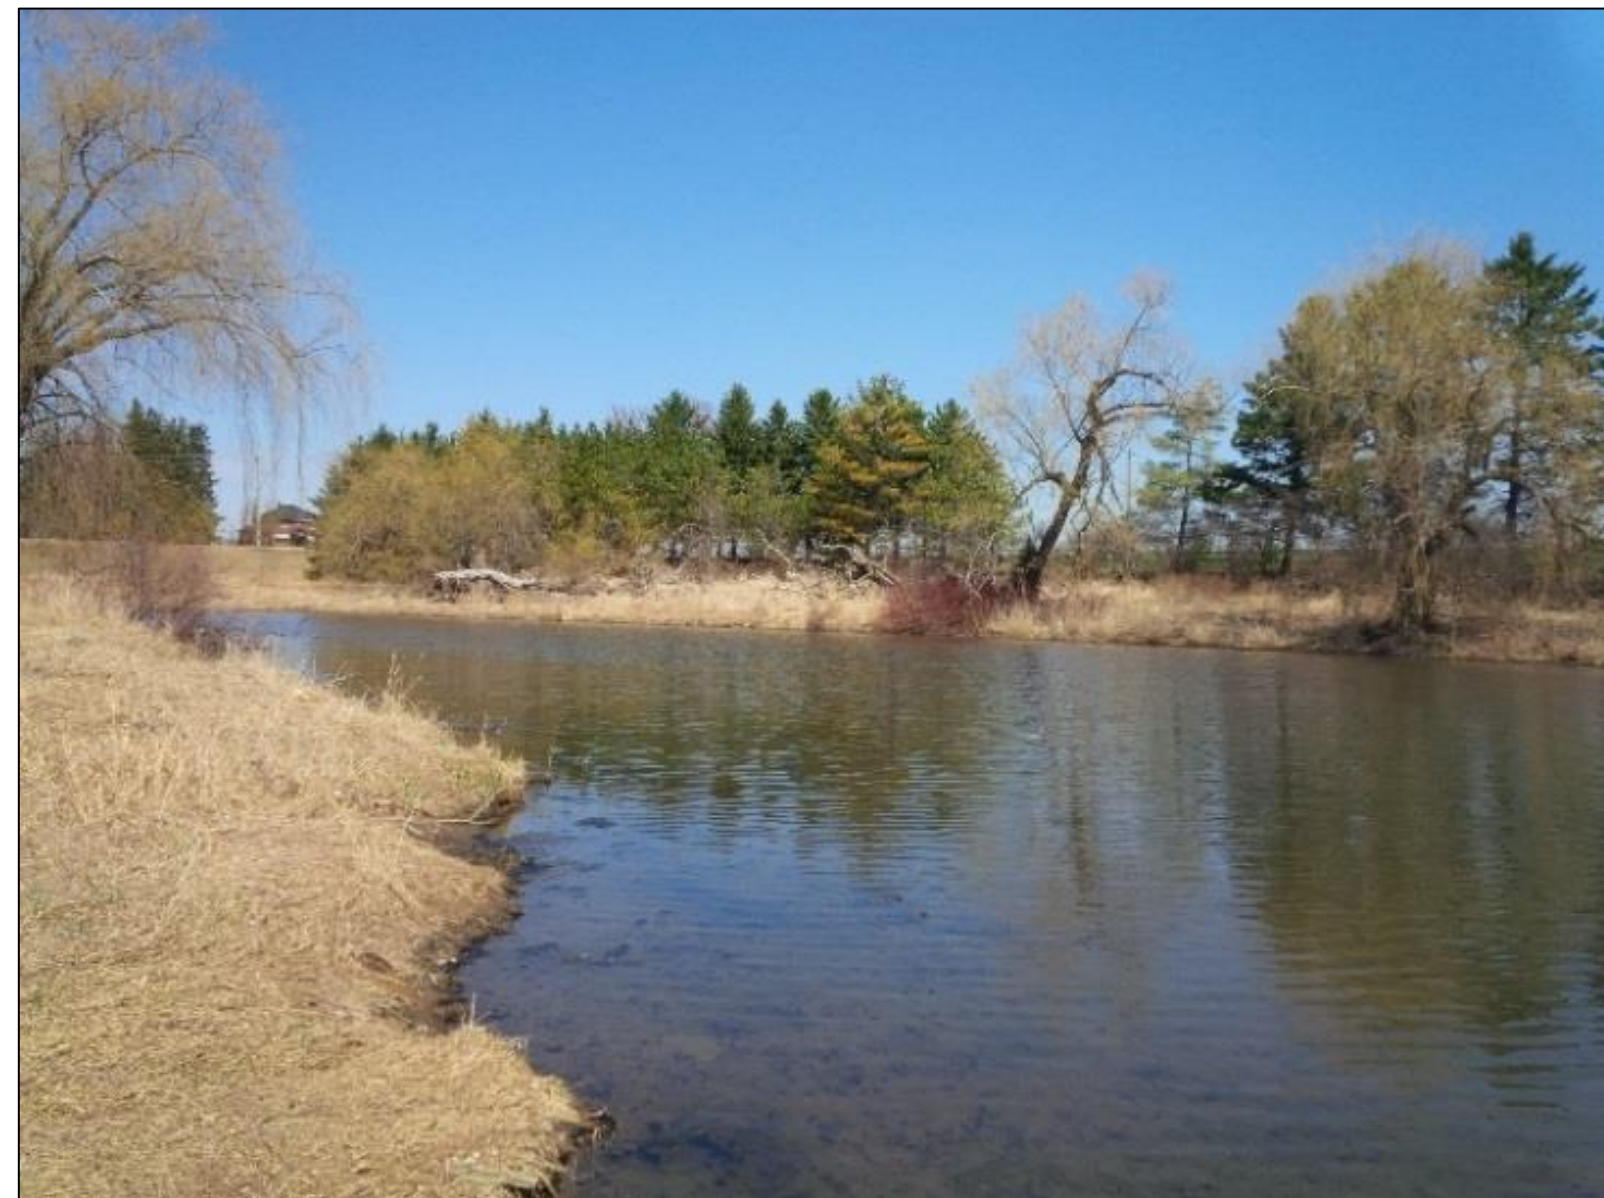
Upstream drainage area to the Embro dam is 7 km². Based on monitoring undertaken in 2011, 2012, and 2015, Youngsville Drain contributes 3.5%, 12.4%, and 6.4% respectively, of the total flow measured downstream of Thamesford. It is predicted that Youngsville Drain has a high resiliency to drought/ low flow conditions due to geological and hydrogeological conditions.

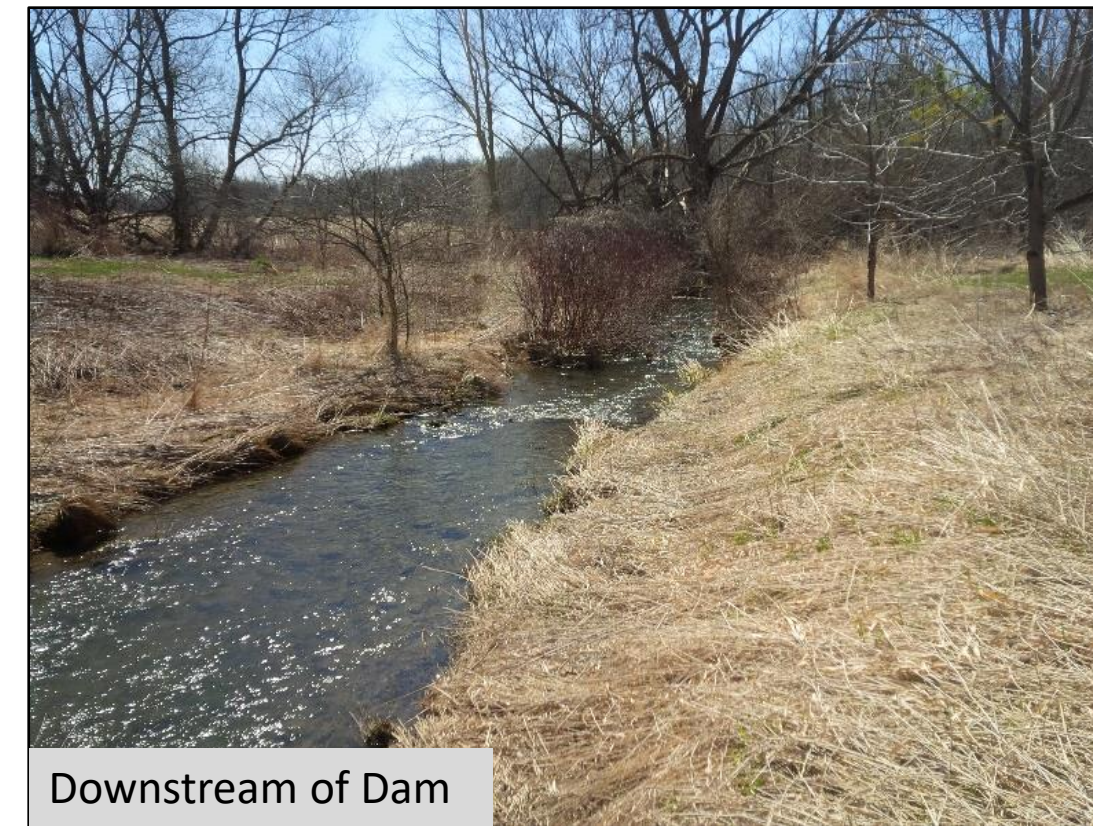
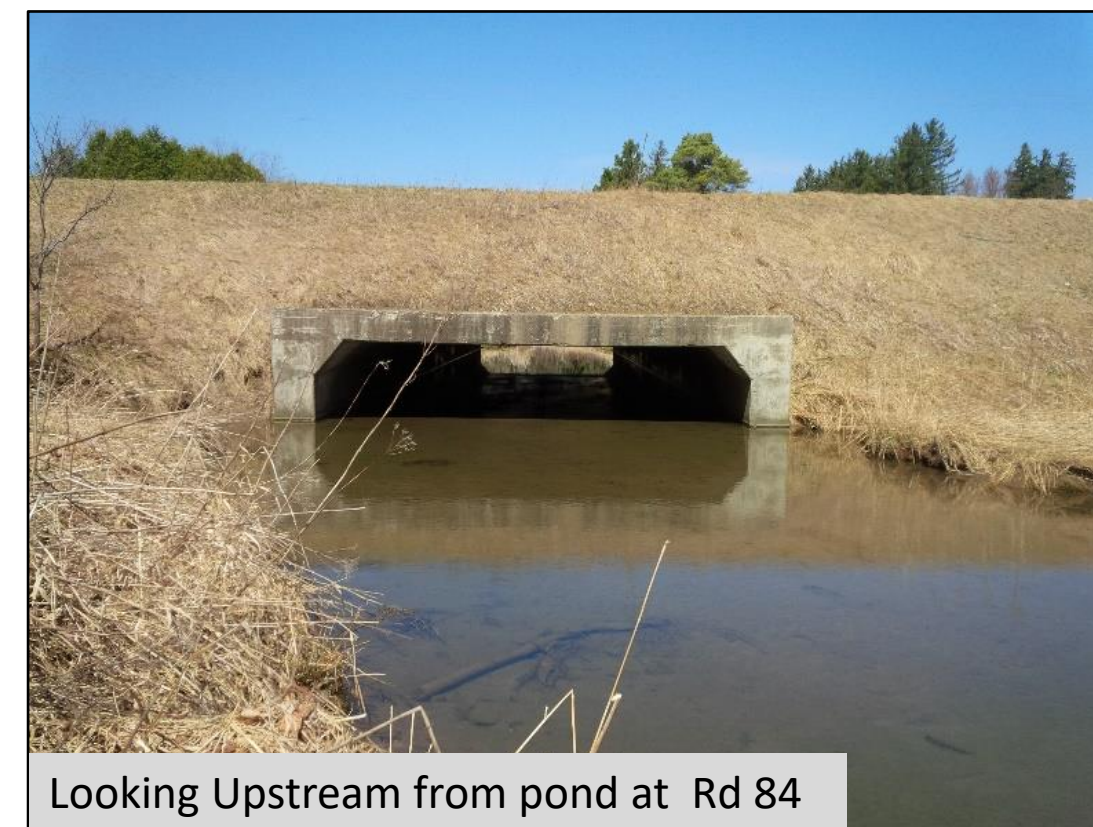
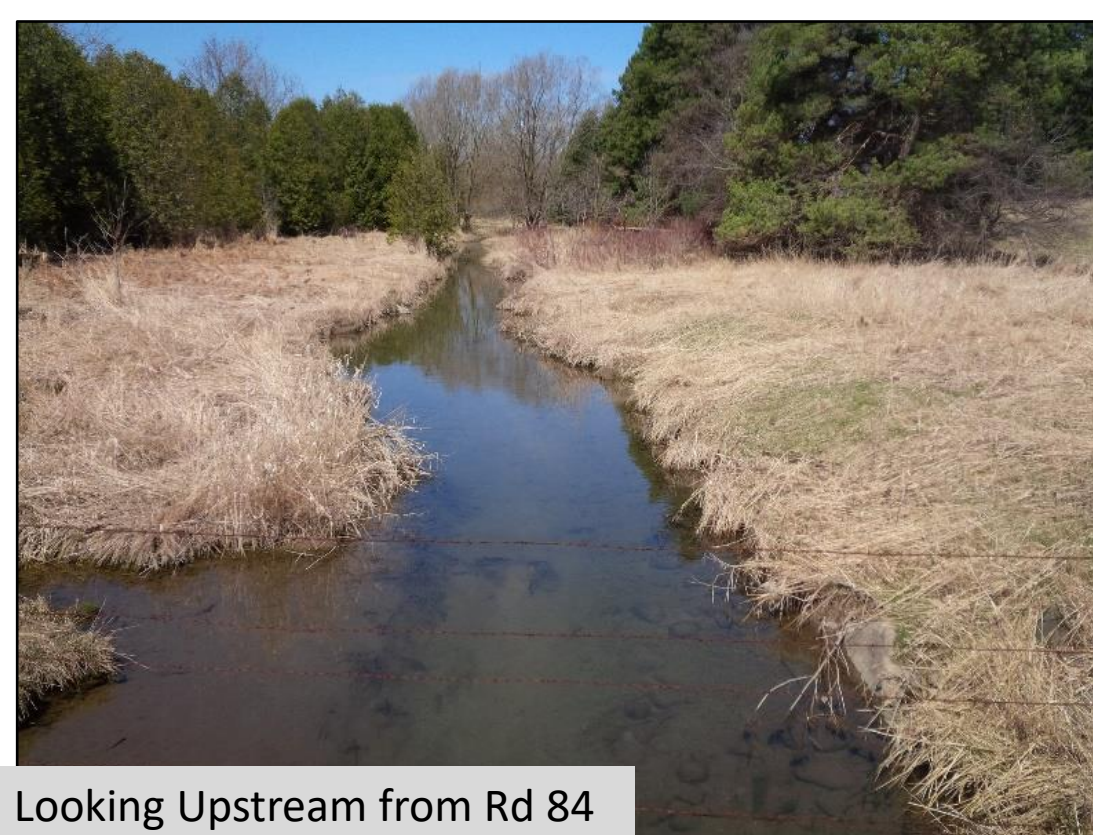
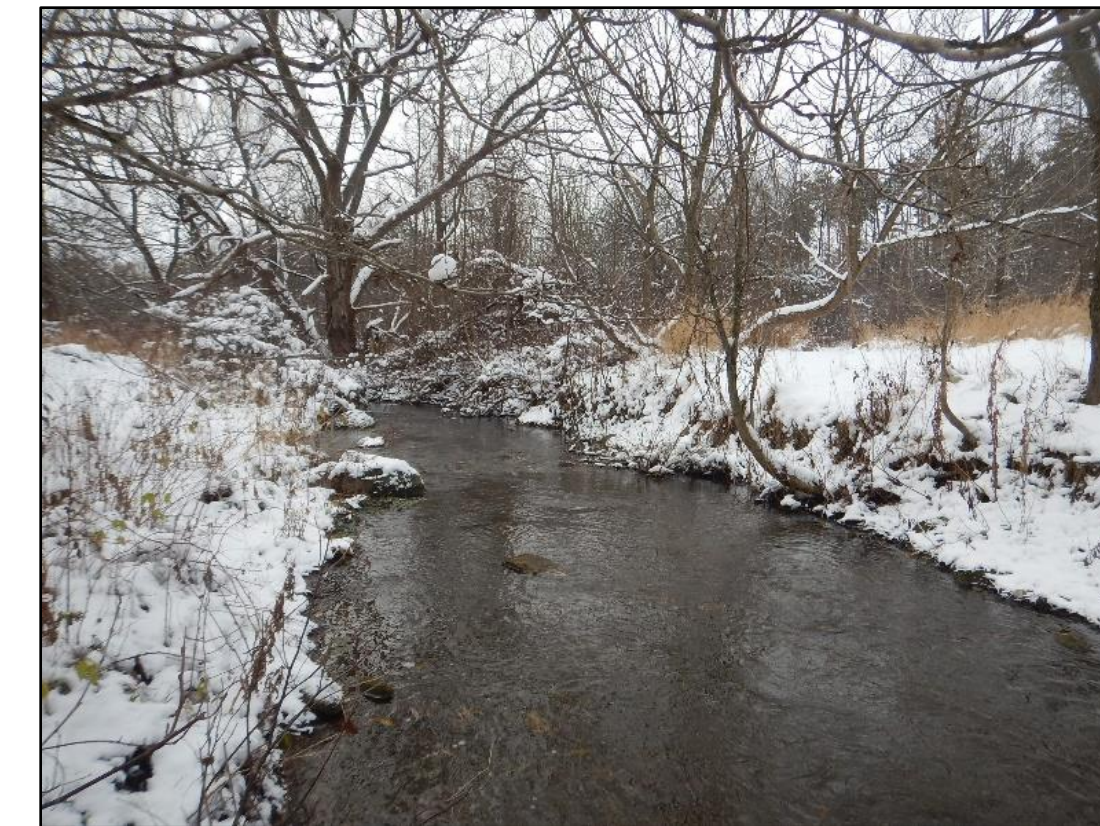
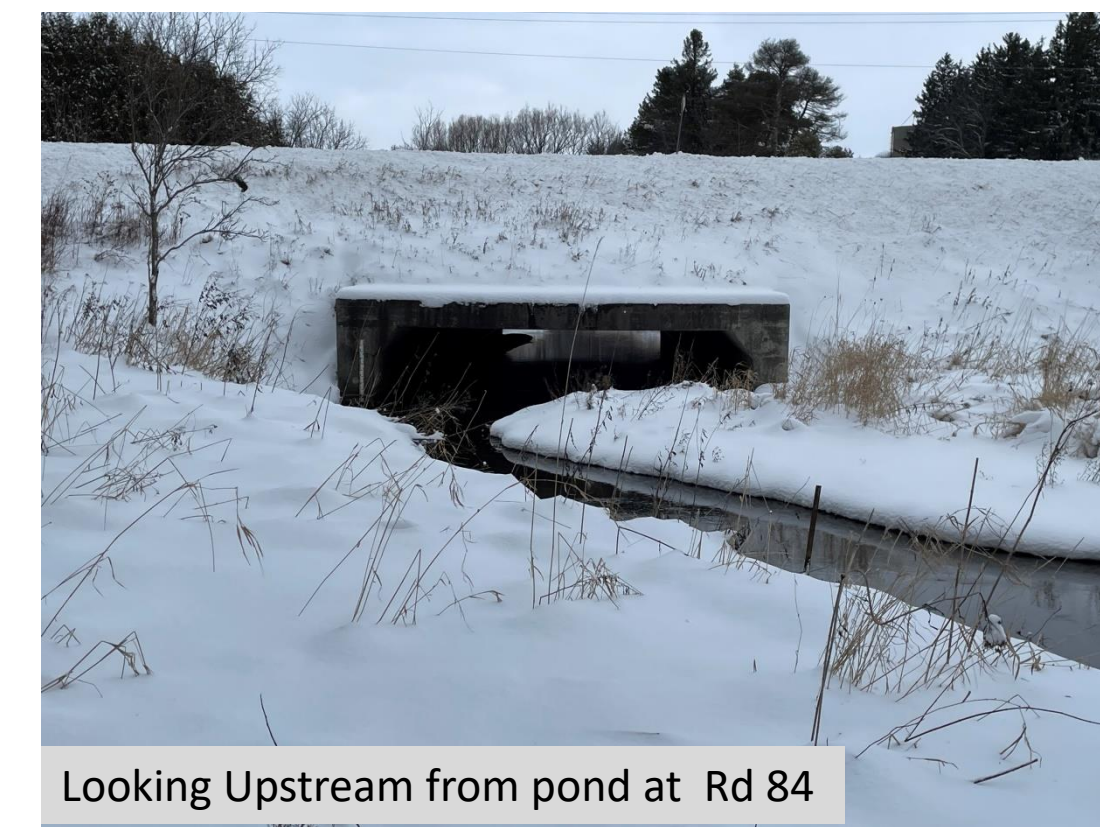
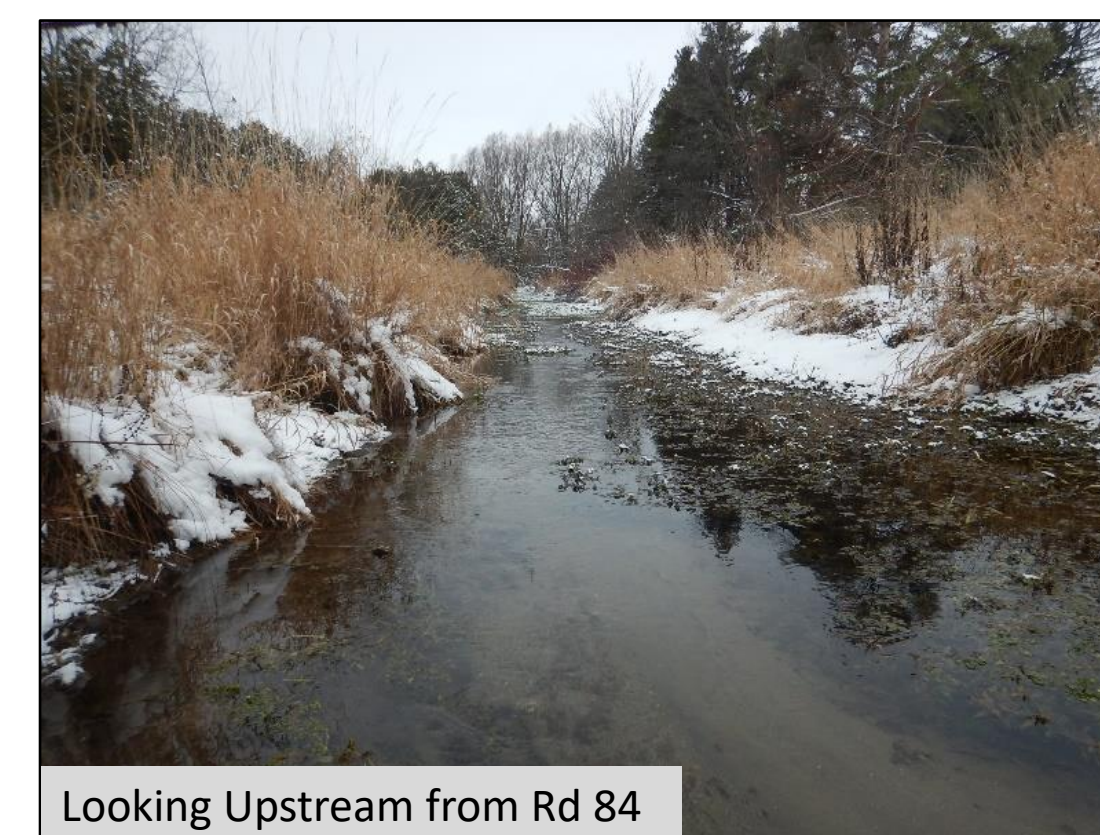
Results of the 2022 investigation show that the channel downstream of Embro Dam is degrading, with increased width and depth when compared to the initial assessment.

Upstream of the road, the channel was reclassified as aggrading, with large deposits of fine sediment observed due to the backwater conditions created by the dam.

The geomorphic characterization was completed in 2016. A second visit was completed in November 2022 to revise and update existing conditions
