Embryo Dam Class Environmental Assessment

Public Information Centre #1

Upper Thames River Conservation Authority
Embryo Zorra Community Centre
June 23rd, 2015 7:00 p.m. to 9:00 p.m.

Embro Dam Study Area

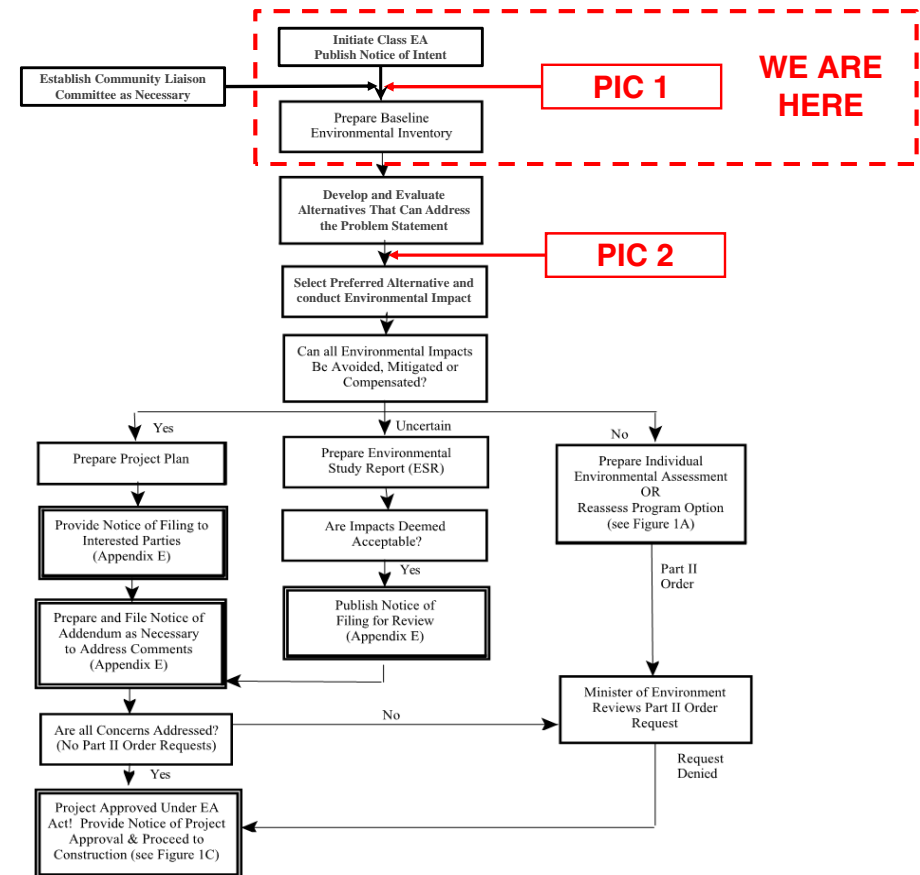
Class EA Process for Conservation Ontario Class Environmental Assessment for Remedial Flood and Erosion Control Works

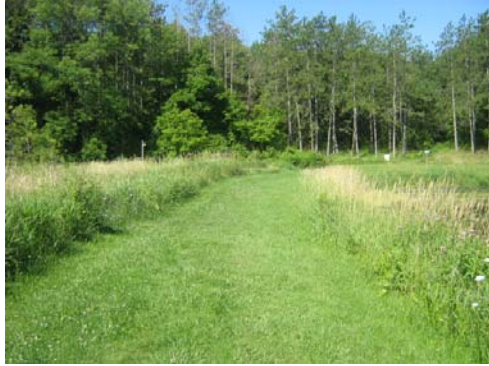
The Embro Dam is approximately 100 m in length, 4.5 m in height and includes 1.1 m of freeboard. The entire dam is founded on overburden as opposed to bedrock or engineered soil.

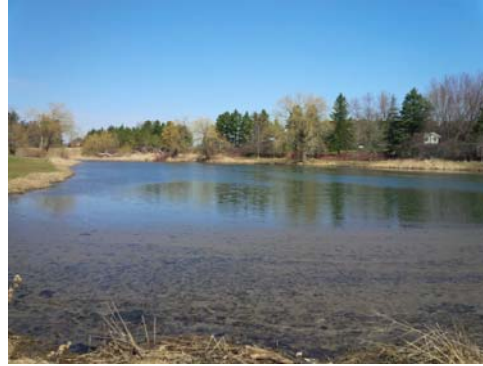
The dam contains water year round and includes approximately 3.4 m of head acting across the dam.

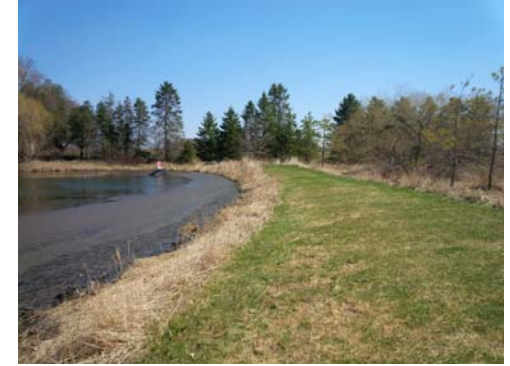
Low earth fill embankment, a grassed, emergency spillway is located at the east end of the embankment. This spillway has a clear width of about 4.0 m and the inlet invert is 0.6 m below the crest of the dam.

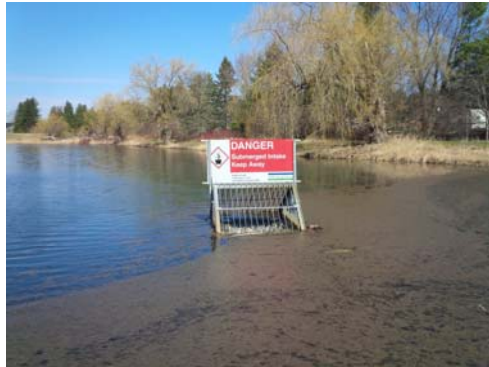
The outlet of the dam includes a concrete bottom draw inlet structure covered with grated trashrack.

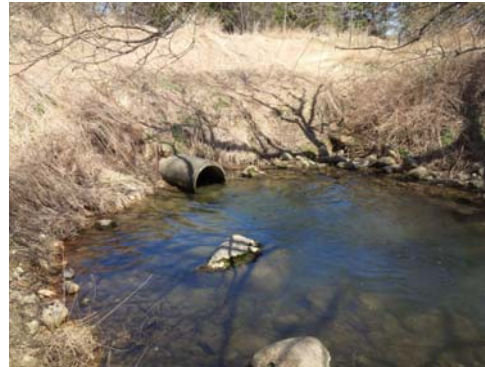
A 762 mm diameter (inner) concrete pipe conveys flow from the pond to a pool at the creek outlet.

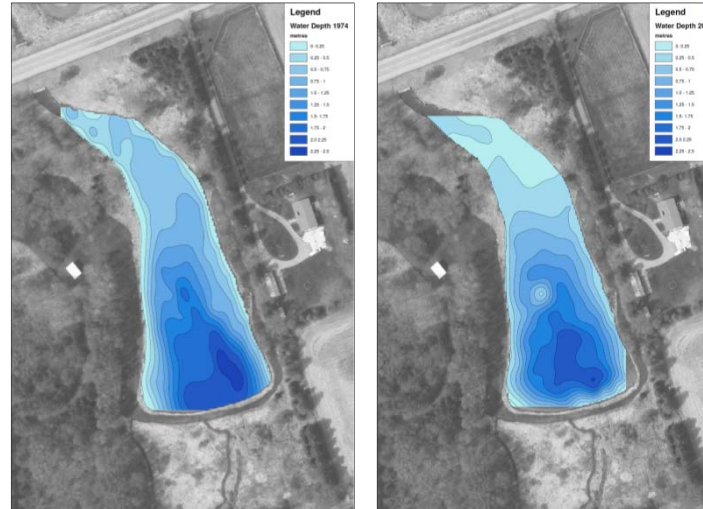
Preliminary sediment depths and volumes have been determined at the pond; contour maps showing water depth (indirectly showing sediment accumulation) are shown at right.

Survey of the pond bottom and depths of sediment are completed using GPS survey equipment.
