# Emburo Dam and Conservation Area

## Existing Environmental Conditions

Updated October 13, 2016

**UPPER THAMES RIVER**  
**CONSERVATION AUTHORITY**

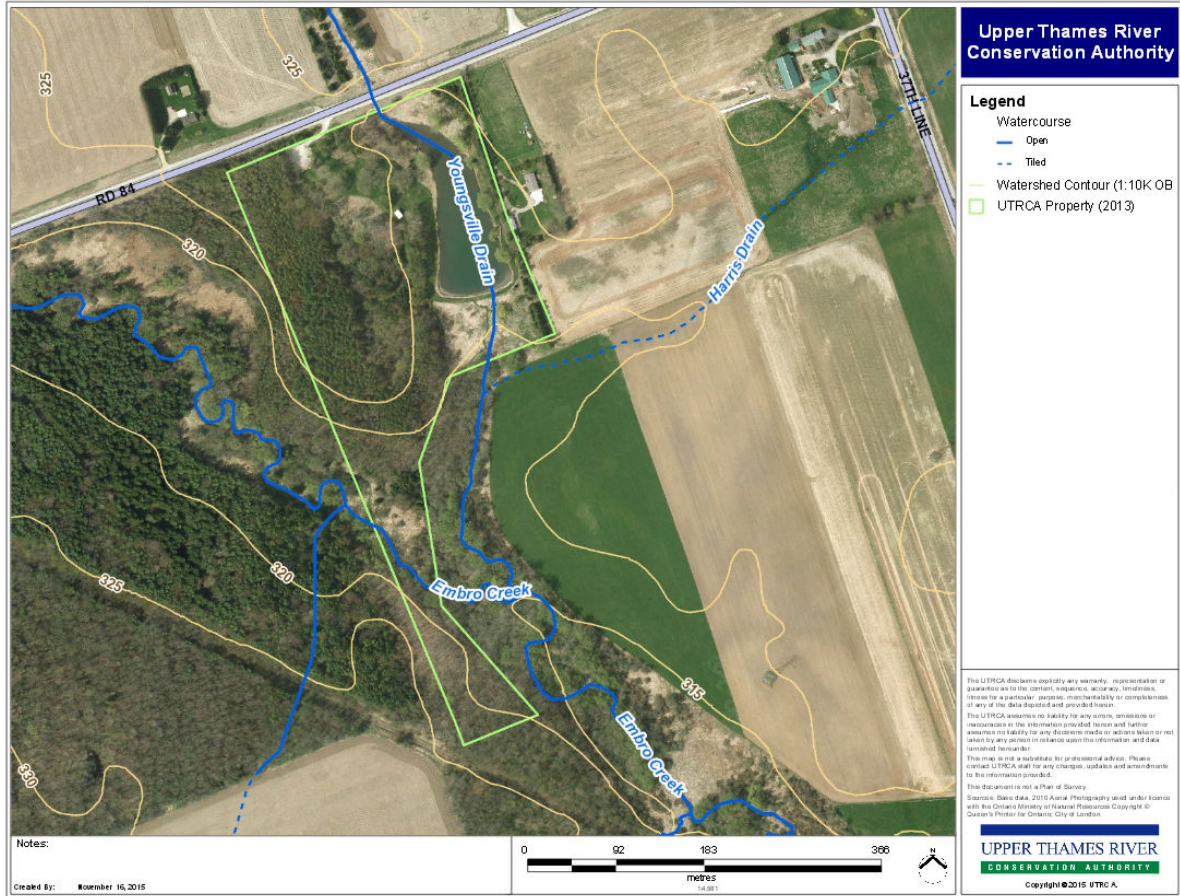
Figure 4: Elevation of Embro Conservation Area (Source: UTRCA)

The general topographic setting of Embro CA in the downstream reaches of Youngsville Drain catchment is shown on the map in Figure 4. North Branch Creek meets Embro Creek immediately south of Embro CA. The lowest elevation point the catchment area is 315 m at Embro CA where Embro Creek leaves the CA. Embro CA is located in some of the highest elevations in the UTRCA watershed.

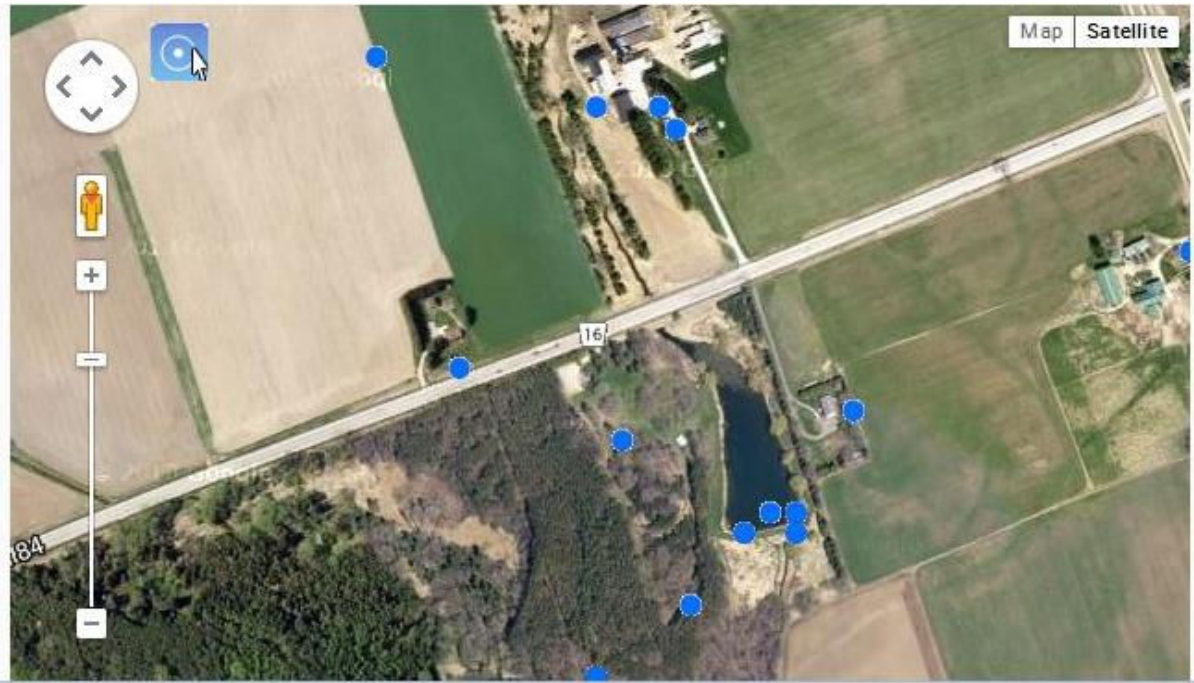
Figure 7: Known wells in the area of Embro CA (Source: MOECC)

All background information and individual well records were retrieved from the Ministry of the Environment and Climate Change (MOECC) and provided to Ecosystem Recovery Inc. for analysis by their sub-consultant Englobe (formerly LVM). Figure 7 shows the locations of the known wells in the area. The wells shown on the Embro Dam are Bore Holes for the past Dam Safety investigations.

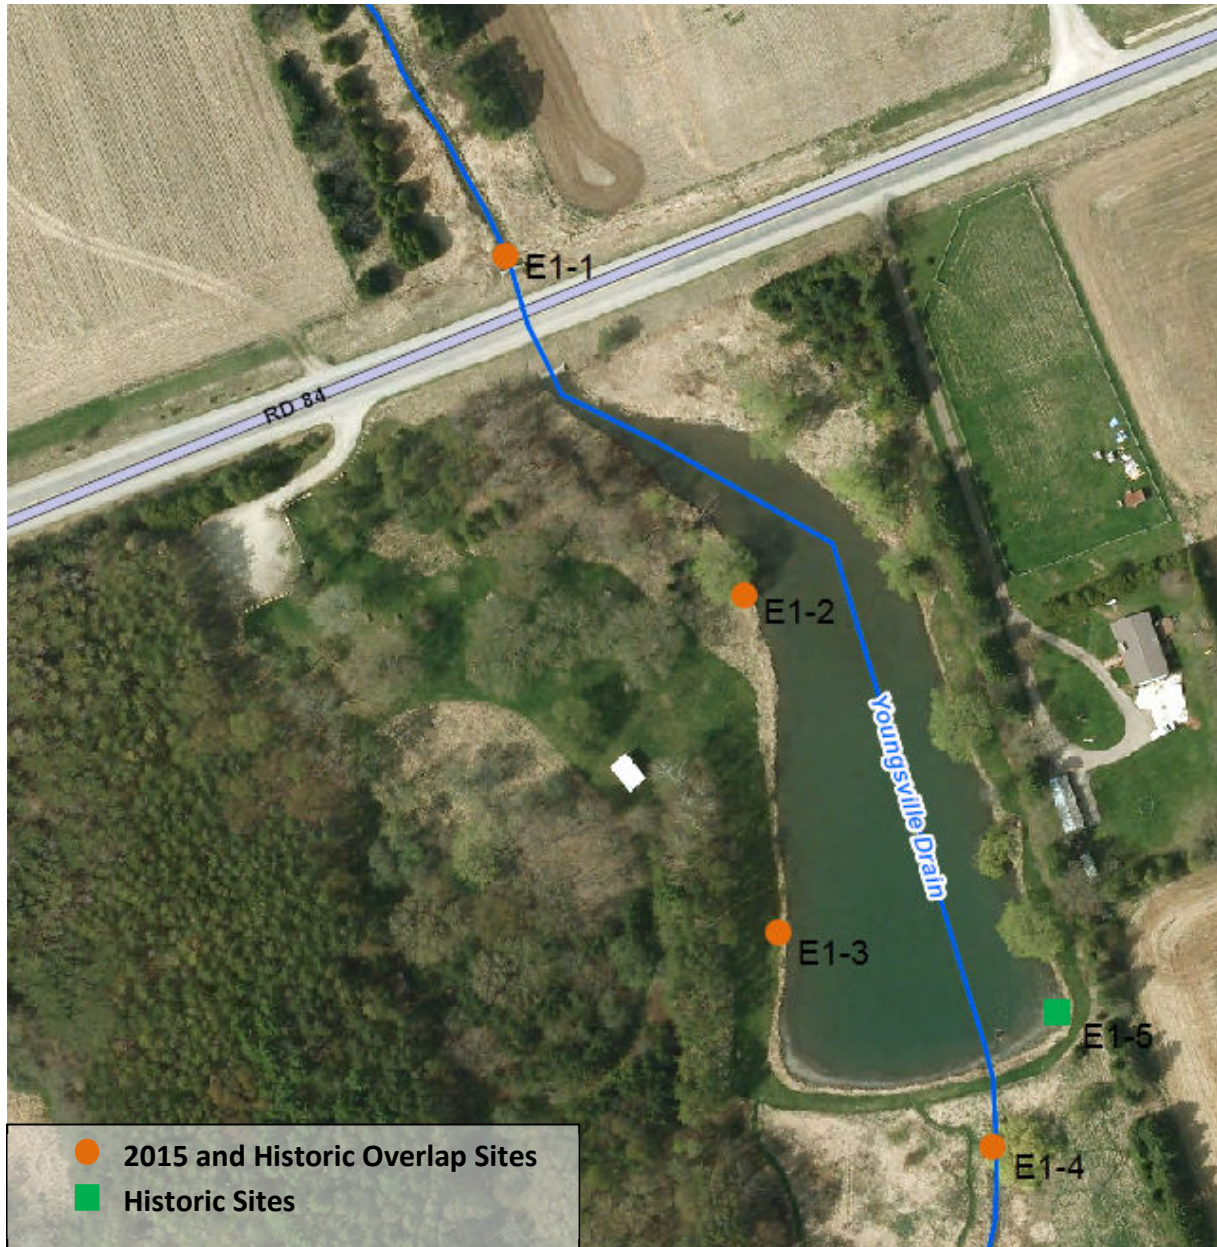
Figure 8: Embro Pond water quality sampling sites 2015 (Source: UTRCA)

A series of five water samples were collected at four locations in the area of Embro CA: one upstream of the pond, two in the pond, and one downstream of the dam (see map in Figure 8). This monitoring provides a snapshot of water quality, and is limited to the conditions of April to October 2015. Embro Pond was part of a past targeted watershed study and remediation work, with water monitoring occurring from 1986 to 1994. This data has been included in the evaluation of the results, which can be found in Appendix B: Embro Pond Water Quality Assessment.

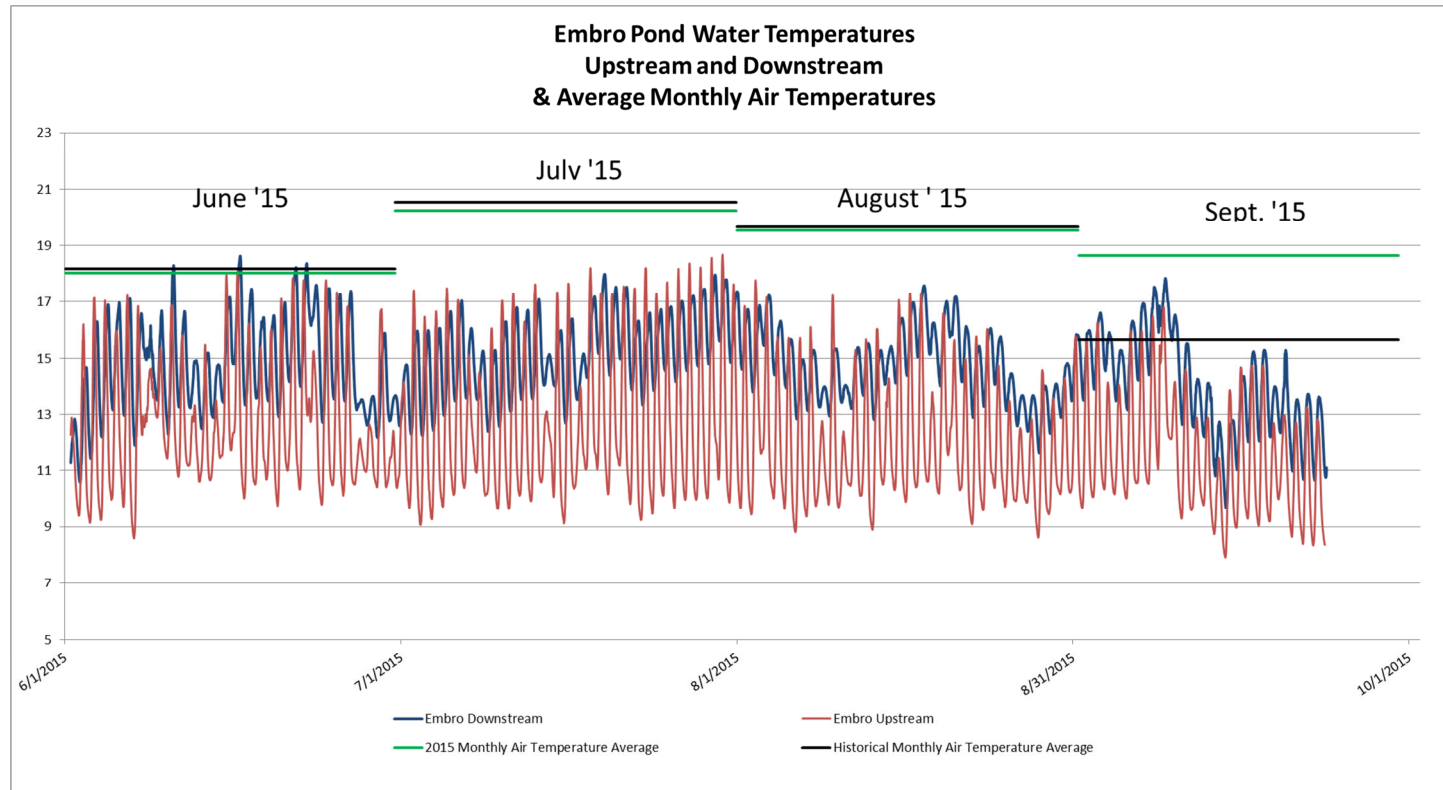
Figure 9: Temperature upstream and downstream of Embro Pond, June – Sept 2015 (Source: UTRCA)

Temperature differences are apparent between upstream and downstream of the pond based on continuous measurements and show a greater difference as the summer progressed, likely as a result of the warming effect of the pond.

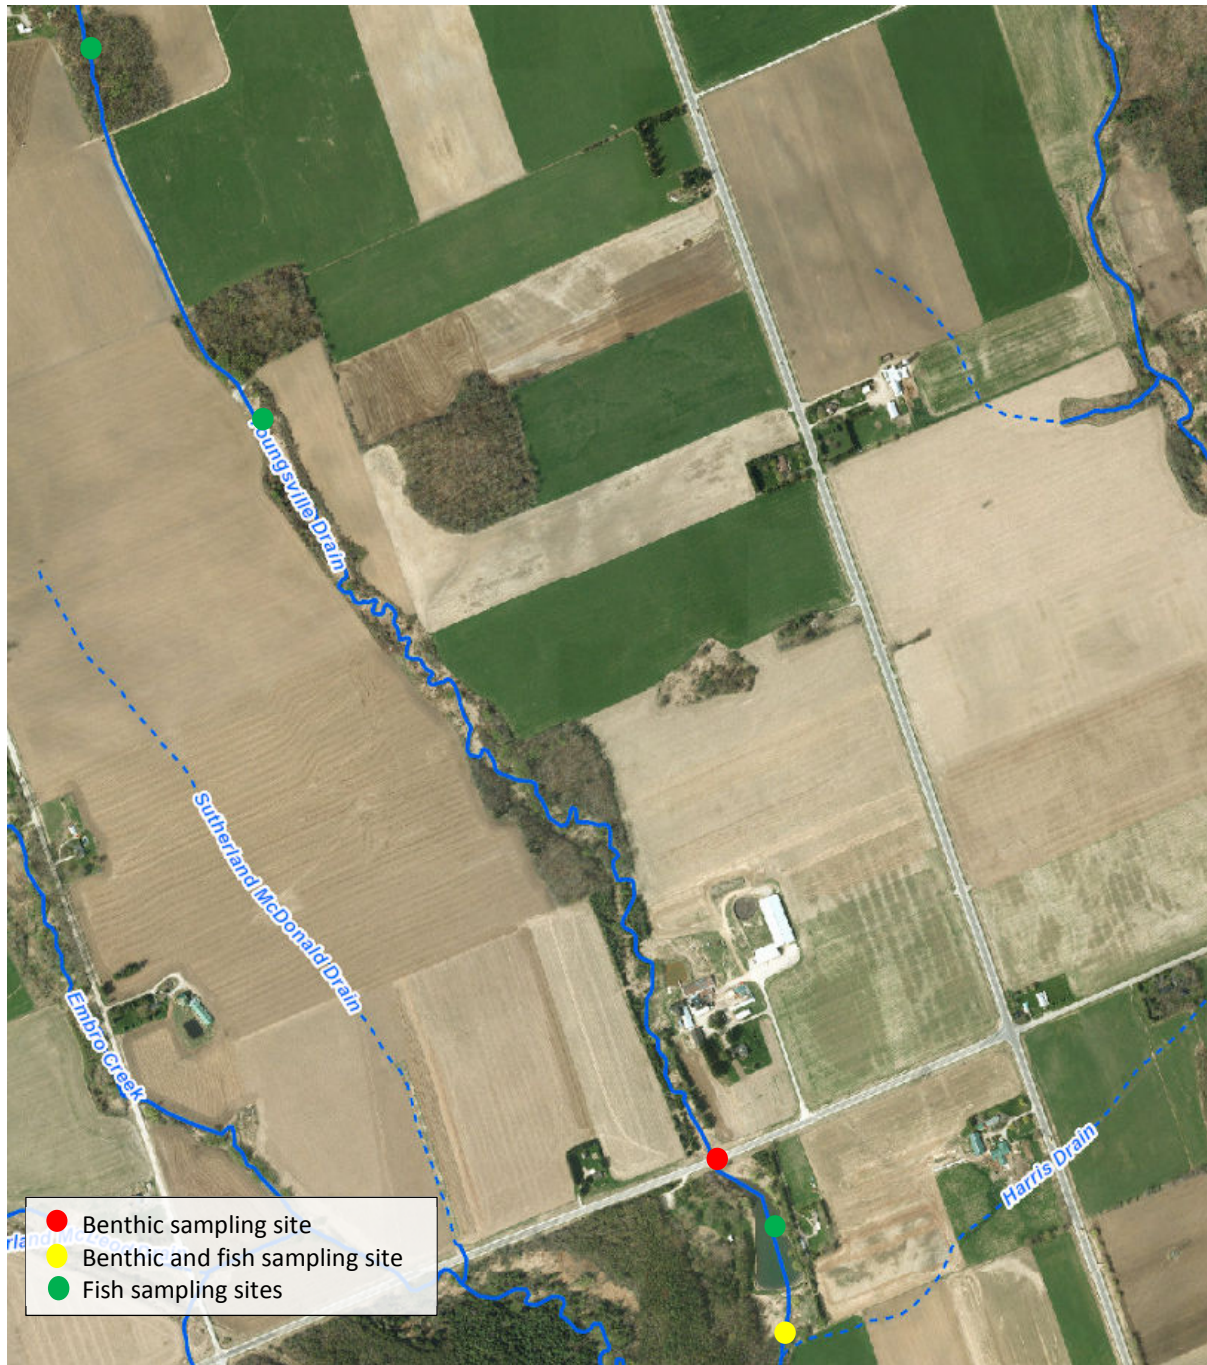
Figure 11: Embro Dam area benthic and fish sampling sites (Source: UTRCA)

Electrofishing and benthic surveys were carried out during the spring, summer and fall of 2015. The map in Figure 10 shows the different sampling sites. A list of recorded fish and benthic species, separated into sampling location, is provided in Appendix C: Embroid Dam area Fish and Benthic Records.
