Embro Dam and Conservation Area Existing Environmental Conditions Report

(this includes appended report "Flow Characteristics of Harrington Creek at Harrington Dam and Youngsville Drain at Embro Dam")

Prepared by UTRCA, Updated October 2016

Existing Environmental Conditions

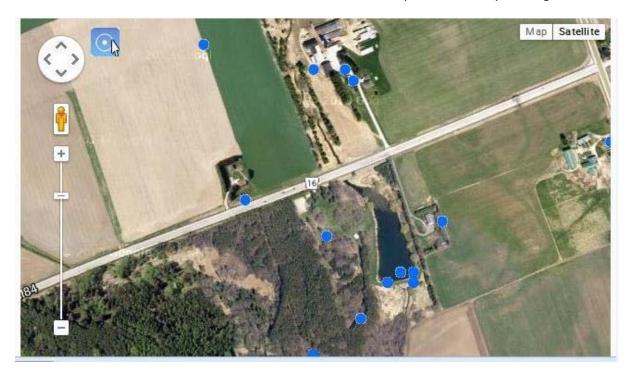
All background information and individual well records were retrieved from the Ministry of the Environment and Climate Change (MOECC) and provided to Ecosystem Recovery Inc. for analysis by their sub-consultant Englobe (formerly LVM). Figure 7 shows the locations of the known wells in the area. The wells shown on the Embro Dam are Bore Holes for the past Dam Safety investigations.

Figure 7: Known wells in the area of Embro CA (Source: MOECC)

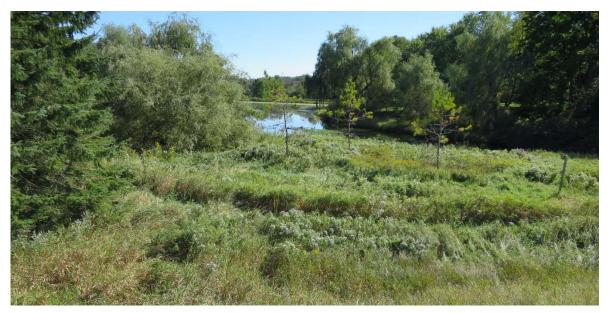
Photo 1. Community 1 – View looking south from Rd 84 at the small meadow and treed areas on the north side of the reservoir/pond.

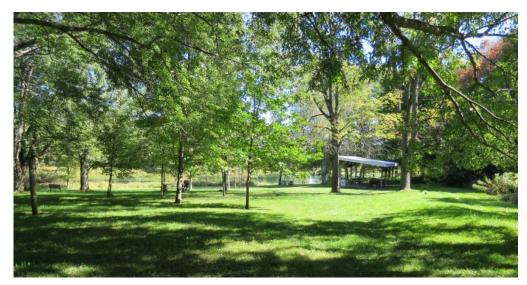
Photo 2. Community 1 – Cultural Savanna, showing the day use area of spaced shade trees and the pavilion west of the reservoir

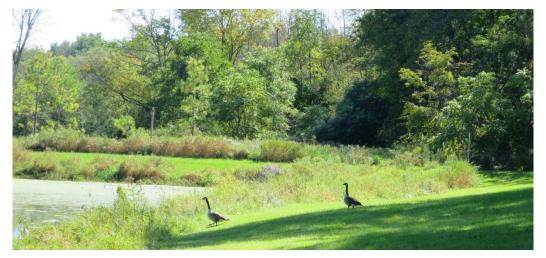
Photo 3. Community 1 (lawn and pond fringe) meets Community 2 at the far side of the reservoir (behind bird box).

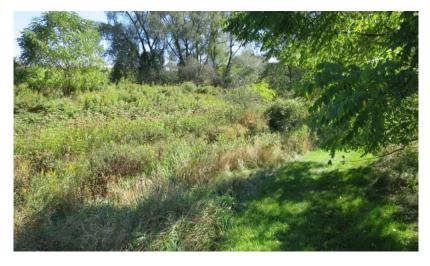
Photo 3. Community 2 – Riparian area along Youngsville Drain downstream of Embro Dam.

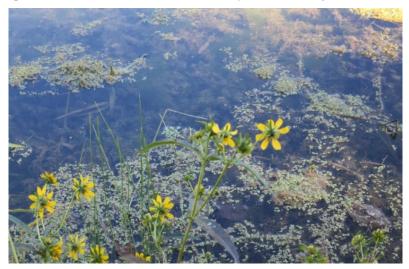
Photo 7. Community 4 – Floating Duckweed on the surface, pondweeds and waterweeds under the surface and beggarticks on the shore. Photo by Cathy Quinlan, Sept 2015

Because there is good water clarity and a surplus of nutrients in the water, there is a heavy growth of these pondweeds and waterweeds, and smaller amounts of arrowheads. It is estimated that 50% of the pond/reservoir volume is filled with aquatic vegetation. This vegetation does provide good cover for fish species that are adapted to ponds. Other sections of the Embro Environmental Assessment discuss the fisheries.

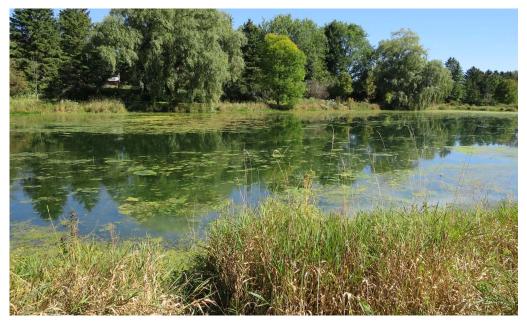
Photo 8. Community 4 - View of Embro Pond/Reservoir in Sept. 2015, looking east.

There are very few wetland emergent plants growing along the edges of the pond. The Pond contours don't seem to favour these plants (e.g., steep sided). As well, the pond is kept at the same elevation all year with no drawdowns that would expose mudflats and promote colonization of species such as cattails and rushes. Any shoreline vegetation is included in Community 1.

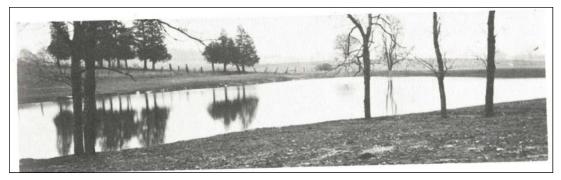
Photo 9. Historical photo of Embro Pond shortly after construction in the 1960s. Source: *Twenty Five Years of Conservation on the Upper Thames Watershed* 1947 – 1973, published by the UTRCA.

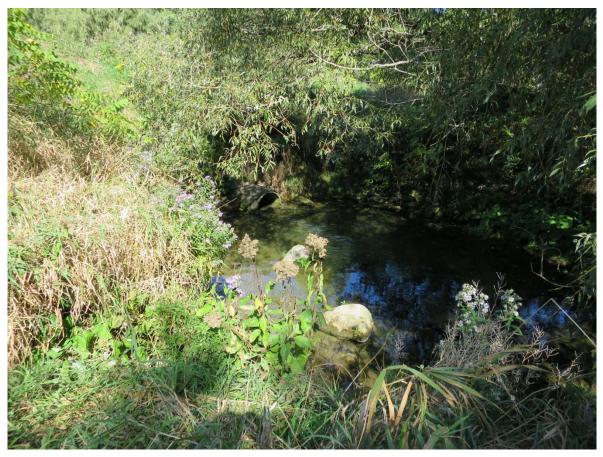
Photo 13. Youngsville Drain downstream of the dam

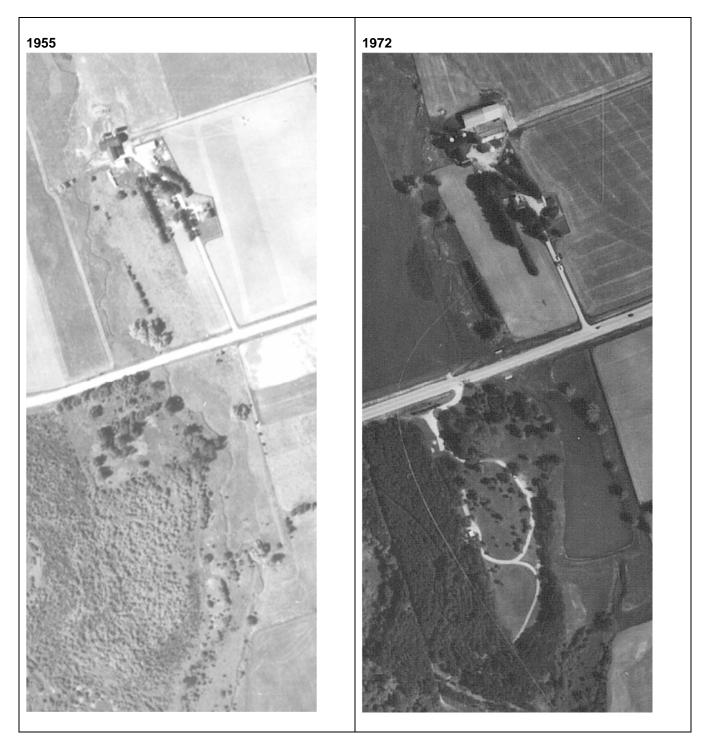
2010	 Vegetation/tree growth north of Road 84 is notable. Portions of Youngsville Drain are obscured from view on the photo. Overall, no change in planform configuration is evident in comparison to the 2000 image.

Figure 1-1a. Overview of historical channel change along Youngsville Drain in proximity to Embro Pond

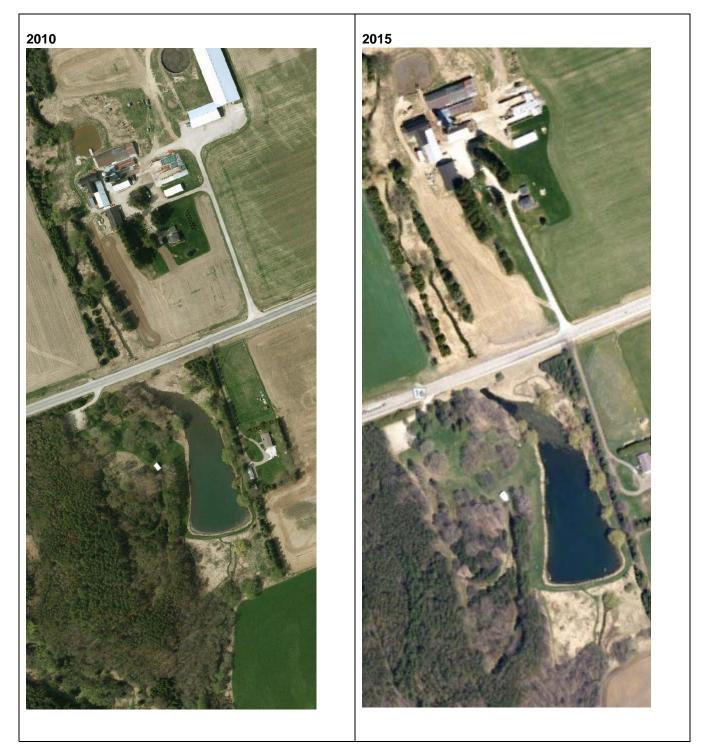
Figure 1-1c. Overview of historical channel change along Youngsville Drain in proximity to Embro Pond

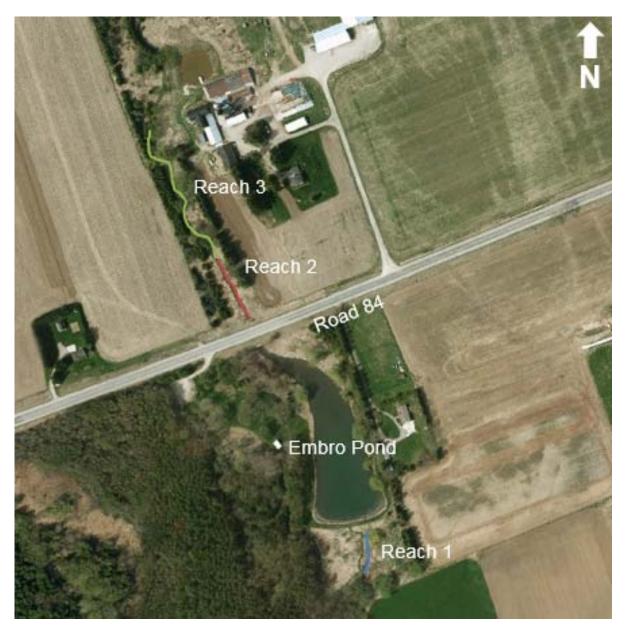
The focus of field data collection/measurements was predominantly upstream of the dam's backwater influence and included cross-section profiles and substrate characterization. A topographic survey of the channel bed morphology was undertaken by UTRCA and provided to the ERI team for analysis and integration into the fluvial geomorphic assessment. The reach delineation is demonstrated on **Figure 1-2** the surveyed channel bed profile is illustrated in **Figure 1-3** which includes a profile through Embro Pond based on 2015 water depth mapping provided by the UTRCA.

Figure 1-2. Reach delineation along Youngsville Drain.

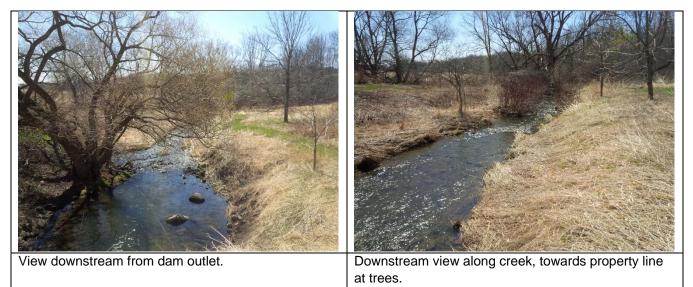
Overall, the Youngsville Drain appeared to be stable throughout the reach.

Figure 1-4. Reach 1 photos illustrating site conditions

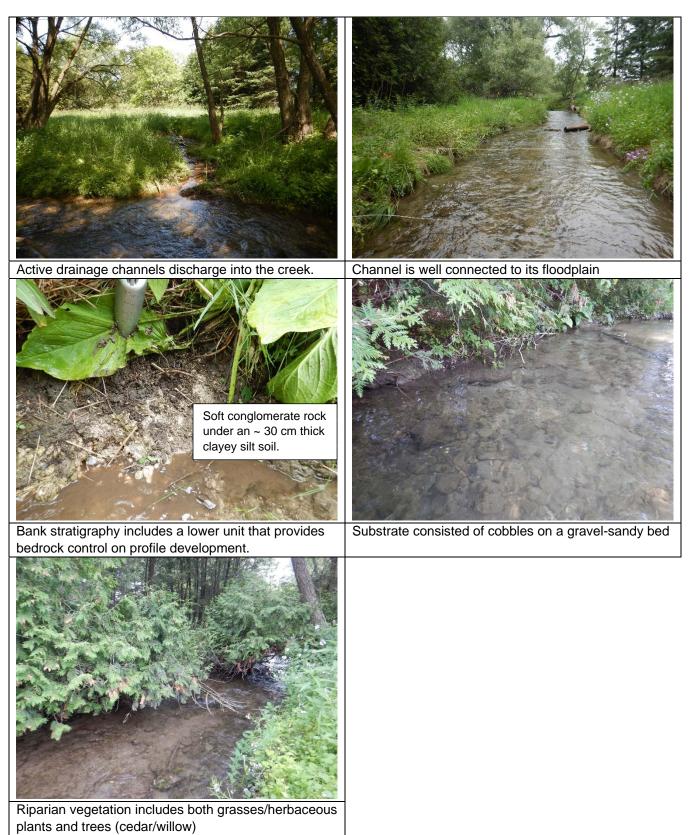
Figure 1-6. Reach 3 photos illustrating site conditions
