Appendix G
Stage 1 Archaeological Assessment
Prepared by Archaeological Research Associates, 2015

**Stage 1 Archaeological Assessment
Harrington Dam and Embro Dam
Class Environmental Assessment
963656 Road 96 and 843970 Road 84
Township of Zorra
Part of Lot 30, Concession 2 and
Part of Lot 15, Concession 4
Geographic Township of West Zorra
Oxford County, Ontario**

Project #P007-0690

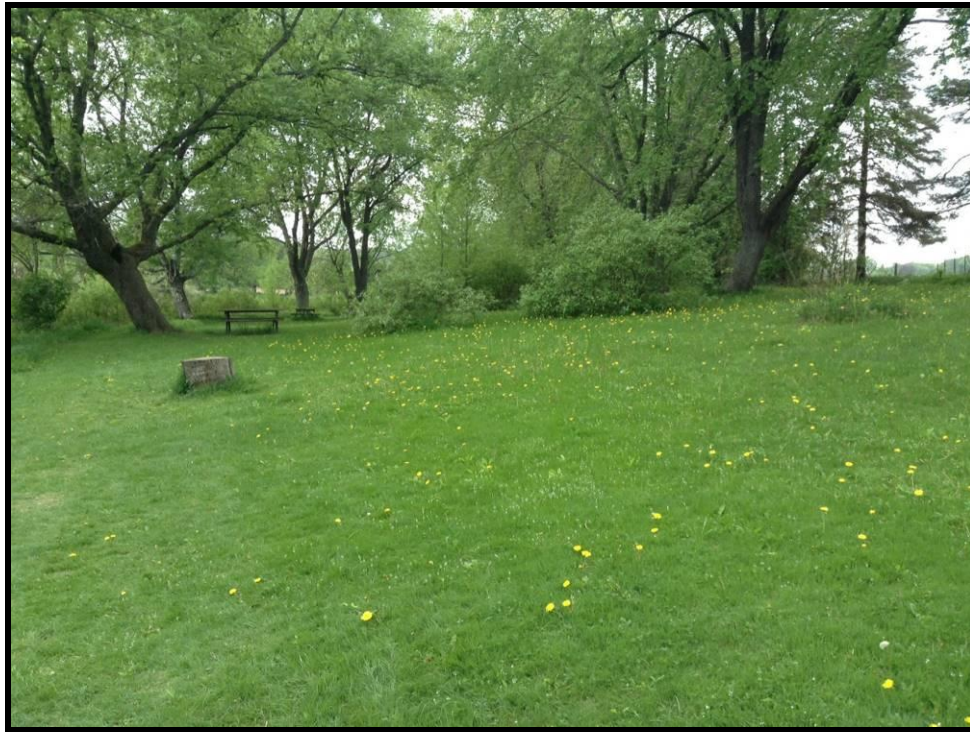
Image 1: Current Land Conditions, Harrington Dam
(Photo Taken on May 19, 2015; Facing Southwest)

At the time of assessment, the Harrington Dam parcel comprised Harrington Pond, the Harrington Grist Mill, a gravel driveway, pedestrian bridges, maintained lawns, wooded areas and part of an agricultural field, whereas the Embro Dam parcel comprised Embro Pond, a pavilion, a culvert, maintained lawns and wooded areas. The specific weather and lighting conditions for the day of assessment are summarized in Section 2.2. No unusual physical features were encountered during the property inspection that affected the results of the Stage 1 assessment.

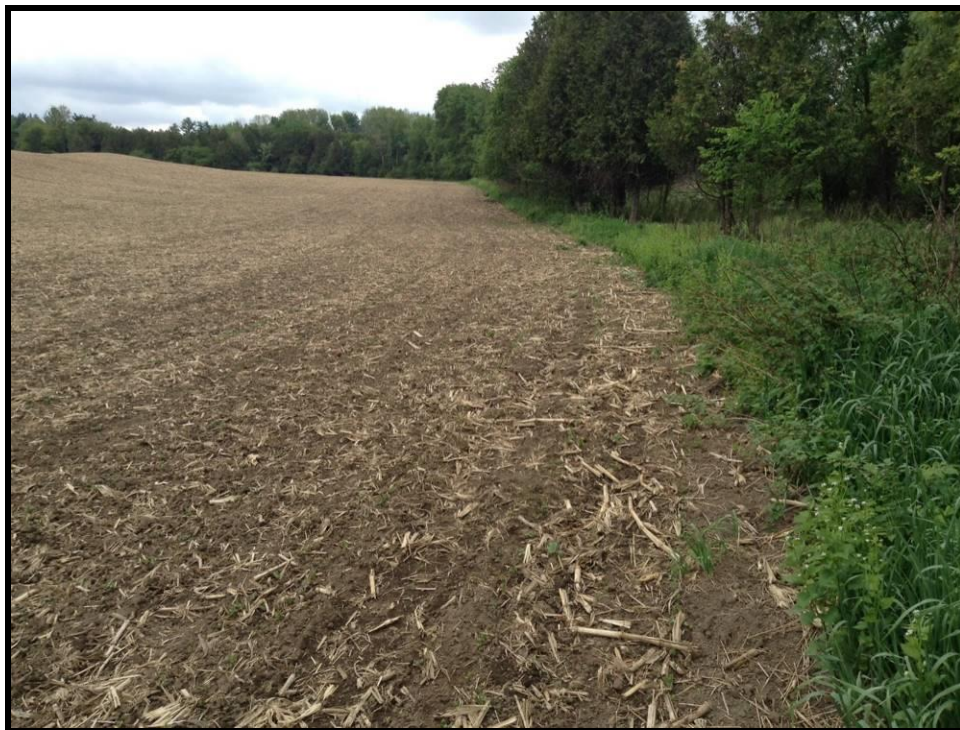
Image 2: Current Land Conditions, Harrington Dam
(Photo Taken on May 19, 2015; Facing Southwest)

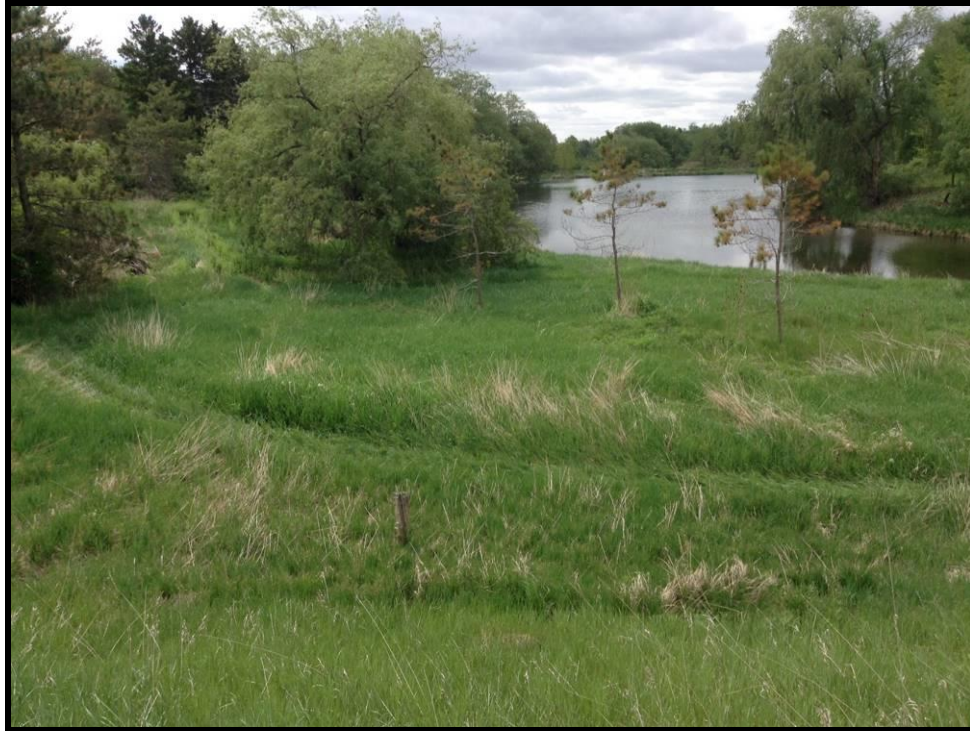
Image 3: Current Land Conditions, Embro Dam
(Photo Taken on May 19, 2015; Facing Southeast)

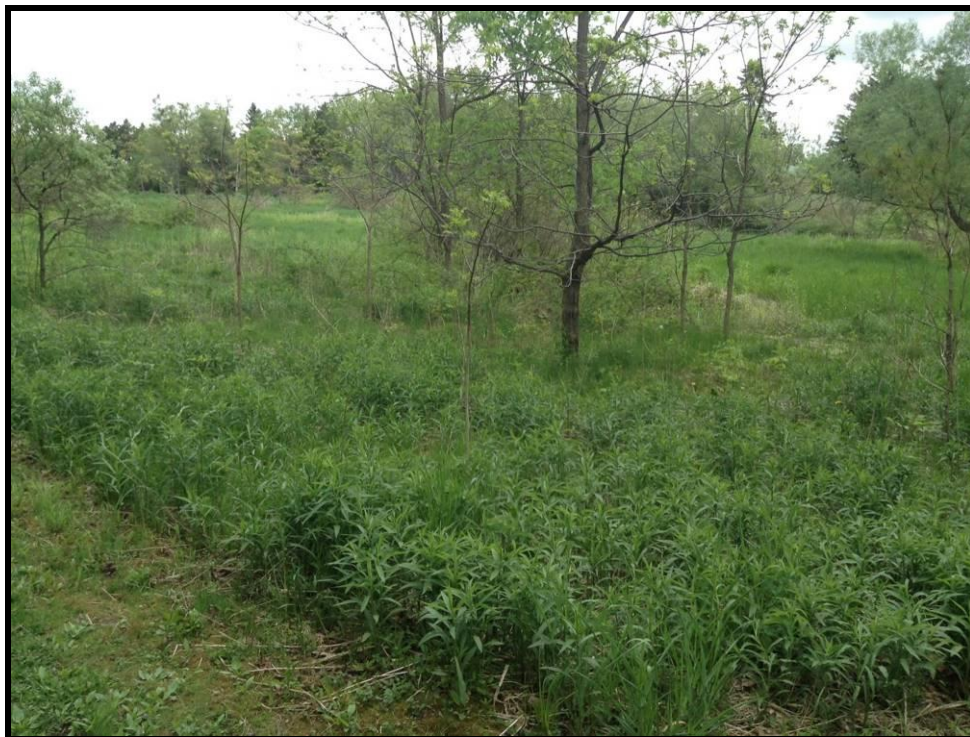
Image 4: Current Land Conditions, Embro Dam
(Photo Taken on May 19, 2015; Facing Northeast)

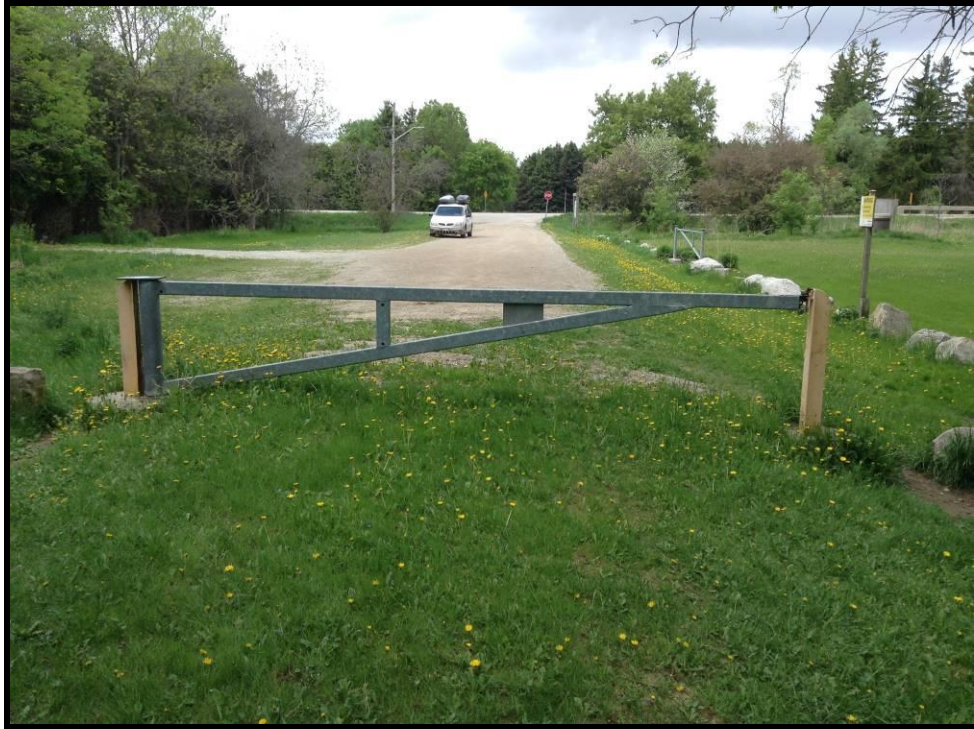
Image 5: Area of No Archaeological Potential, Harrington Dam – Disturbed
(Photo Taken on May 19, 2015; Facing North)

Based on the results of the visual survey, both the Harrington and Embro Dam parcels currently comprise a mixture of areas of archaeological potential and areas of no archaeological potential. In total, 4.49% (0.25 ha) of the Harrington Dam parcel falls within an agricultural field and requires pedestrian survey at an interval of ≤ 5 m, 52.00% (2.94 ha) falls within 300 m of a feature of archaeological potential and requires test pit survey at an interval of ≤ 5 m, 3.45% (0.20 ha) was identified as disturbed and 40.06% (2.27 ha) was found to be permanently wet. Regarding the Embro Dam parcel, 66.79% (2.09 ha) falls within 300 m of a feature of archaeological potential and requires test pit survey at an interval of ≤ 5 m, 0.19% (0.01 ha) was identified as disturbed, 30.96% (0.97 ha) was found to be permanently wet and 2.06% (0.07 ha) was sloped $> 20^\circ$. The identified areas of archaeological potential and areas of no archaeological potential (separated by class or category) are depicted in Map 21–Map 22.

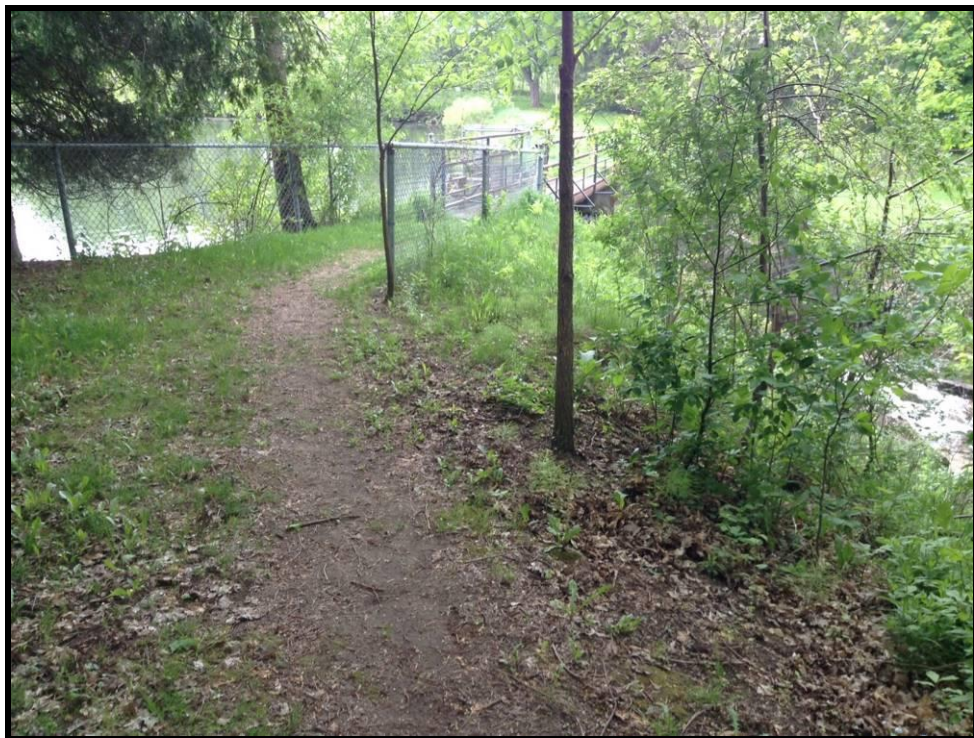
Image 6: Area of No Archaeological Potential, Harrington Dam – Disturbed
(Photo Taken on May 19, 2015; Facing Southwest)

ARA's property inspection/visual survey, coupled with the analysis of modern satellite imagery and topographic mapping, resulted in the identification of several areas of disturbance within the assessed area (see Image 5–Image 10). Specifically, deep land alterations have resulted in the removal of archaeological potential from 1) the driveways/walkways associated with the grist mill and pedestrian bridges at the Harrington Dam parcel, 2) the footprint of the Harrington Grist Mill and a look-out platform at the Harrington Dam parcel, 3) the footprint of a concrete-footed pavilion at the Embro Dam parcel and 4) culverts and/or dams at the north and south ends of the ponds at both parcels. Natural areas of no archaeological potential included several permanently wet areas associated with the waterways and ponds at both parcels (see Image 11–Image 12), and two area of lands sloped $> 20^\circ$ at the Embro Dam parcel (see Image 13–Image 14). The remainder of the assessed area either has potential for Pre-Contact and Euro-Canadian archaeological materials or requires test-pitting to confirm disturbance.

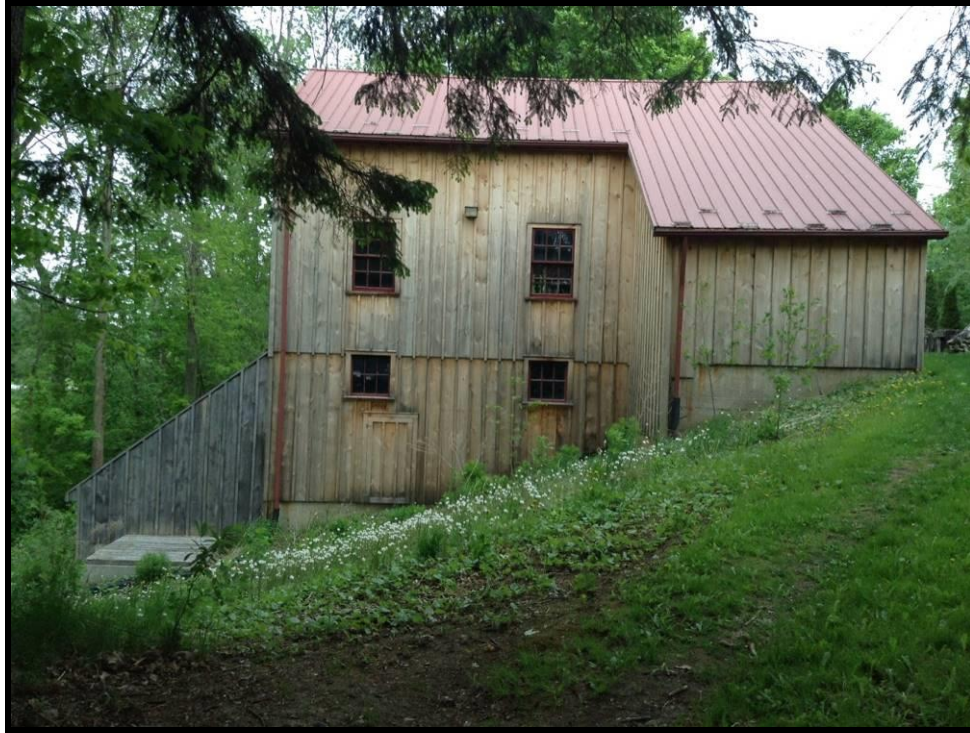
Image 7: Area of No Archaeological Potential, Harrington Dam – Disturbed
(Photo Taken on May 19, 2015; Facing North)

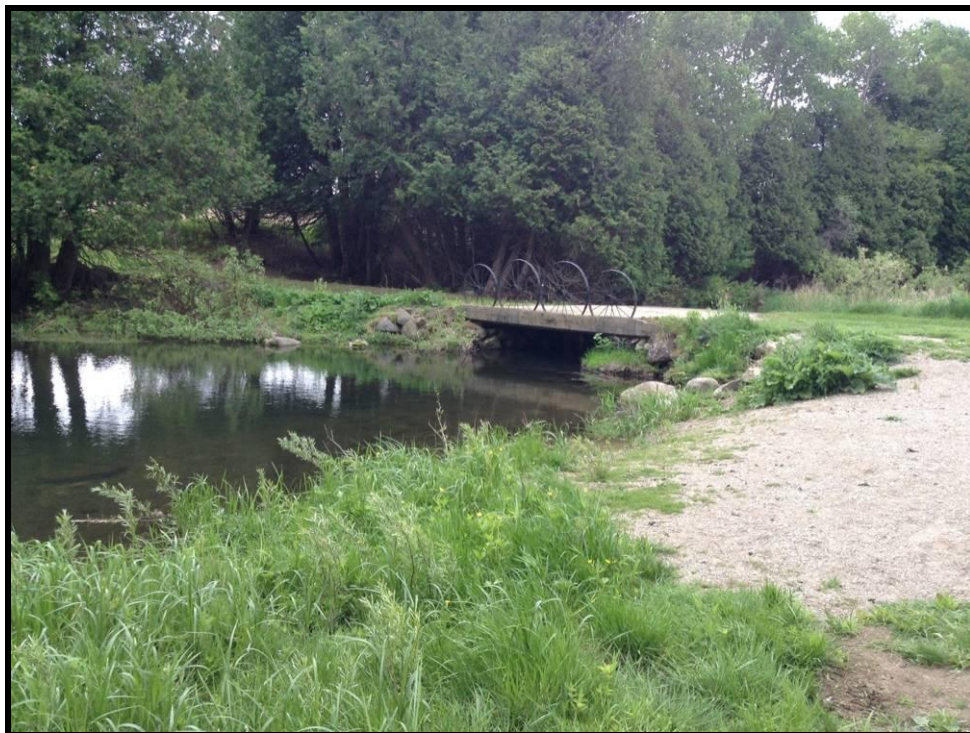
Image 8: Area of No Archaeological Potential, Harrington Dam – Disturbed
(Photo Taken on May 19, 2015; Facing Southeast)

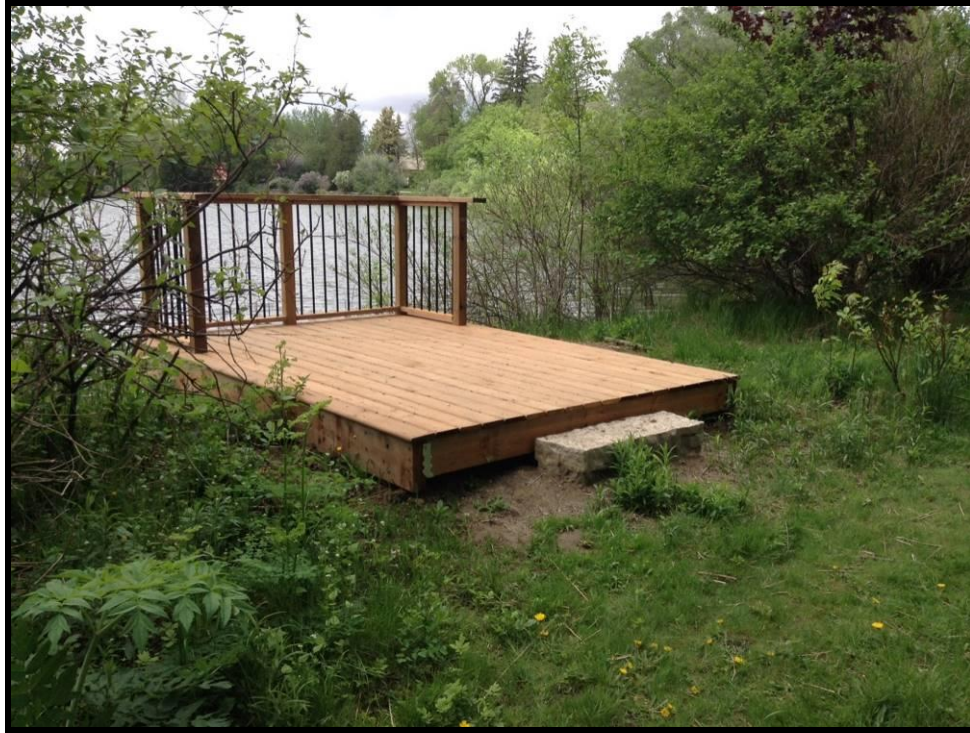
Image 9: Area of No Archaeological Potential, Harrington Dam – Disturbed
(Photo Taken on May 19, 2015; Facing Northwest)

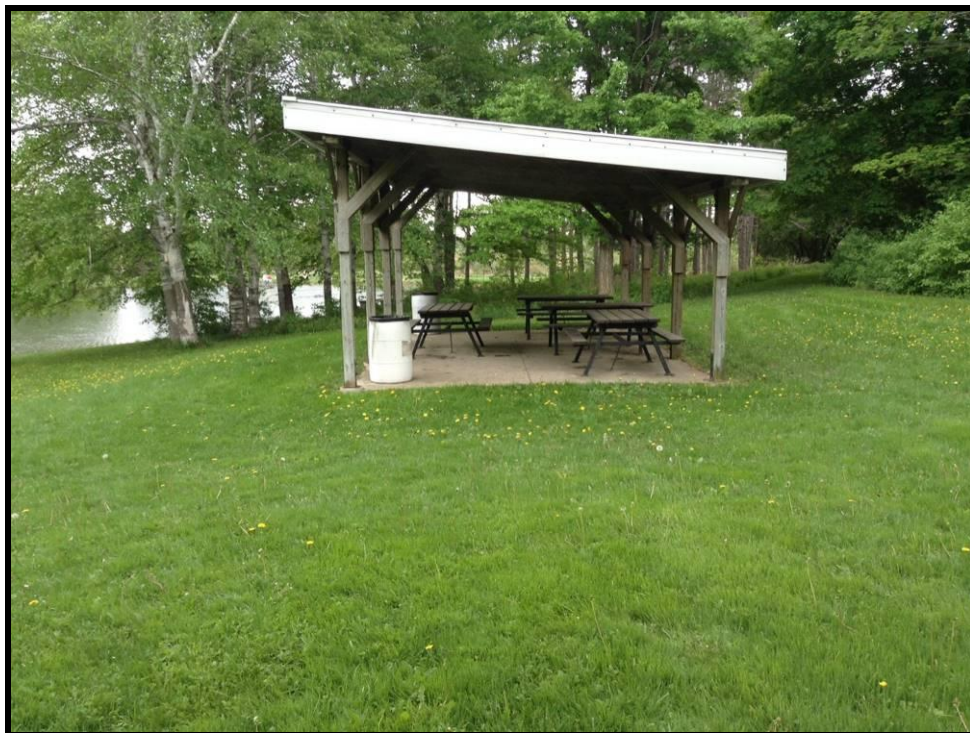
Image 10: Area of No Archaeological Potential, Embro Dam – Disturbed
(Photo Taken on May 19, 2015; Facing South)

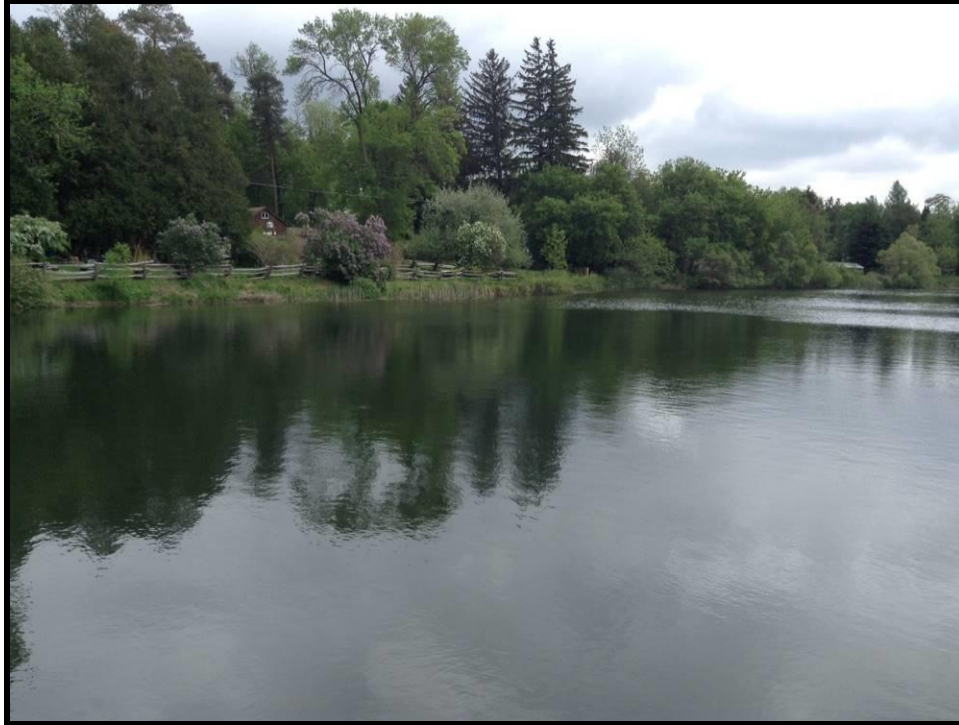
Image 11: Area of No Archaeological Potential, Harrington Dam – Permanently Wet
(Photo Taken on May 19, 2015; Facing Southeast)

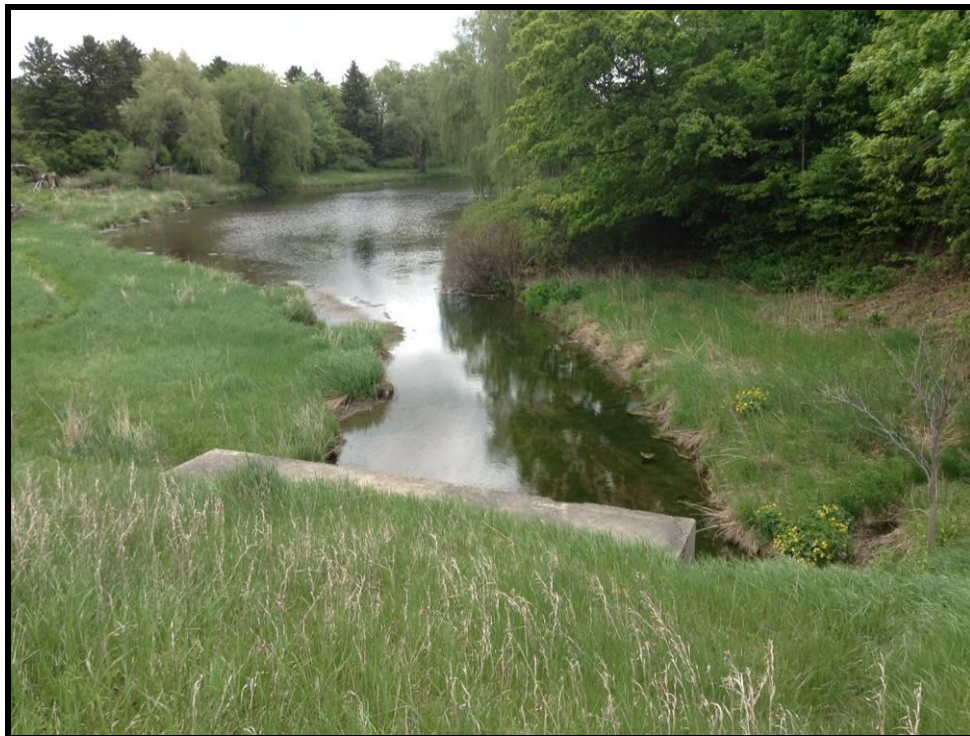
Image 12: Area of No Archaeological Potential, Embro Dam – Permanently Wet
(Photo Taken on May 19, 2015; Facing Southeast)

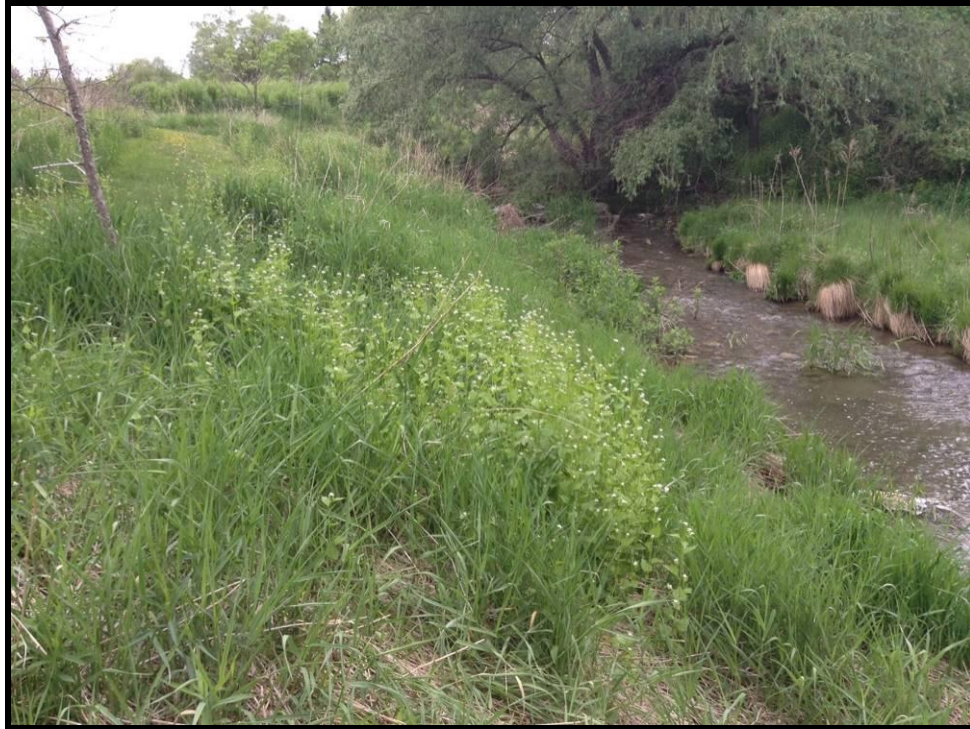
Image 13: Area of No Archaeological Potential, Embro Dam – Slope > 20°
(Photo Taken on May 19, 2015; Facing North)

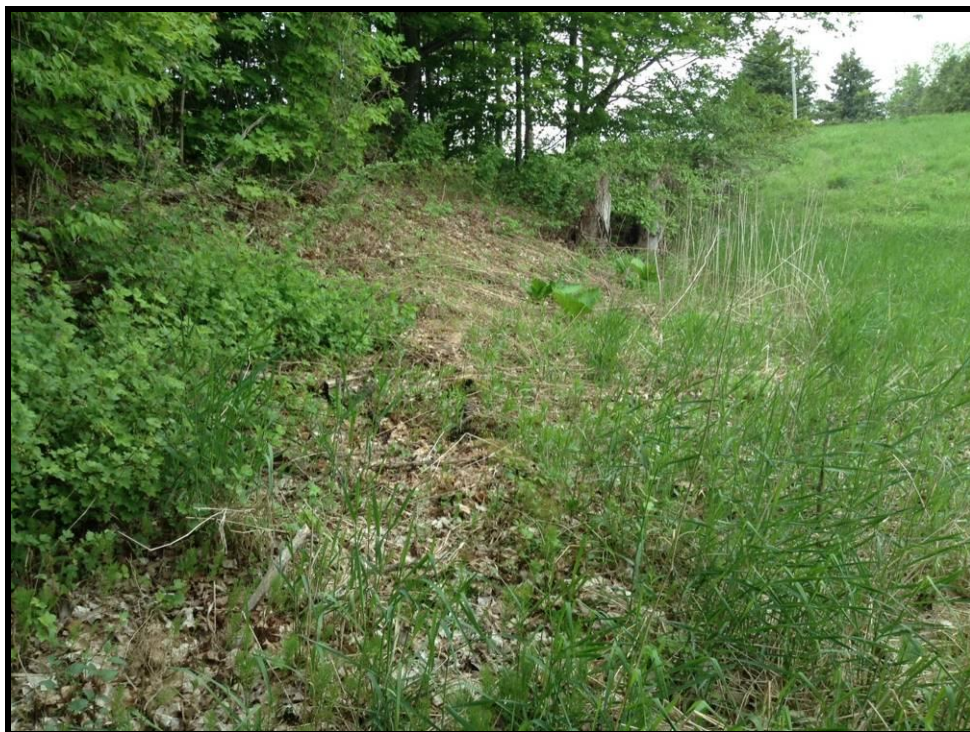
Image 14: Area of No Archaeological Potential, Embro Dam – Slope > 20°
(Photo Taken on May 19, 2015; Facing Northwest)

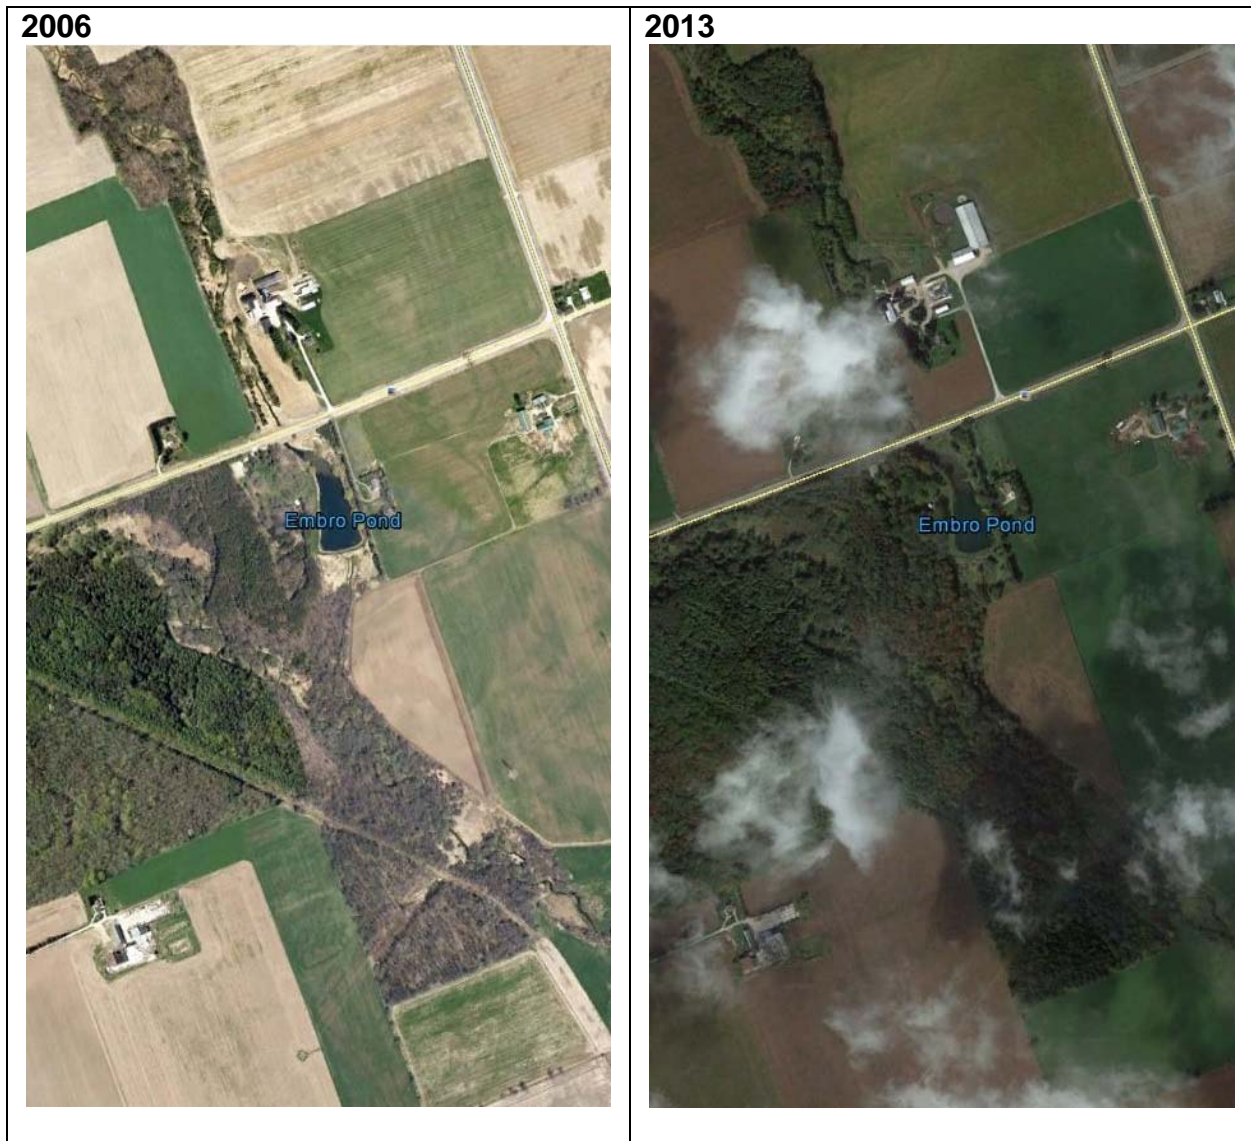
Figure 1: Aerial Photo Comparison of Study Area (Google Inc., 2015)

The dam hazard potential classification requires update based on the 2011 Guidelines and due to the Class EA being completed for Embro Dam. Aerial photographs of Embro Dam were examined and it was determined that no significant land use changes occurred from 2006 to 2013 and it is presumed that no significant land use changes are expected to occur in the foreseeable future (**Figure 1**). Therefore, the hazard potential classifications of the study site should remain similar to that of the 2007 Dam Safety Assessment. Life safety hazard was rated as very low and given that no new permanent dwellings have been constructed in the study area, it is reasonable to assign a HPC of low for the current conditions of Embro Dam. Similarly, it is expected that the incremental hazard potential for property loss, environmental losses and heritage losses will remain low. Therefore, the overall incremental hazard potential for Embro Dam would be low based on these hazard potential ratings.

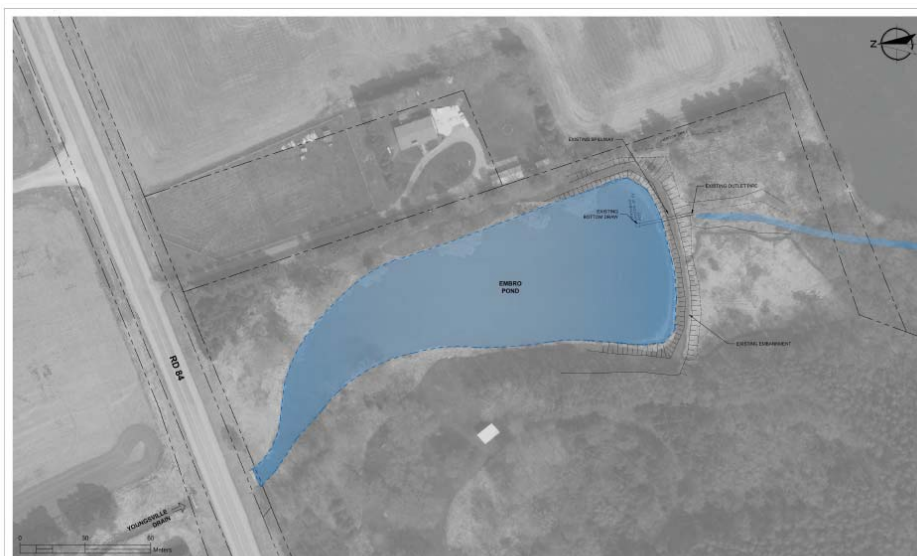
Alternative 1 – Do Nothing

- 1) Do Nothing
- 2) Repair Dam
 - construct dam 'shell', add rock protection, extend outlet pipe, provide emergency spillway
- 3) Remove Dam and Construct a Natural Channel
 - provide landscape restoration
- 4) Remove Dam and Construct Offline Pond(s) or Wetland(s)
 - create natural channel, provide landscape enhancement
- 5) Lower Dam Crest and Outlet and Naturalize New Pond and Perimeter
 - provide landscape enhancement
