Embro Dam Class Environmental Assessment

Community Liaison Committee Meeting No. 2

November 22, 2023

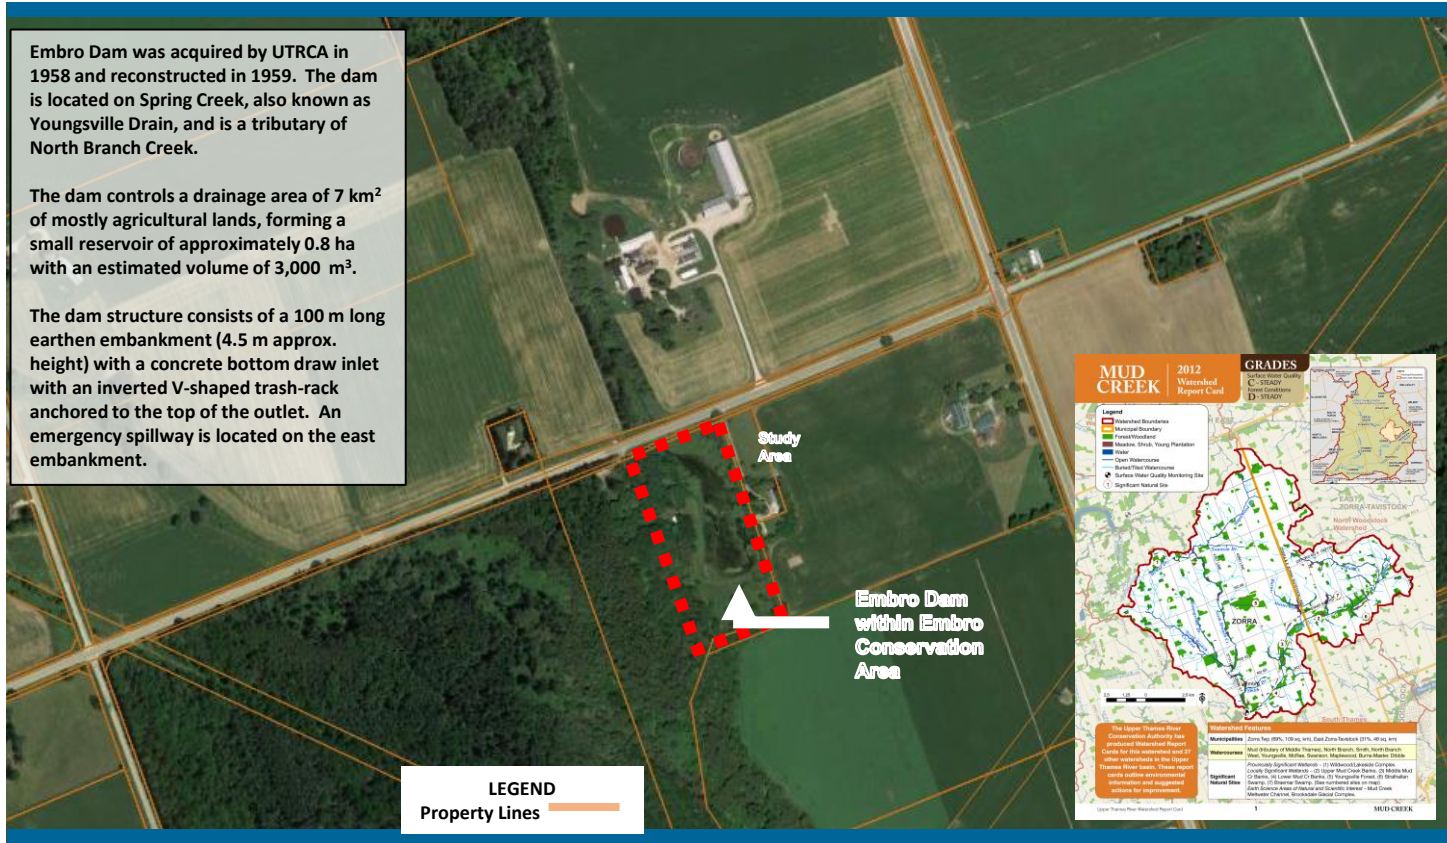
STUDY LOCATION

Embro Dam was acquired by UTRCA in 1958 and reconstructed in 1959. The dam is located on Spring Creek, also known as Youngsville Drain, and is a tributary of North Branch Creek.

The dam controls a drainage area of 7 km² of mostly agricultural lands, forming a small reservoir of approximately 0.8 ha with an estimated volume of 3,000 m³.

The dam structure consists of a 100 m long earthen embankment (4.5 m approx. height) with a concrete bottom draw inlet with an inverted V-shaped trash-rack anchored to the top of the outlet. An emergency spillway is located on the east embankment.
