# Embro Dam Class Environmental Assessment

## UTRCA Board Meeting

January 30, 2024

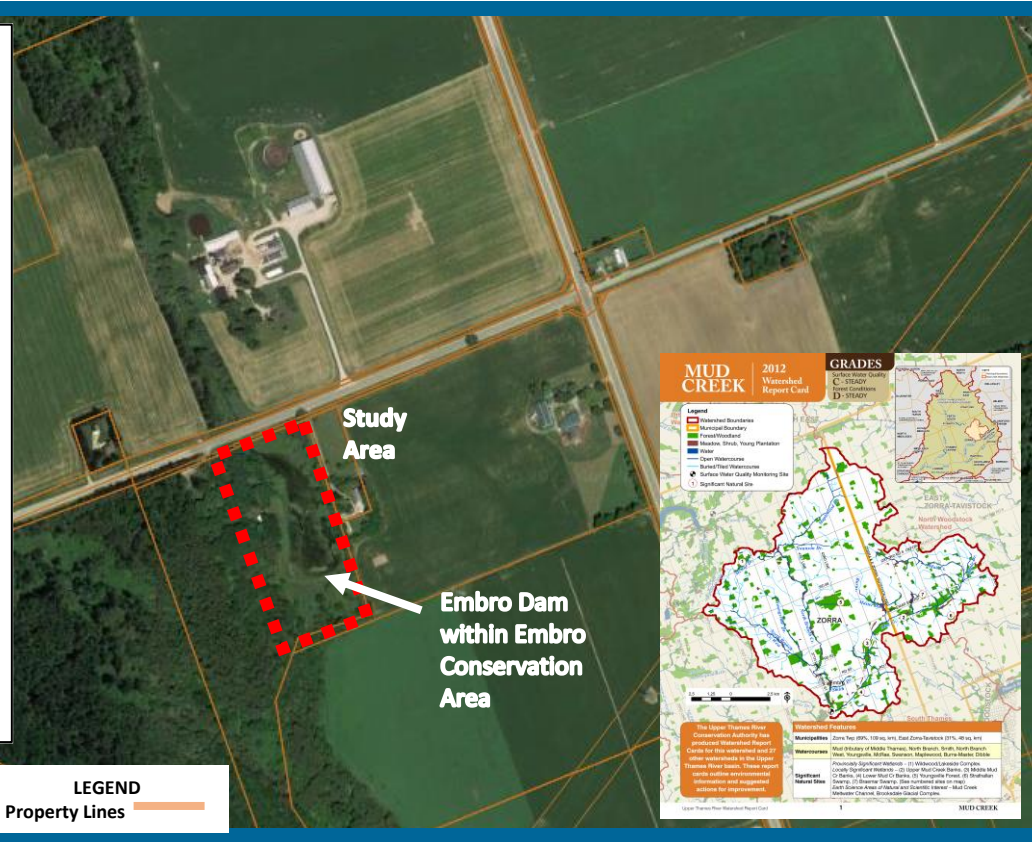
# STUDY LOCATION

Embro Dam was acquired by UTRCA in 1958 and reconstructed in 1959. The dam is located on Spring Creek, also known as Youngsville Drain, and is a tributary of North Branch Creek.

The dam controls a drainage area of 7 km<sup>2</sup> of mostly agricultural lands, forming a small reservoir of approximately 0.8 ha with an estimated volume of 30,000 m<sup>3</sup>.

The dam structure consists of a 100 m long earthen embankment, 4.5 m approx. height, with a concrete bottom draw inlet with an inverted V-shaped trash-rack anchored to the top of the outlet. An emergency spillway is located on the east embankment.
