Embryo Dam Class Environmental Assessment 2022

Presentation 2 – Zorra Heritage Committee

UPPER THAMES RIVER
CONSERVATION AUTHORITY

Embro Dam and Area Description

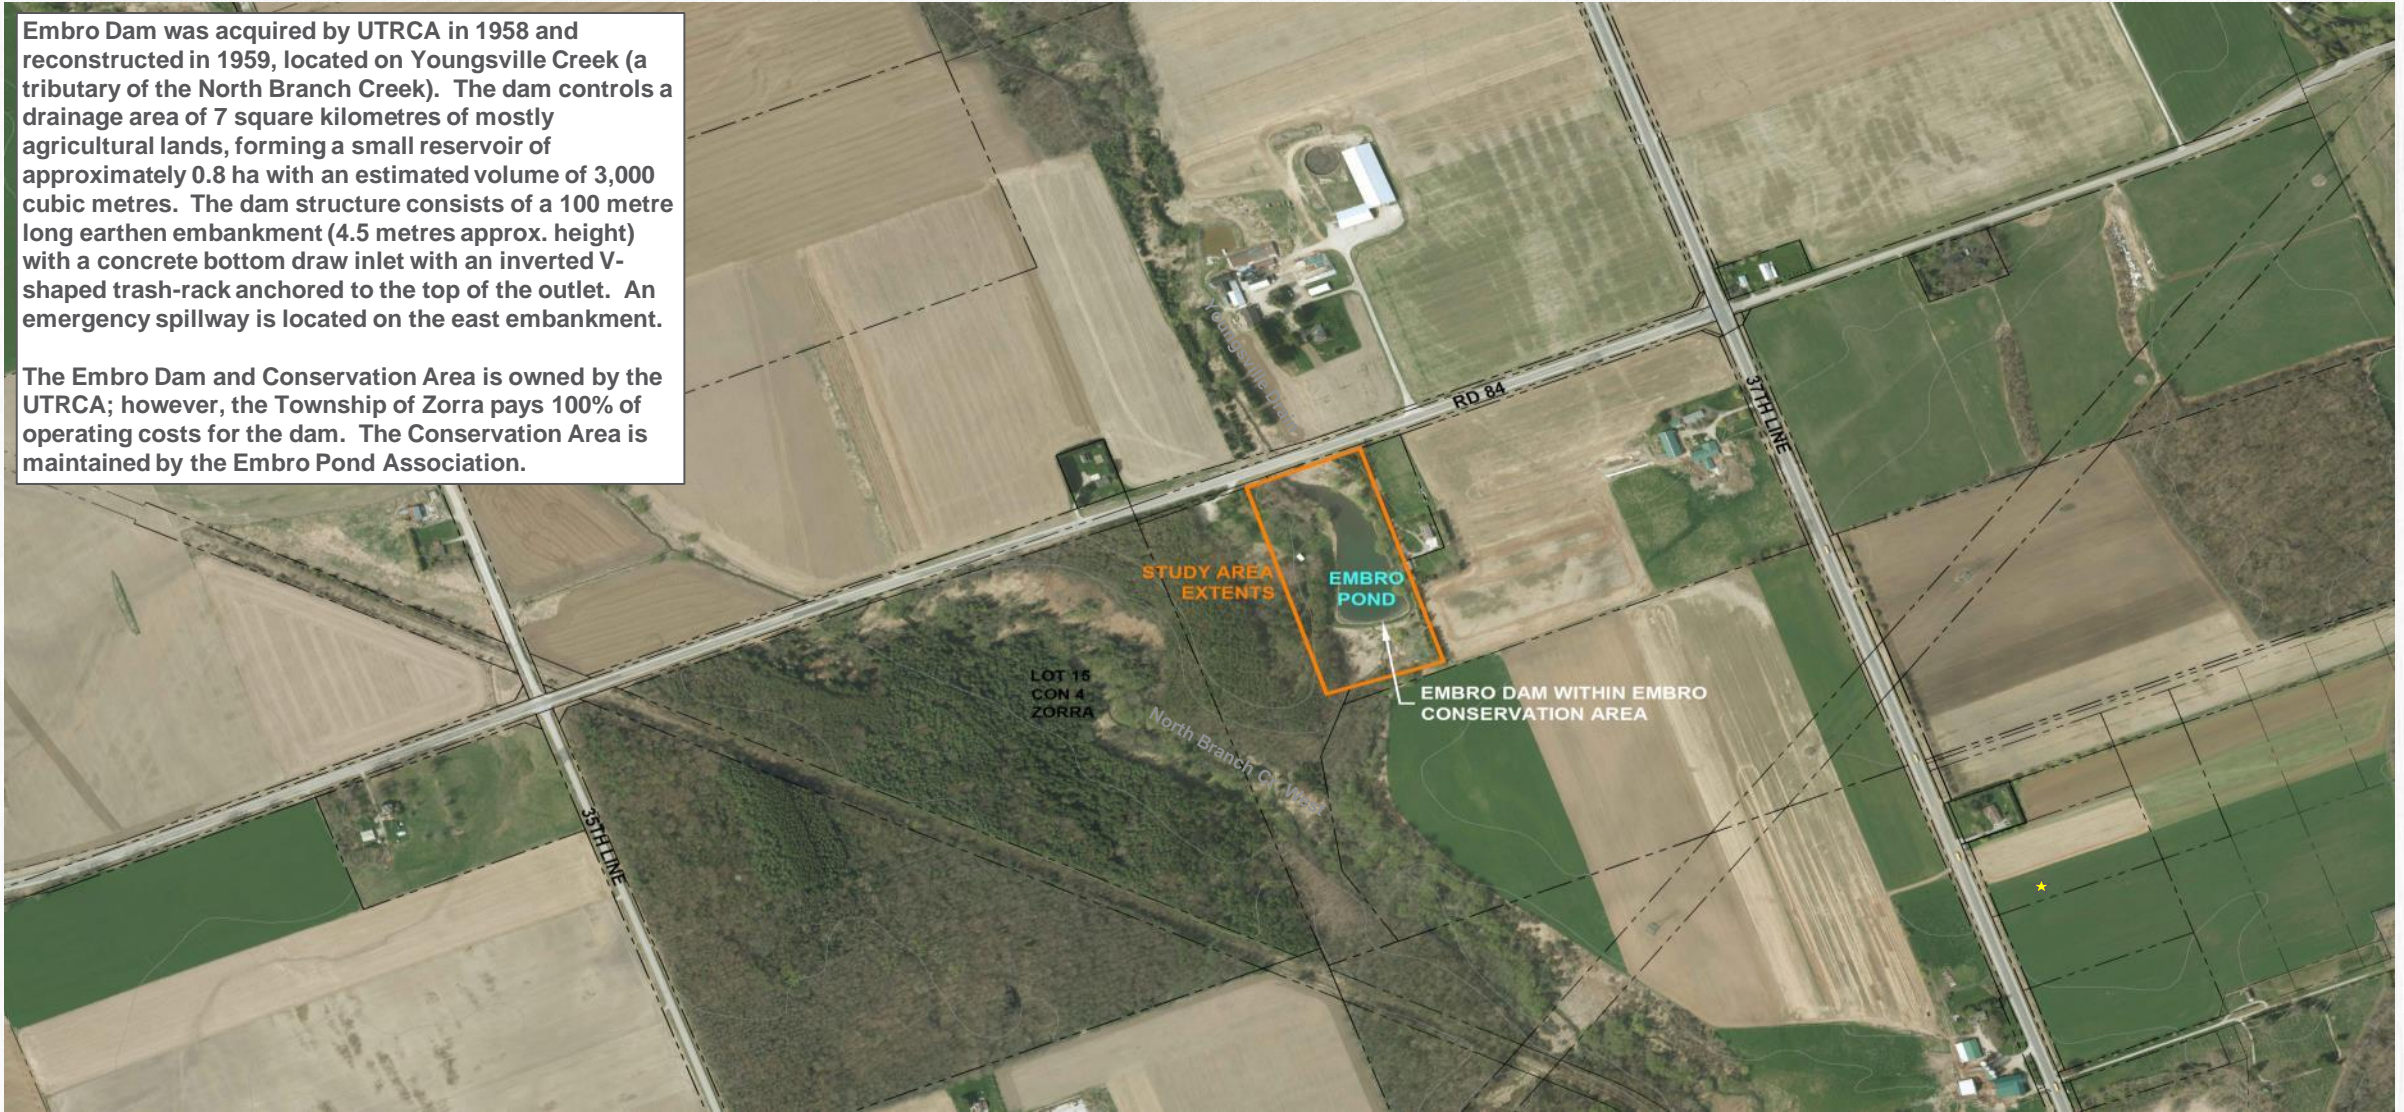
Embroid Dam was acquired by UTRCA in 1958 and reconstructed in 1959, located on Youngsville Creek (a tributary of the North Branch Creek). The dam controls a drainage area of 7 square kilometres of mostly agricultural lands, forming a small reservoir of approximately 0.8 ha with an estimated volume of 3,000 cubic metres. The dam structure consists of a 100 metre long earthen embankment (4.5 metres approx. height) with a concrete bottom draw inlet with an inverted V-shaped trash-rack anchored to the top of the outlet. An emergency spillway is located on the east embankment.

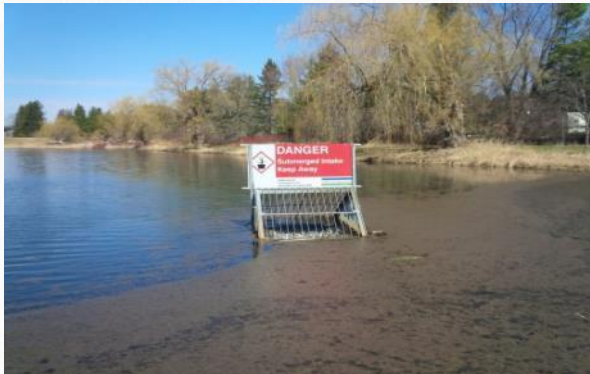
The outlet of the dam includes a concrete bottom draw inlet structure covered with grated trashrack.

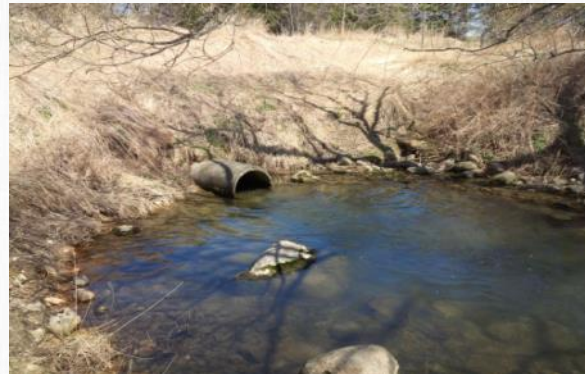
A 762 mm diameter (inner) concrete pipe conveys flow from the pond to a pool at the creek outlet.

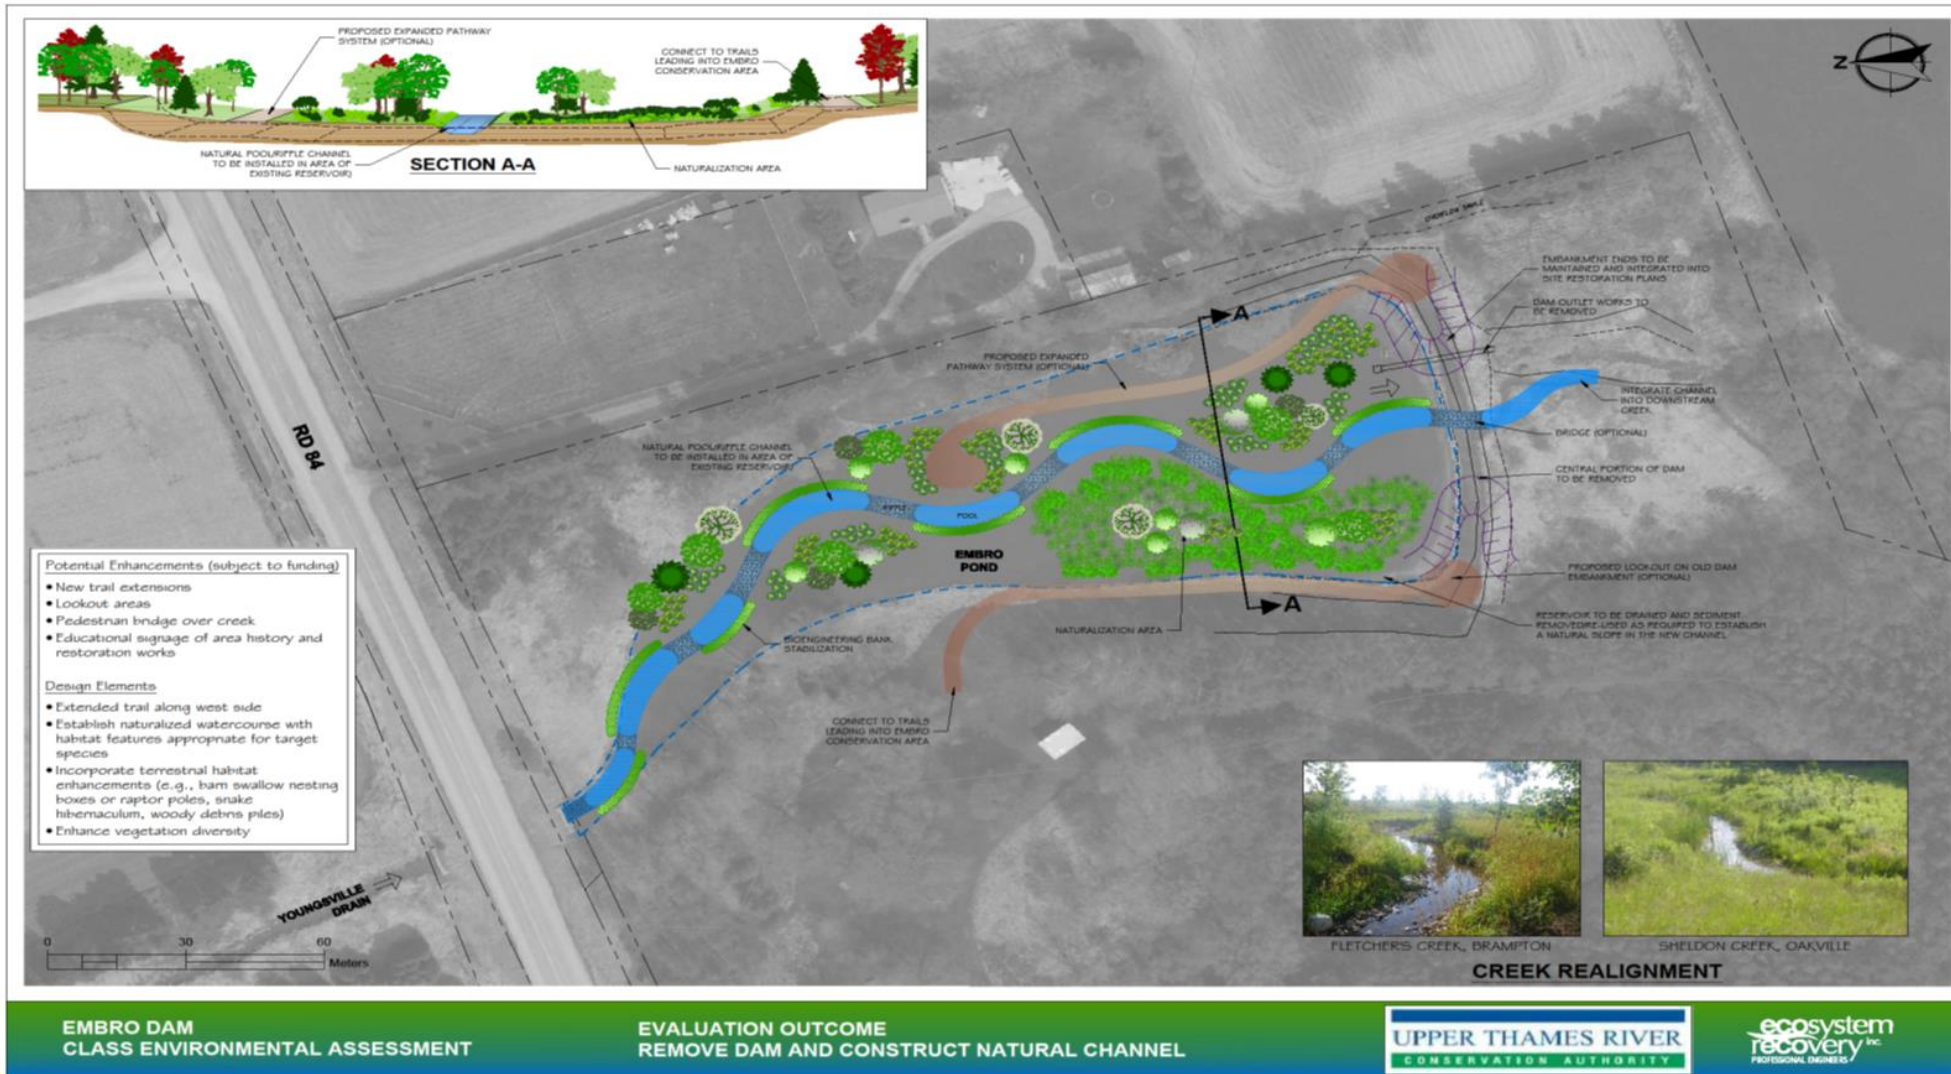
Preferred Alternative – Alternative 3 - Remove Dam and Construct Natural Channel

3 – Remove Dam and construct Natural Channel
