# Emburo Dam Class Environmental Assessment 2022

Presentation 1 – Zorra Township Council

December 21<sup>st</sup>, 2022

UPPER THAMES RIVER  
CONSERVATION AUTHORITY

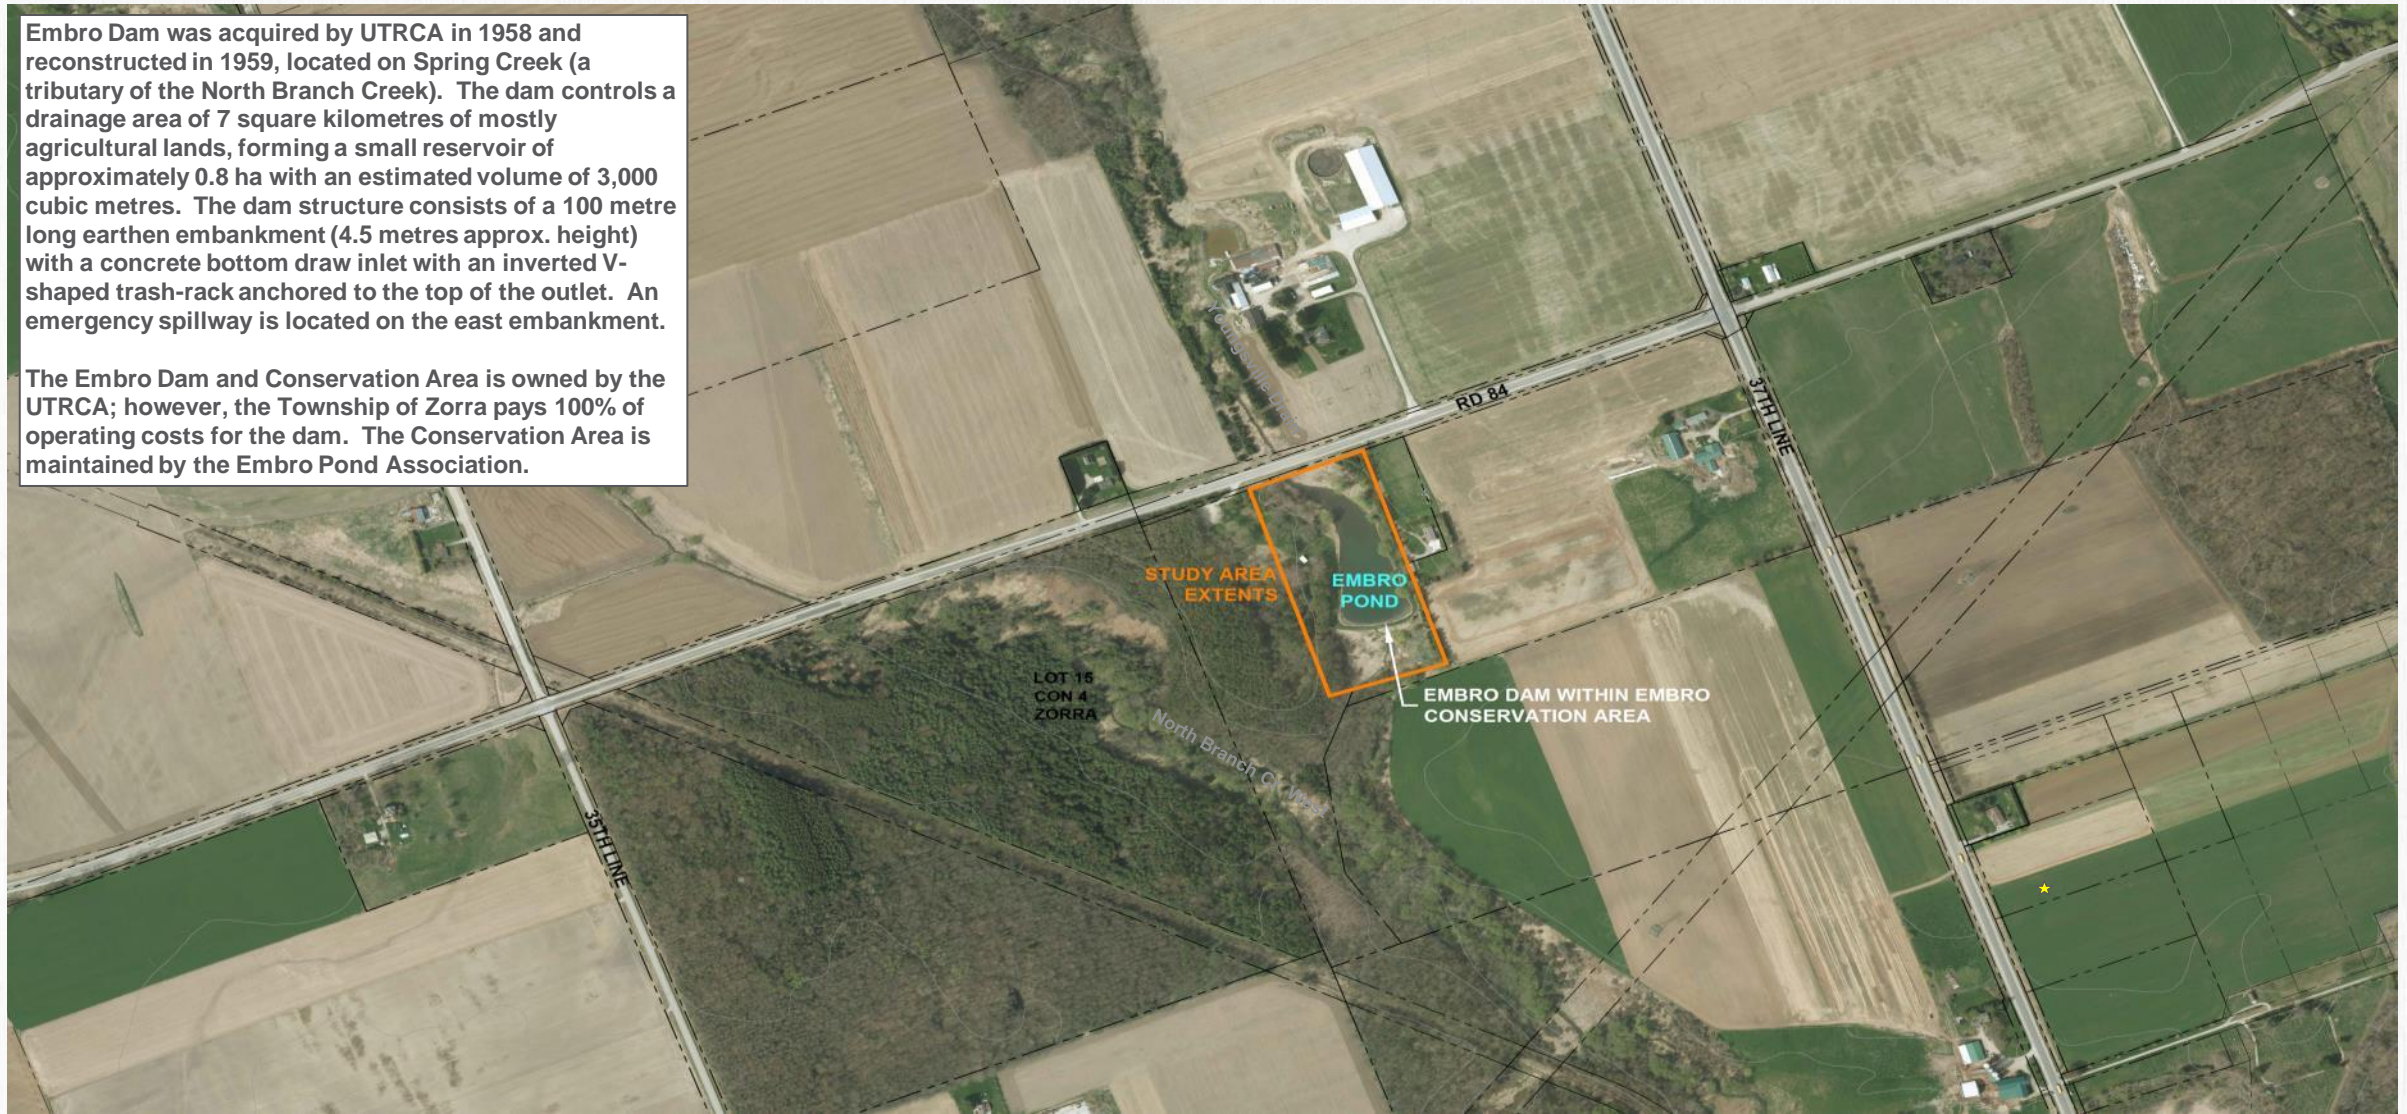
Embroid Dam was acquired by UTRCA in 1958 and reconstructed in 1959, located on Spring Creek (a tributary of the North Branch Creek). The dam controls a drainage area of 7 square kilometres of mostly agricultural lands, forming a small reservoir of approximately 0.8 ha with an estimated volume of 3,000 cubic metres. The dam structure consists of a 100 metre long earthen embankment (4.5 metres approx. height) with a concrete bottom draw inlet with an inverted V-shaped trash-rack anchored to the top of the outlet. An emergency spillway is located on the east embankment.

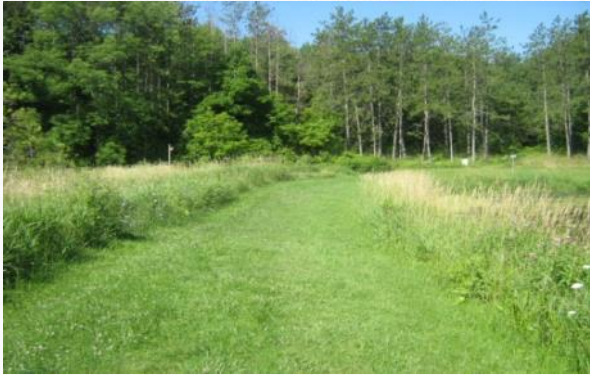
The Embro Dam is approximately 100 m in length, 4.5 m in height and includes 1.1 m of freeboard. The entire dam is founded on overburden as opposed to bedrock or engineered soil.

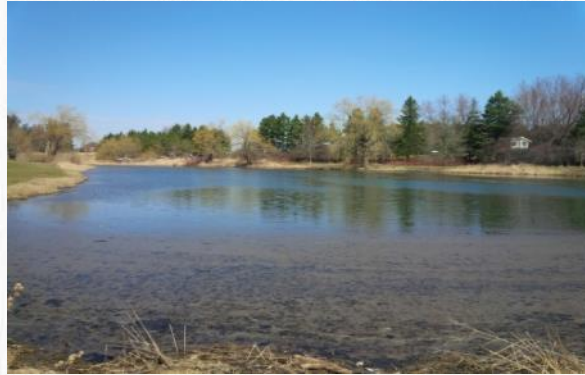
The dam contains water year round and includes approximately 3.4 m of head acting across the dam.

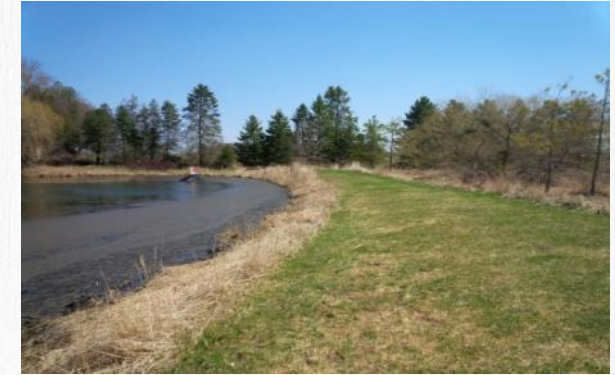
Low earth fill embankment, a grassed, emergency spillway is located at the east end of the embankment. This spillway has a clear width of about 4.0 m and the inlet invert is 0.6 m below the crest of the dam.

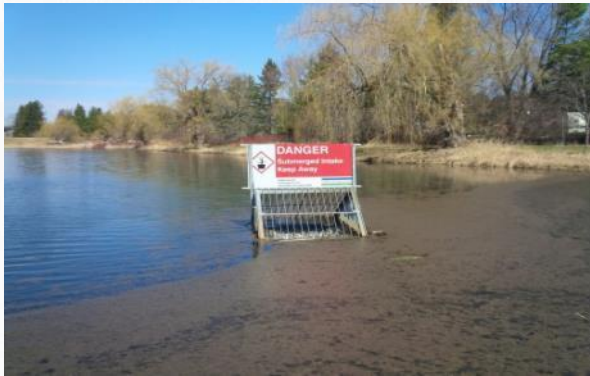
The outlet of the dam includes a concrete bottom draw inlet structure covered with grated trashrack.

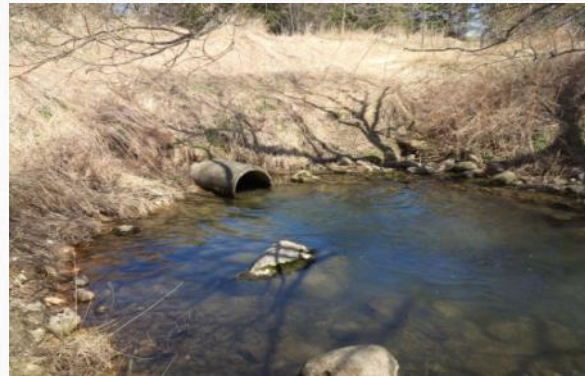
A 762 mm diameter (inner) concrete pipe conveys flow from the pond to a pool at the creek outlet.

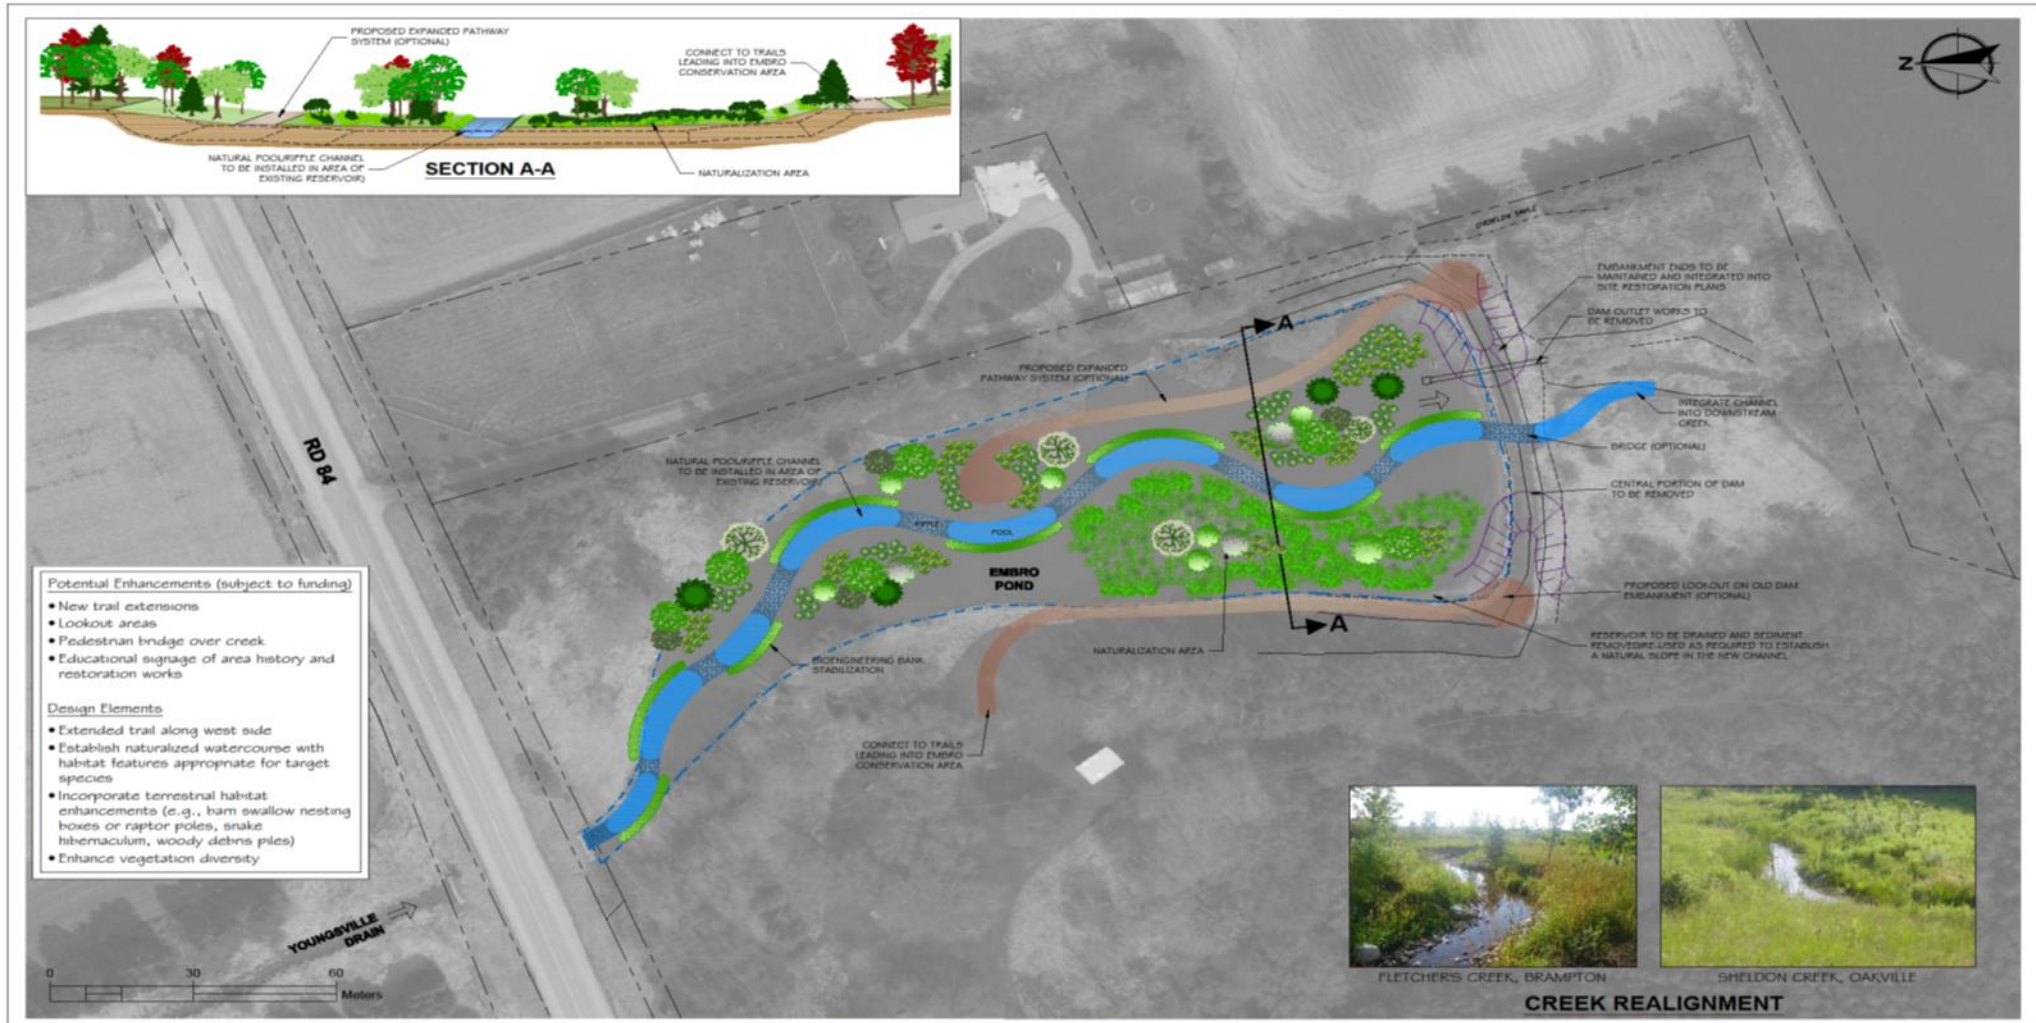
EMBRU DAM  
CLASS ENVIRONMENTAL ASSESSMENT

EVALUATION OUTCOME  
REMOVE DAM AND CONSTRUCT NATURAL CHANNEL

# Preferred Alternative – Alternative 3 - Remove Dam and Construct Natural Channel
