Emburo Dam Class Environmental Assessment

Township of Zorra Council Meeting

January 17, 2024

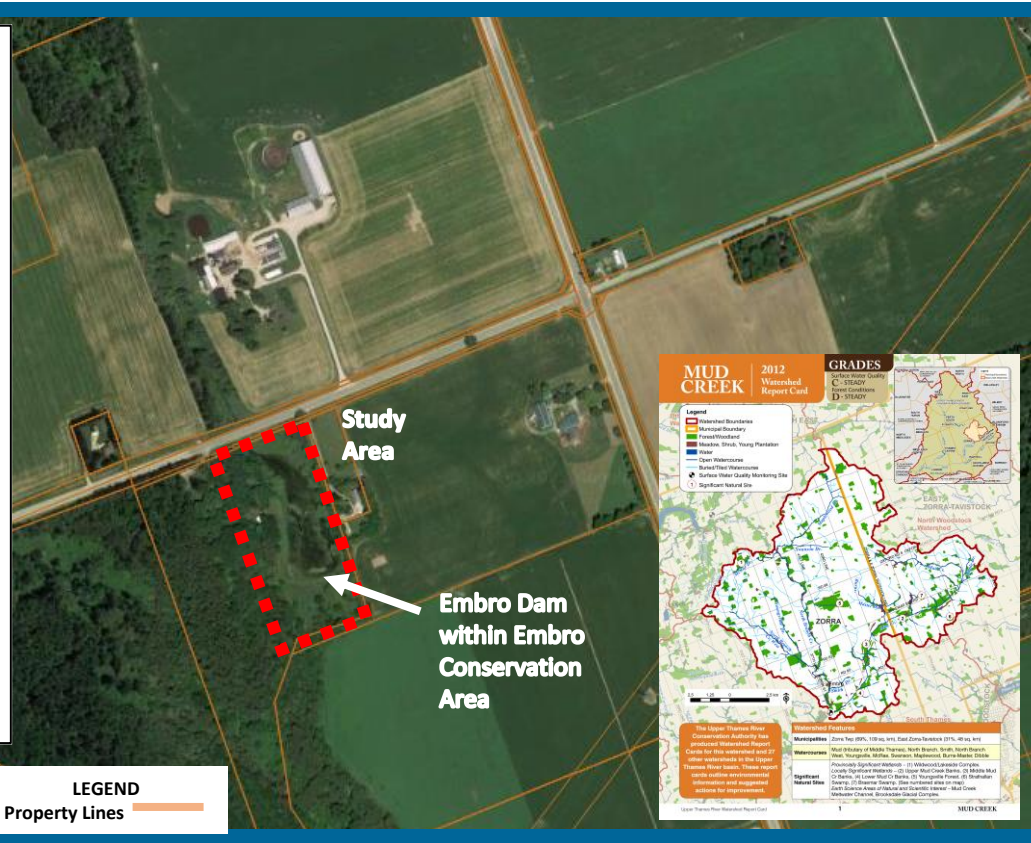
STUDY LOCATION

Embro Dam was acquired by UTRCA in 1958 and reconstructed in 1959. The dam is located on Spring Creek, also known as Youngsville Drain, and is a tributary of North Branch Creek.

The dam controls a drainage area of 7 km² of mostly agricultural lands, forming a small reservoir of approximately 0.8 ha with an estimated volume of 3,000 m³.

The dam structure consists of a 100 m long earthen embankment, 4.5 m approx. height, with a concrete bottom draw inlet with an inverted V-shaped trash-rack anchored to the top of the outlet. An emergency spillway is located on the east embankment.

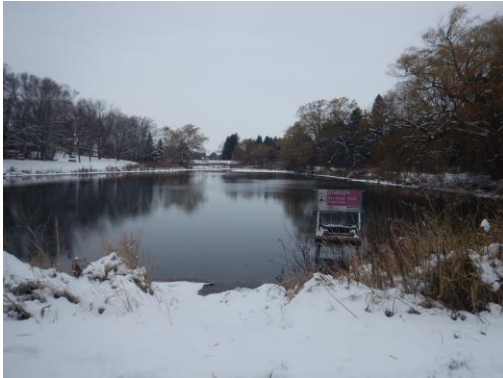
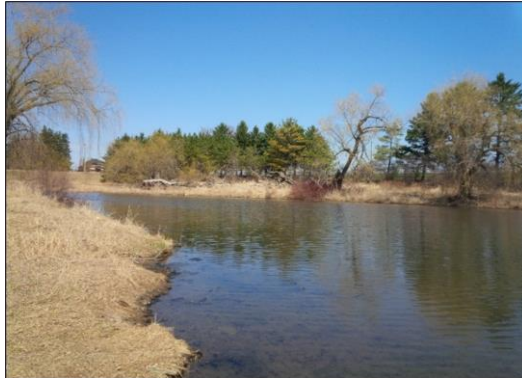
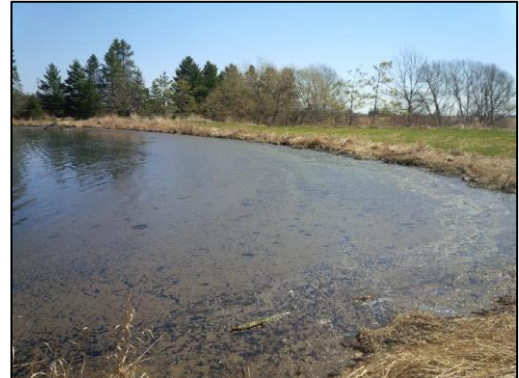
Embro Dam- Issues

- Does not meet current safety or stability standards
- 2007/2008 geotechnical assessments determined that upstream and downstream embankment slopes do not meet slope stability acceptance criteria
- 2015 Hazard Classification: **Threat levels for Life Safety, Property Losses, Environmental Losses, and Cultural-Built Heritage were considered LOW.**
- Date of last repair is unknown
