**Upper Thames River Conservation Authority**

**Embroid Dam Class Environmental Assessment  
DRAFT Report**

**June 2017**

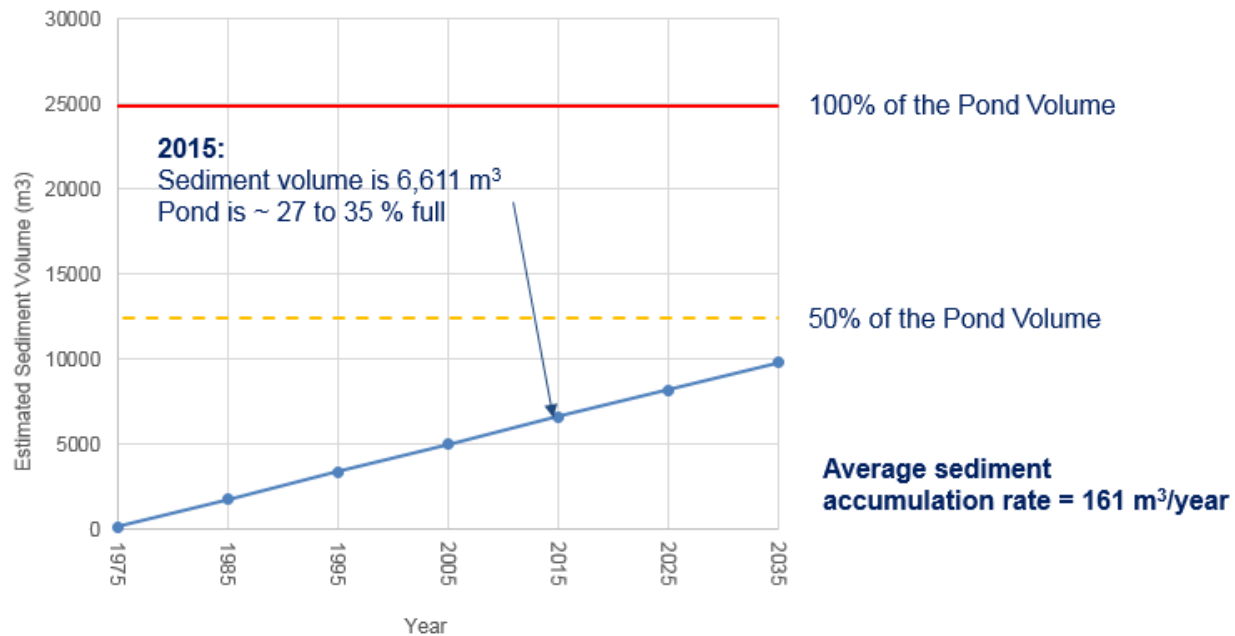
**Figure 3-7. Rate of pond infilling**

The bathymetric data were used to quantify the volume of sediment that had been deposited between 1974 and 2015 (i.e., 6,611 m<sup>3</sup>). This data was used to determine an average rate of infilling (i.e., 161 m<sup>3</sup>/yr). Based on the data, it is clear that the Embro pond is ~ 27 – 35 % full of sediment. Complete filling-in of the pond, at the existing sedimentation rate, would occur in ~ 115 years. It is important to keep in mind that the impetus for this study is the safety of the dam structure and not the sedimentation.

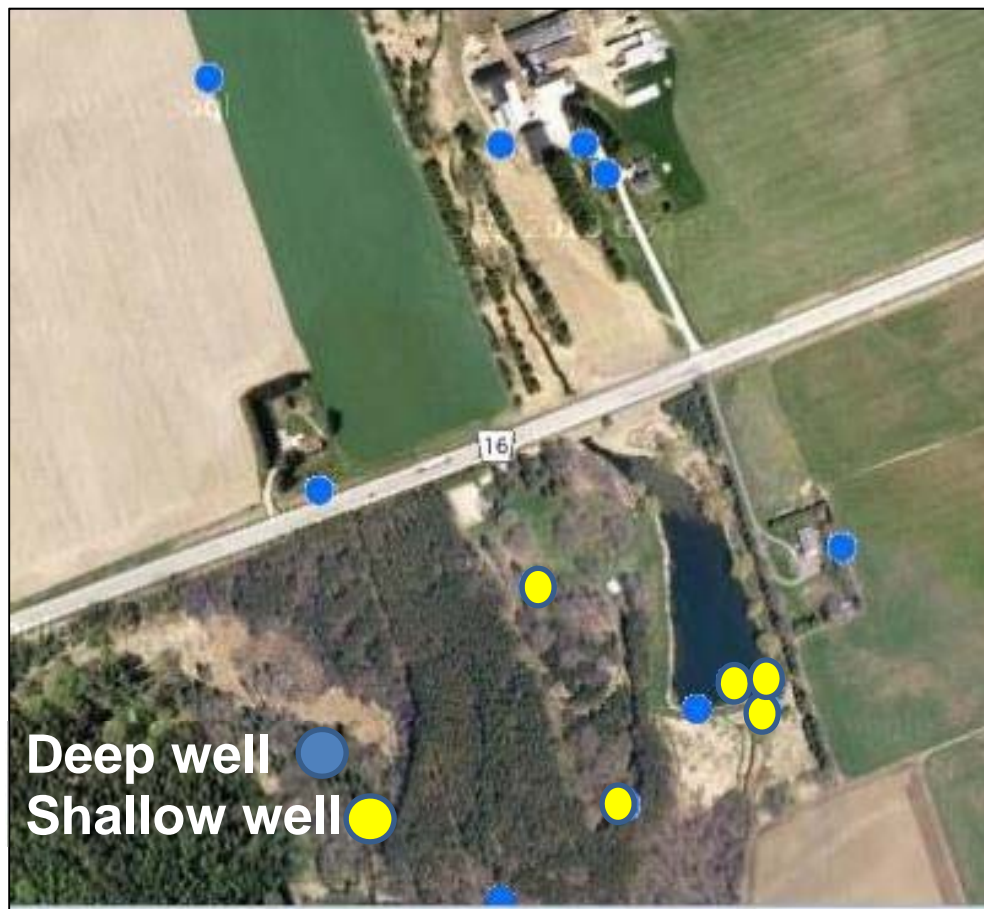
**Figure 3-8. Known wells in the area of Embro CA (Data Source: MOECC; Appendix A)**

The UTRCA reviewed internal thematic mapping and Ministry of Environment and Climate Change (MOECC) well records to characterize the general hydrogeological setting of Embro Conservation Area and the local surrounding area. The well records were examined and classified as shallow or deep on **Figure 3-8**. The shallow wells generally represent those that were drilled in association with field studies rather than those used for other purposes (drinking water).

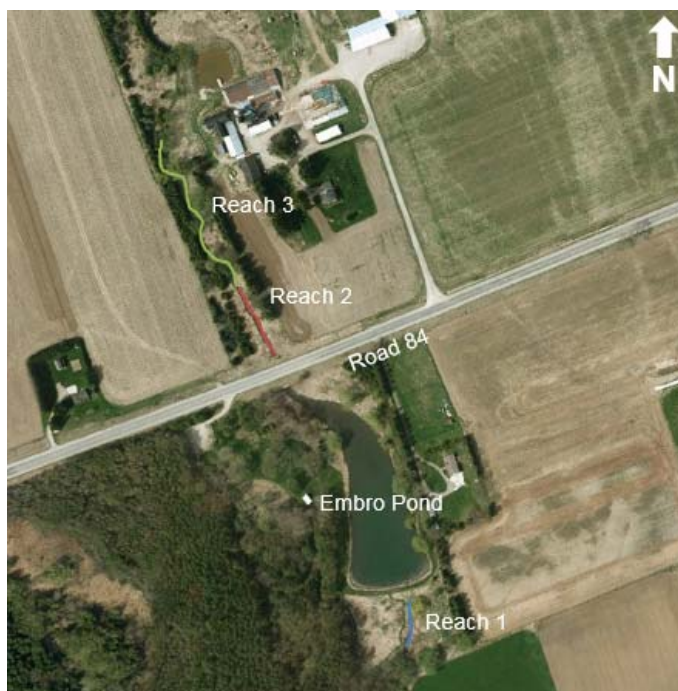
**Figure 3-10. Reach delineation along Youngsville Drain.**

A geomorphic field investigation was undertaken on June 11, 2015 to assess existing conditions along Youngsville Drain, both upstream and downstream of Embro Pond. During the field assessment, three reaches were identified. A brief description of dominant channel characteristics is provided by reach below. The reach delineation is demonstrated on **Figure 3-10** the surveyed channel bed profile is illustrated in **Figure 3-11** which includes a profile through Embro Pond based on 2015 water depth mapping provided by the UTRCA.

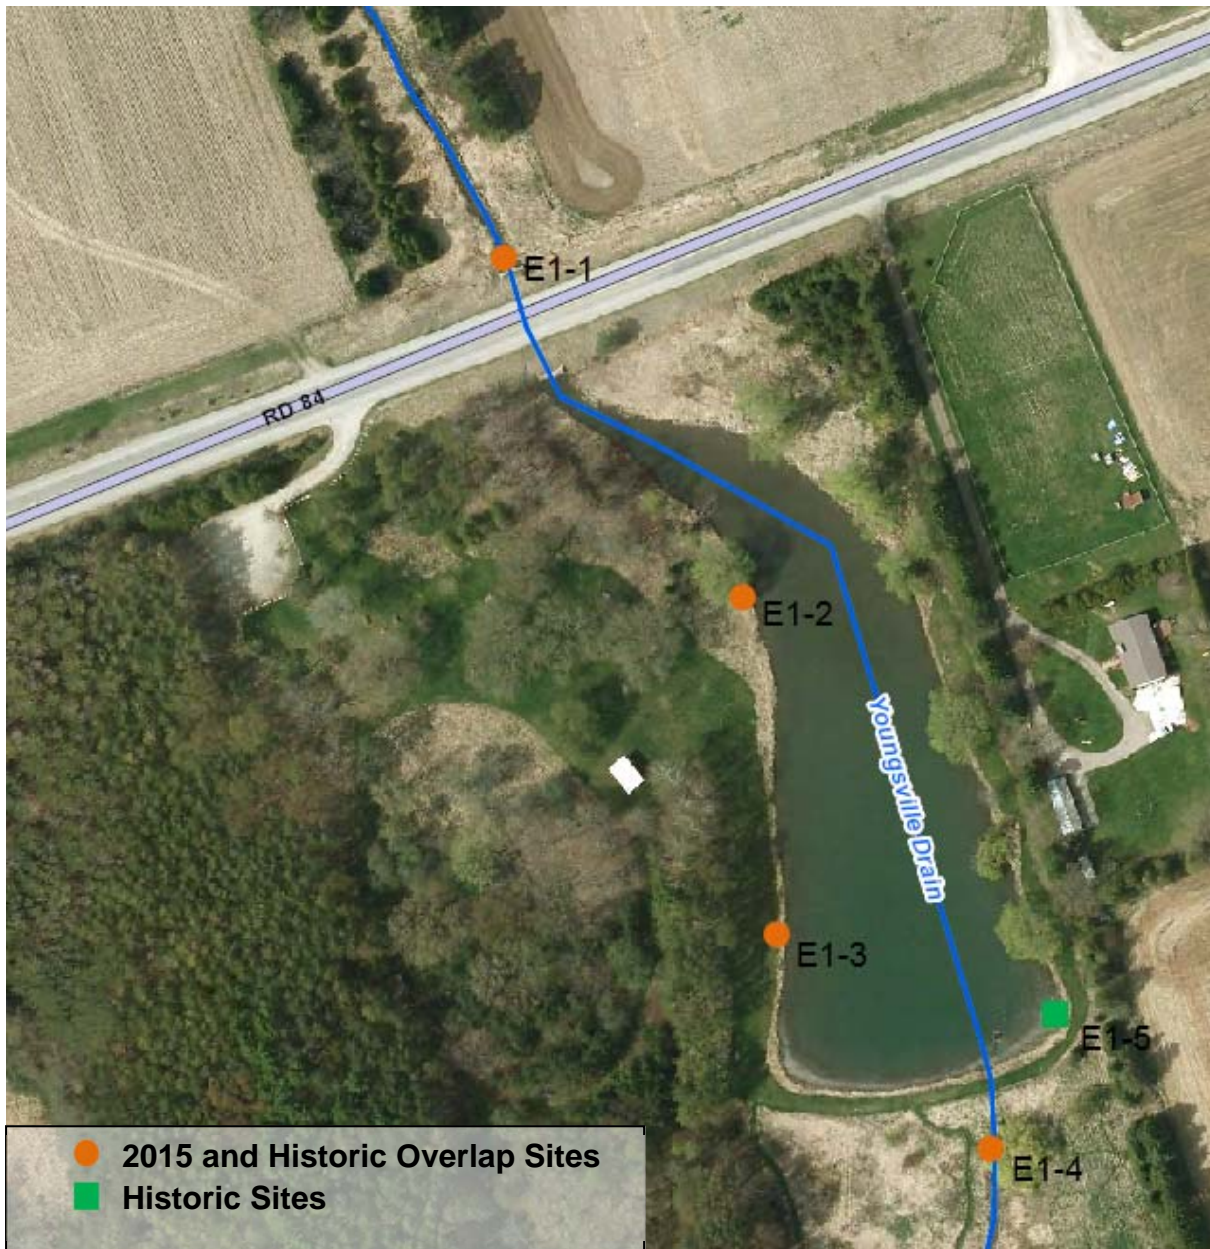
Figure 3-133. Embro Pond water quality sampling sites 2015 (Source: UTRCA; Appendix B)

The 2015 field program included the collection of five water samples at four locations in the area of Embro CA (i.e., one upstream of the pond, two in the pond, and one downstream of the dam as illustrated on **Figure 3-133**). Given the limited duration of sampling, the monitoring provides only a snapshot of water quality that is limited to the conditions extending from April to October 2015.

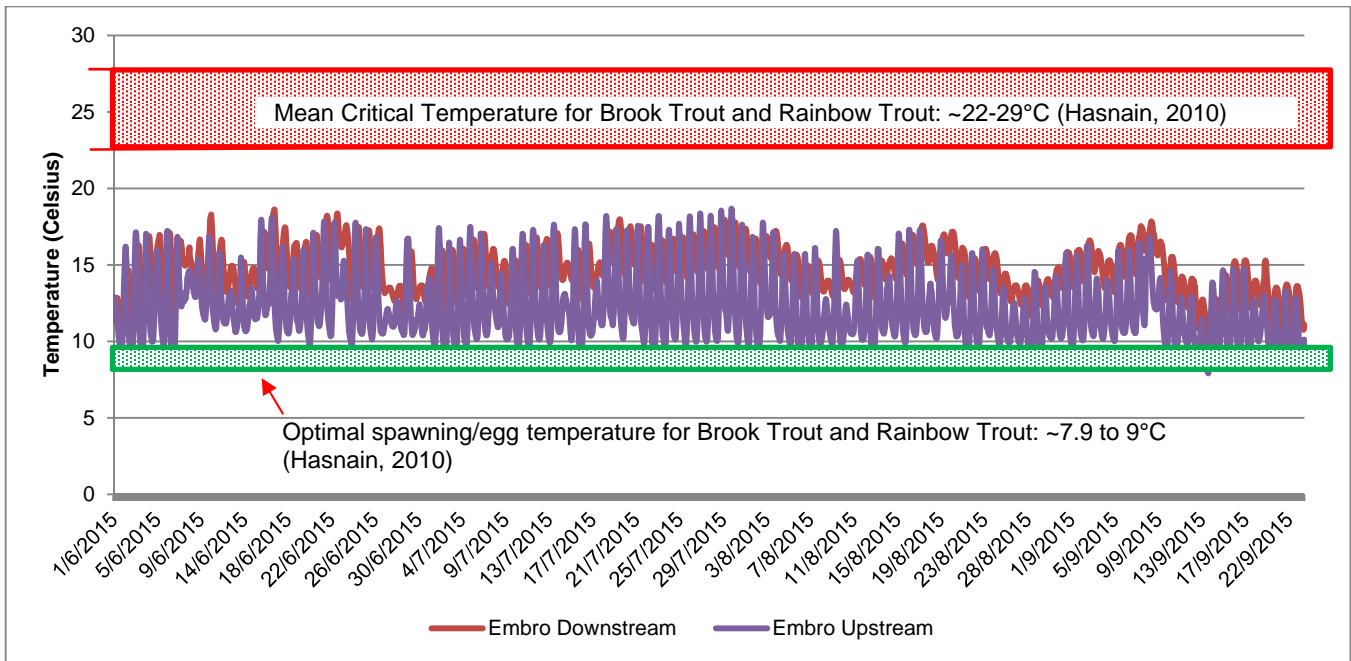
**Figure 3-14. Temperature Upstream and Downstream of Embro Pond (Source: UTRCA, Appendix B)**

Temperature differences are apparent between upstream (lower) and downstream (higher) of the pond during the 2015 continuous monitoring. Differences in temperature increased as the summer progressed and is considered attributable to the warming effect of the pond. During the 2015 sampling, the least, average and maximum temperature differences from upstream to downstream were plus 0°C, 2.5°C, and 7.0°C respectively.

Water temperature affects aquatic habitat and the survival potential of eggs and health of fish. In **Figure 3-14**, the optimal temperature range for Brook and Rainbow Trout spawning/egg survival, and the mean critical temperature for fish survival as defined by Hasnain (2010) are plotted on the temperature graph. Results clearly demonstrate that the water is often warmer both upstream and downstream of the dam than the optimal spawning/egg survival temperatures.

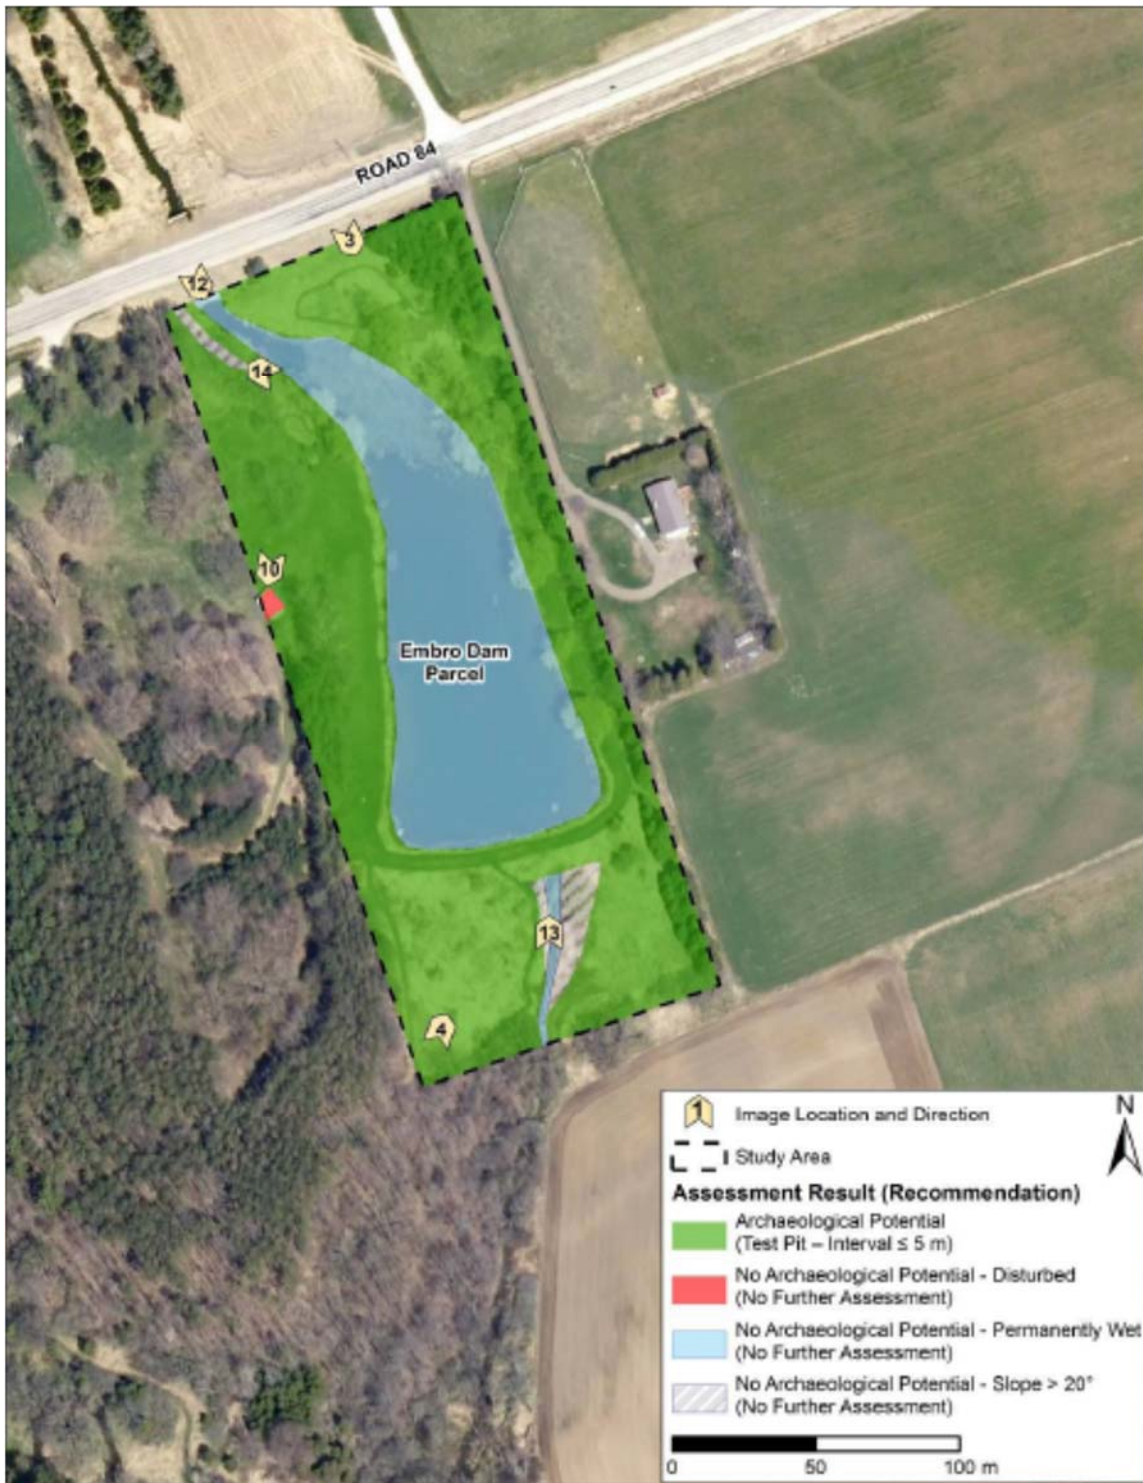
Figure 3-15. Archaeological Assessment Results for Embro Dam CA (see Appendix G)

A Stage 1 Archaeological Assessment was conducted in order to determine the archaeological potential of the study area; this includes identification of previously known archaeological sites, if any, and to provide recommendations for further assessment if necessary. The results of the archaeological assessment for Embro Dam are summarized in **Figure 3-15** and in **Appendix G**.

The background information revealed no record of previously completed work, reports, or known archaeological sites within the study area. The Embro Dam study area has the potential for archaeological sites based on location, drainage and topography, and based on the application of land-use modelling. The Youngsville Drain, historically surveyed roadways (Road 84 and 37<sup>th</sup> Line), and an area of early Euro-Canadian settlement represent local indicators of archaeological potential.

The existing condition of the study site has a reduced archaeological potential due to sloped lands greater than 20 degrees, permanently wet lands, and extensive land alterations. In terms of archaeological potential, the Embro Dam study area is characterized by 2.09 ha (66.8% of study area) of archaeological potential and 1.05 ha (33.2% of study area) of land identified as areas of no archaeological potential. The 2.09 ha of lands identified as having archaeological potential are within 300 m of a feature of archaeological potential and it is noted that test pit surveying is required for further assessment in the event that any works are proposed for the area (ARA, 2015).

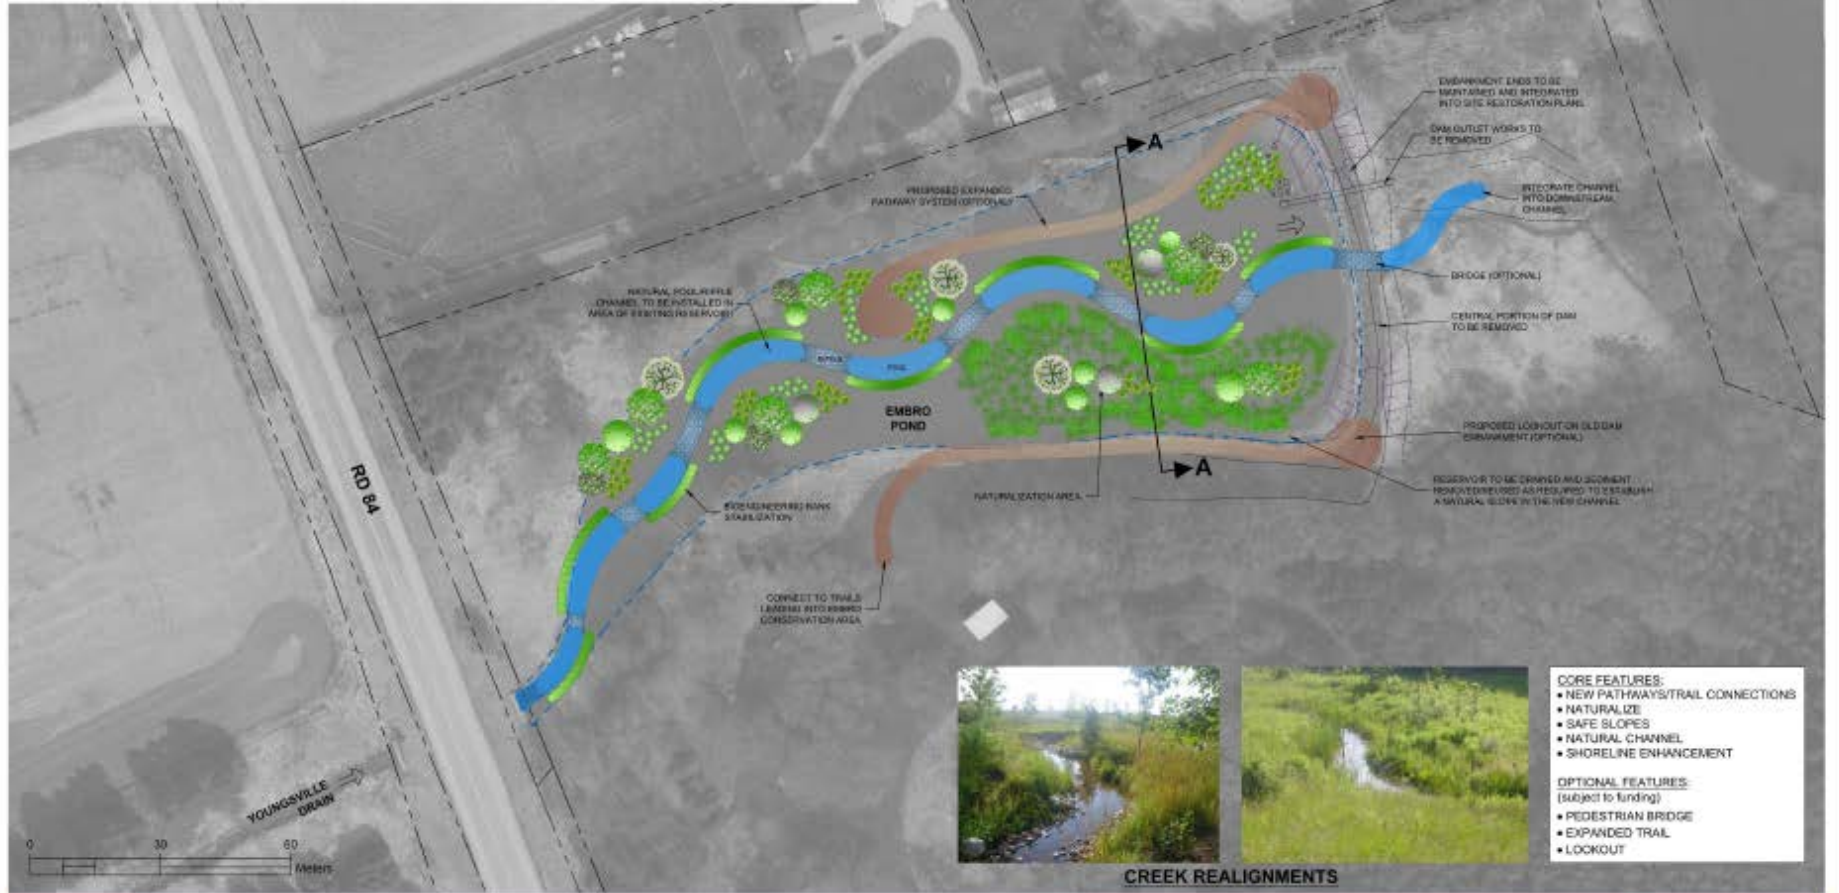
- CORE FEATURES:**
- NEW PATHWAYS/TRAIL CONNECTIONS
  - NATURALIZATION AREAS
  - SAFE SLOPES
  - NATURAL CHANNEL
  - SHORELINE ENHANCEMENT
  - OFFLINE POND/WETLAND
- OPTIONAL FEATURES:**  
(Subject to funding)
- PEDESTRIAN BRIDGE
  - EXPANDED TRAIL
  - LOCKOUT

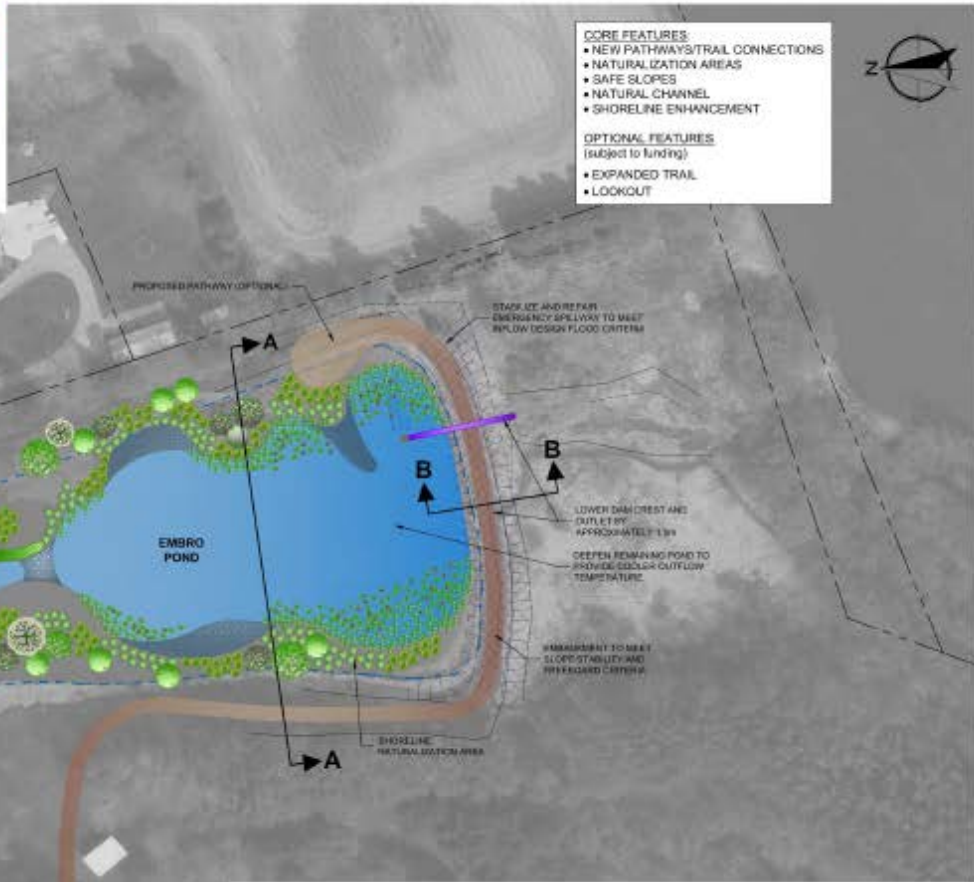
- CORE FEATURES**
- NEW PATHWAYS/TRAIL CONNECTIONS
  - NATURALIZATION AREAS
  - SAFE SLOPES
  - NATURAL CHANNEL
  - SHORELINE ENHANCEMENT
- OPTIONAL FEATURES**  
(subject to funding)
- EXPANDED TRAIL
  - LOOKOUT

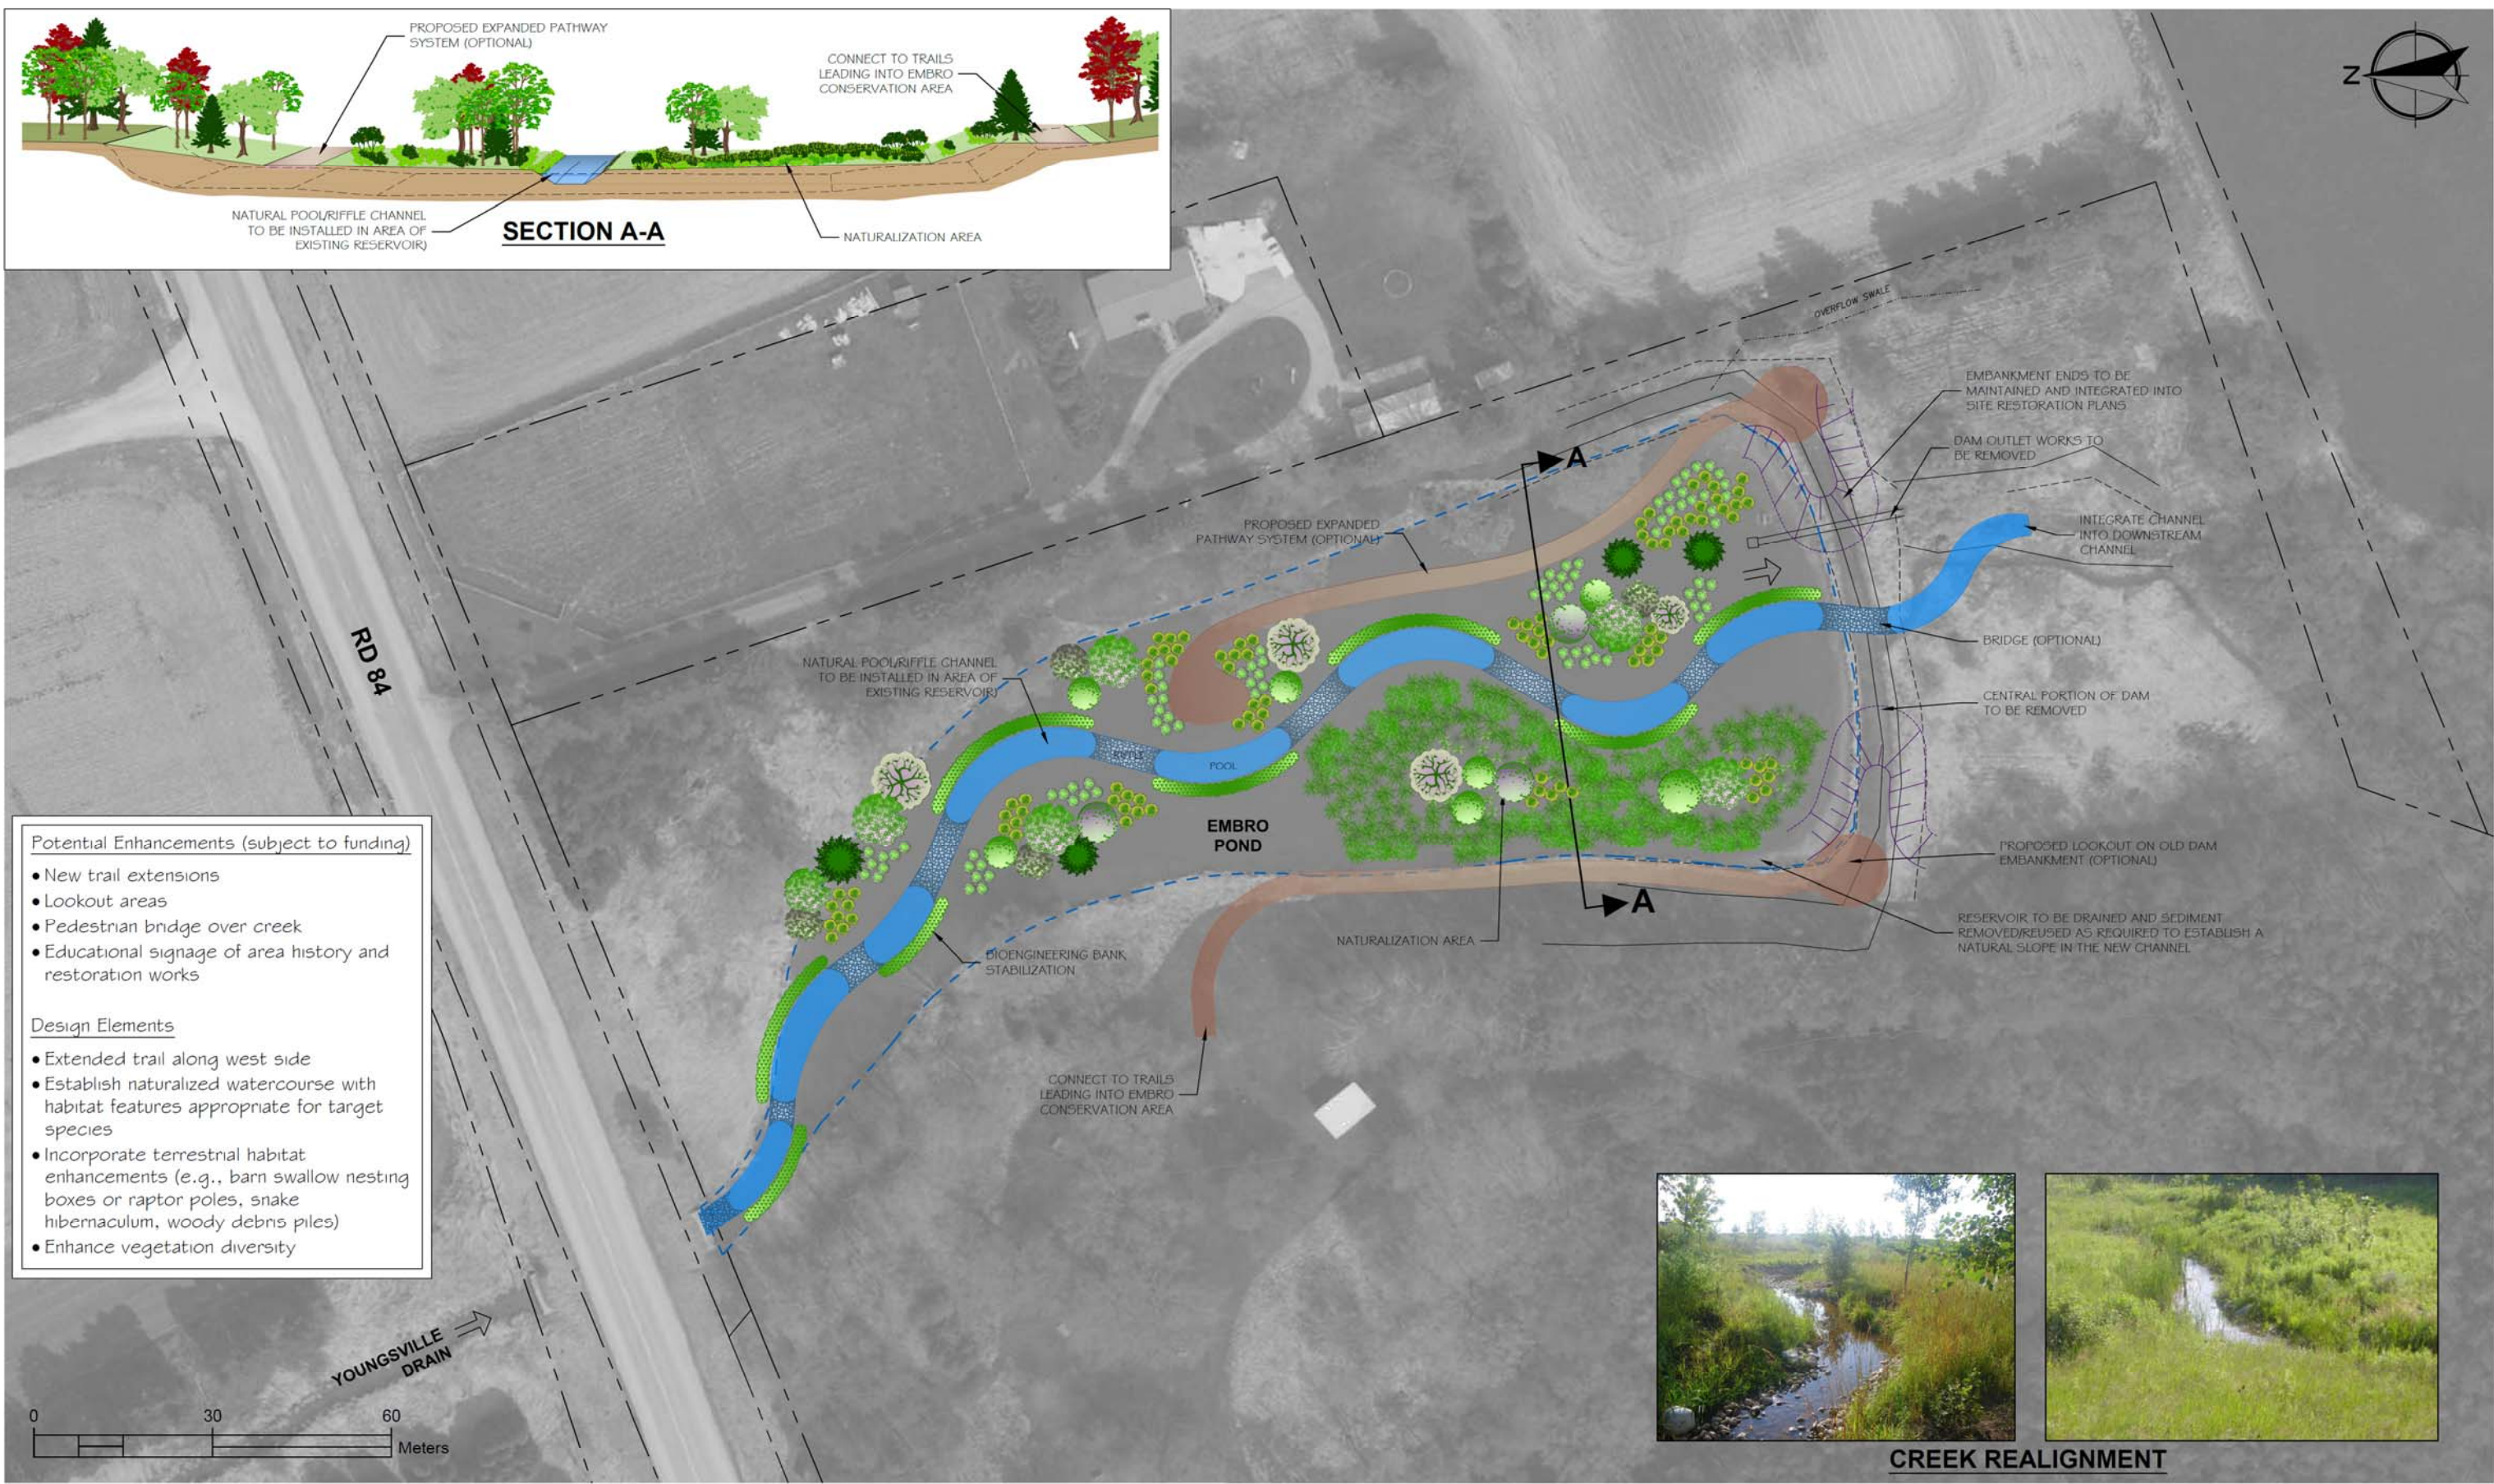
- Potential Enhancements (subject to funding)
- New trail extensions
  - Lookout areas
  - Pedestrian bridge over creek
  - Educational signage of area history and restoration works
- Design Elements
- Extended trail along west side
  - Establish naturalized watercourse with habitat features appropriate for target species
  - Incorporate terrestrial habitat enhancements (e.g., barn swallow nesting boxes or raptor poles, snake hibernaculum, woody debris piles)
  - Enhance vegetation diversity

The restored watercourse should incorporate principles of fluvial geomorphology and include, where possible, aquatic habitat elements that are beneficial/preferred by resident species. The planform and profile (e.g., riffle-pool) configuration of the watercourse should be suitable for the energy and bankfull flow conditions (i.e., recurrence interval of ~ 1.6 yrs) that occur within the study area, provide floodplain connectivity (i.e., for larger than bankfull flows), and consider implication of larger flow events on both the floodplain and the channel.

Incorporation of bioengineered materials is recommended to minimize risk of erosion and channel failure in the area immediately post-construction. Vegetative plantings that enhance bank stability through the rooting network are recommended. Woody debris could be implemented in the design.
