# **Appendix A      Baseline Geomorphological Characterization Report**

**Fullarton Dam Rehabilitation  
Environmental Assessment,  
Baseline Geomorphological  
Characterization Report**

Revision 2

January 28, 2025

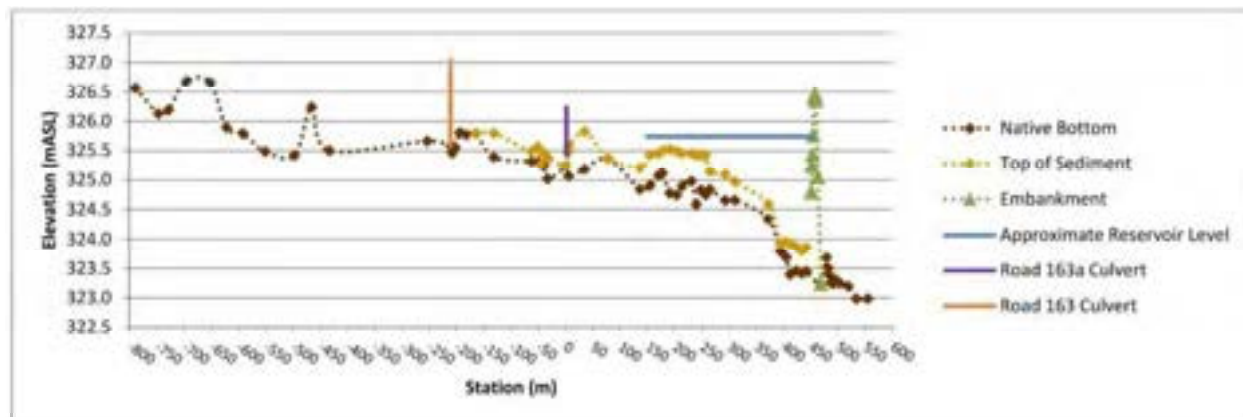
**Figure 2: Watercourse Channel and Sediment Profile (UTRCA, 2017)**

depths of 0.3-0.4 m in the reservoir. The UTRCA's sediment and natural channel profile is presented in Figure 3 below.

Figure 2 by UTRCA indicates that sedimentation extends upstream of the dam's reservoir through the Perth Road 163a culvert to nearly Perth Road 163, located approximately 670 m from the dam and corresponding to the identified extent of reservoir backwater discussed in section 3.3. Stantec observed the sedimentation between Perth Road 163 and Perth Road 163a and noted that sediment depths increased closer to Perth Road 163a, contributing to a reduction in channel slope upstream of the reservoir. Sedimentation from the effects of reservoir backwater has caused a morphological transition of the unnamed watercourse upstream of the reservoir, with sediment filling pools, inundating riffles and resulting in a plane-bed flow.

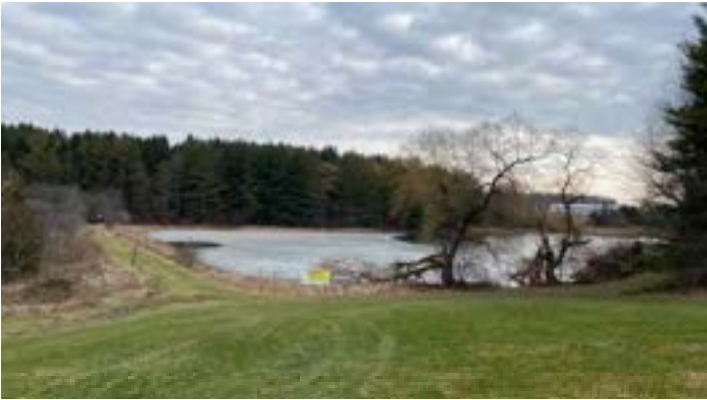
Photo 1: Fullarton Dam and Reservoir.

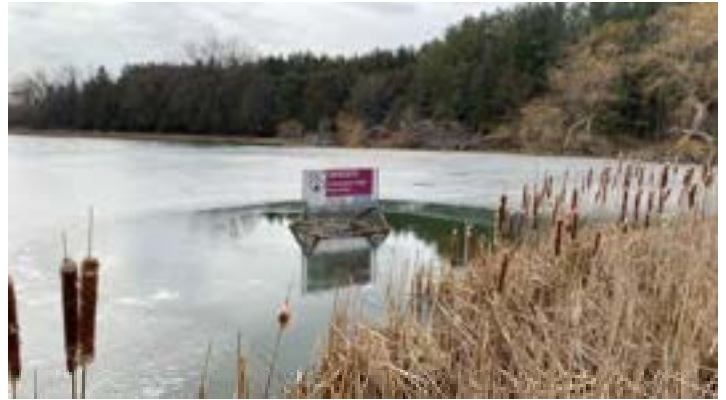
Photo 2: Reservoir Drop Inlet Structure.

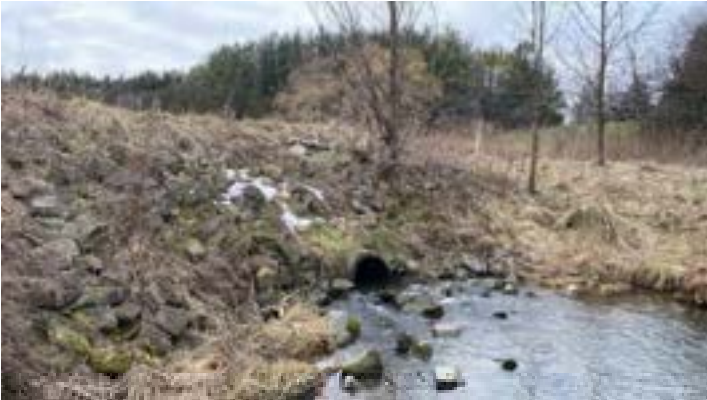
Photo 3: Reservoir outlet structure.

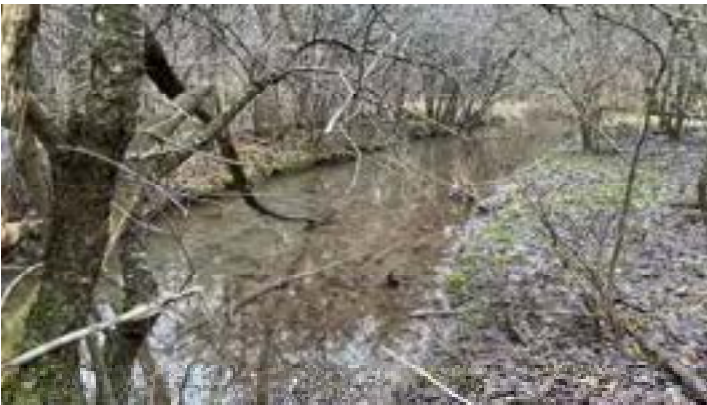
Photo 5: Reach 1 plane-bed channel with silt between Perth Road 163 and Perth Road 163a.

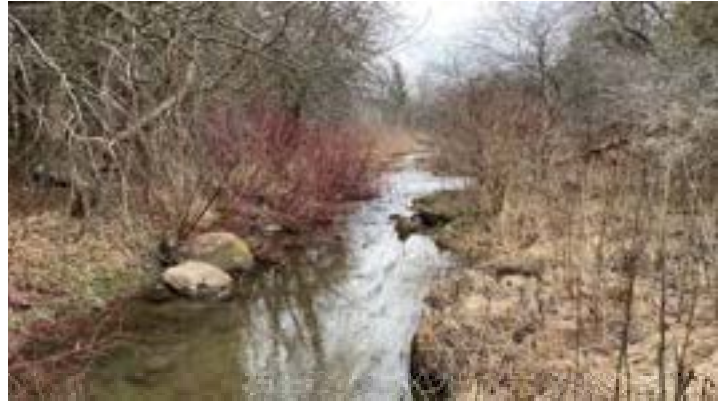
Photo 10: Reach 2 looking downstream at riffle-pool sequencing.

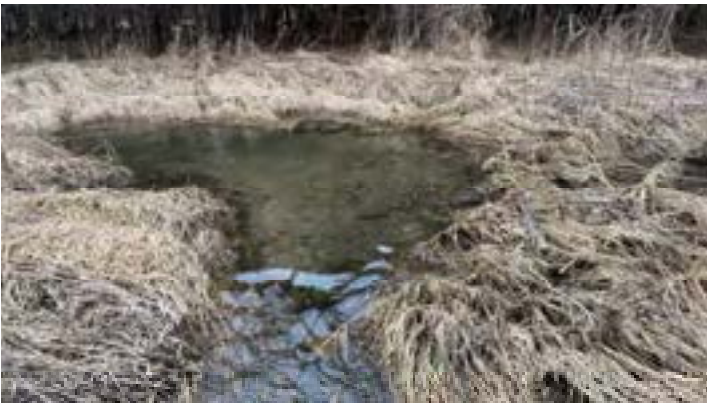
Photo 11: Reach 2 fine gravels on glide between pool and downstream riffle.

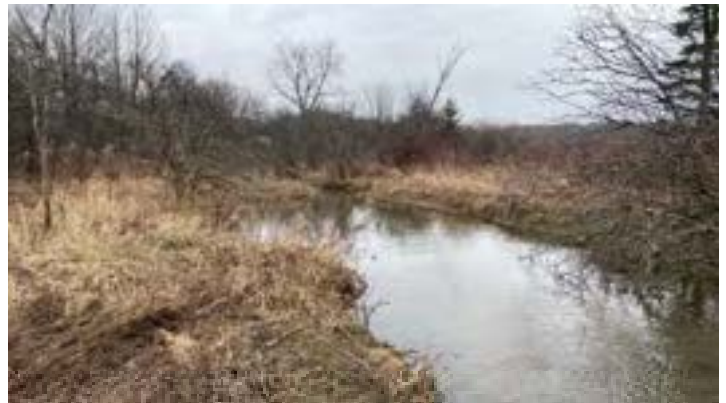
Photo 12: Reach 3 lower gradient over-widened channel.

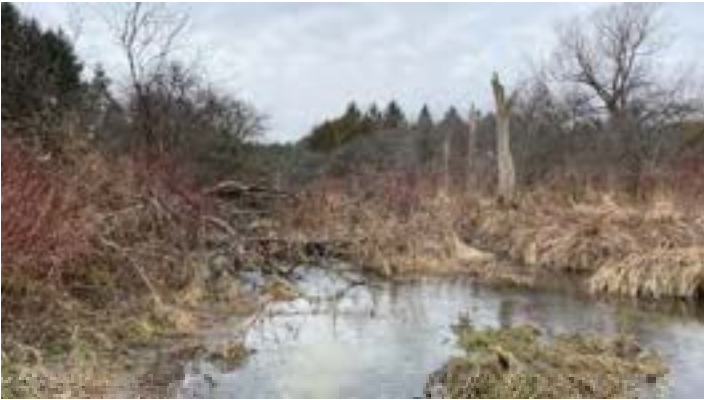
Photo 13: Reach 3 silt accumulation and over-widened channel.

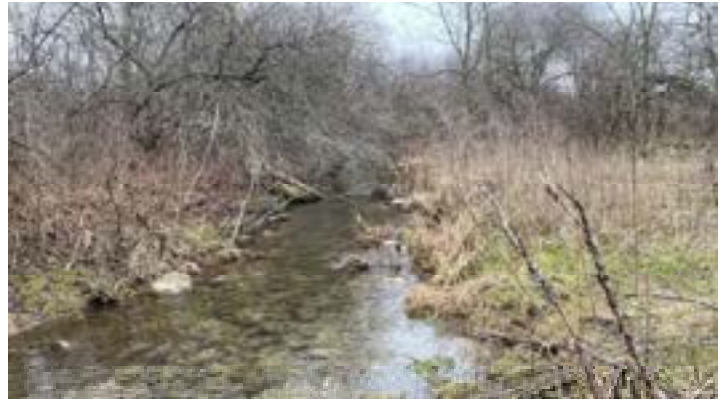
Photo 14: Reach 4 looking downstream with cobbles on channel bed.

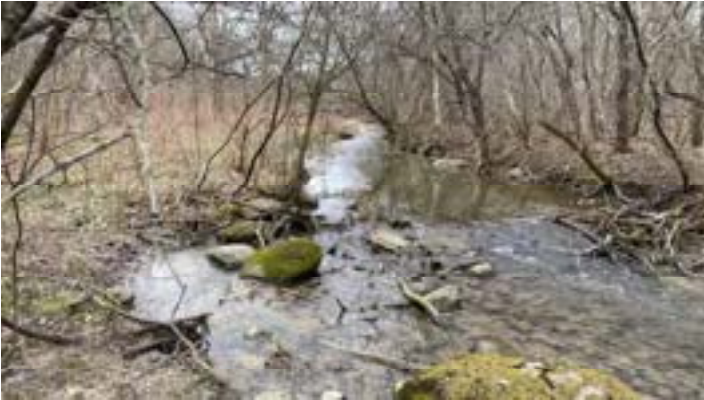
Photo 15: Reach 4 looking upstream at riffle-pool sequencing.

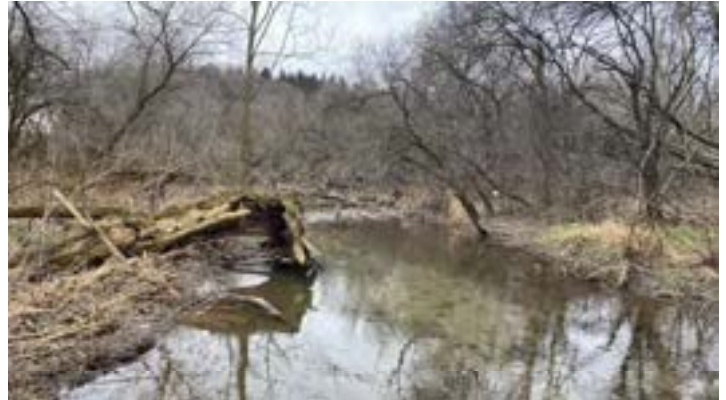
Photo 16: Reach 5 looking upstream at silt in a backwatered reach.

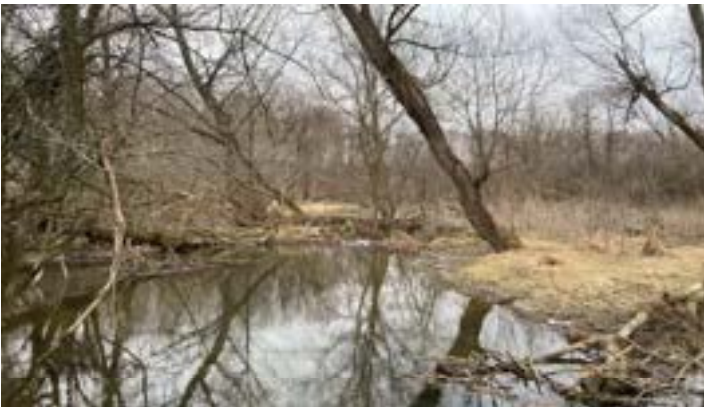
Photo 17: Reach 5 looking downstream at downstream beaver dam.

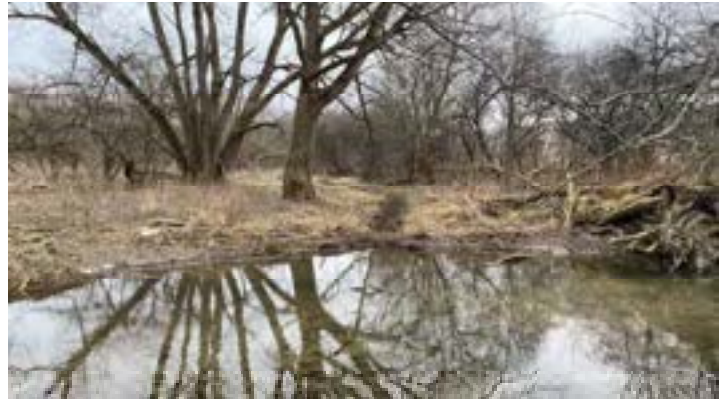
Photo 20: Beaver dam obstructing pre-1954 watercourse Alignment.

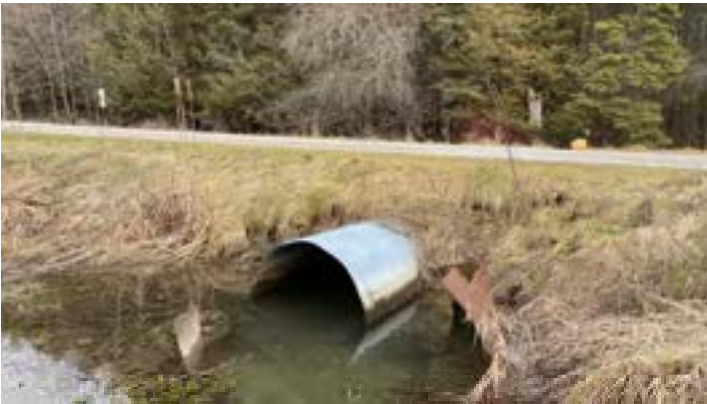
Photo 21: Perth Road 163a culvert.

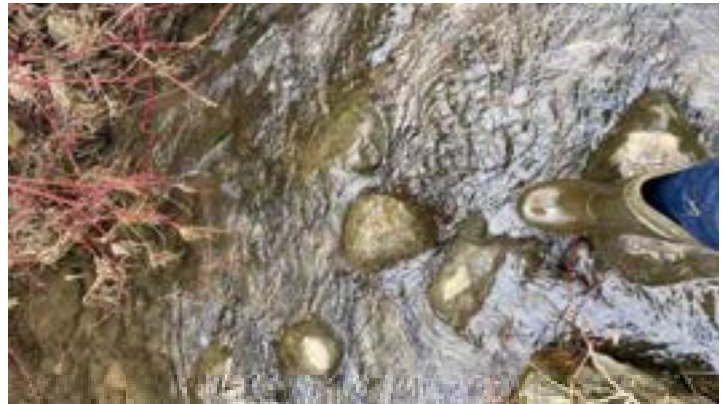
Photo 22: Reach 2 riffle cobbles.
