# Appendix A

# Flow Characteristics of Harrington Creek at Harrington Dam and Youngsville Drain at Embro Dam

Updated October 13, 2016

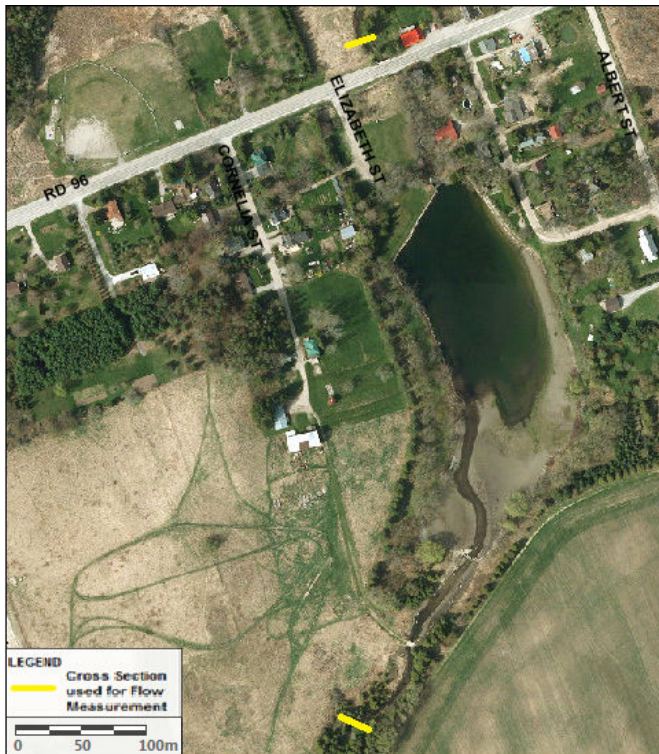
Figure 1: Locations of Cross Sections Used for Stream Flow Measurement at Harrington

The location of the cross-sections where stream flow was measured at Harrington is indicated below in

Figure 1. The total catchment area for the most downstream cross section with the largest number of flow measurements is illustrated in Figure 2.

From July 2010 to August 2015, the field measured flow rate of Harrington Creek and the corresponding water level on the bridge pier staff gauge was recorded a total of ten times in a variety of high, low, and average flow conditions. Additionally on June 11, July 22, and August 28, 2015, the flow rate was also measured at cross sections 80 m upstream from the farm crossing South of Harrington Pond.

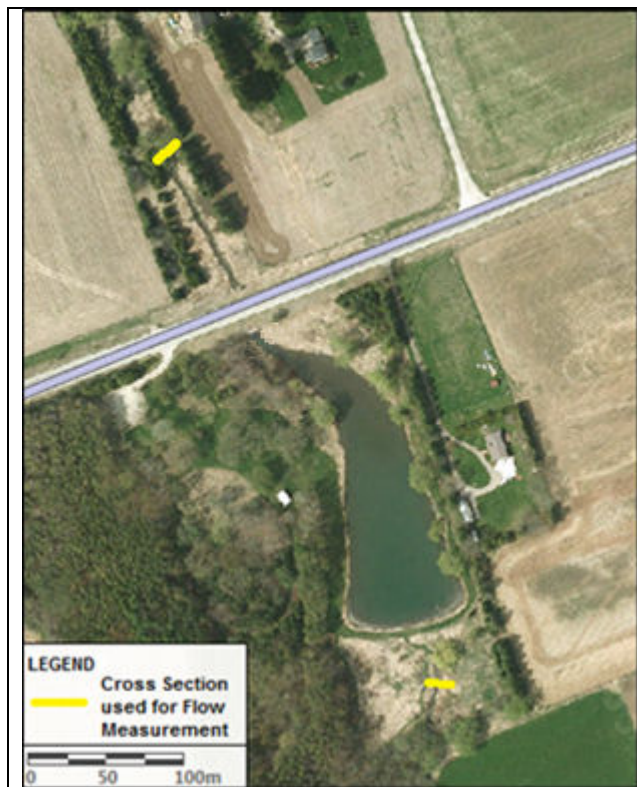
There is no HOBO data logger or stream gauge to produce a record of pressure from which a time series of the water level or a time series of flows could be derived. There is also no staff gauge present at Embro which prohibits the development of a rating curve. A series of flow measurements were undertaken at Embro in conjunction with flow measurements at Harrington. The flow measurements at Embro were performed in the same manner as previously described for Harrington. The flow measurements were performed at a cross section approximately 25 m downstream of the outlet for Embro Dam. Additionally on June 11, July 22, and August 28, 2015, the flow rate was also measured at a cross section upstream of Embro pond, approximately 100 m upstream from the culvert on the North side of Road 84.

Figure 4: Locations of Cross Sections Used for Stream Flow Measurement at Embro

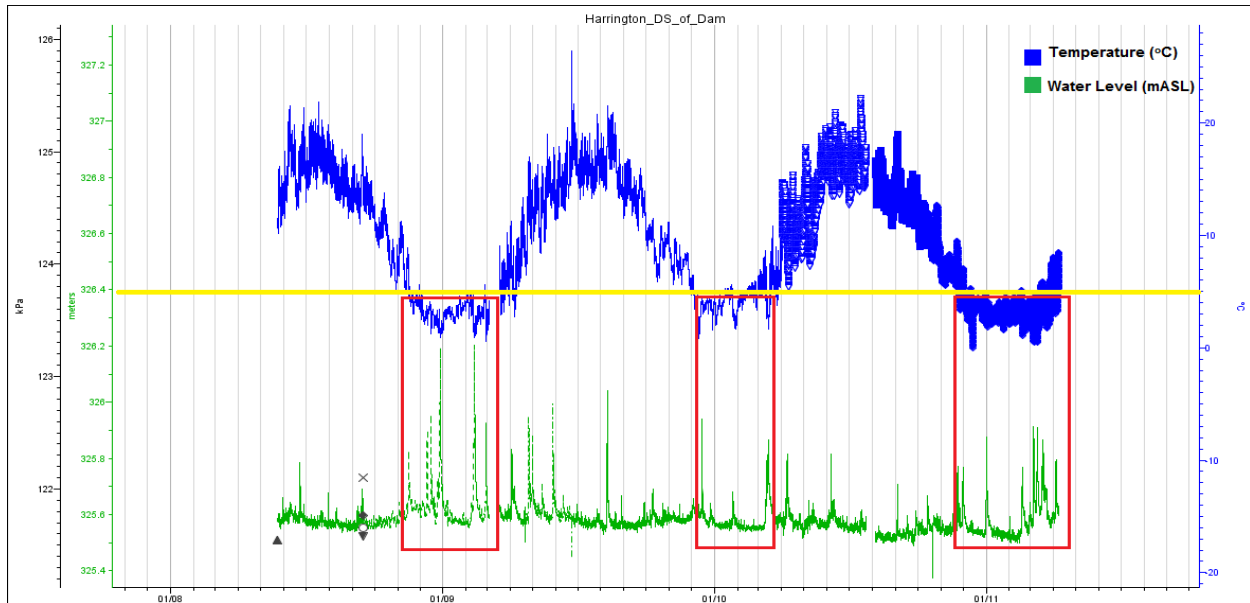
Figure 11 illustrates the Harrington creek water levels at the Rd. 96 bridge pier for the time period of May 24, 2008 to April 9, 2011. The yellow horizontal line indicates the water temperature of 5°C that was used to filter out irregular logger readings. The red rectangular outlines indicate data that was recorded at a temperature below the cut off line and as such was omitted from subsequent calculations and analyses.

Figure 11: Water Temperature (°C) and Water Level (m) from HoboLogger Downstream of Harrington

These irregular results were omitted from the water level calculation and the subsequent calculation and analysis of flows. The omitted irregular results coincided with colder water temperatures ( $<5^{\circ}\text{C}$ ) and the time periods where snow and/or freezing could be expected. These winter conditions are considered to be the probable cause of the irregular logger readings.
