Harrington Dam and Conservation Area

Existing Environmental Conditions

Updated March 8, 2017

UPPER THAMES RIVER
CONSERVATION AUTHORITY

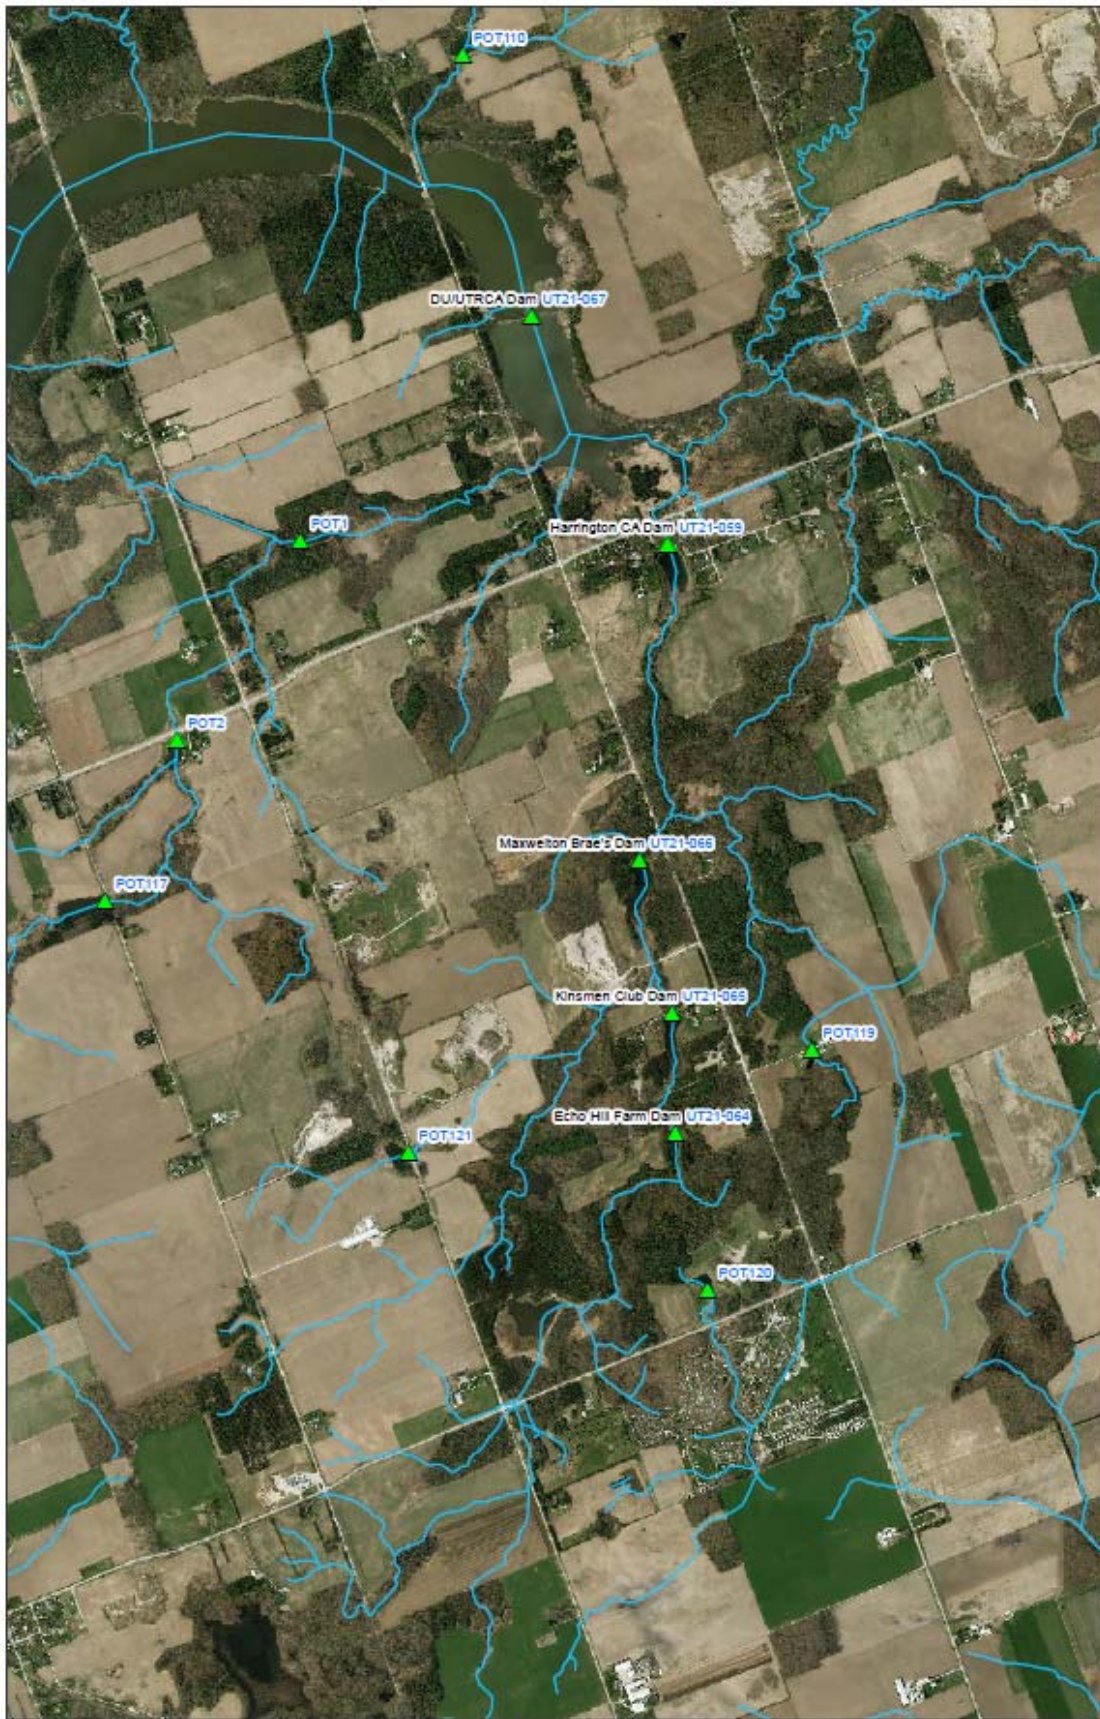
Figure 4 shows the dams that exist upstream of Harrington CA. Dams labeled with a “POT” (potential) number have not been verified as to existence, whereas dams labeled with a “UT21” number are believed to have been surveyed at some point in the past. A Ducks Unlimited (DU)/UTRCA Dam exists downstream of the Harrington CA Dam within the Wildwood Reservoir and is currently under review by DU and UTRCA.

Figure 4: Location of dams upstream and downstream of Harrington Dam (Source: UTRCA)

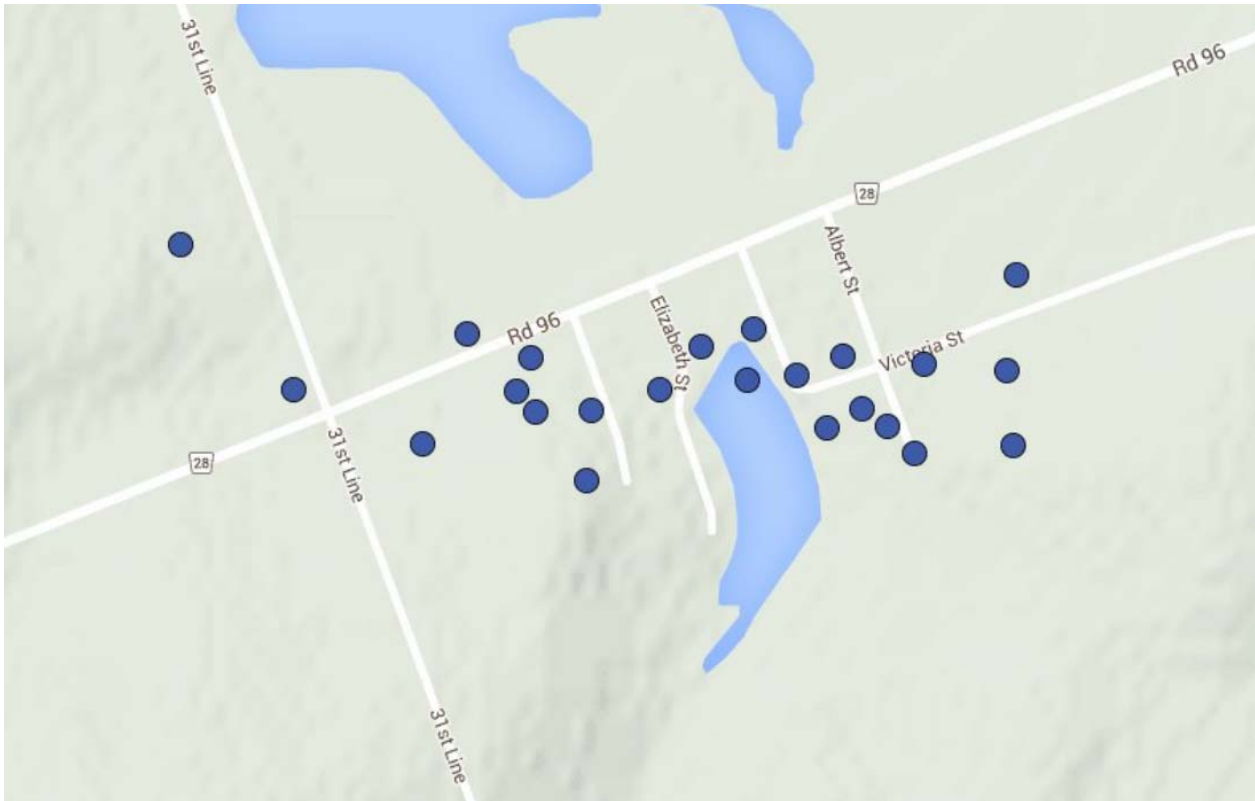
All background information and individual well records were retrieved from the Ministry of the Environment and Climate Change (MOECC) and provided to Ecosystem Recovery Inc. for analysis by their sub-consultant Englobe (formerly LVM). Figure 8 shows the locations of the known wells in the area. The well location information suggests that some residences may share or do not have documented wells. The wells shown on the Harrington Dam are Bore Holes for the past Dam Safety investigations.

Figure 8: Known wells in the area of Harrington CA (Data Source: MOECC)

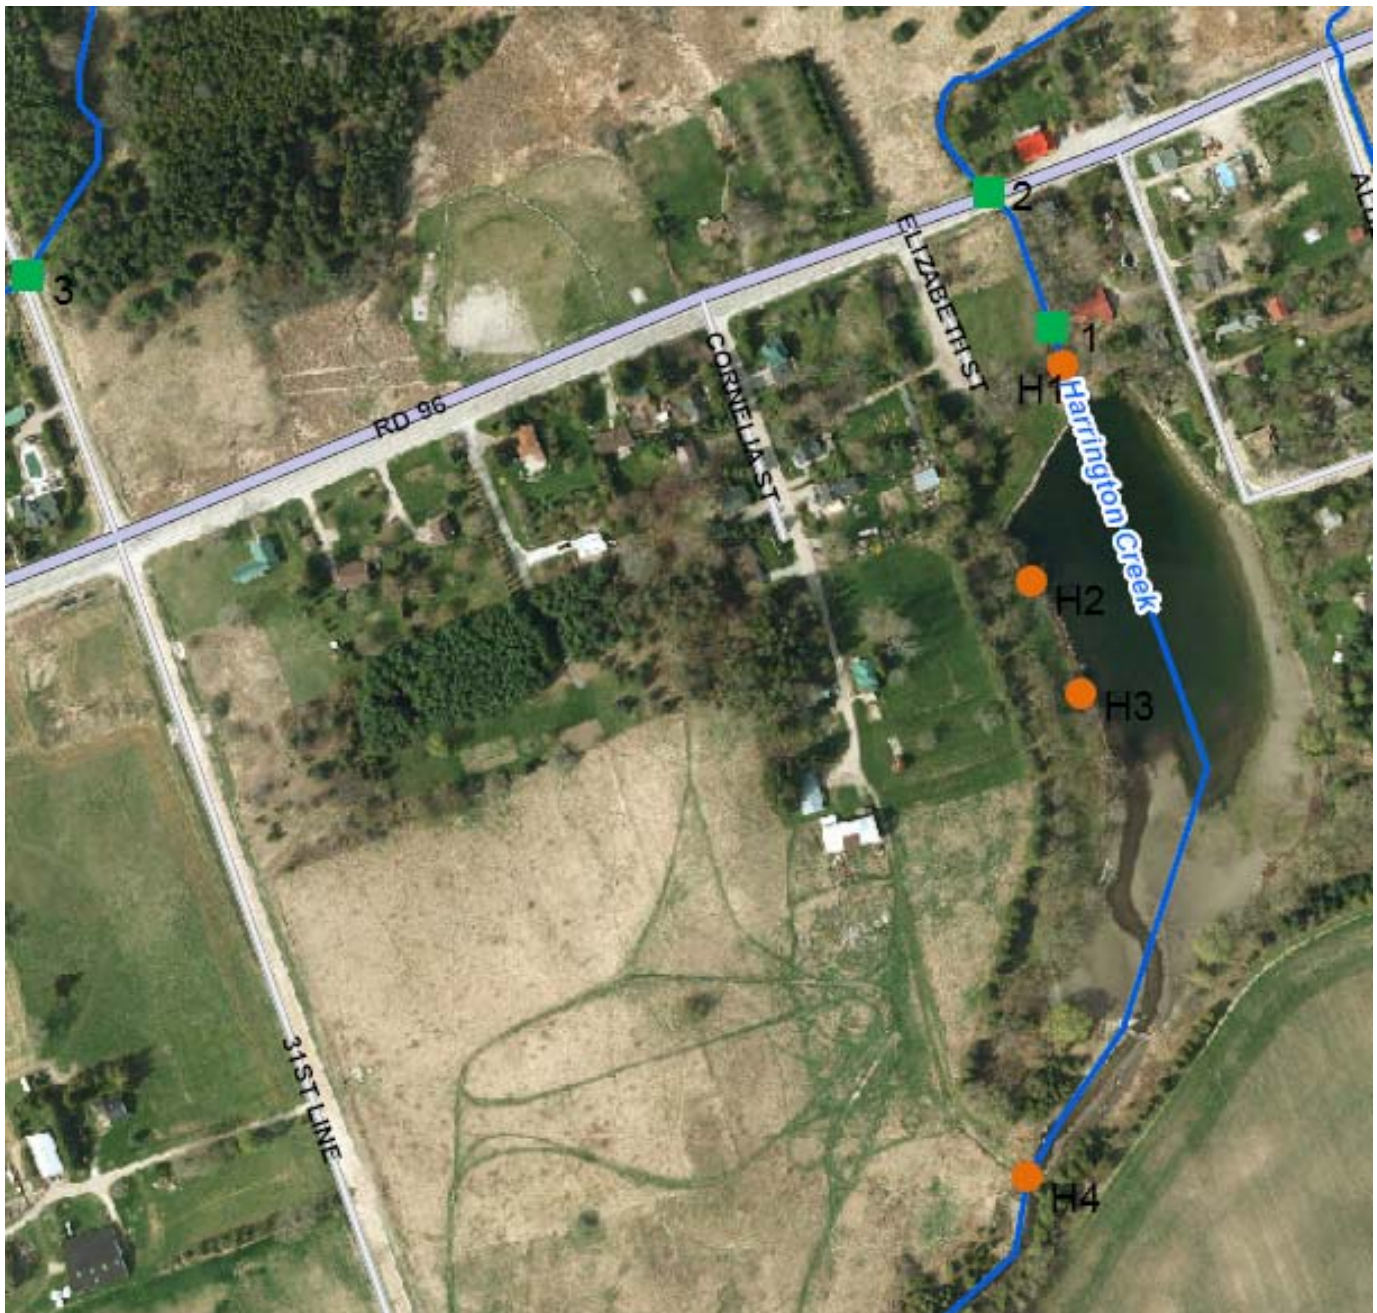
A series of five water samples were collected at four locations in the area of Harrington CA: one upstream of the pond, two in the pond, and one downstream of the dam (see map in Figure 9). This monitoring provides a snapshot of water quality, and is limited to the conditions of April to October 2015. Harrington Pond also had one year of historical data from 1989, which has been included in the evaluation of the results, which can be found in Appendix B: Harrington Pond Water Quality Assessment.

Figure 9: Harrington Pond Water Quality Survey Sites 2015 (Source: UTRCA)

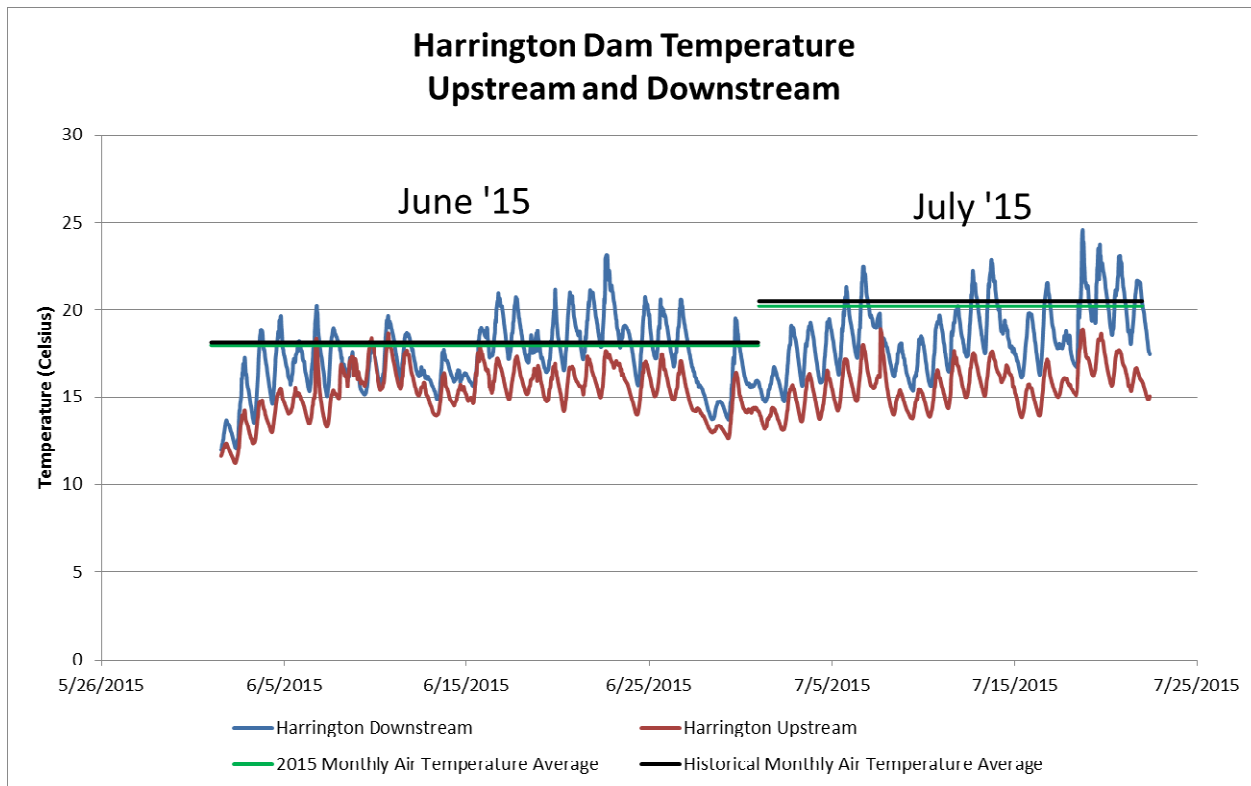
Temperature differences are apparent between upstream and downstream of the pond based on continuous measurements and show a greater difference as the summer progressed, likely as a result of the warming effect of the pond.

Figure 10: Harrington Pond Continuous Temperature Upstream and Downstream, Summer 2015 (Source: UTRCA)

Stream temperature data for June and July 2015 were taken during periods in which the monthly air temperature averages (ref. Environment Canada – London Airport) were similar to historical monthly air temperature averages.
