# Harrington Dam Class Environmental Assessment

## Public Information Centre #1

Upper Thames River Conservation Authority  
Harrington Hall and Library  
June 25<sup>th</sup>, 2015 7:00 p.m. to 9:00 p.m.

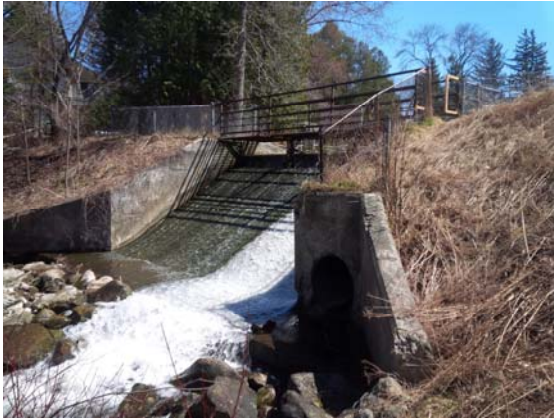
The Harrington Dam is approximately 90m to 95m long, with two earthen embankments flanking a concrete spillway.

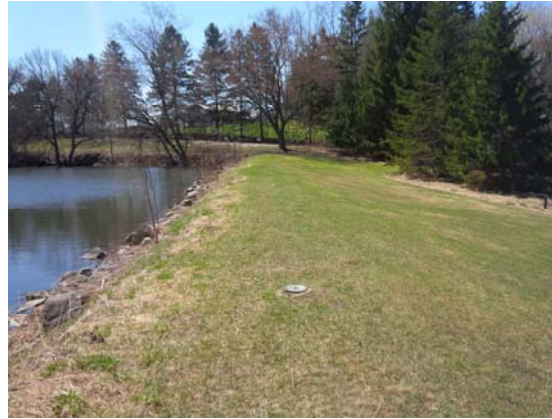
The earthen embankments of the dam are founded on soil overburden, rather than bedrock or engineered soil.

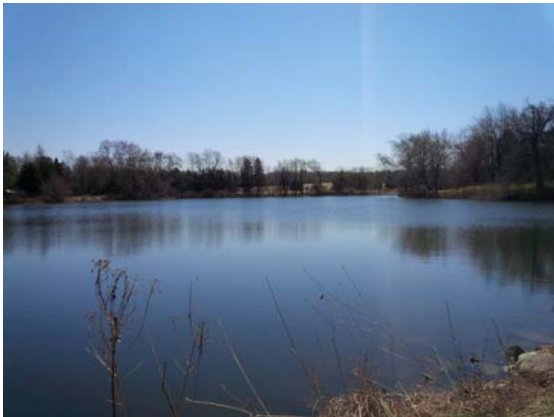
The dam contains water year round and includes approximately 3.3 m of head acting across the dam.

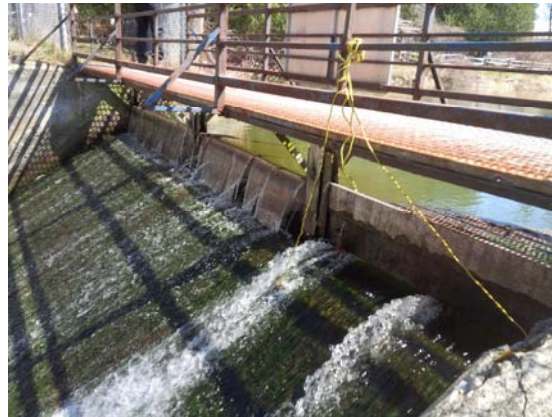
The dam spillway is considered to have an inadequate capacity for safety and stability purposes; the water level in the reservoir can be adjusted by adding stop logs to the spillway.
