Harrington Dam Class Environmental Assessment

Public Information Centre #1

Upper Thames River Conservation Authority
Harrington Hall and Library
June 25th, 2015 7:00 p.m. to 9:00 p.m.

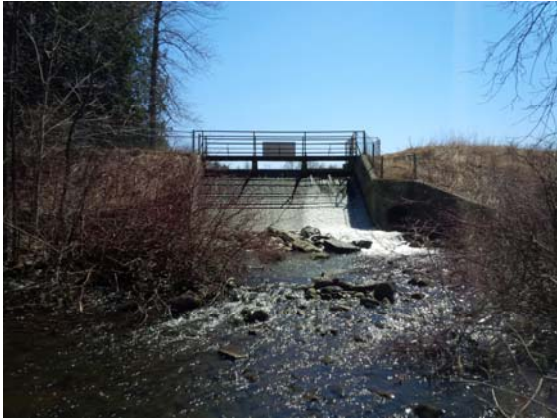
The Harrington Dam is approximately 90m to 95m long, with two earthen embankments flanking a concrete spillway.

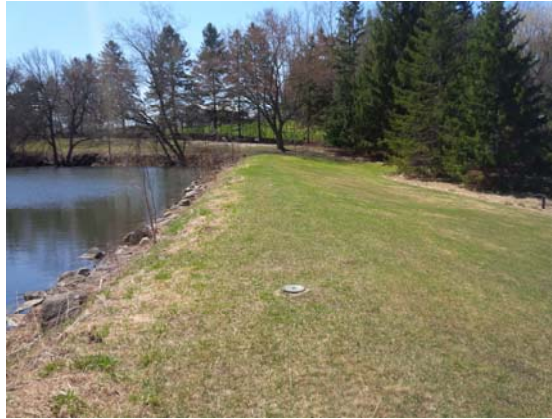
The earthen embankments of the dam are founded on soil overburden, rather than bedrock or engineered soil.

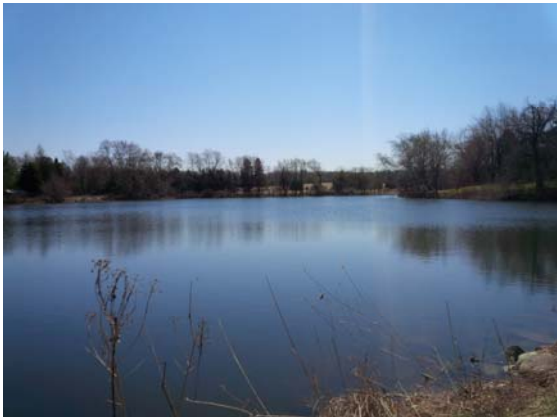
The dam contains water year round and includes approximately 3.3 m of head acting across the dam.

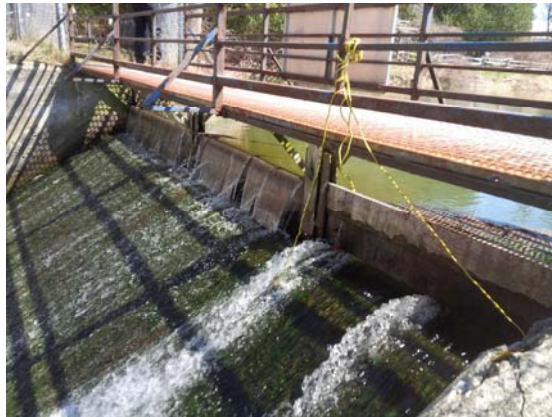
The dam spillway is considered to have an inadequate capacity for safety and stability purposes; the water level in the reservoir can be adjusted by adding stop logs to the spillway.

Significant concerns related to the structural integrity and hydraulic capacity of the Harrington Dam have been identified through recent engineering assessments.

- **Acres International. July, 2007.** *Dam Safety Assessment Report for Harrington Dam: Identified issues with insufficient spillway capacity, spillway instability and embankment stability*
- **Naylor Engineering Associates. September 2008.** *Geotechnical Investigation Harrington Dam Embankment Stability Assessment: The existing dam does not meet current standards and is not considered stable under existing conditions*
