Upper Thames River Conservation Authority

Harrington Dam Class Environmental Assessment DRAFT

June 2017

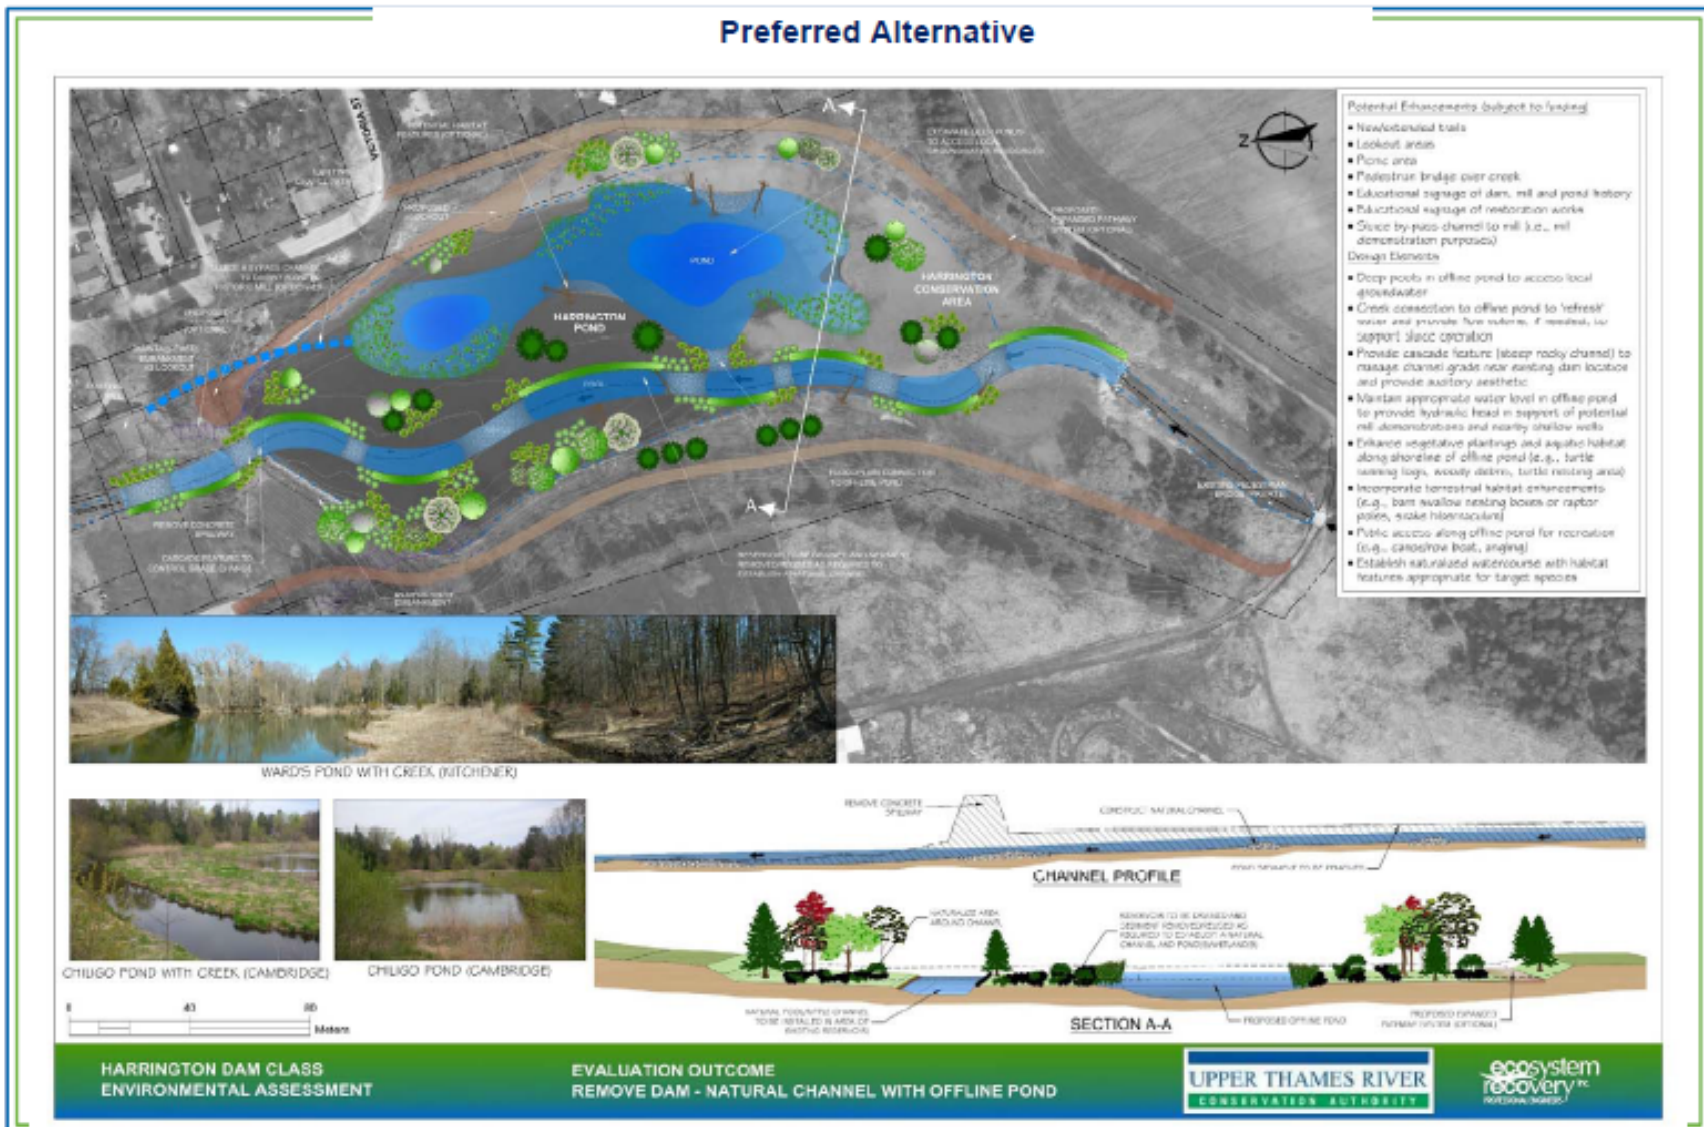
Figure 7-1. Preferred Alternative

The preferred alternative, resulting from both the equal and the weighted evaluation processes, was Alternative 4 (**Figure 7-1**). In this alternative, the dam would be removed and one or more off-line ponds would be created. The channel would be naturalized and flow around the off-line pond. The alternative recognizes the socio-cultural value of the community regarding viewscape of the pond and recreational uses of the area along with environmental benefits that would be achieved with placing a pond off-line (i.e., improved water quality, species diversity, habitat continuity, etc.). The alternative allows for replication and enhancement of the terrestrial environment. Subsequent to the third PIC, an additional alternative was proposed by the community, and considered by the study team. That alternative was a variation of Alternative 7 (i.e., partial rather than full replacement; creation of a spillway at the upstream

end of the pond) and considered a temporary solution rather than long-term. In conjunction with their description of the alternative, the community identified measures for environmental enhancement and recreational potential; many of these would not be exclusive to the variation of Alternative 7. The variation of Alternative 7 was evaluated, informally, to examine how the final scoring would compare to the preferred alternative. While the score, in both the equal and weighted evaluation tables would be higher than Alternative 7, the rank did not increase to be within the top 3 alternatives. Alternative 4 therefore remained the preferred alternative.

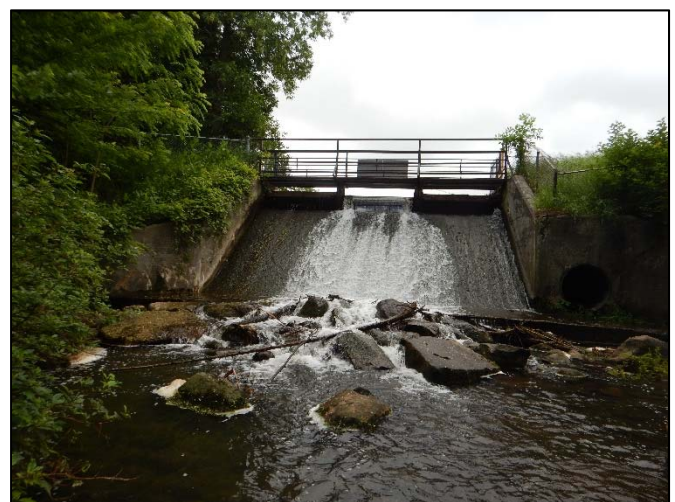
The dam structure consists of a three bay, reinforced concrete gravity spillway with a 65 m long earthen embankment to the west and a 20 m long earthen embankment to the east. The side slopes of the embankment are approximately 2 to 6:1 (horizontal: vertical). The entire dam is founded on overburden. There is approximately 3.3 m of head water across the dam with 1.1 m of freeboard. The spillway is approximately 4.0 m high and has a trapezoidal concrete section. Stop logs are

located on the crest between two sets of steel stanchions. Above the concrete spillway, a low level pedestrian bridge provides access above the spillway.

The main spillway includes concrete wing walls extending to a short, concrete apron. At the end of the concrete apron, rip-rap has been installed to control the energy of the flow as it leaves the concrete spillway. Gabion baskets are located at the east bottom embankment, at the end of the concrete wing walls. A low-level 700 mm diameter outlet pipe is located on the left wingwall looking downstream.

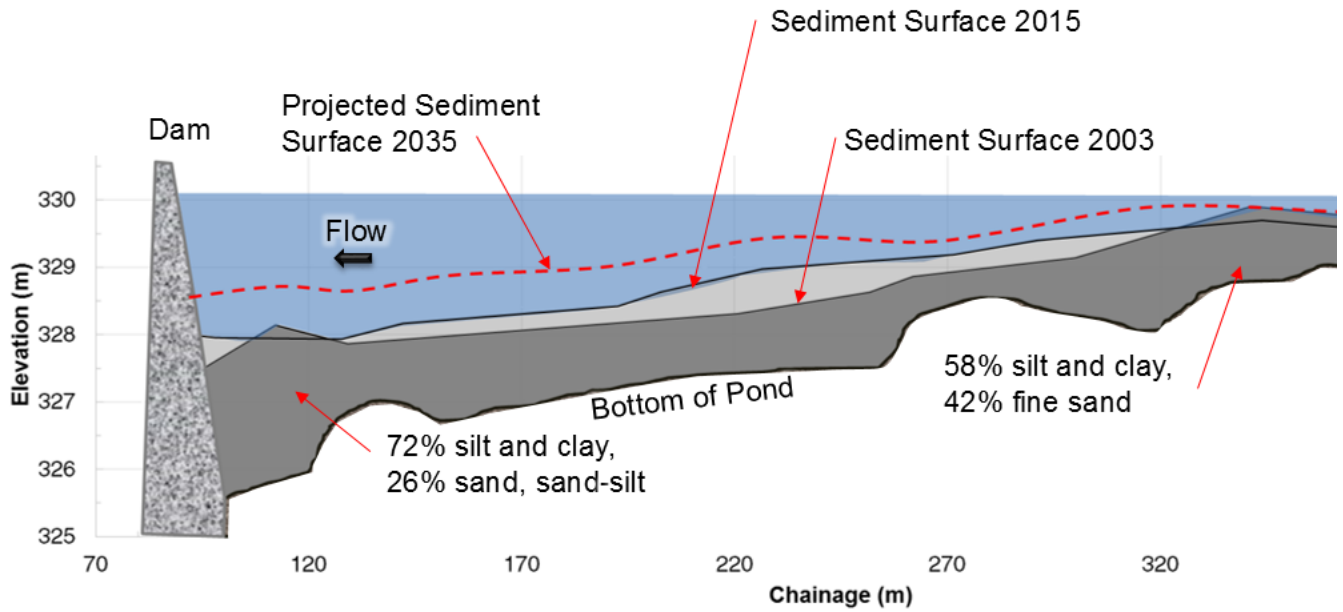
Figure 3-5. Sediment profiles in Harrington pond

Results of the water depth assessments were plotted on a profile through Harrington Pond (**Figure 3-5**). The figure shows that infilling depth appears to be somewhat greater immediately upstream of the dam.

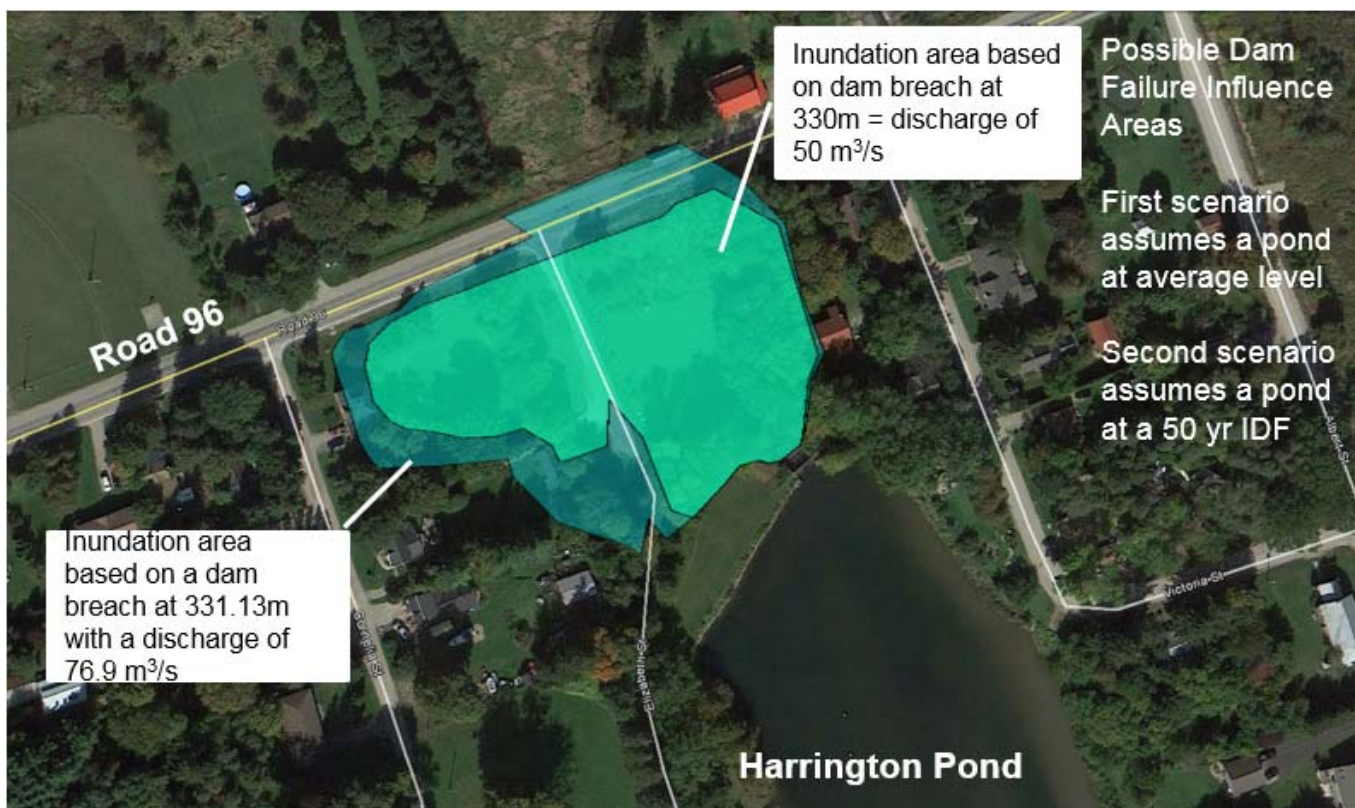
Figure 3-7. Inundation Limit for Dam Failure Scenarios

Analyses were completed to assess the area that may be flooded due to a breach in the dam. Two scenarios were assessed including an average pond water level (i.e., elevation of 330 m) with a discharge rate of 50 cms and the pond assuming a 50 year IDF (i.e., elevation 331.13 m). The anticipated flood area is illustrated in **Figure 3-7**. The breach simulation was also undertaken in the Dam Safety Study. The breach analysis does not include the potential effect of volumes of sediment or erosion that may be released to downstream and that may contribute to greater flooding still.

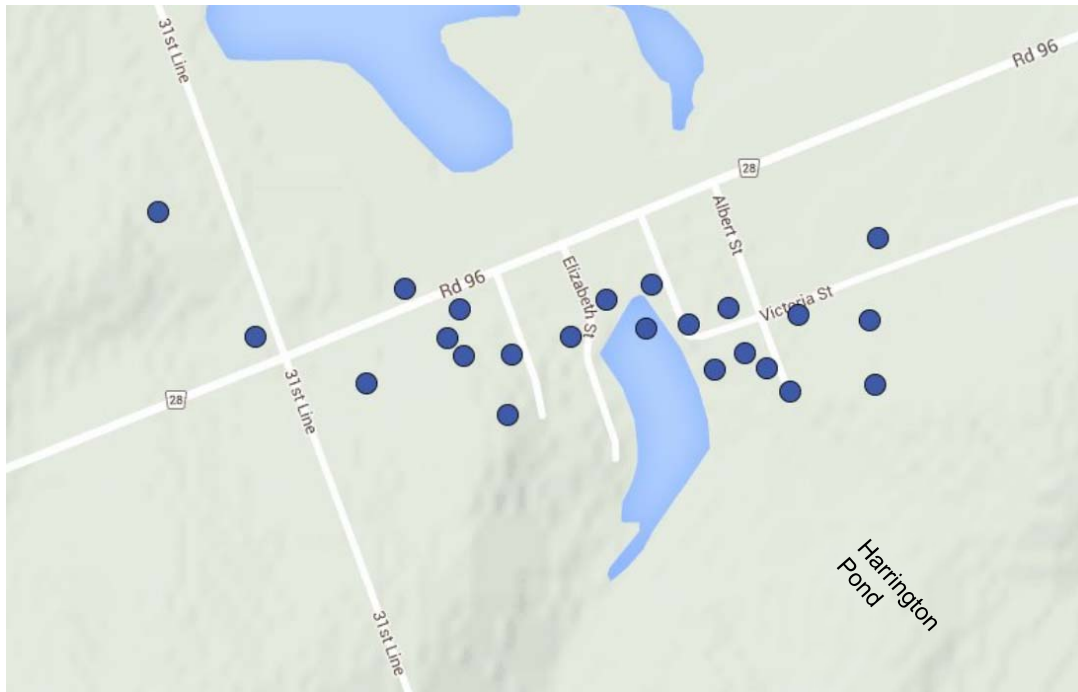
Figure 3-8. Known wells in the area of Harrington CA (Data Source: MOECC)

The well records were examined and data were plotted on **Figure 3-8**. Position information for wells within MOEE well records may not be precise on the maps. The recorded water depths of the wells were plotted on **Figure 3-9**. For the purpose of the current study, an inventory of the shallow wells was not completed but may need to be undertaken in conjunction with detailed design of the preferred alternative since shallow wells may be affected by a change in head pressure due to Harrington Pond (note: impacts are mitigatable through the installation of deep wells). Anecdotal observations provided by the public, through the public information centres (see **Appendix J**) suggest that, in times of previous dam failure, shallow water wells were affected.

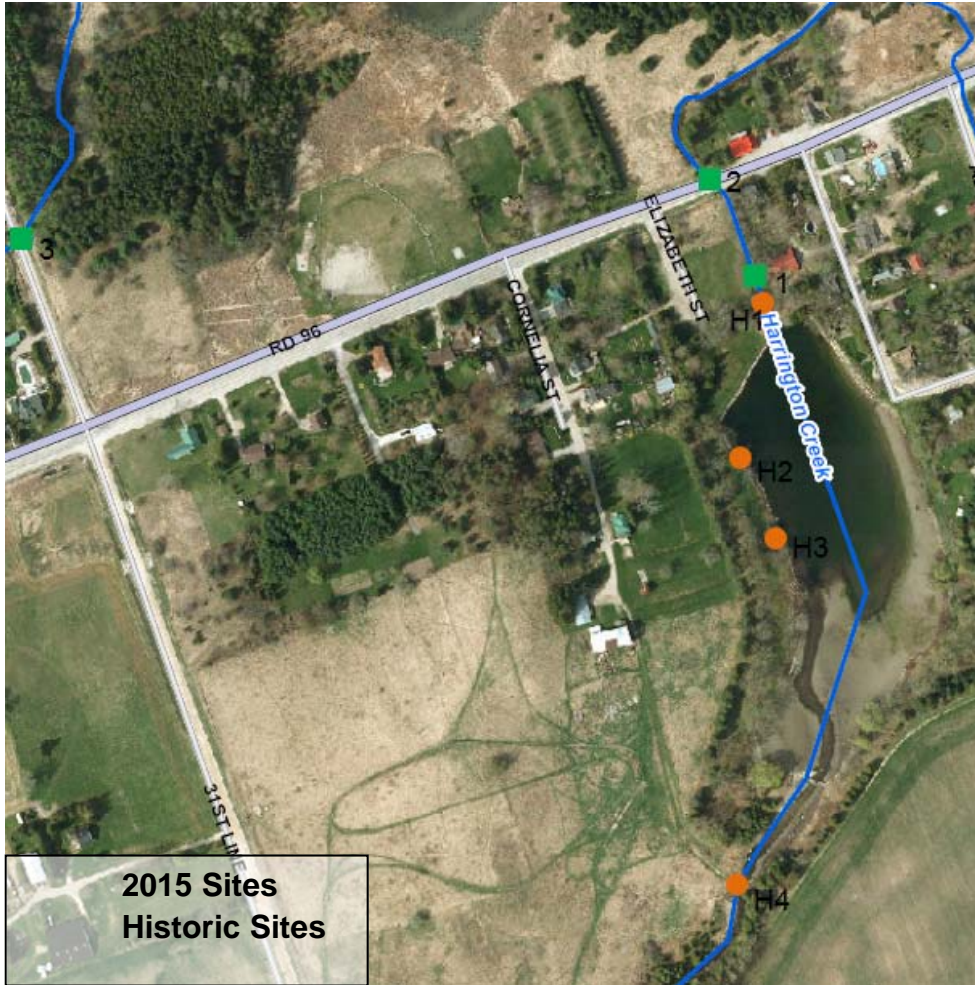
Figure 3-14. Harrington Pond Water Quality Survey Sites 2015 (Source: UTRCA)

A series of five water samples were collected at four locations in the area of Harrington CA: one upstream of the pond, two in the pond, and one downstream of the dam (see map in **Figure 3-14**). This monitoring provides a snapshot of water quality, and is limited to the conditions of April to October 2015. Harrington Pond also had one year of historical data from 1989, which has been included in the evaluation of the results.
