Meeting of the Upper Thames River Conservation Authority  
Hearing Committee – Agenda  
Tuesday June 20, 2023 12:30pm, 1424 Clarke Rd. London

**To: Chair and Members of the UTRCA Hearings Committee**  
**From: Jenna Allain, Manager – Environmental Planning and Regulations**  
**Cari Ramsey, Land Use Regulations Officer**  
**Date: June 13, 2023**  
**Filename: ENVP #126511**  
**Agenda #: 6**  
**Subject: Section 28 Permit Application #108/23 for Proposed Interference Within a Wetland and Proposed Development Within an Erosion Hazard Associated With a River or Stream Valley and Area Regulated by the Conservation Authority at 60 Hog Back Close, Municipality of Middlesex Centre (Delaware), Ontario.**

**THAT Application #108/23 for the proposed interference with a wetland and proposed development within an erosion hazard associated with a river or stream valley and area regulated by the Conservation Authority at 60 Hog Back Close, Municipality of Middlesex Centre (Delaware), Ontario be denied as it is contrary to UTRCA approved wetland alteration and erosion hazard policies.**

*A Section 28 Application for Development, Interference with Wetlands and Alterations to Shorelines and Wa

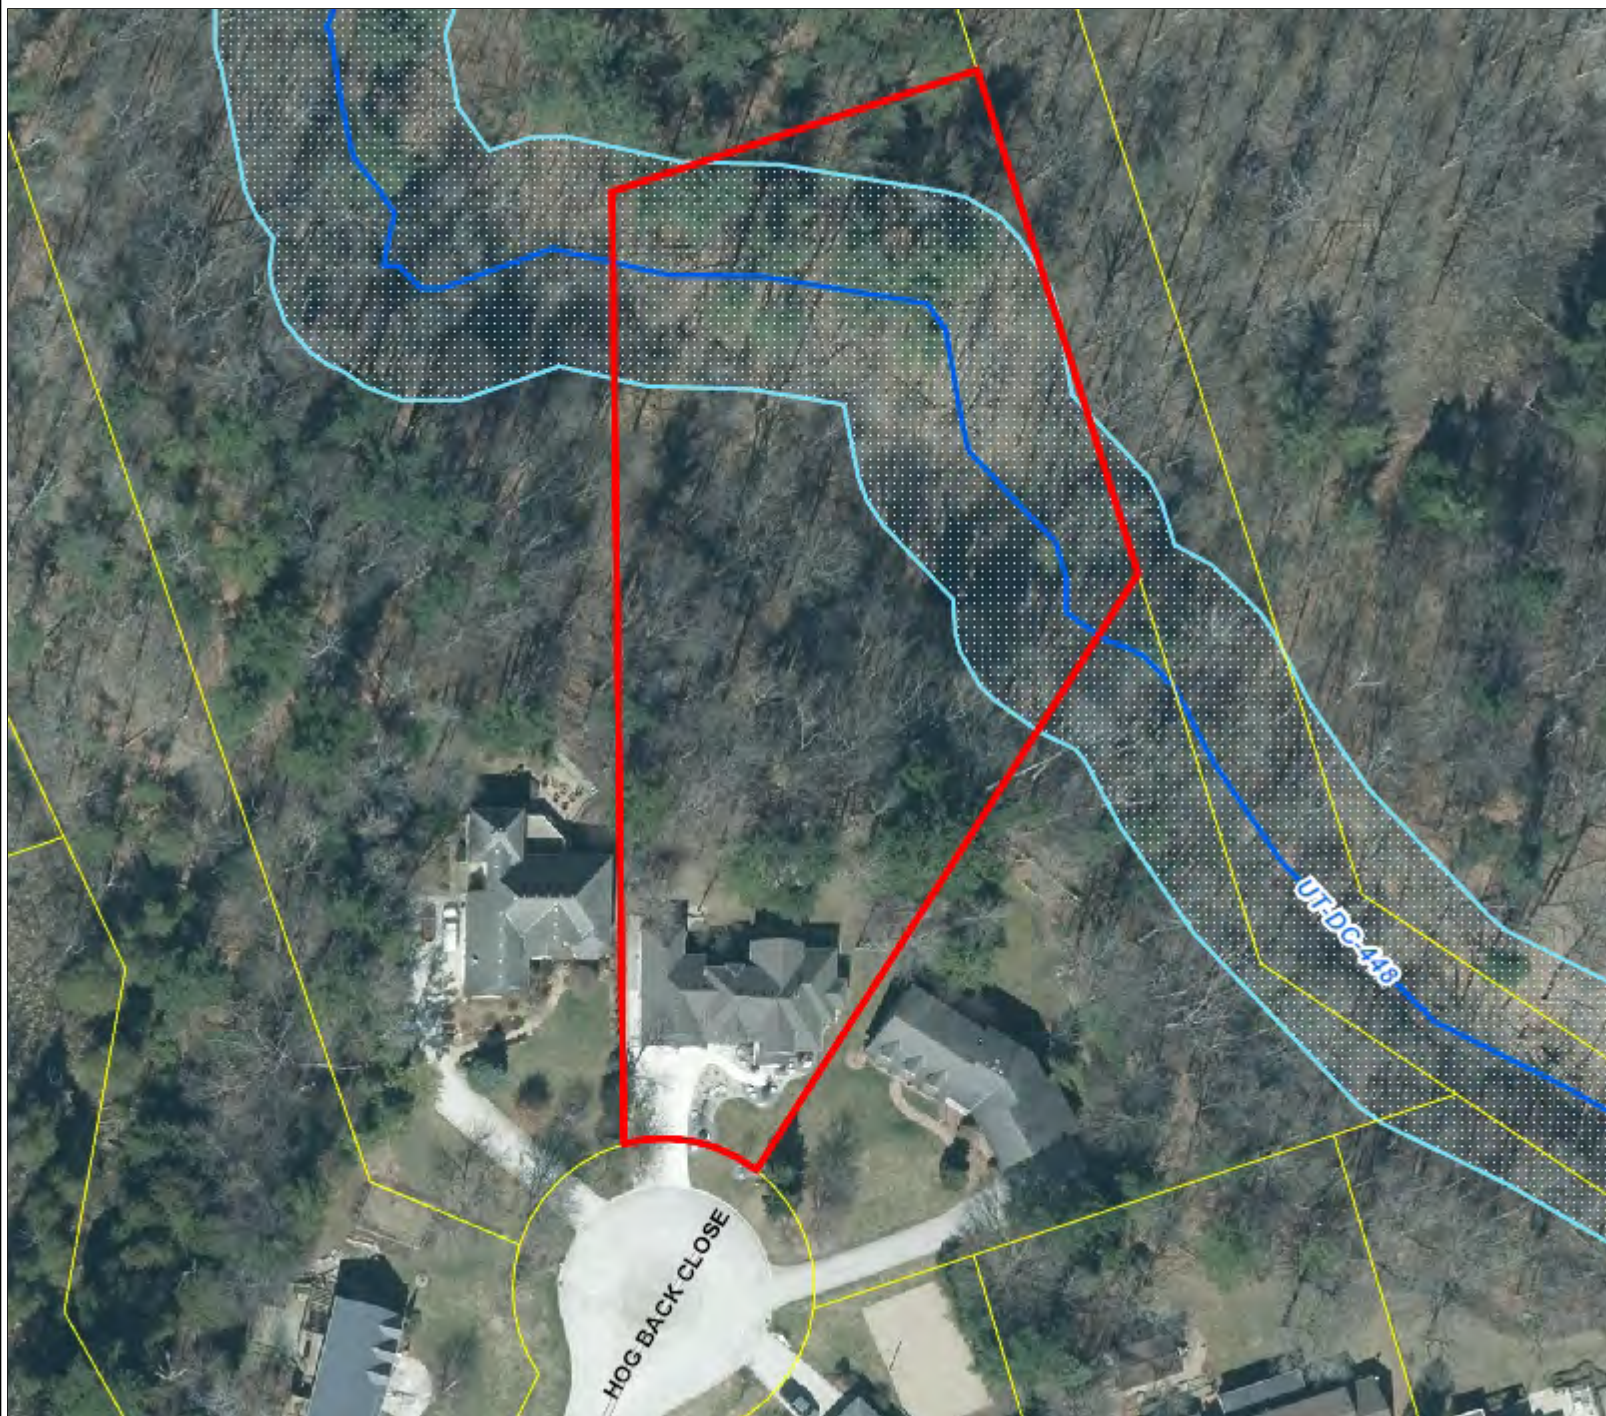
Flooding Hazard Limit

Notes:  
60 Hog Back Close, Delaware - Mapping prepared to show estimated location of watercourse and associated flood hazard. Flood hazard is a "generic" 15 metre setback at this location.

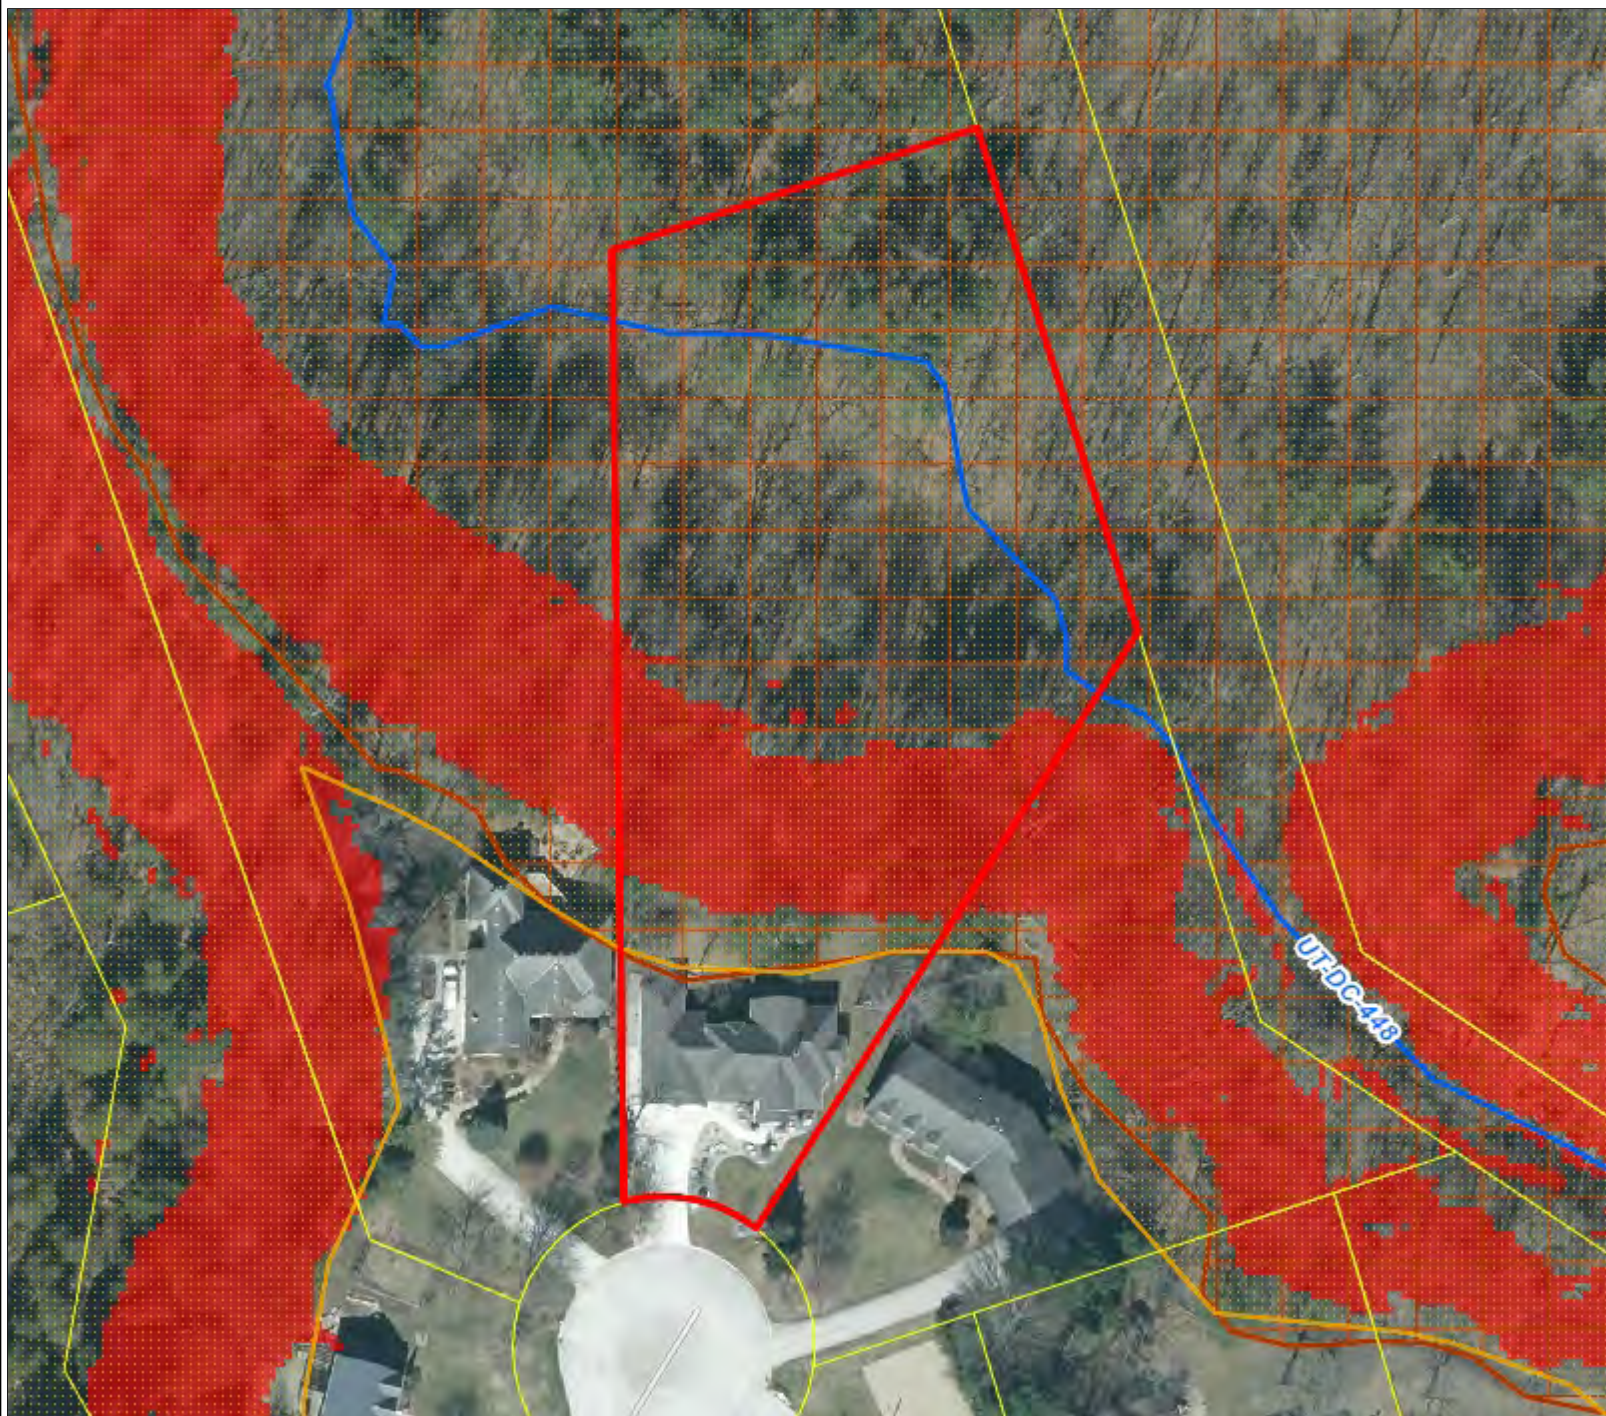
Potential Slope Hazard

Notes:  
60 Hog Back Close, Delaware - Mapping prepared to show estimated location of erosion (steep slope) hazard on the property.

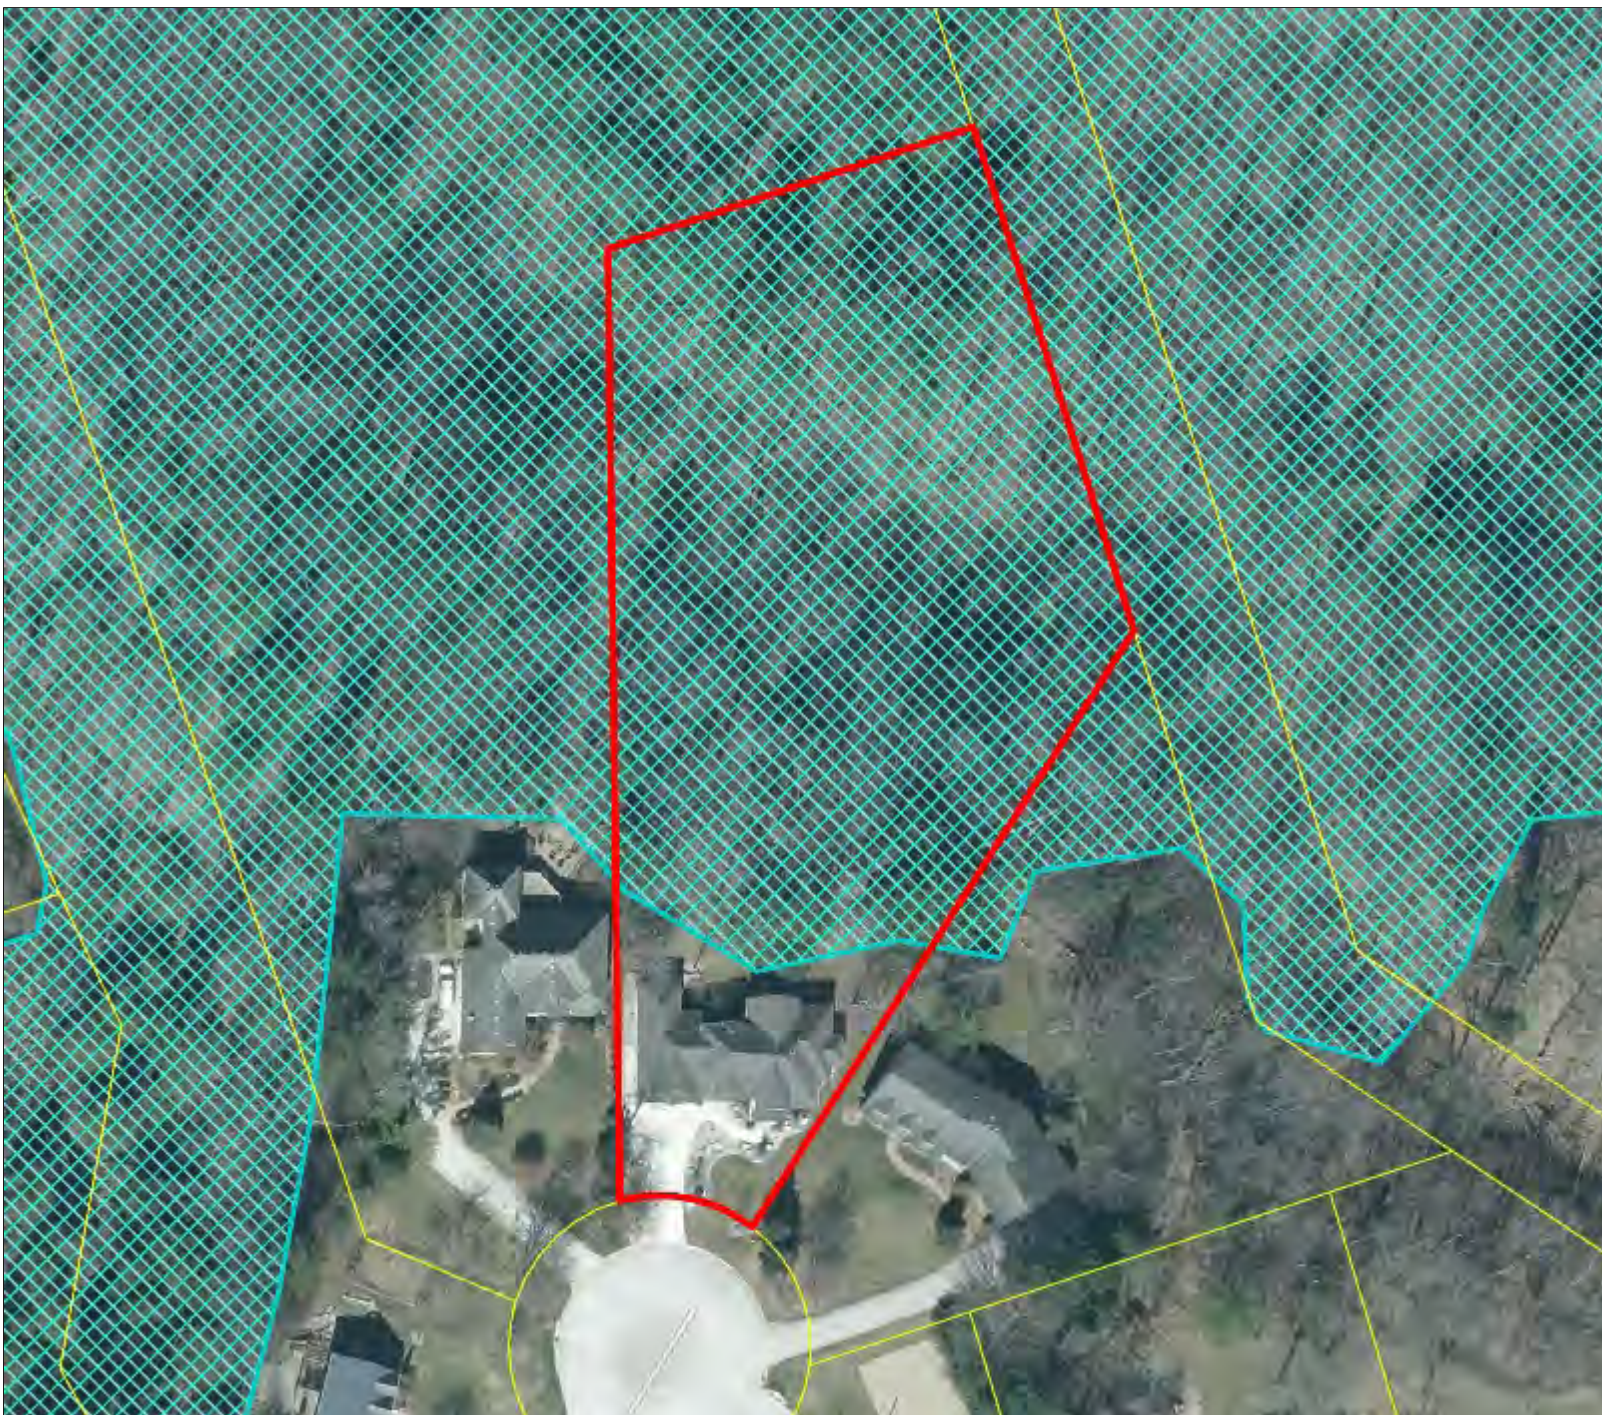
Regulated Wetland

Notes:  
60 Hog Back Close, Delaware - Mapping prepared to show estimated location of wetland features on the property.

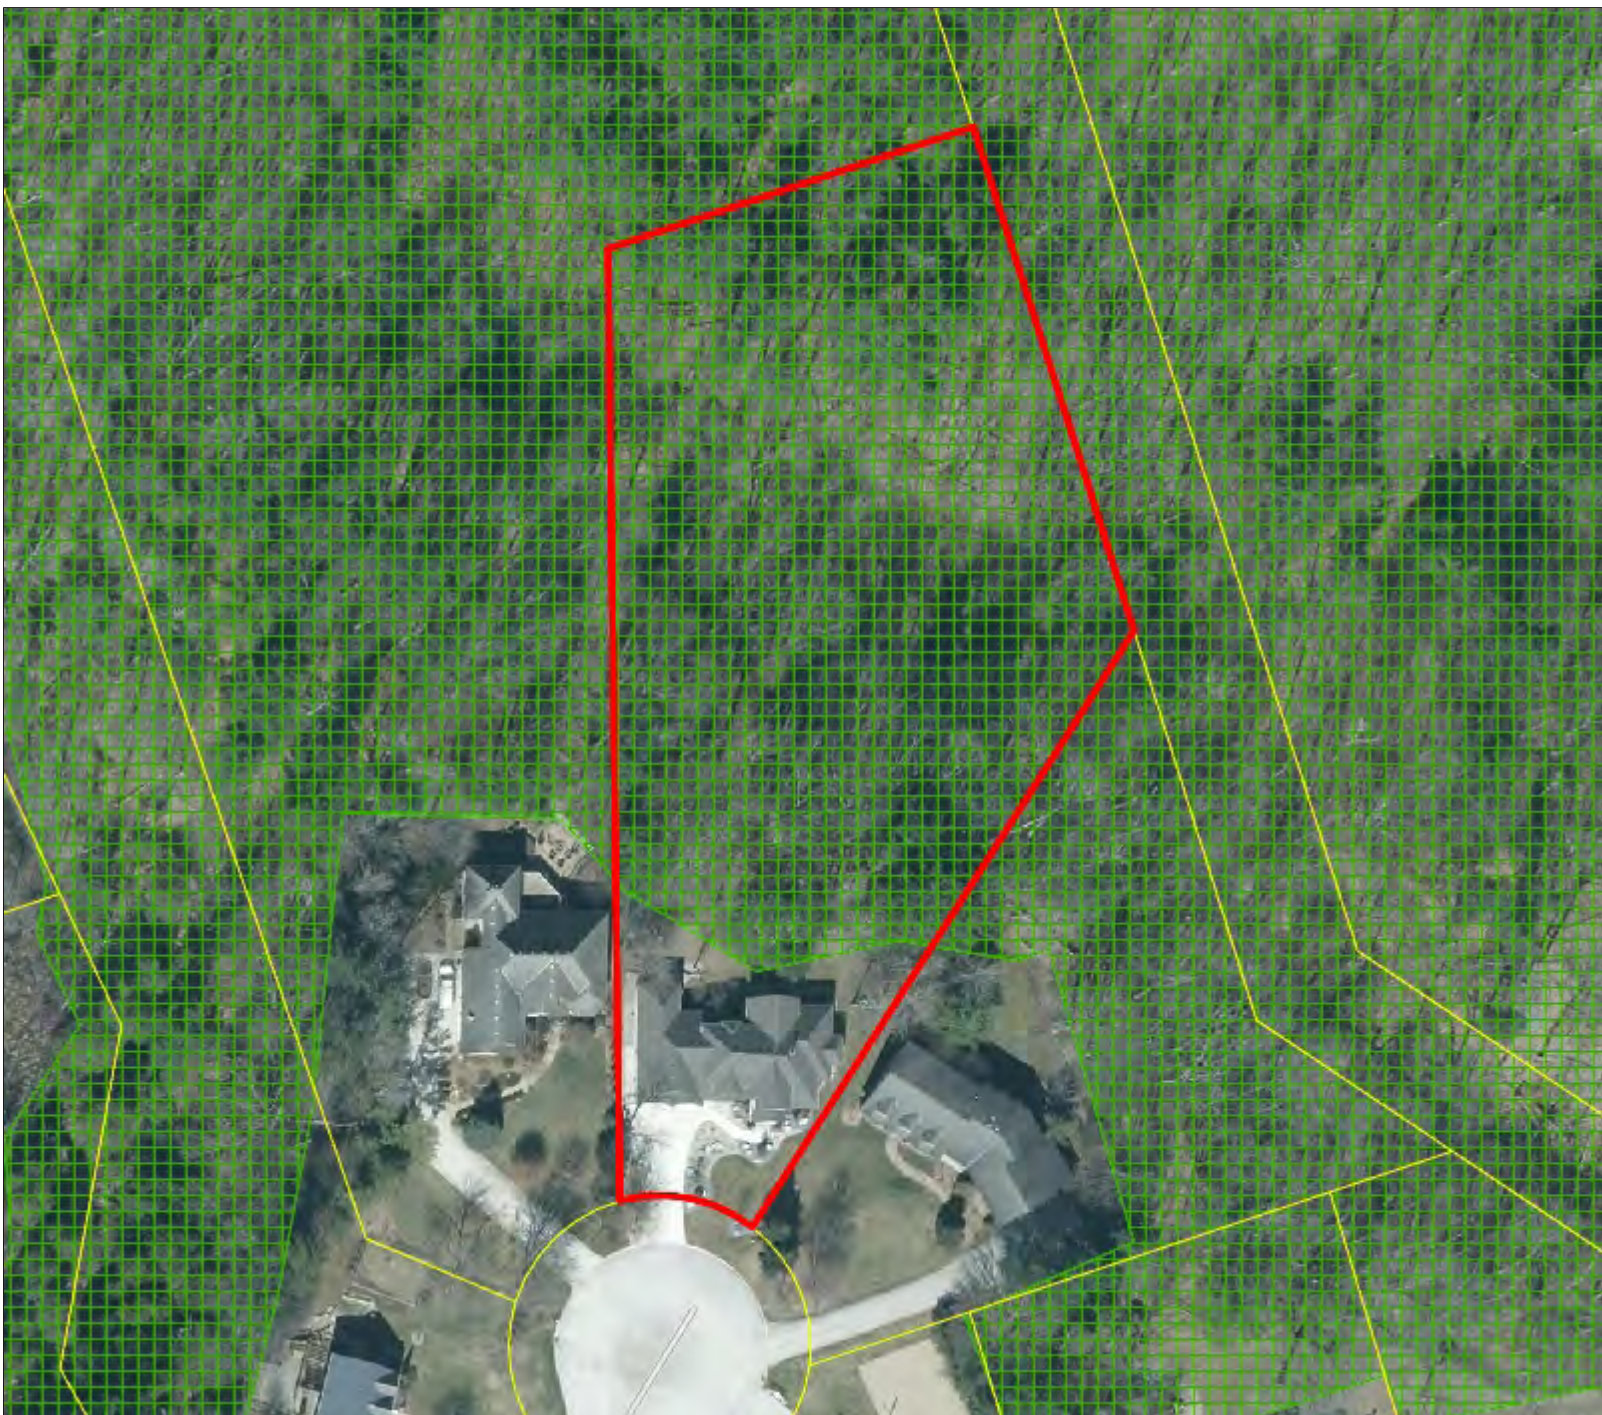
Significant Ecologically Important

Notes:  
60 Hog Back Close, Delaware - Mapping prepared to show estimated location of (Natural Heritage Significant) woodland on the property.

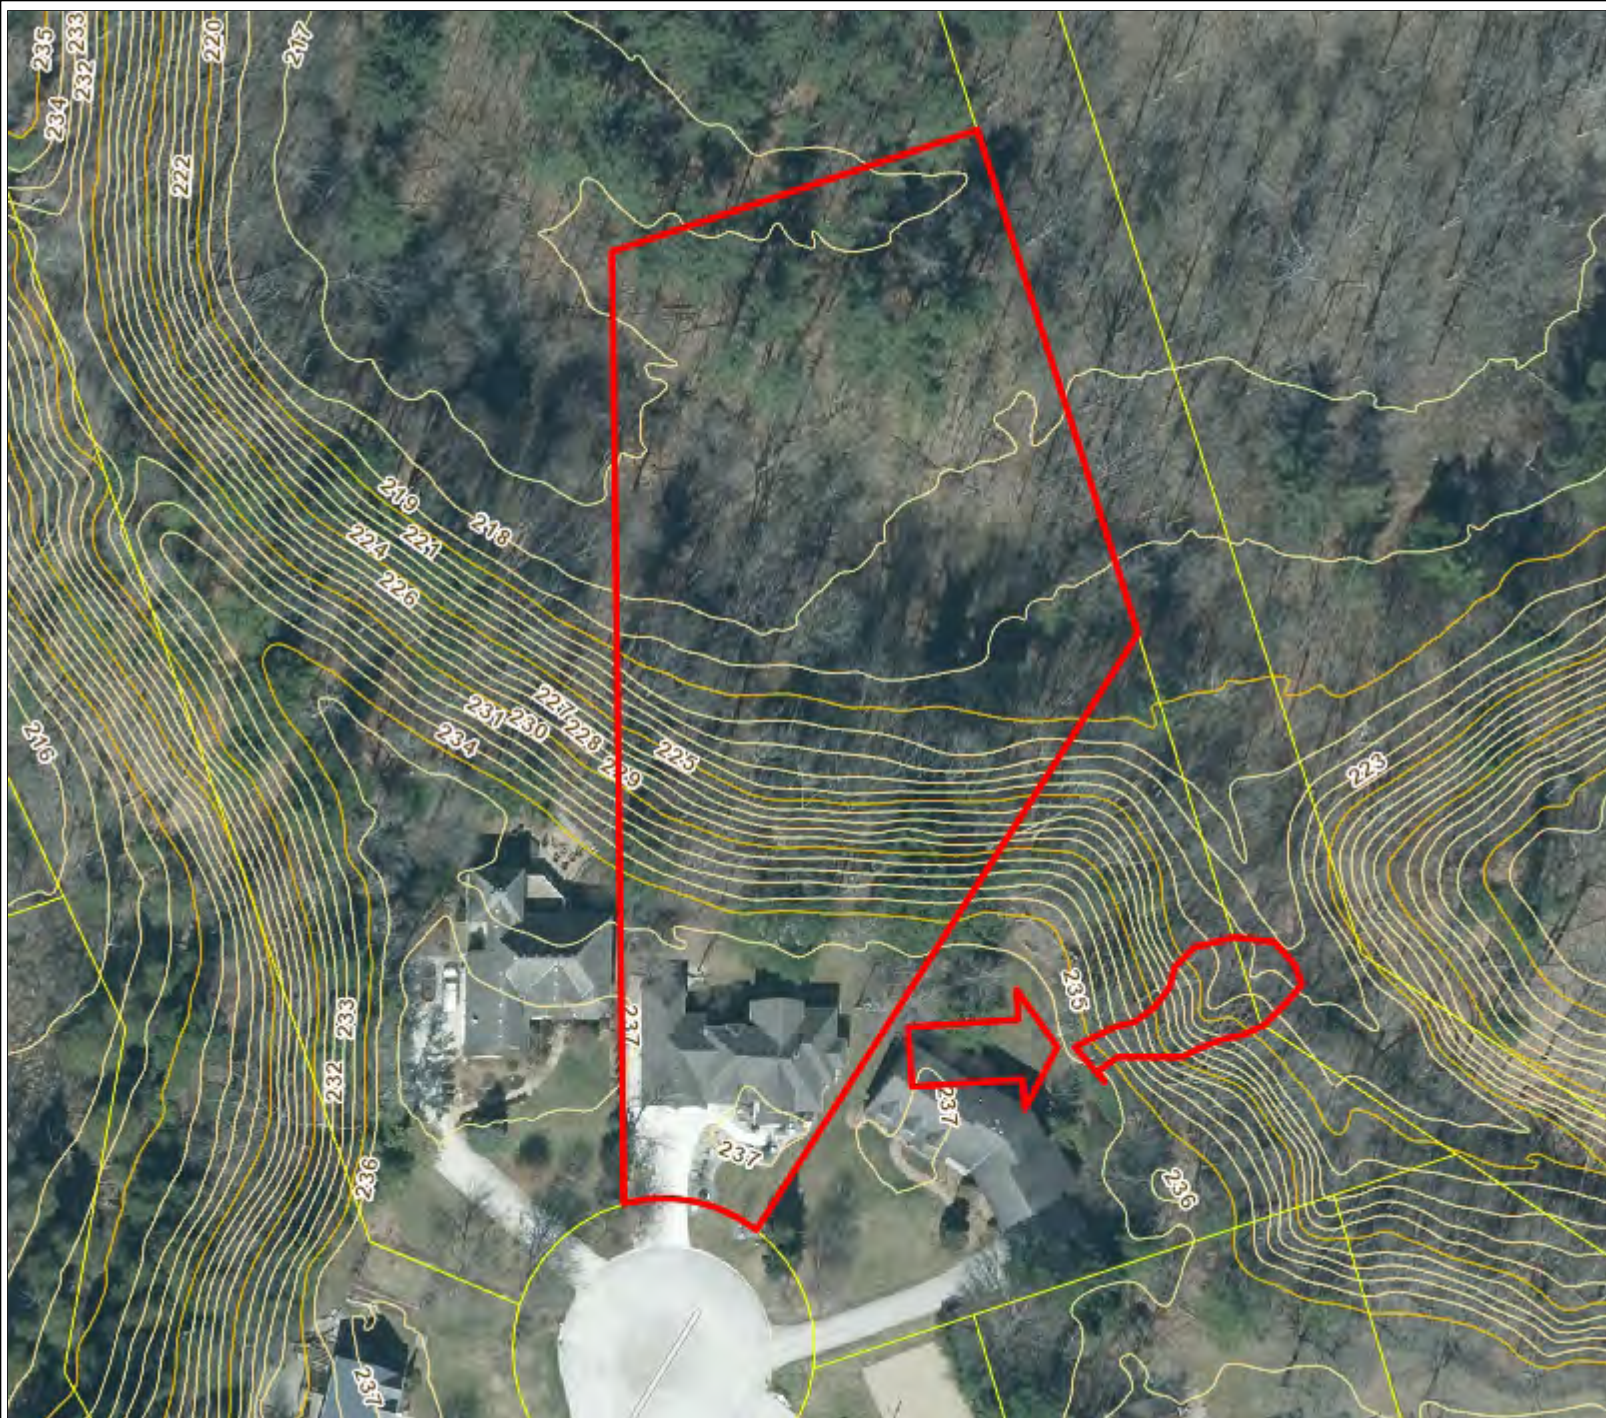
## Attachment #7

Notes:  
60 Hog Back Close, Delaware - Mapping prepared to show location ("red arrow") of existing slope failure on adjacent property.

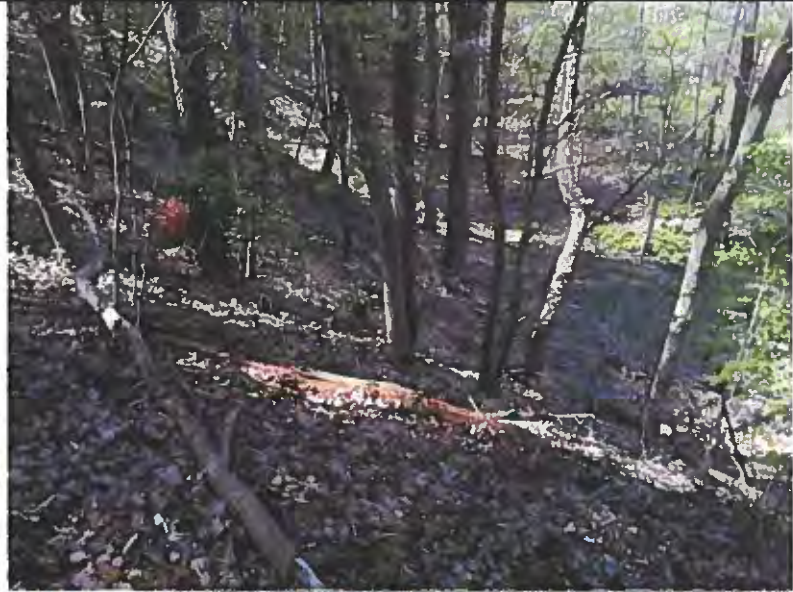
A site visit was conducted on May 9, 2013 to examine the current conditions of the slopes at the site. The valley slope located along the northern edge of the site was reviewed using the 'Slope Stability Rating Chart' (created by MNR), which summarizes the site observations, and empirically scores various elements which contribute to slope stability, to provide an assessment of the potential for slope instabilities at the site. A rating chart for the cross section examined is provided for review and consideration. A photographic record of the slope conditions was obtained during the site visit; select photographs are shown below.

<p><b>Photo 1</b> – From crest of slope looking north west.</p>

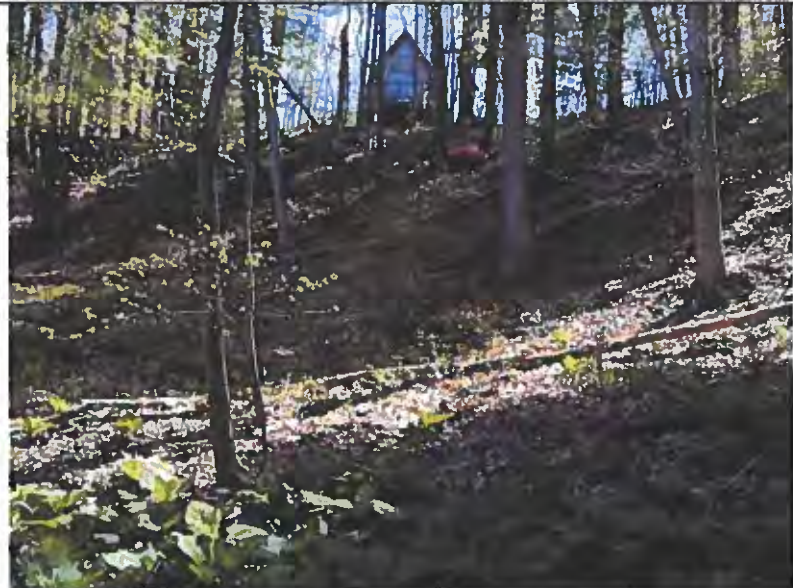
<p><b>Photo 2</b>– From bottom of slope looking south east.</p>

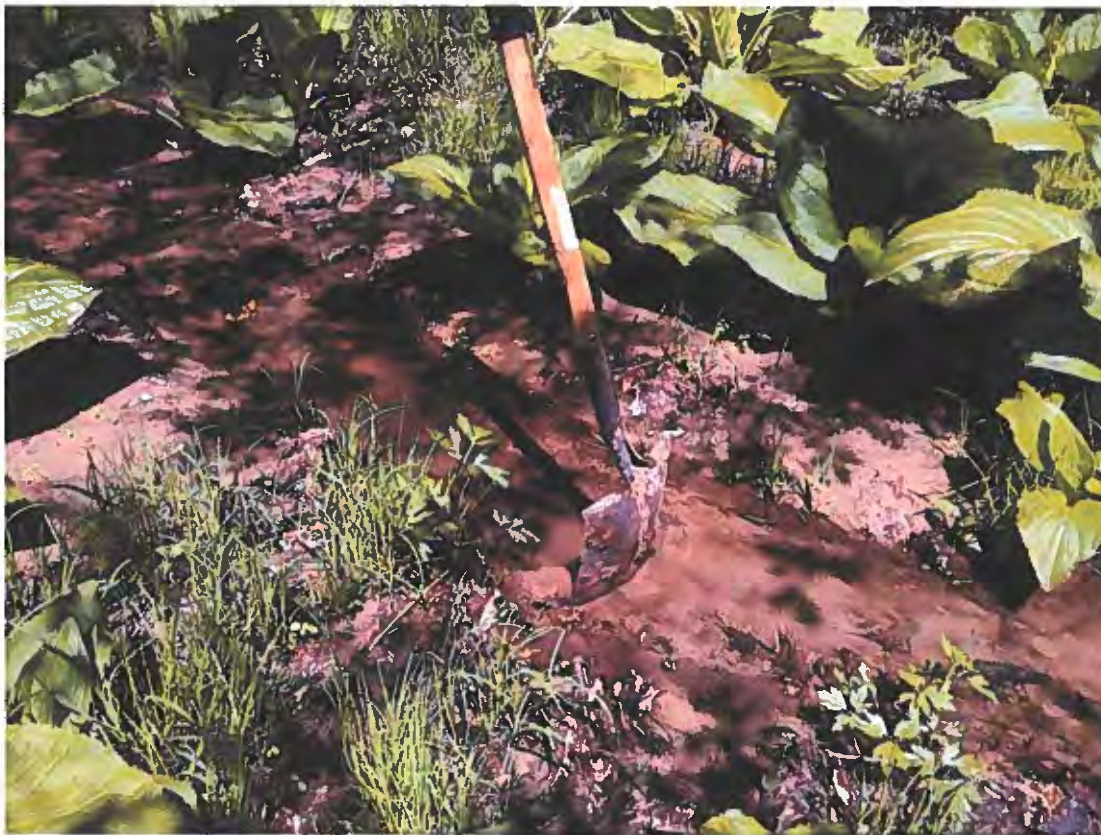
As noted above, the slopes are generally inclined at about 1.8H:1V, water depths adjacent to the slopes within the watercourse are shallow (less than 125 mm as shown below), and have been considered in the overall stability of the existing site slopes.

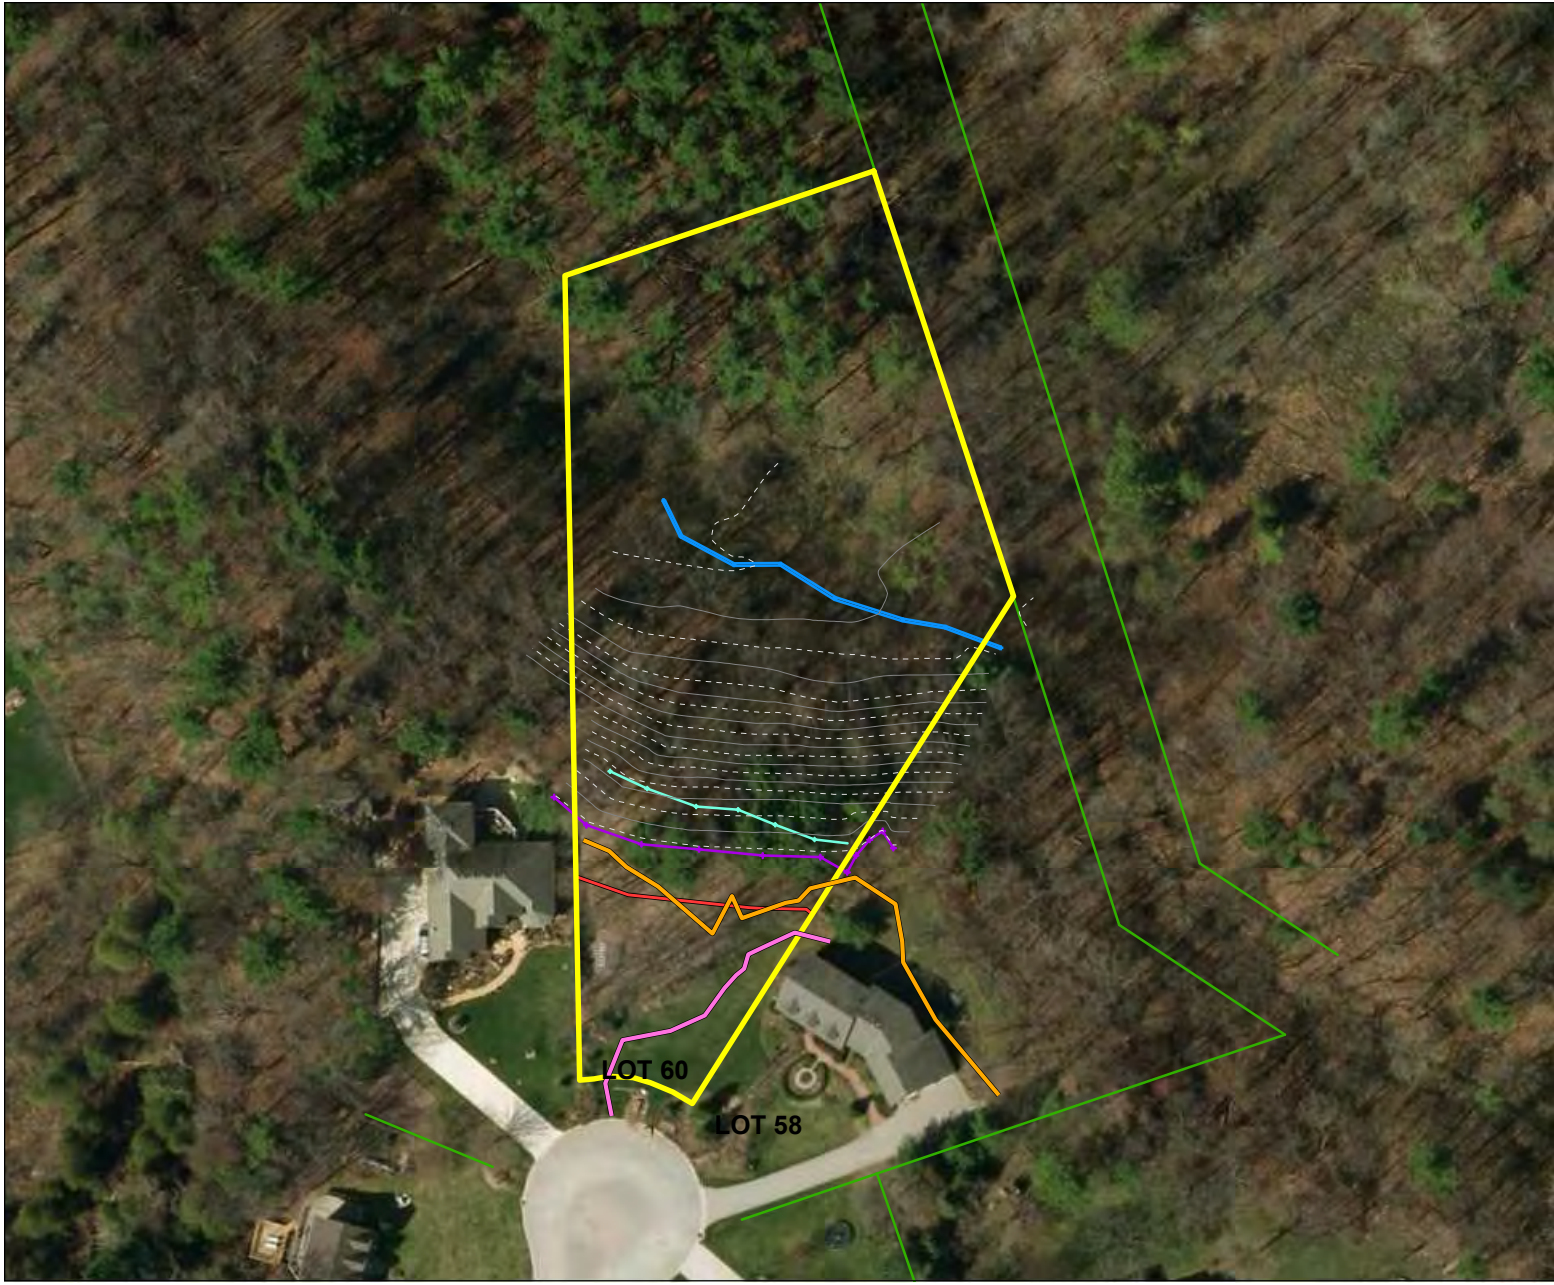
2

- Cultural Plantation Dripline
- Woodland Dripline
- Site Boundary
- Erosion Hazard Limit
- Major Topography
- Minor Topography
- Creek
- Parcels
- Top of Slope
- Toe Erosion Allowance

For Ecosite and Vegetation Type polygons refer to **Figure 2**.

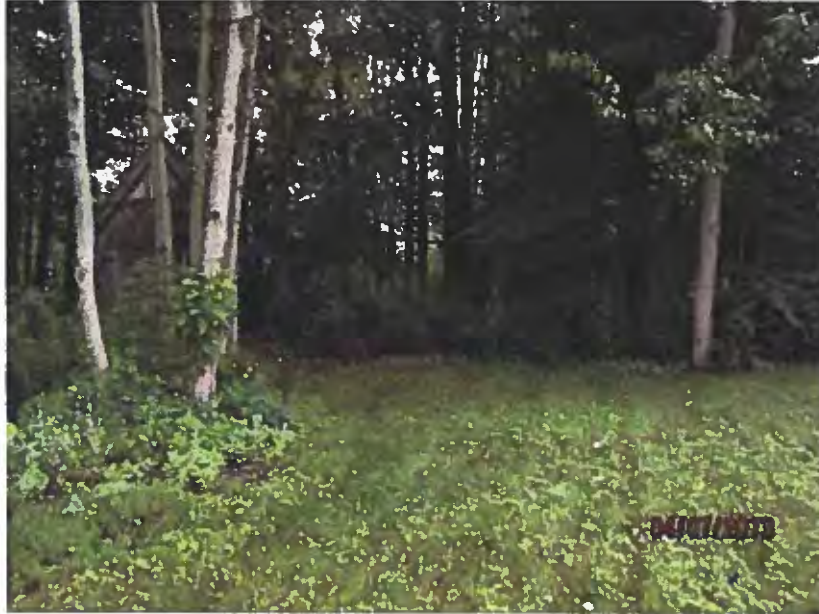
**Photograph 13:** Closer view with the gardens and planted large-tooth aspen of the north portion of Lot 60 at the ecotone with the woodlands. This view shows how the gardens and a shed extend in to the upper edge of the woodlands, at the top of the slope. In the background, this view shows the inner woodlands are essentially not disturbed by this land development.

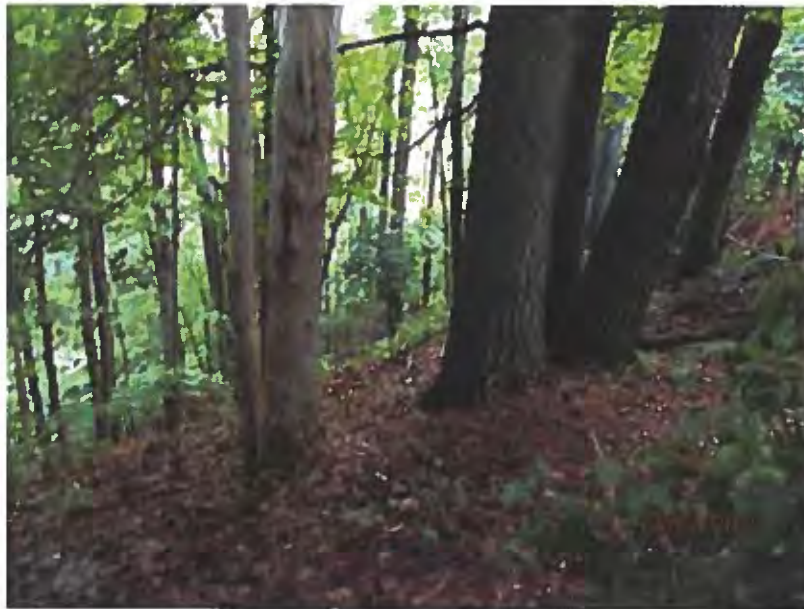
**Photograph 14:** View of the top of slope adjacent to Lot 60, with the gardens in the foreground. The woodland in the background shows mature and immature trees, with examples of coppice growth forms. Based on the size of the trees and growth forms, it is probable that intensive forestry was completed on the slope approximately 60 – 100 years ago.

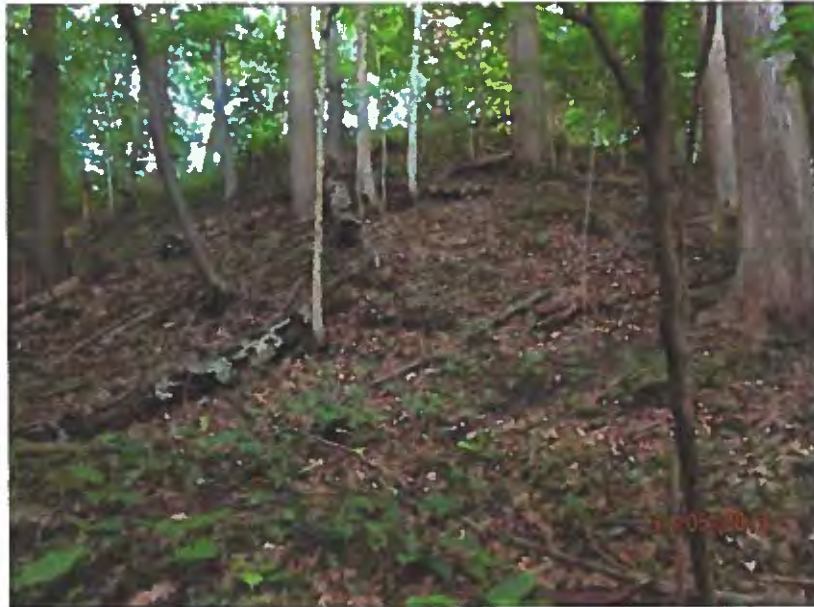
**Photograph 15:** View of the initial portion of the slope at Lot 60. The woodland shows mature and immature trees. It is noteworthy that wildlife browse was interpreted to be minimal.

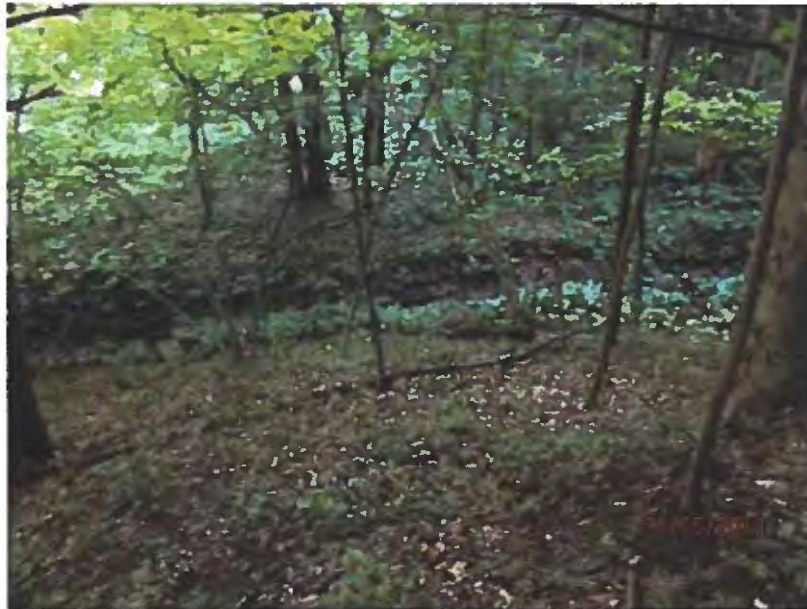
**Photograph 18:** View of the base of the slope and valley, with a tributary of Dingman Creek in background. This portion of the woodland valley also includes mature and immature trees, with examples of coppice growth forms. The channel for Dingman Creek was well defined.

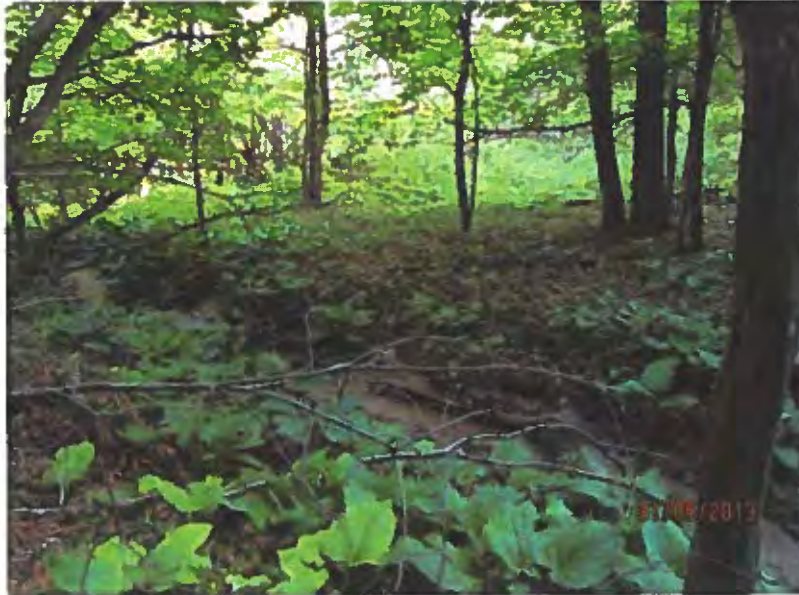
**Photograph 19:** Another view of the tributary of Dingman Creek, in the valley downslope from Lot 60. This habitat included poorly drained soils and was dominated by Skunk cabbage (visible in the foreground, adjacent to the creek).

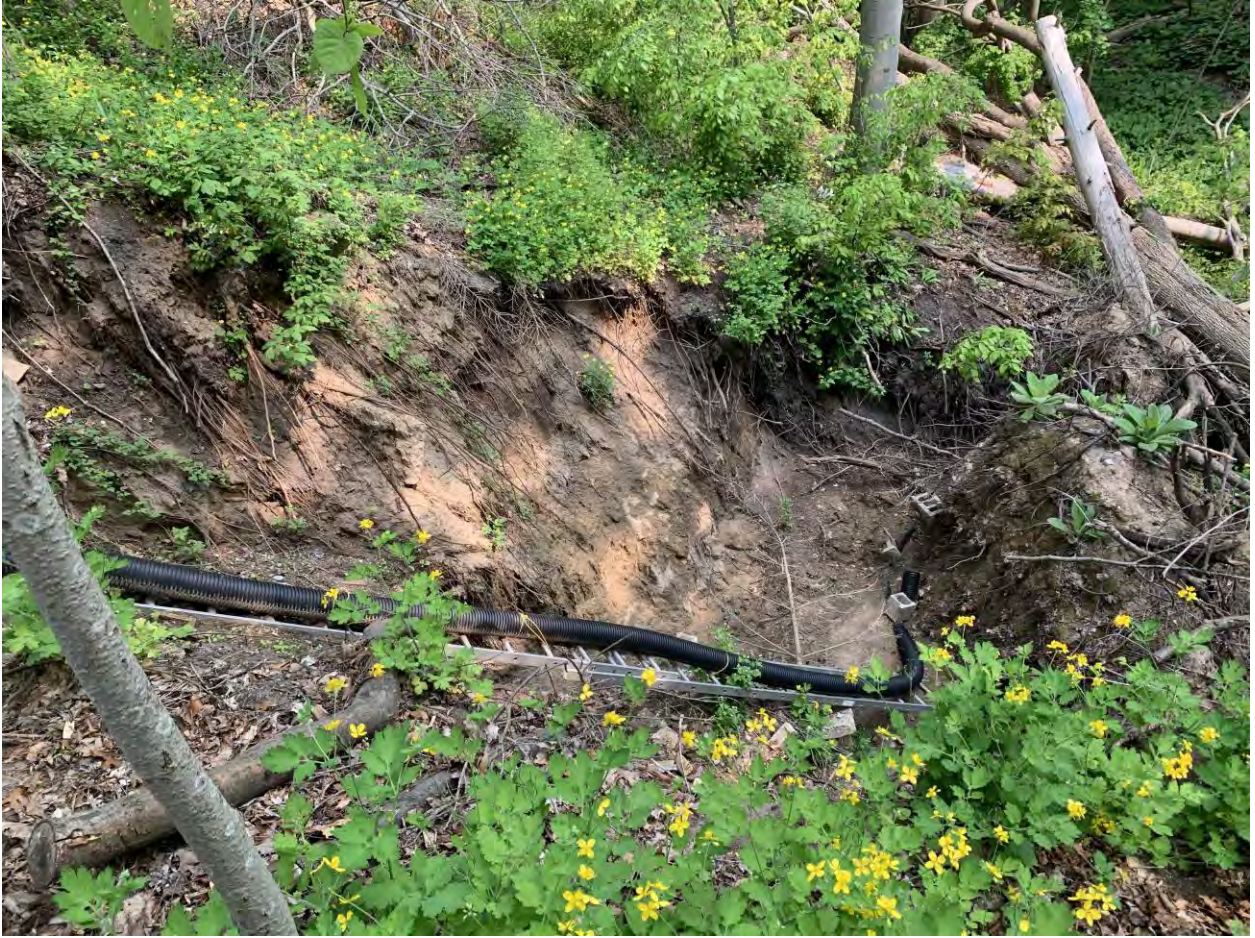
17a

In March of 2022 UTRCA staff were contacted by the Drainage Superintendent from the Municipality of Middlesex Centre advising us about a slope failure on the property next door to the subject lands. This slope failure impacted both a private property and a municipal stormwater easement and the municipality subsequently hired a consultant to undertake the design of slope remediation works. A geotechnical report and preliminary construction drawings were submitted to our office and our technical staff have met with consultants to discuss the project design. We have also met on site with the consultants and municipal staff to view the slope failure and to discuss site specific project construction details, mitigation measures and “lessons learned” from other slope remediation projects. We are of the understanding that the project is currently out for tender. The slope failure appears to have increased in size since March of 2022. Recent photos (**Attachment #17**) of the slope failure (May 2023) on adjacent property are included with this report.

Photos of Slope Failure on Adjacent Property Parcel
