**LONDON DYKES VEGETATION MANAGEMENT PLAN
PRELIMINARY INVESTIGATION PHASE**

FINAL REPORT

CITY OF LONDON

Upper Thames River Conservation Authority

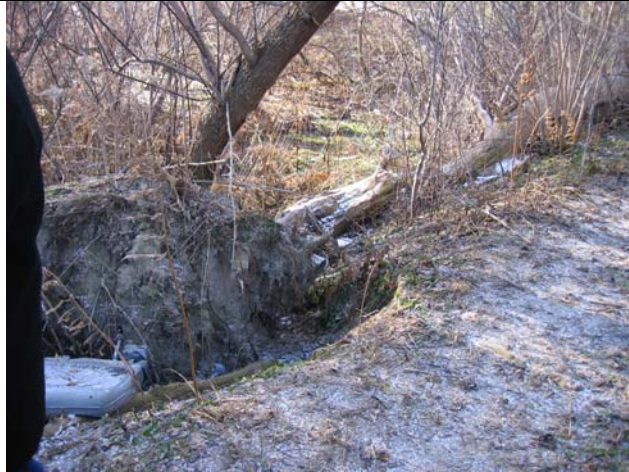
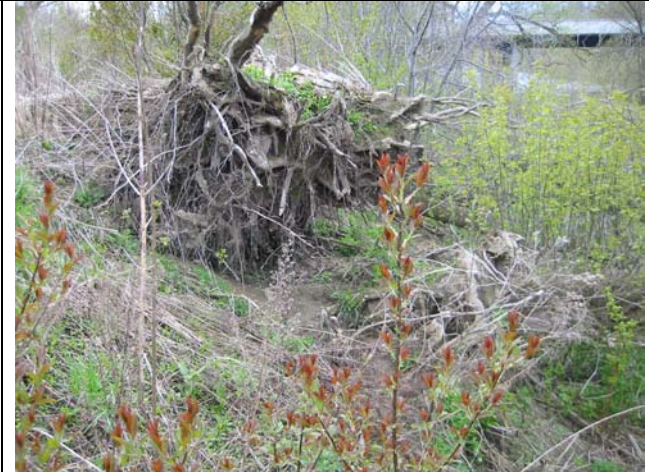
DEGRADED – Imminent Action Recommended

Fallen Manitoba Maples heaving section of Ada-Jaquelin Dyke east of Adelaide Street. Note physical degradation of dyke integrity. Extensive maintenance and repair required.

For the one site in the Degraded risk category (Ada-Jacqueline from station 0+150 to 0+350), the damage potential from hazard trees has already been realised. Sections of the dyke have been lifted, opened or moved due to the upheaval of root systems from leaning and fallen trees. Hazard tree removal will necessitate the removal of exposed root systems; and, in addition to hazard tree removal, sections of the dyke must be repaired. The structural integrity of a major section of this dyke has already been compromised and its ability to function in the event of a flood should be assessed from an engineering standpoint. The identified project schedule and phasing may not be sufficient to address the risks at the Ada-Jacqueline dyke: we would recommend immediate action.

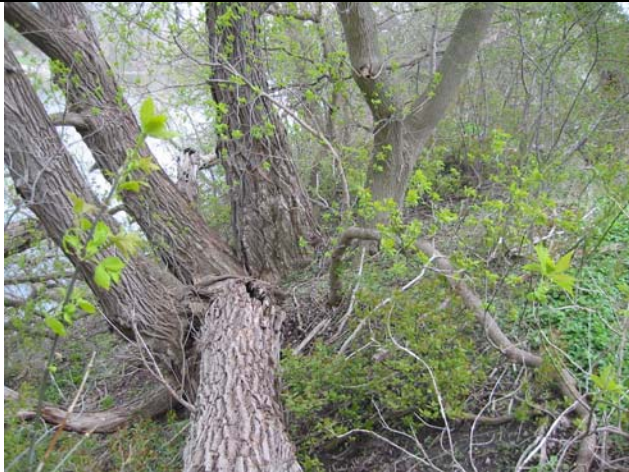
CRITICAL – Action Within 1-2 Years Recommended

Manitoba Maple on the slopes at Riverview Dyke. Physical degradation of dyke integrity likely within 3 years. Extensive maintenance required.

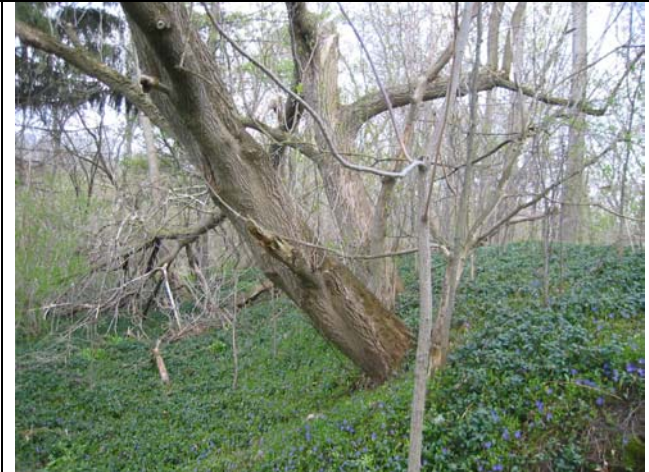
Manitoba Maple growing out of the side of Byron Dyke among a ground cover of Vinca. Potential for physical degradation in near future; localized maintenance required.

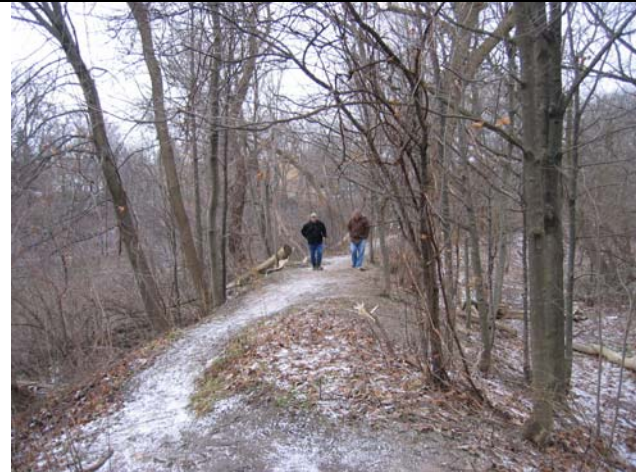
THRESHOLD – Action in 3-5 Years Recommended

A mixture of immature Manitoba and Norway Maples growing on the Nelson-Clarence Dyke. Selective maintenance in 3-5 years will avoid more extensive maintenance or repairs in future.

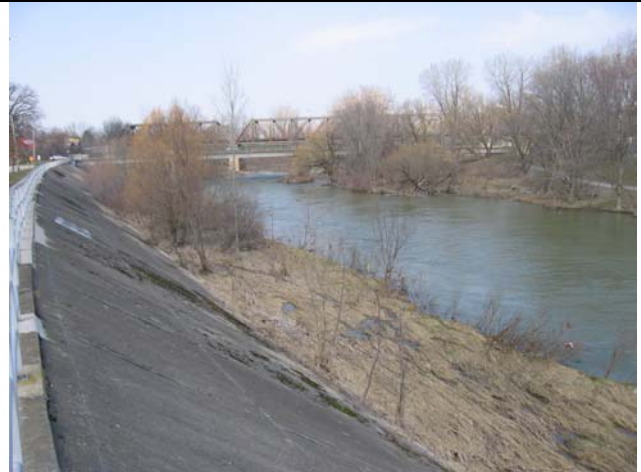
Regenerating vegetation in deposition zone south of Blackfriar Bridge. Monitoring should ensure that invasive species do not become established in gaps between concrete pads.

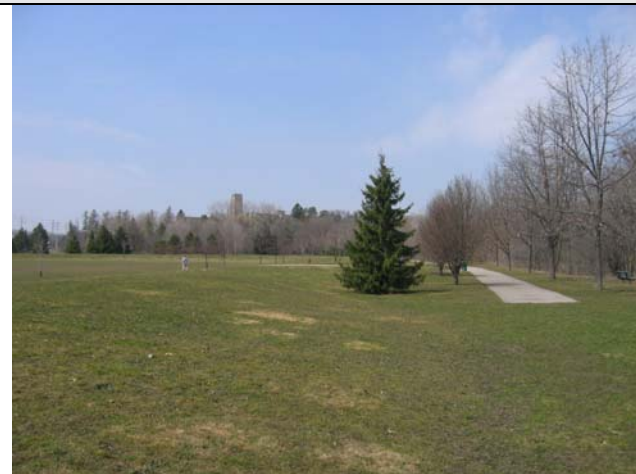
NO ACTION

View of Dyke at Broughdale through Park. No maintenance required.

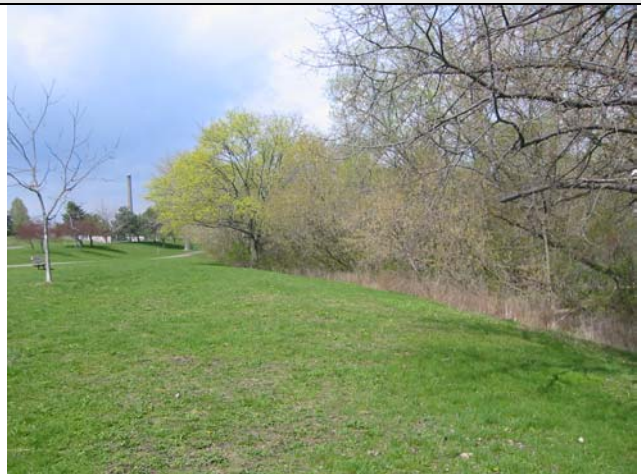
View of the edge of Coves Dyke at crest of slope before descending to the floodplain.
