2022 Watershed Report Card

Cedar Creek

The Upper Thames River Conservation Authority (UTRCA) has produced Watershed Report Cards for the Cedar Creek watershed and 27 other watersheds in the Upper Thames River basin. These report cards outline environmental information and suggested actions for improvement.

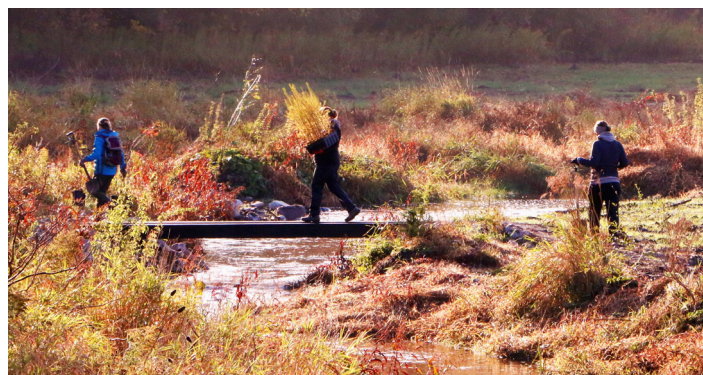
UTRCA staff restoring the headwaters of Cedar Creek at Hodge's Pond.

- Along with several partners, the UTRCA is restoring the headwaters of Cedar Creek at Hodge's Pond (photo below). The project has involved the removal of a small dam to improve water quality, wetland creation, and planting native trees, shrubs, and aquatic plants. Instream work has also been completed, and a hiking trail is being developed.
