2022 Watershed Report Card

Ingersoll

The Upper Thames River Conservation Authority (UTRCA) has produced Watershed Report Cards for the Ingersoll Corridor watershed and 27 other watersheds in the Upper Thames River basin. These report cards outline environmental information and suggested actions for improvement.

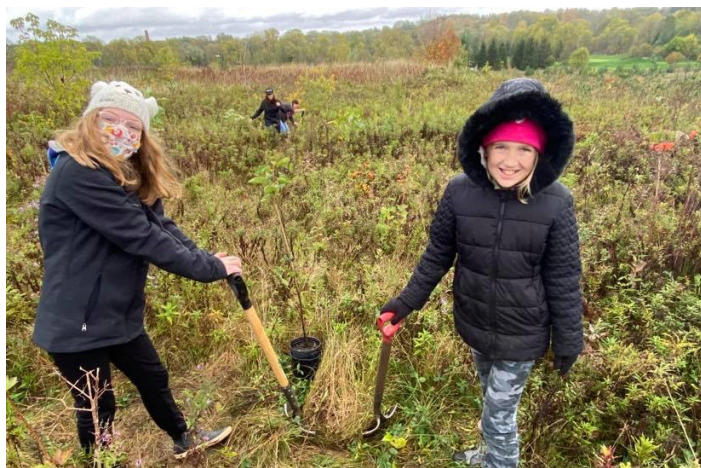
At Burgess Park, the UTRCA and City of Woodstock installed wetlands, undertook erosion control work, and seeded a two acre tallgrass prairie. With the assistance of students and community groups, trees and shrubs have been planted to increase biodiversity in the area.
