**Riverview Dyke  
Vegetation Management Plan  
November 2009**

UPPER THAMES RIVER  
CONSERVATION AUTHORITY

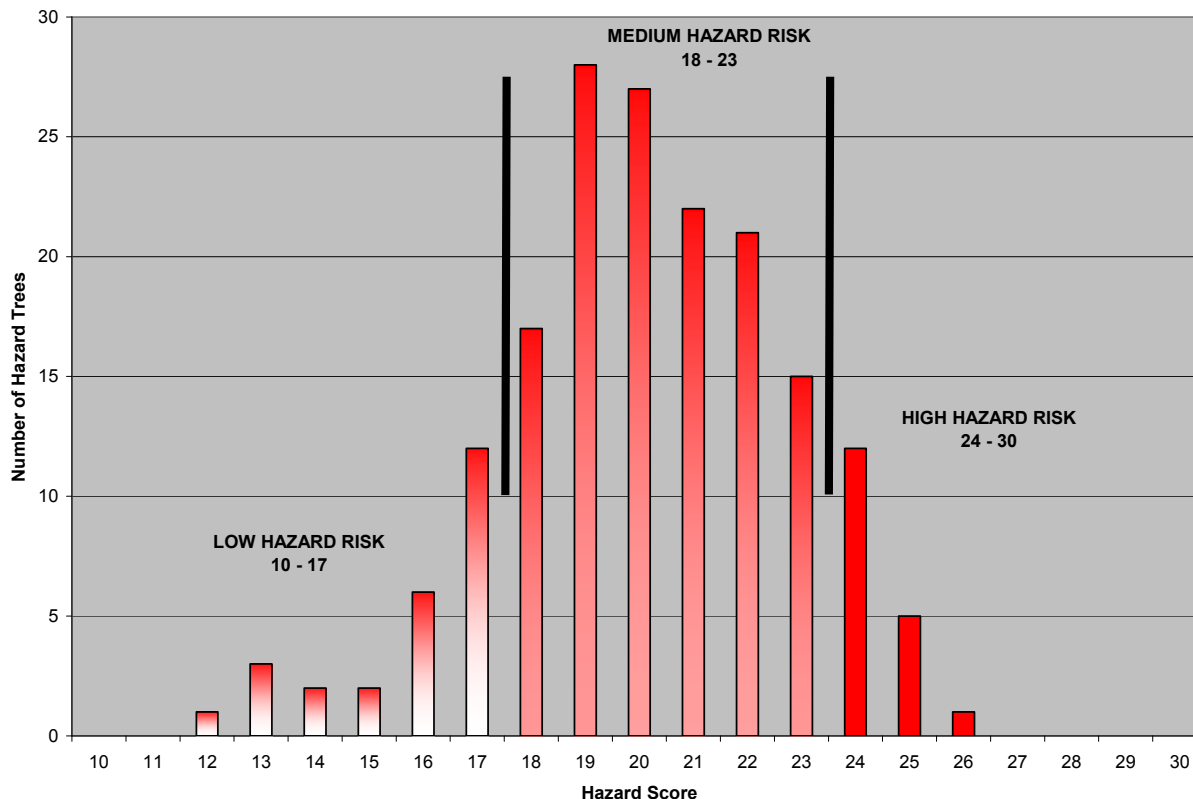
**Chart 1. Distribution of Hazard Tree Scores on Riverview Dyke**

**Appendix D** shows the UTRCA hazard rating for each criterion, as well as the final hazard rating score, for each tree on the Riverview dyke. Many trees on the steep slopes had significant lean or had fallen over. **Chart 1** shows that of the 174 trees on the Riverview dyke, 18 trees were ranked high (10%), 130 trees were ranked medium (75%) and 26 trees were ranked low (15%) in terms of their priority for removal.

**Appendix D** shows that out of the 174 trees on the dyke:

- 67% are species that are prone to structural defects
- 65% have a diameter >25cm DBH
- 47% have a lean of 10° or greater
- Most of the trees that show low to moderate signs of insect damage (59% and 39% respectively) also had low to moderate signs of death and decay (30% and 60% respectively)

- 10% of the trees were dead
- 65% of the trees had no signs of wildlife
- Approximately half of the 174 trees could potentially damage private / public property (i.e., 17% of the trees lean towards private / public property and are tall enough to reach it, while an additional 27% of the trees do not lean but are close enough to reach private / public property)

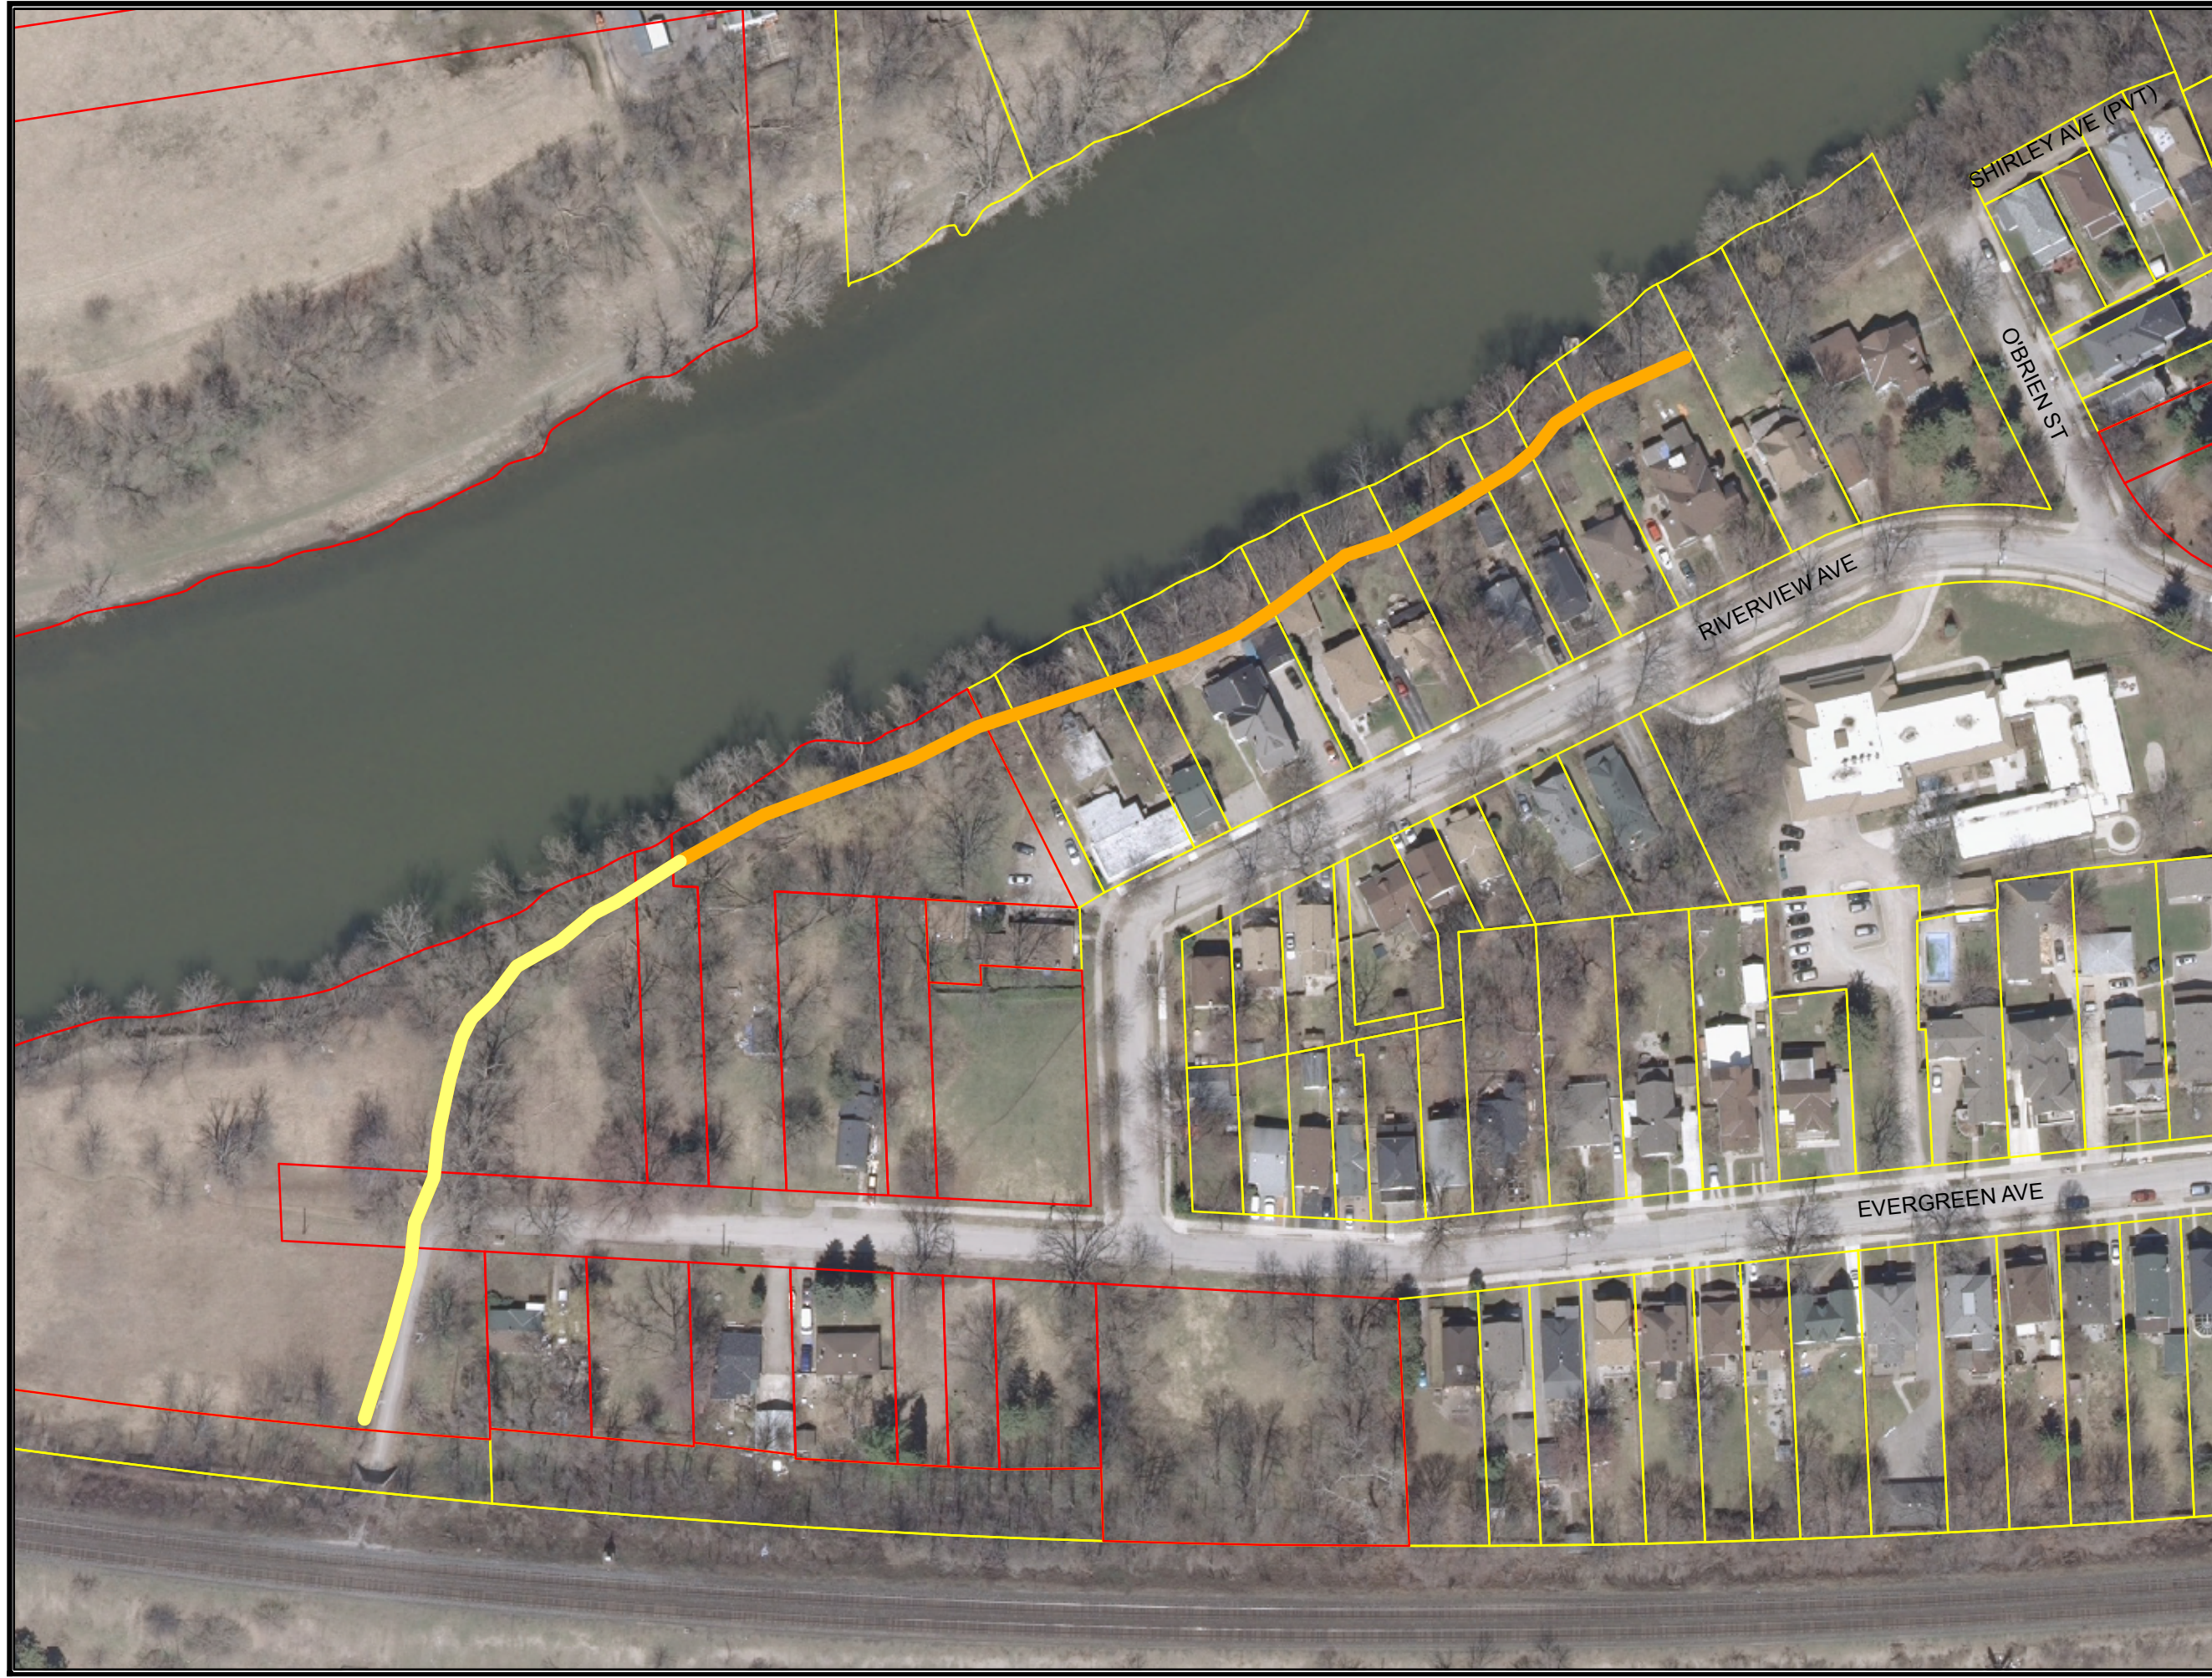
Figure 9  
Location of  
Structural Damage

From Figure: DA06 in the City of London Dyke System by Dougan & Associates, February 2006.  
Dyke Locations provided by the 2004 Inspection for the UTRCA.

A preliminary investigation to evaluate the ability of the dyke to function in the event of a flood (i.e., the structural integrity) was conducted by Dougan & Associates and UTRCA staff on January 6, 2006 to identify risks to all seven dykes in the City of London and then prioritize sections of the dykes by condition (risk category). An additional study was conducted by Stantec in 2008 from sections 0+190 to 0+ 300. In summary, these studies found that:

1. The physical integrity of the dyke is about to be compromised or contains problem species that may lead to hazardous conditions in section 0+000 to 0+275, which is the section that is immediately adjacent to the private homes on Riverview Avenue (**Figure 9 - critical**). This area of the dyke requires immediate action. At this location the dyke is fairly narrow

2. Localized erosion and numerous hazard trees occur throughout section 0+190 to 0+300. To assess the full extent of erosion problems, additional investigation should occur. Hazard trees should be removed. Additionally, steep slopes are found throughout, with emphasis in the vicinity of sections 0+210 and 0+260. At station 0+210, the concrete at the bottom of the headwall is deteriorating and the railing is not fastened due to damage. Remedial work is likely required for the steep slopes, headwall and railing.
