Thorndale Demonstration Farm

In 2021, the UTRCA established a 58 acre demonstration farm near Thorndale, Ontario. The farm is used to research and demonstrate a number of agricultural best management practices (BMPs), and showcase how they can improve and protect soil health and water quality while maintaining productivity in the southern Ontario landscape.

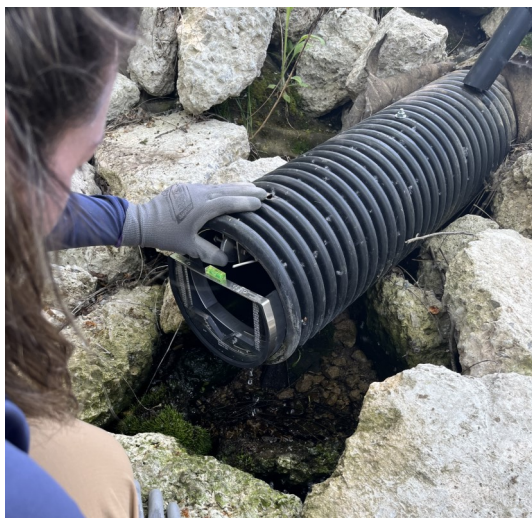
The farm is instrumented to monitor the effectiveness of the contoured controlled drainage system in improving water quality and reducing peak flows during storm events throughout the growing and non-growing seasons, compared to the conventional tile drainage system on the remainder of the field. To do this, each control structure is continuously monitored to assess how much water is being held back in the tile and the duration of time. Event-based water samples are collected to determine water quality differences between the drainage halves over time. Yield data is also collected at harvest to note any differences in productivity between the two treatments. Monitoring began in June, 2023.
